## **HAZARDOUS MATERIALS ASSESSMENT REPORT**

**Client:** Cape Cod Australia Pty. Limited

**Job details:** Owner/s: Mr. A. Whitehead & Ms. A. Robson  
Location: 112 West Street, Crows Nest NSW

**Our reference:** HM04680216

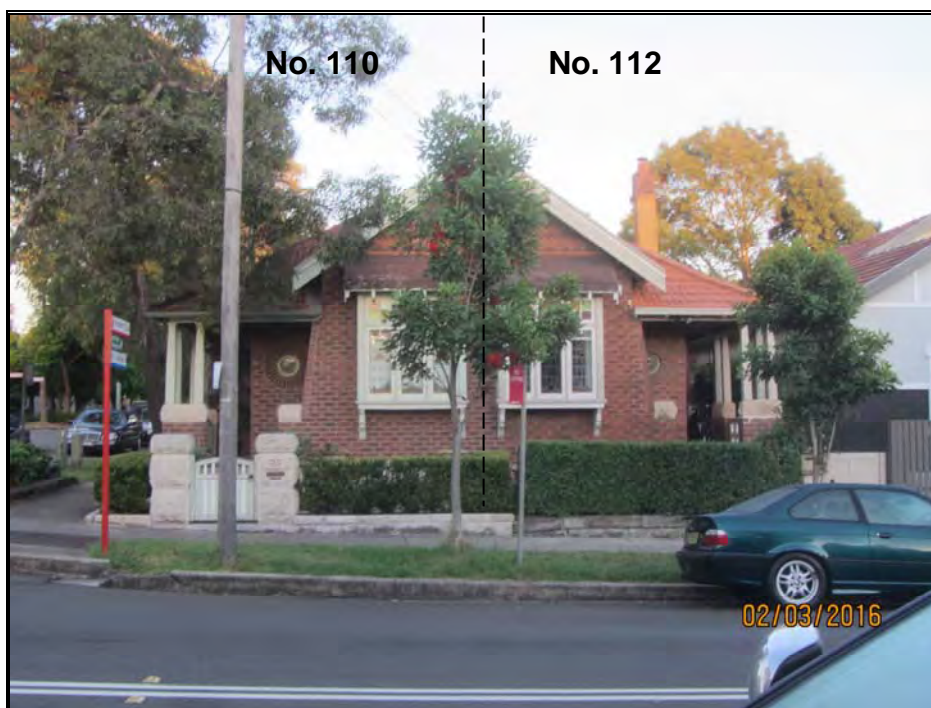
Front eastern elevation of the adjoining properties:  
No. 110 & No. 112 West Street, Crows Nest
