HAZARDOUS MATERIALS ASSESSMENT REPORT

Job details: Owner: Mr. J. & Mrs. K. Swinburn.
Location: 62 Carrington Road, Randwick.

Date of assessment: 24th May 2017

Our reference: HM05680517

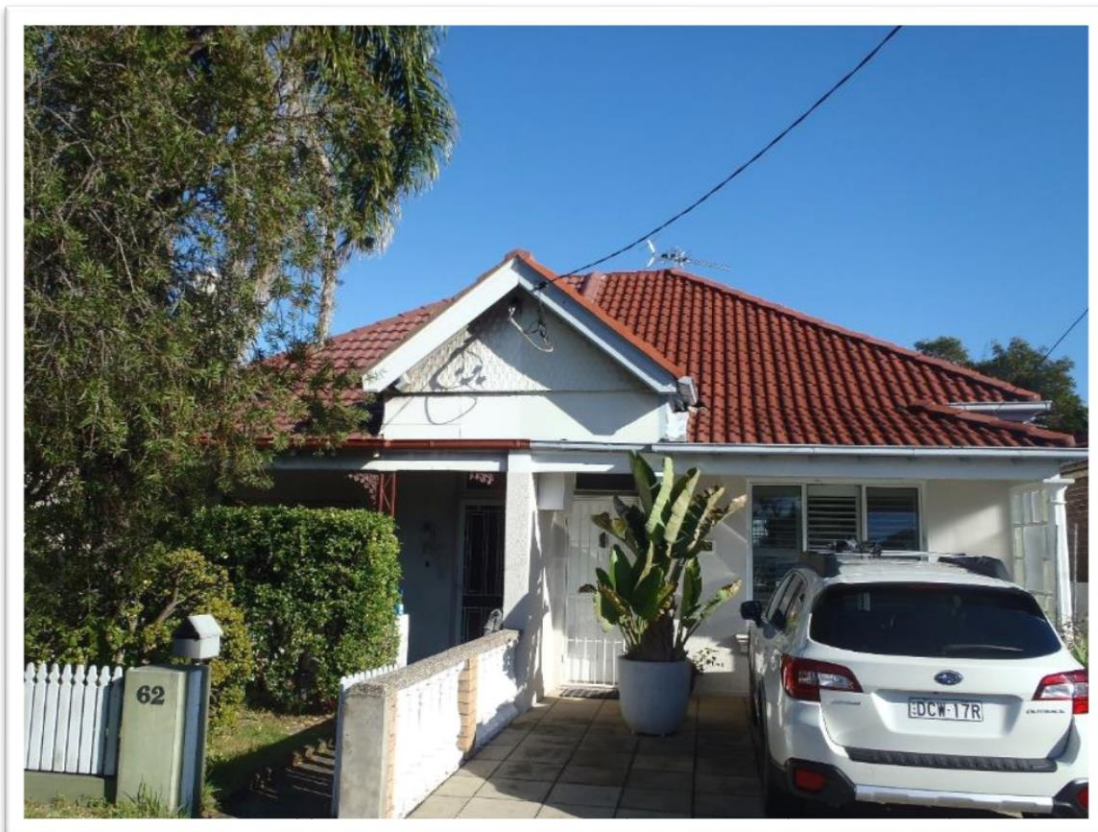
Front eastern elevation of the residence
