## **HAZARDOUS MATERIALS ASSESSMENT REPORT**

**Job details:** Owner/s: Mr. N. & Mrs. R. Perkin  
Location: 21 Australia Avenue, Matraville NSW

**Date of assessment:** 27<sup>th</sup> April 2015

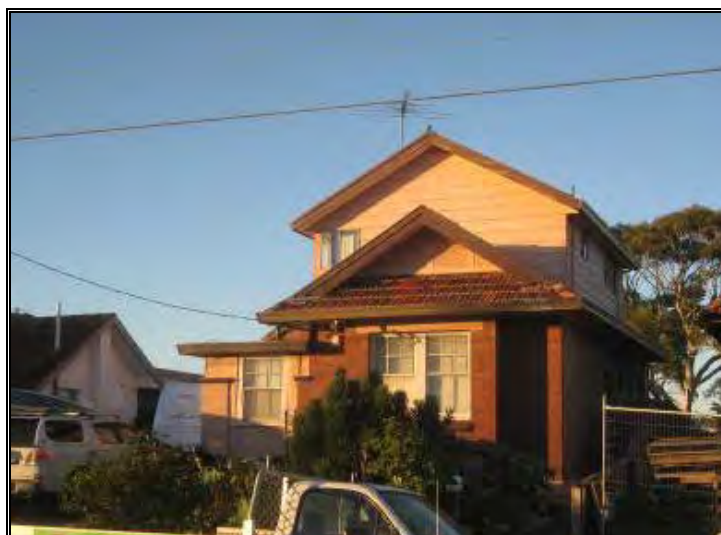
Front northern elevation of the residence
