## **HAZARDOUS MATERIALS ASSESSMENT REPORT**

**Client:** Cape Cod Australia Pty. Limited

**Job details:** Owner/s: Mr. C. & Mrs. N. Forman  
Location: 3 Begonia Street, Pagewood NSW

**Our reference:** HM03451014

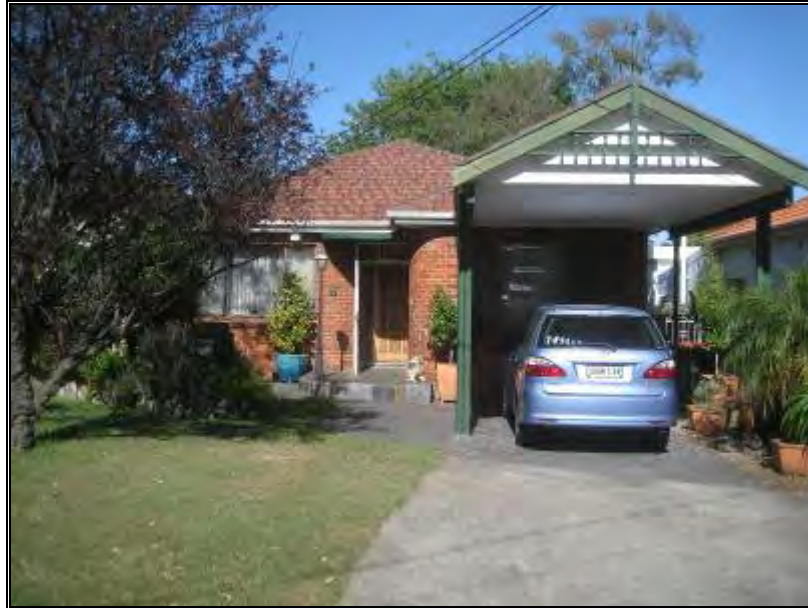
Front eastern elevation of the residence
