## **HAZARDOUS MATERIALS ASSESSMENT REPORT**

**Job details:** Owner/s: Mr. M. & Mrs. C. Norfolk  
Location: 19 Olphert Avenue, Vacluse NSW

**Date of assessment:** 7<sup>th</sup> March 2016

**Our reference:** HM04690216

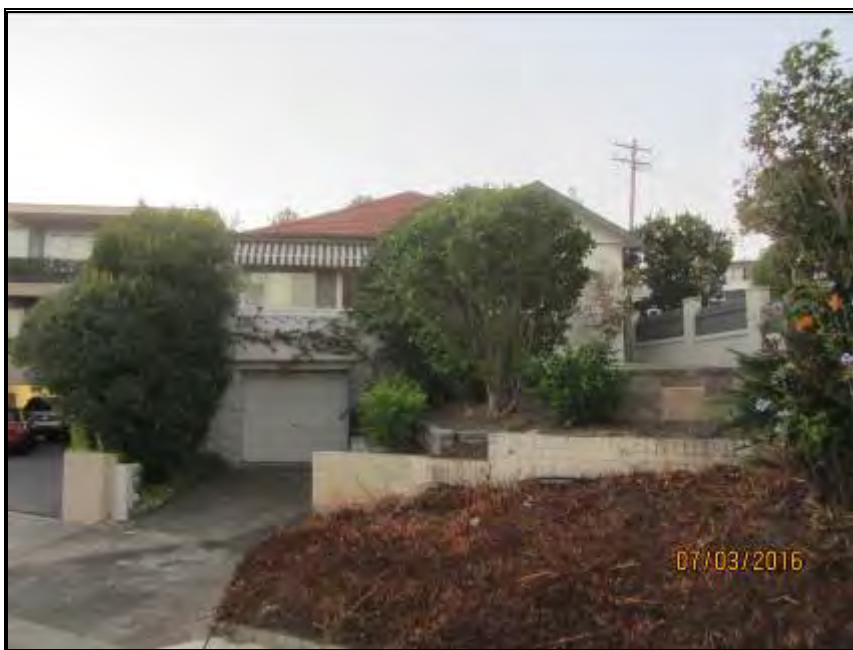
Front northwest elevation of the residence
