Dilapidation Assessment Report

Prepared for: Cape Cod Australia Pty. Limited
Job address: No. 81 Clovelly Road, Randwick.
Property Owner/s: Mr. Kevin Hayes.
Report reference: **RANDWICK CITY COUNCIL**
Development Application No: not available
Date of assessment: 20th January 2017

Re: Dilapidation Report – No. 81 Clovelly Road, Randwick.

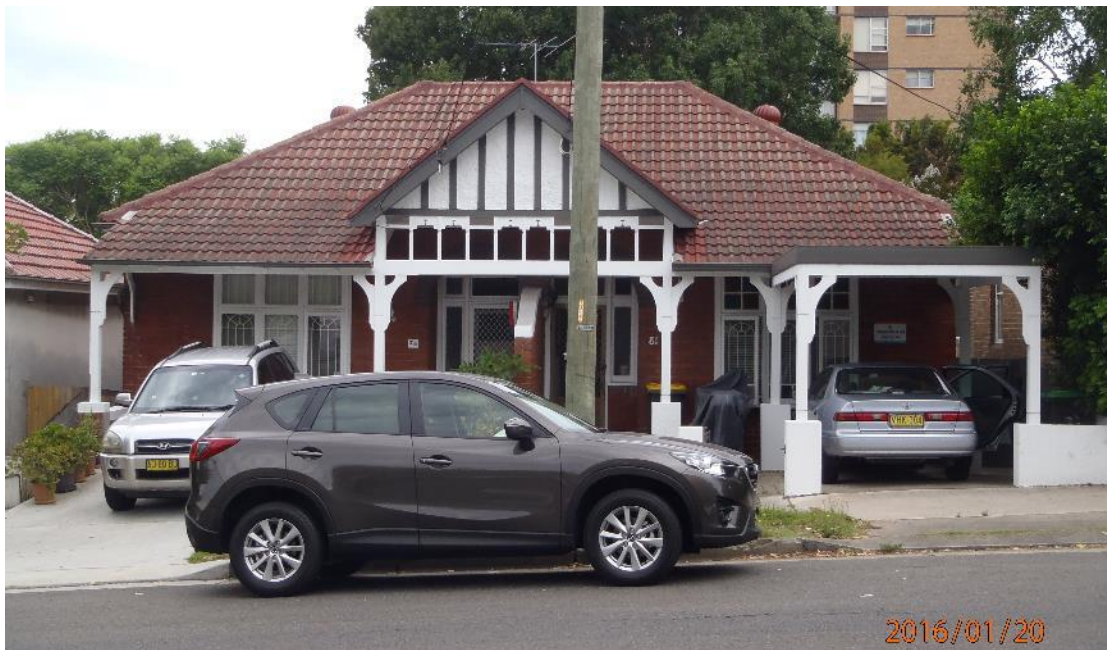
Shows the front western elevation of the adjoining properties:
No. 79 and No.81 Clovelly Road, Randwick.

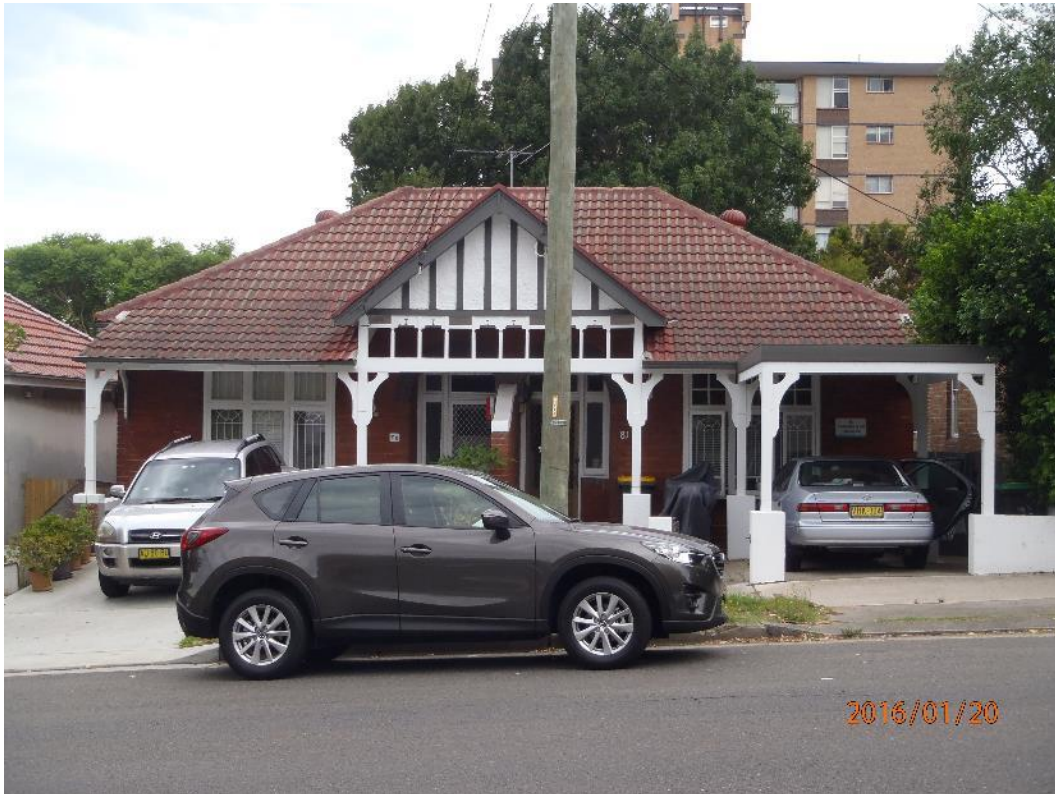
We observed that the concrete roof tiles to the original roof surfaces are generally interlinked and securely bedded, in our opinion forming a weather resistant cover to the residence. **[Photograph 1]**

Photograph 1 shows the general front elevation of the adjoining properties.

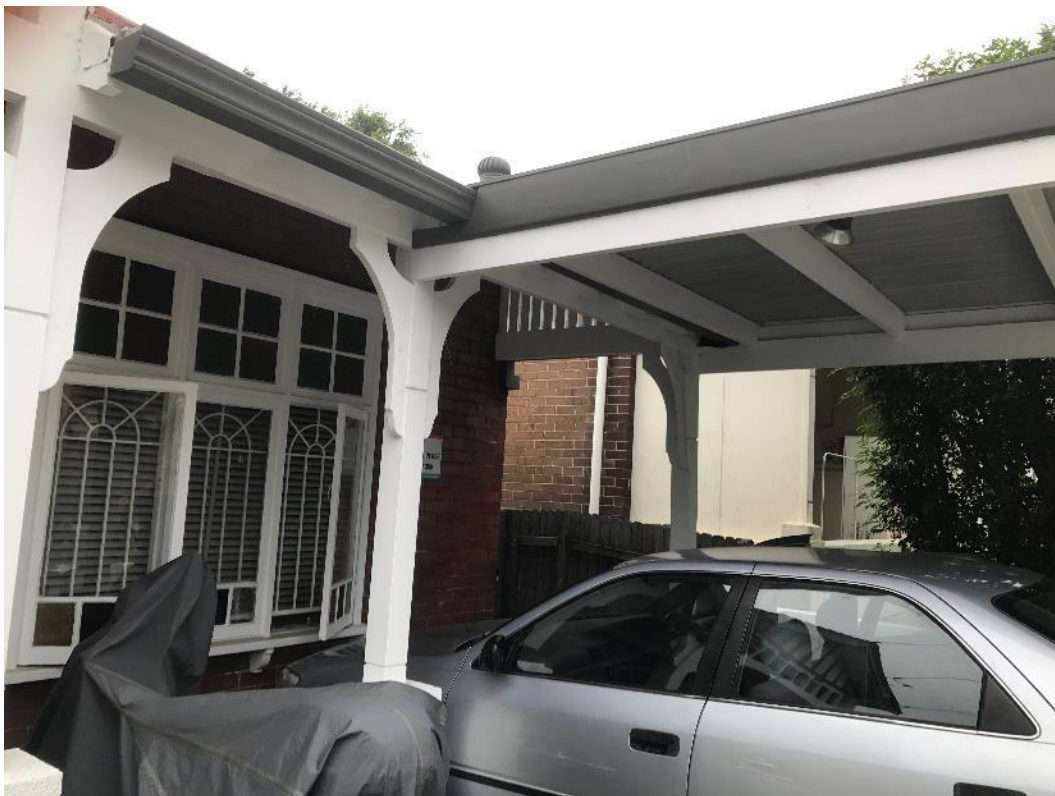
We noted a timber framed carport structure with pre-finished corrugated profile sheet metal roofing. **[Photograph 2]**

Photograph 2 shows the timber framed carport structure.

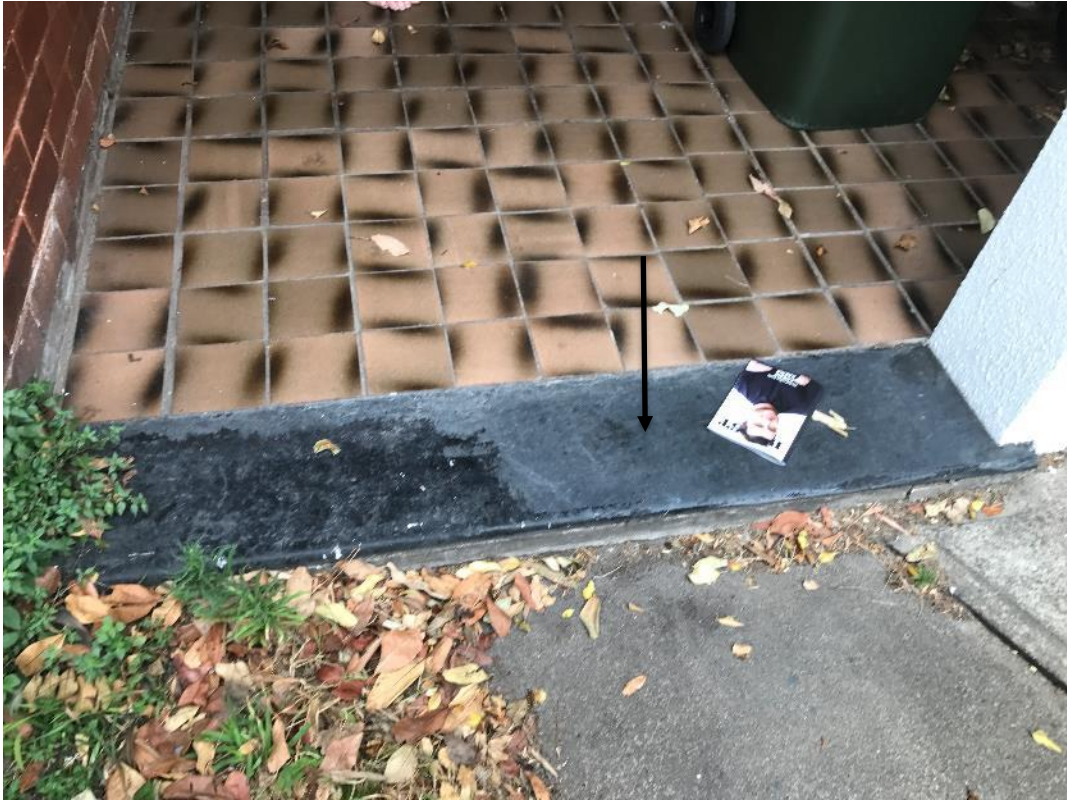
We noted that the tiles to the front verandah were generally sound with some chips and the grout was complete. **[Photograph 3 & 4]**

We noted deterioration to the surface coating on the front verandah threshold step. **[Photograph 3]**

Photograph 3 shows deterioration to the surface coating on the front verandah threshold step.

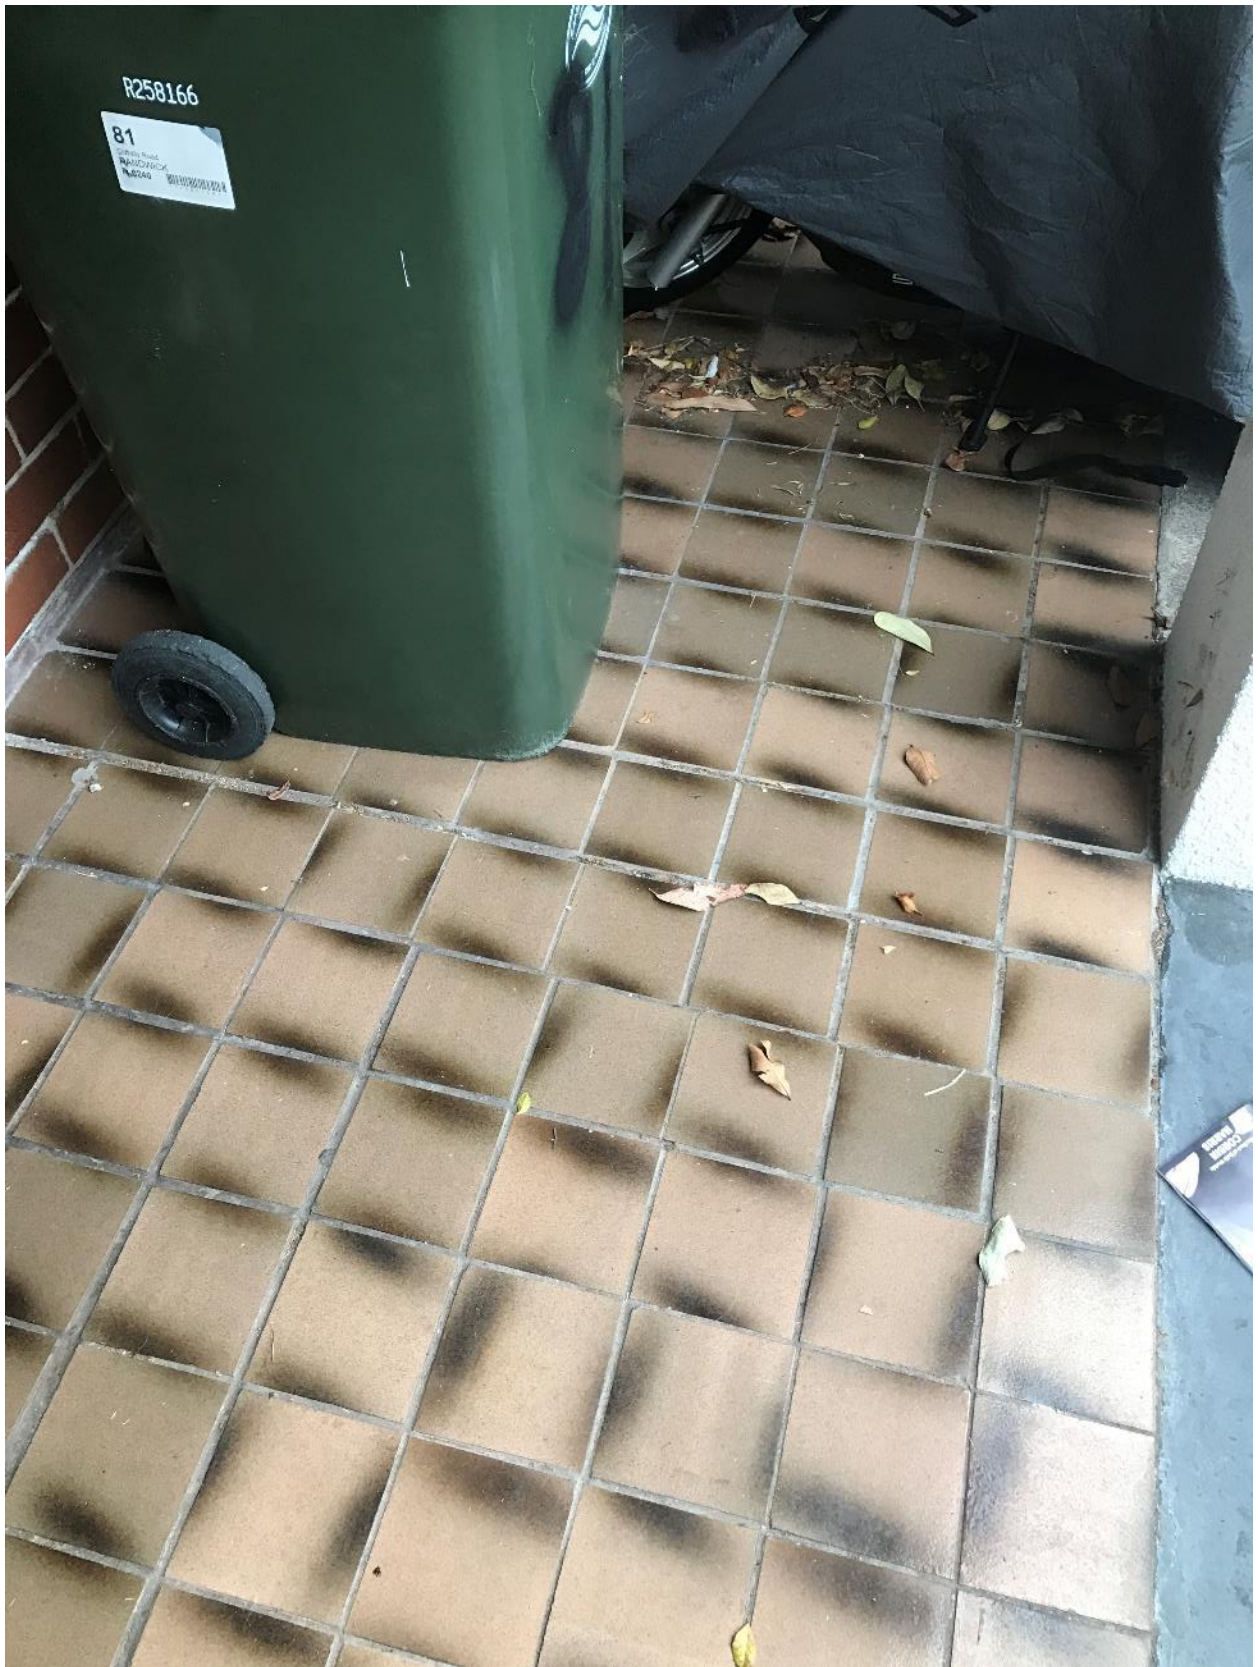
Photograph 4 shows the general condition of the front verandah tiles.

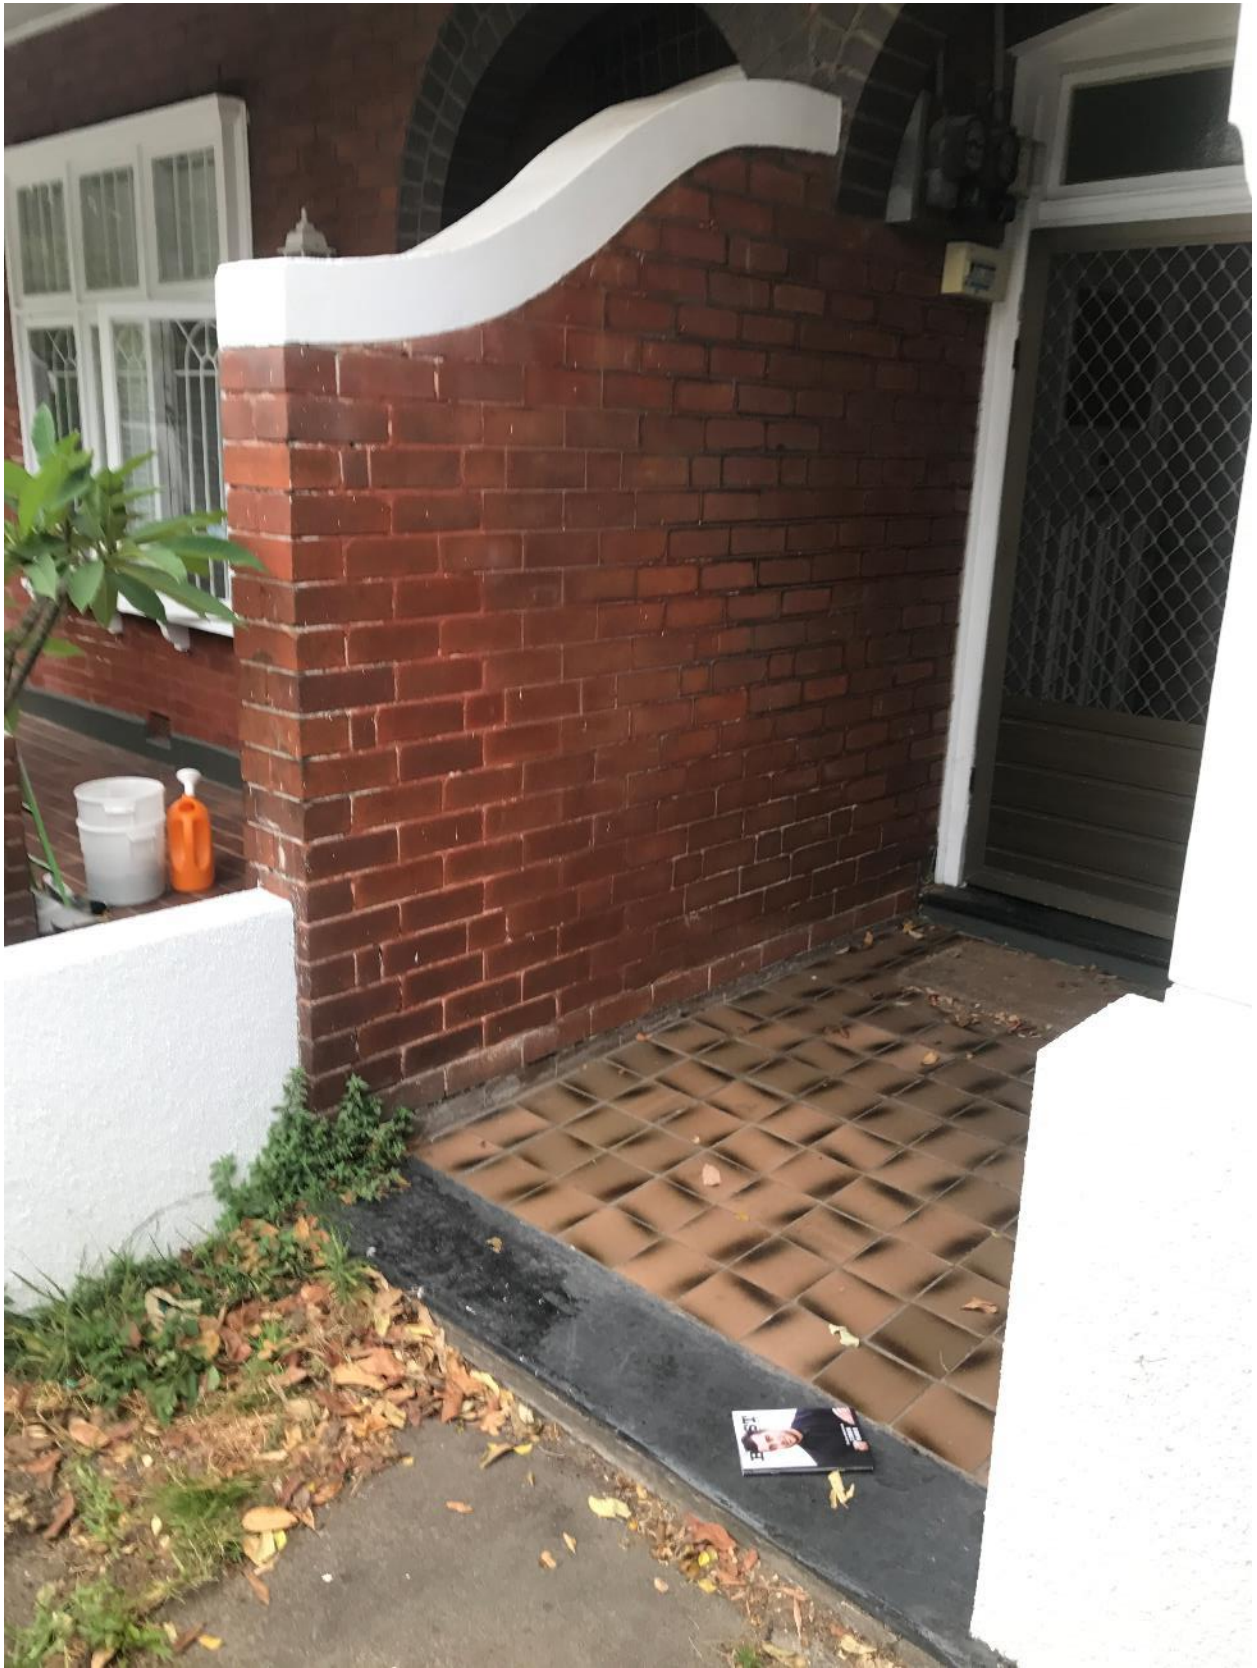
We noted a clay masonry brick common privacy wall with the adjoining property, No. 79 Clovelly Road, Randwick to the front verandah. **[Photograph 5]**

Photograph 5 shows the clay masonry brick common privacy wall with the adjoining property, No. 79 Clovelly Road, Randwick.

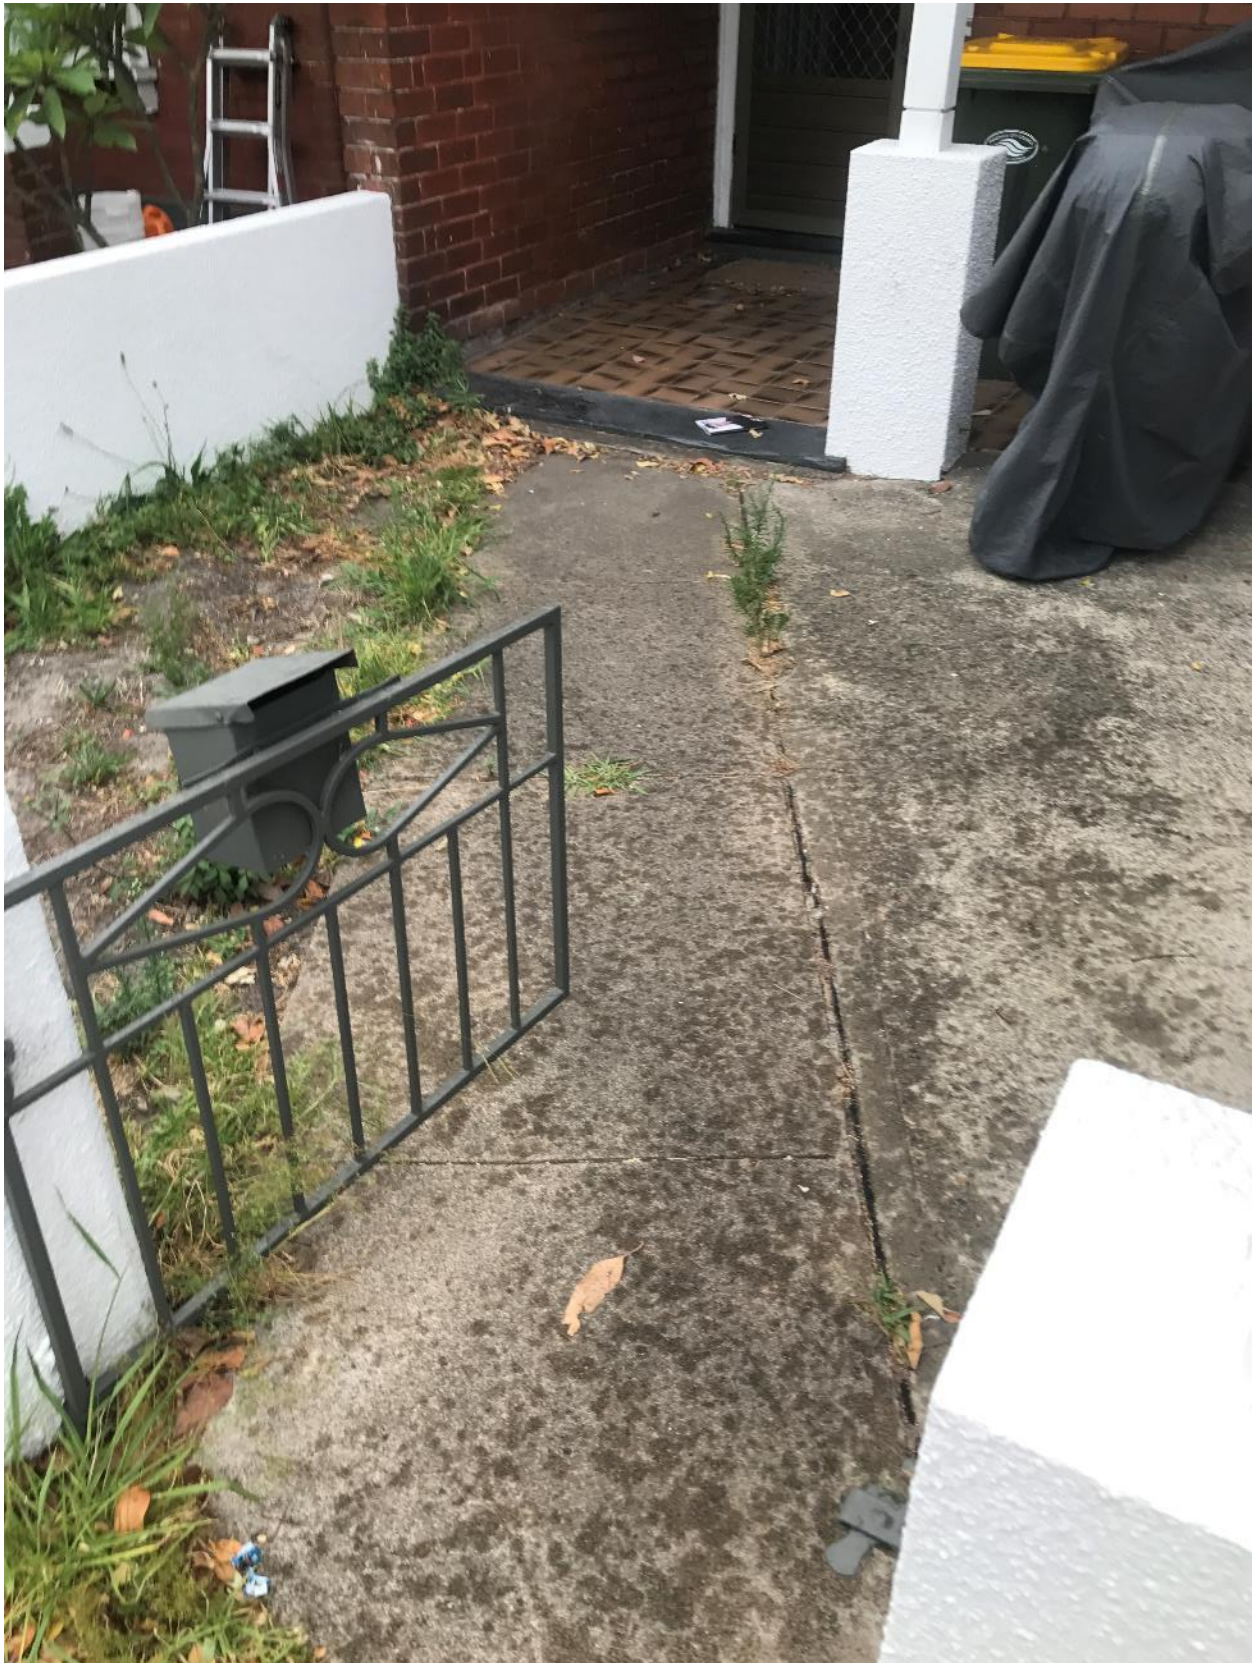
We noted a concrete driveway and entry path to the front of the residence. We further noted vegetation growth through the joins in the concrete path. **[Photograph 6]**

Photograph 6 shows the general condition of the concrete driveway and entry path.

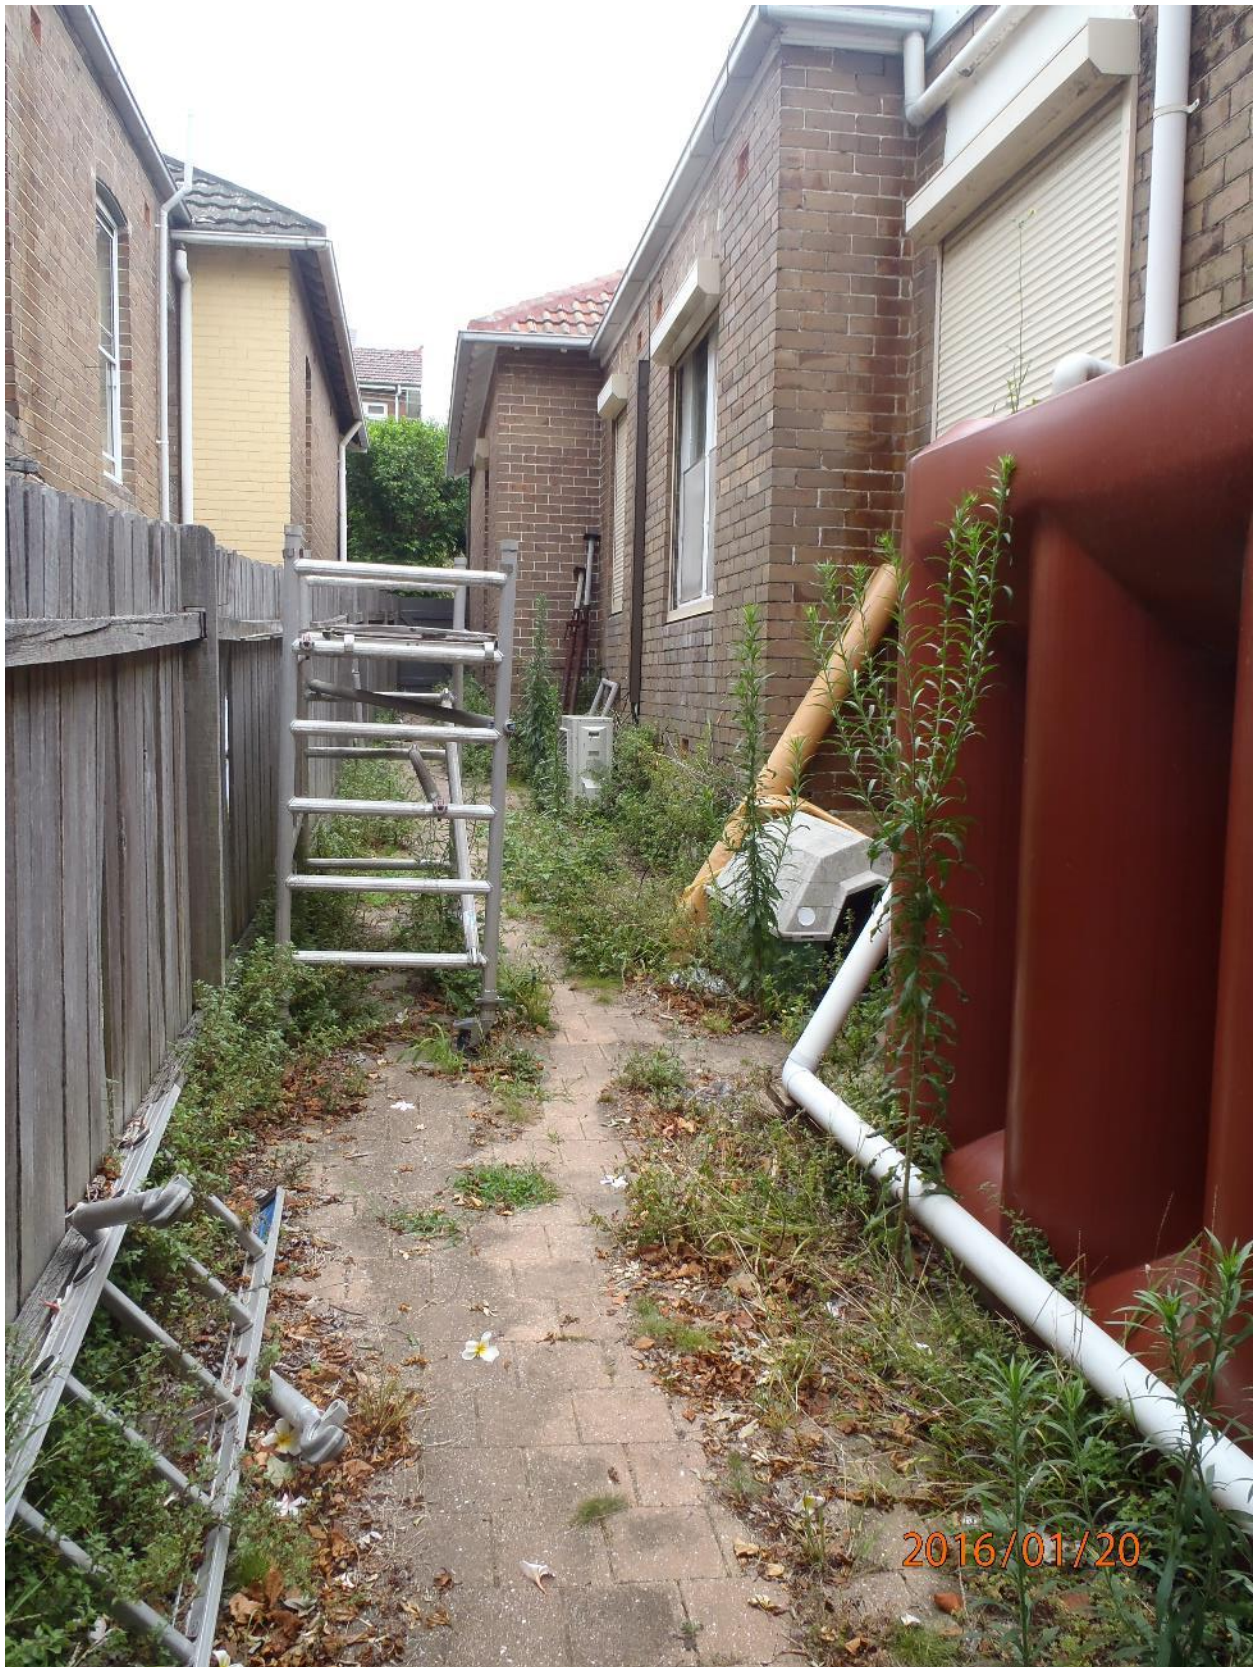
We noted significant vegetation growth through the paved side pathway of the residence. **[Photograph 7]**

Photograph 7 shows the general condition of the paved side pathway of the residence.

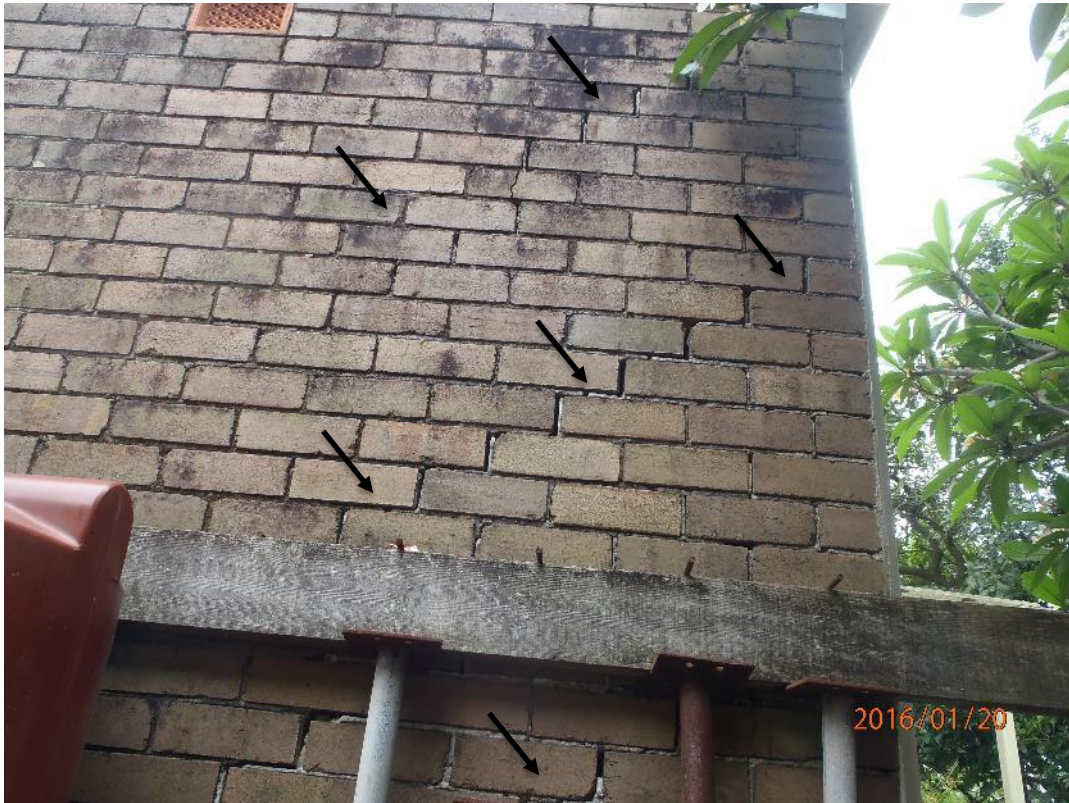
We noted step cracking to the clay masonry brickwork and displaced mortar in the south-eastern corner. **[Photograph 8]**

Photograph 8 shows step cracking to the clay masonry brickwork and displaced mortar in the south-eastern corner.

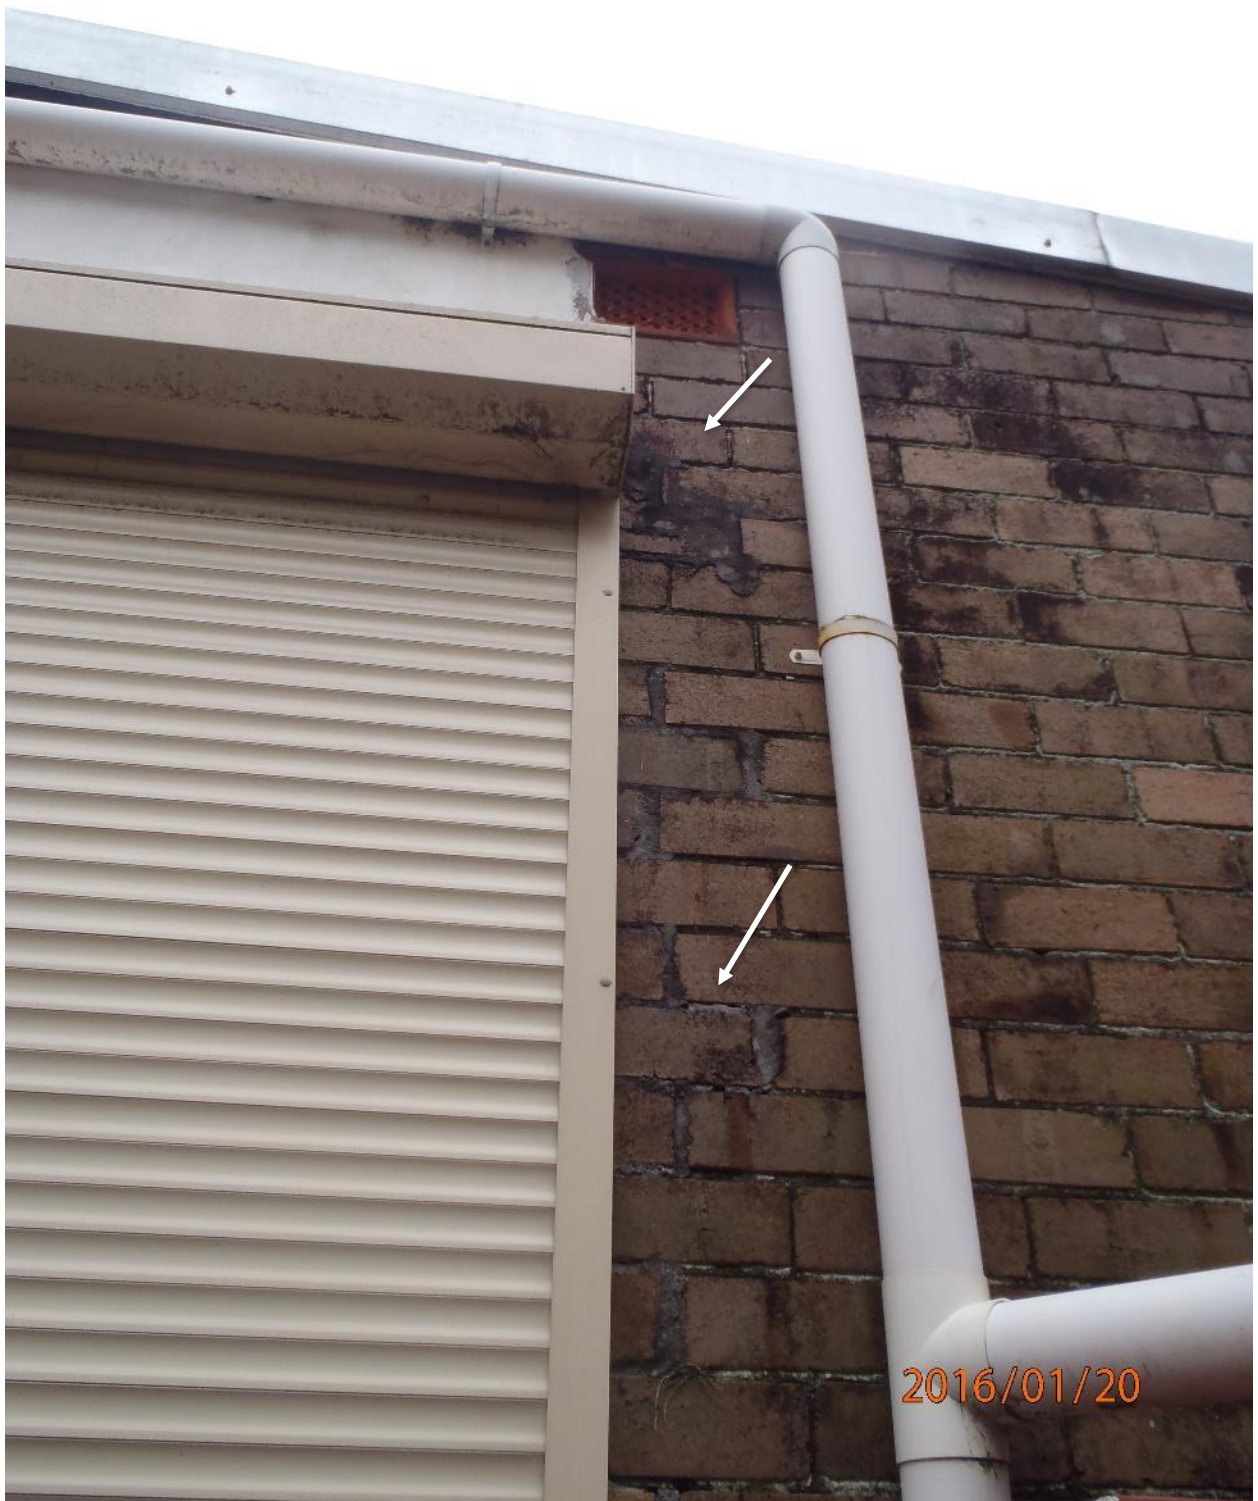
We noted evidence of previous repairs adjacent to the roller shutter outside the study window. **[Photograph 9]**

Photograph 9 shows evidence of previous repairs adjacent to the roller shutter outside the study window.

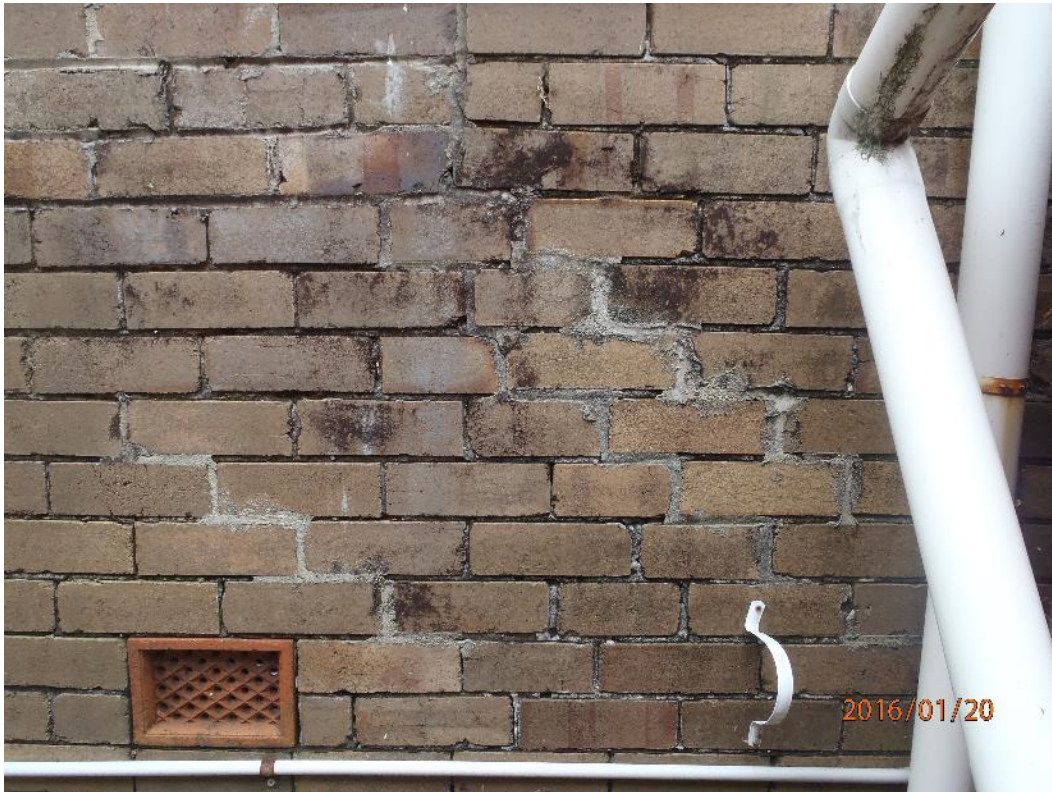
We noted evidence of previous repairs under the roller shutter outside the study window.

Photograph 10 shows evidence of previous repairs under the roller shutter outside the study window.

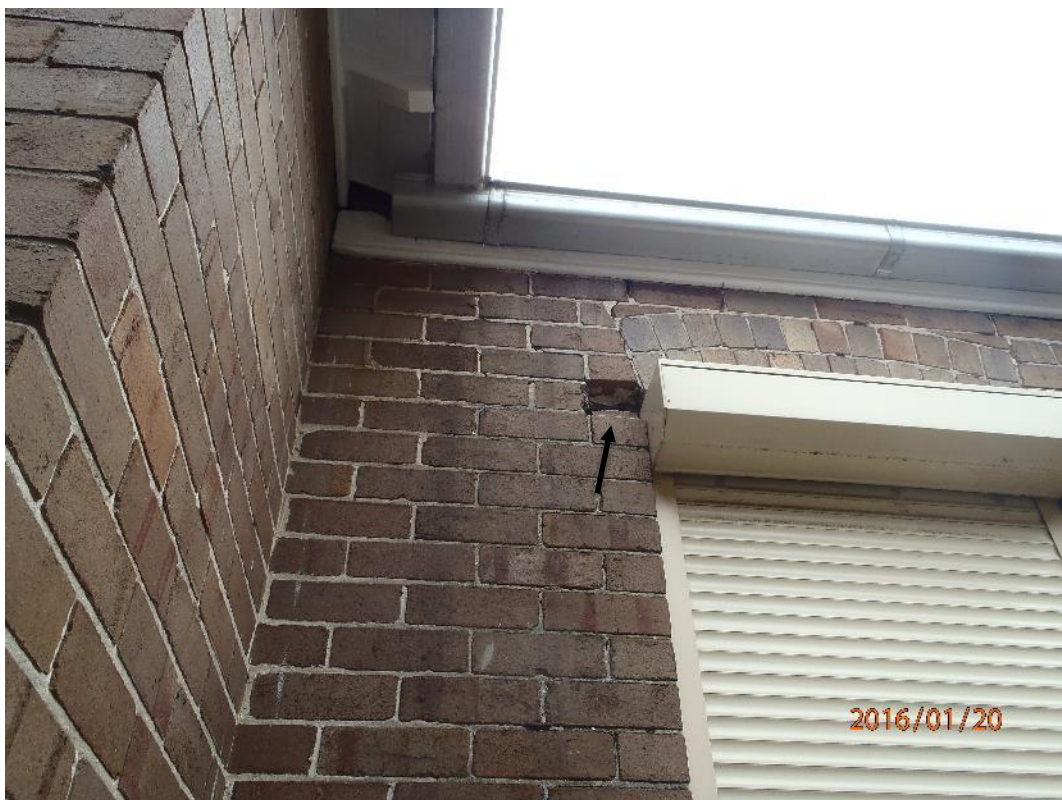
We noted displaced brickwork adjacent to the window head arch outside the Bedroom 3 / Store room window. **[Photograph 11]**

Photograph 11 shows displaced brickwork adjacent to the window head arch outside the Bedroom 3 / Store room window.

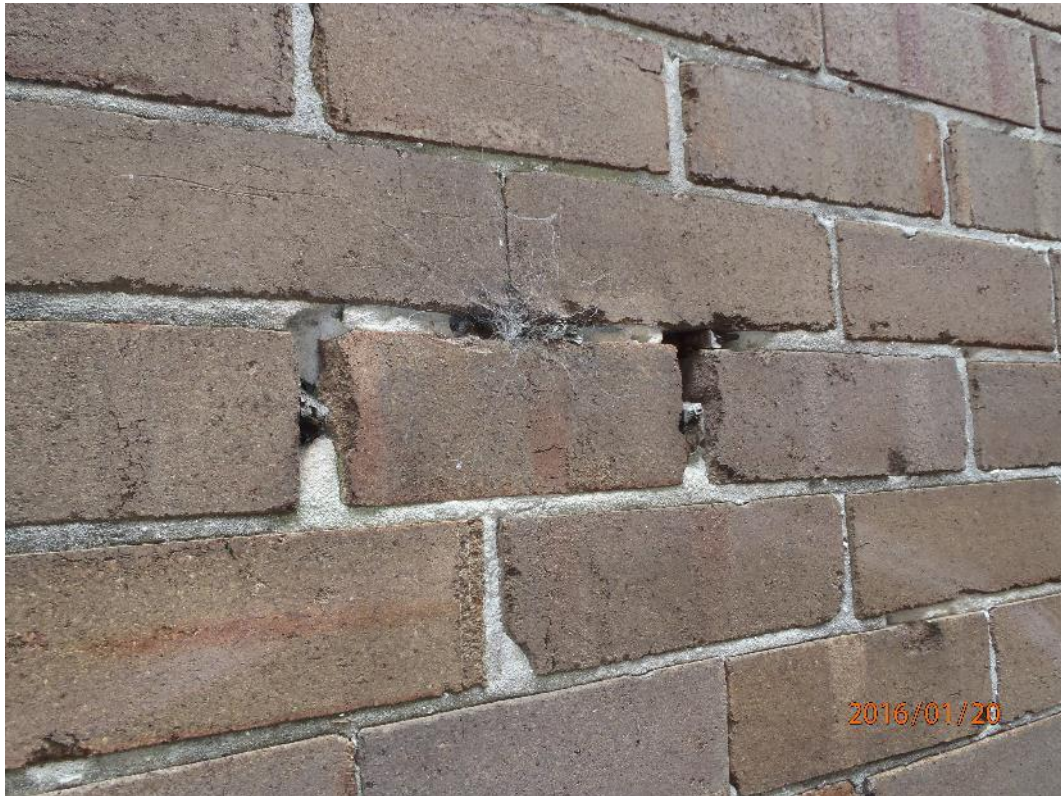
We noted general displacement of the mortar to the clay masonry brick wall surface.

Photograph 12 shows general displacement of the mortar to the clay masonry brick wall surface.

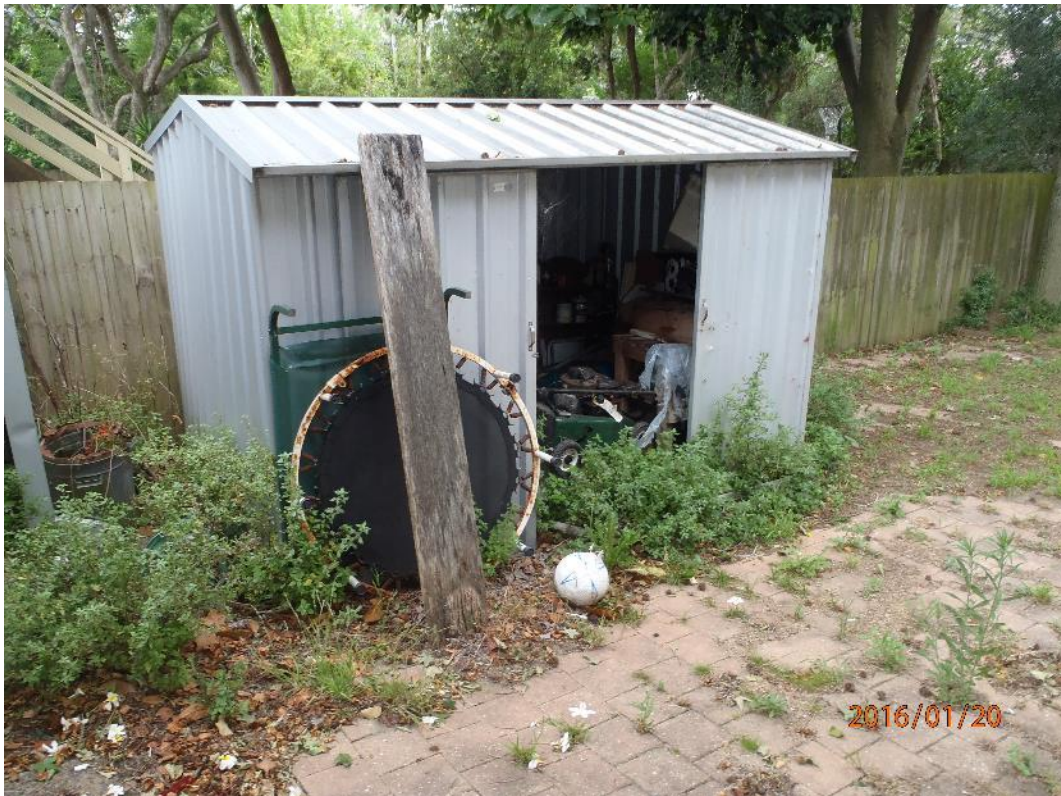
We noted that there is a timber post and rail *common* boundary fence wall with the adjoining property, No. 79 Clovelly Road, Randwick. **[Photograph 13]**

Photograph 13 shows the rear *common* boundary fence wall with the adjoining property, No. 79 Clovelly Road, Randwick.

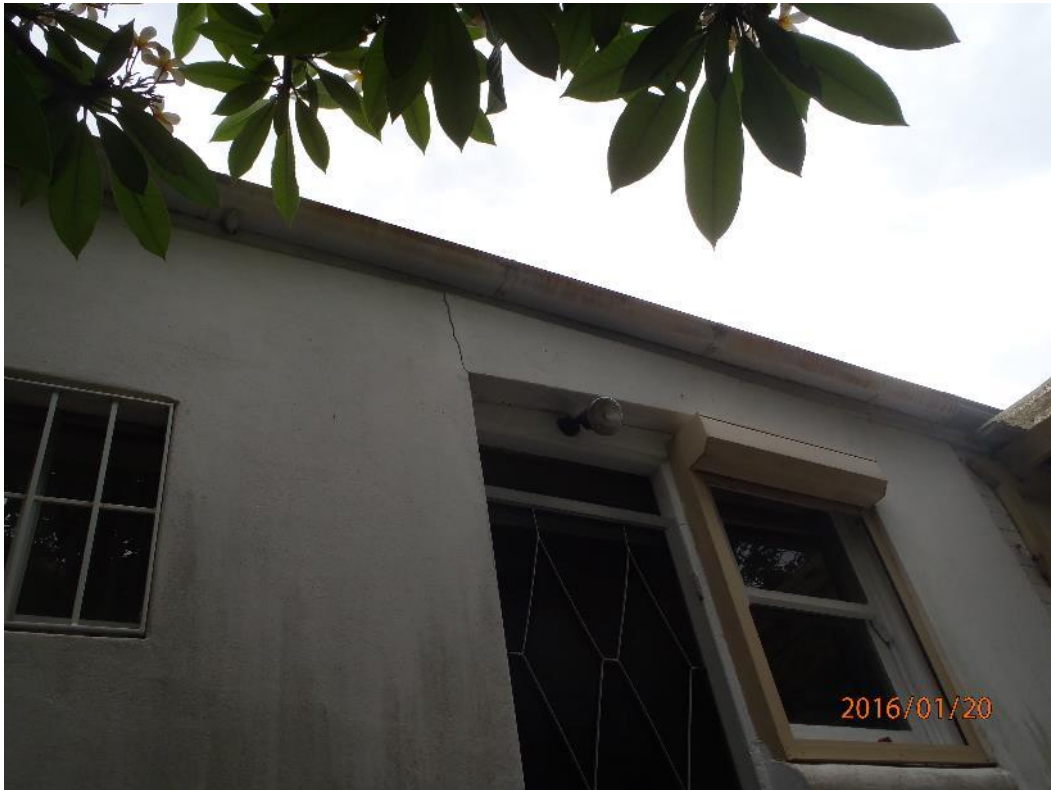
We noted vertical cracking [1mm - 3mm] extending above the rear door head toward the roof.

Photograph 14 shows vertical cracking extending above the rear door head toward the roof.

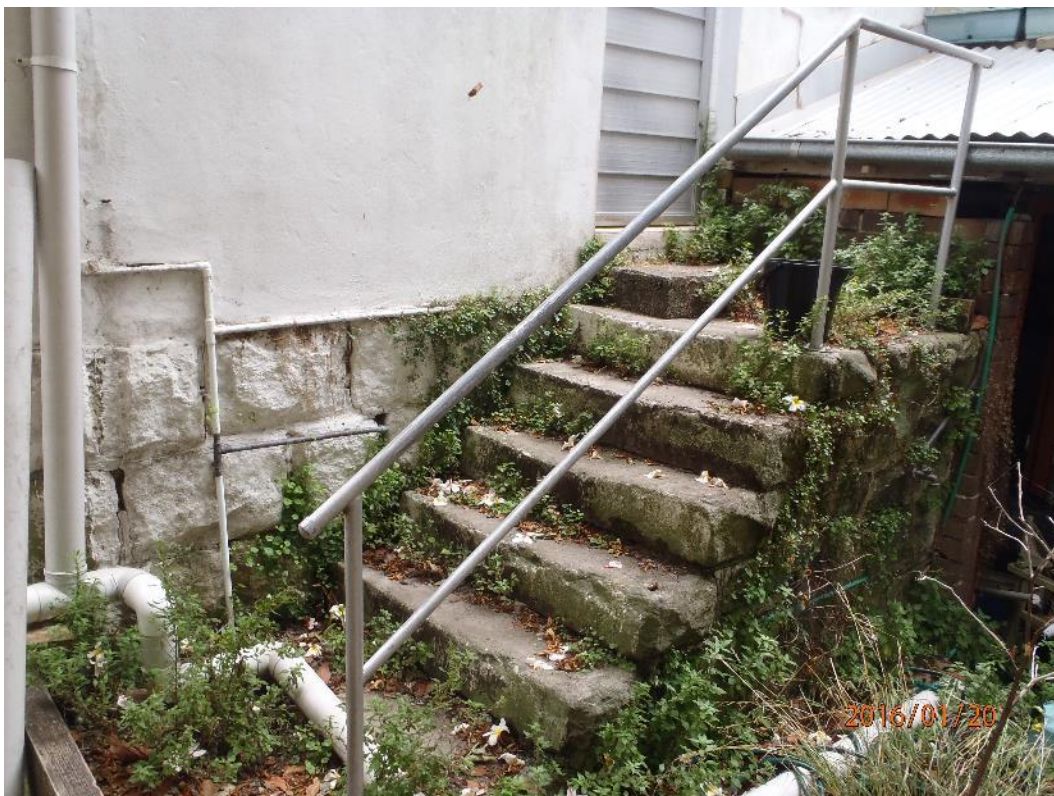
We noted vegetation growth to the sandstone block rear steps. **[Photograph 15]**

Photograph 15 shows vegetation growth to the sandstone block rear steps.

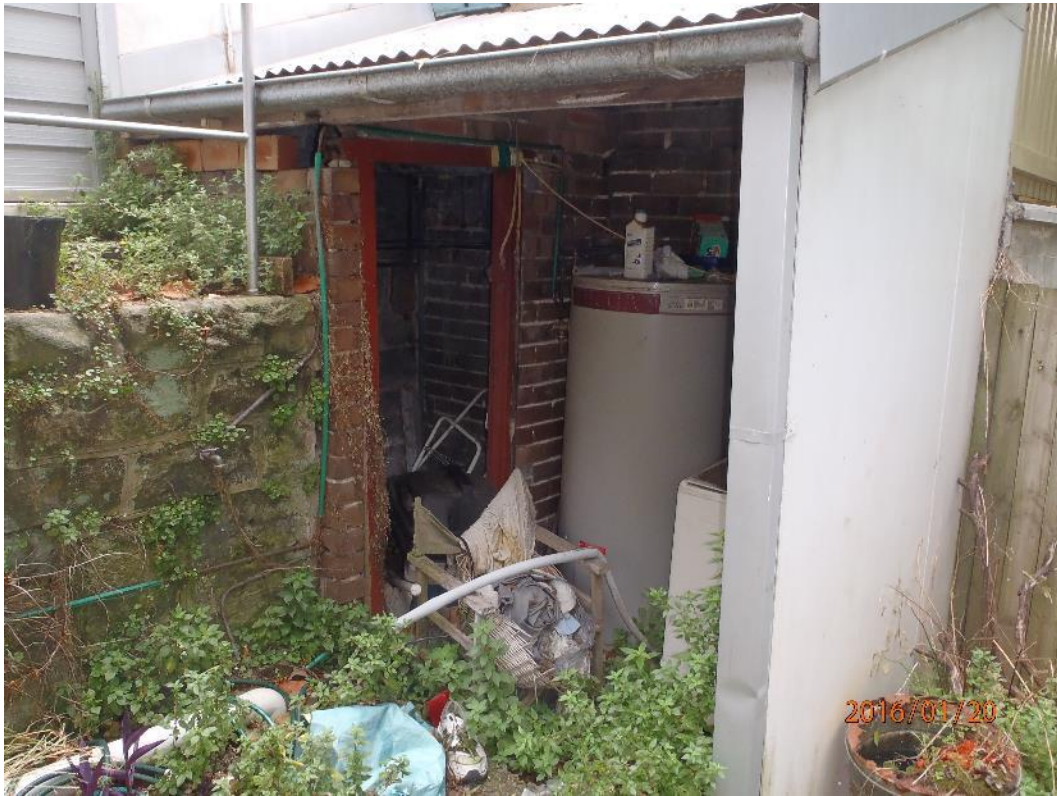
We noted a disused toilet and laundry encompassing the *common* party / separation wall with the adjoining property, No. 79 Clovelly Road, Randwick. **[Photograph 16]**

Photograph 16 shows the disused toilet and laundry encompassing the *common party / separation* wall with the adjoining property, No. 79 Clovelly Road, Randwick.

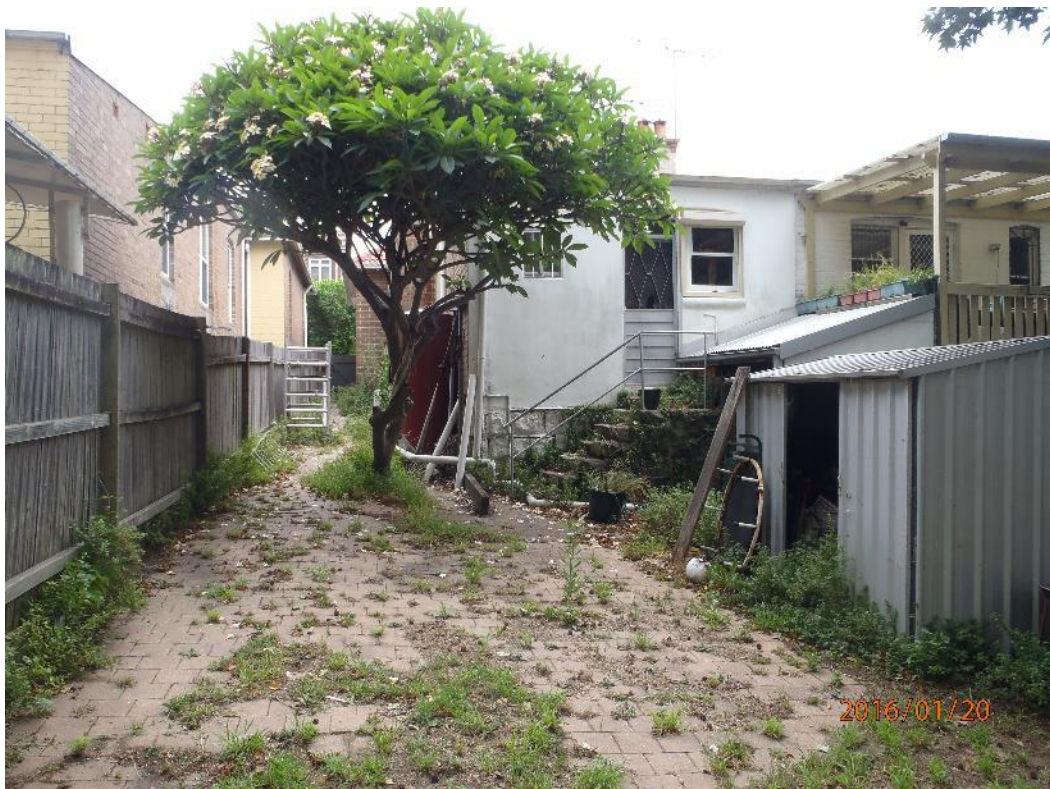
We noted the rear of the property is paved with clay masonry pavers. **[Photograph 17]**

Photograph 17 shows the general condition of the rear of the property.
