Dilapidation Assessment Report

Prepared for: Cape Cod Australia Pty. Limited
Job address: No. 81 Clovelly Road, Randwick.
Property Owner/s: Mr. Kevin Hayes.
Report reference: **RANDWICK CITY COUNCIL**
Development Application No: not available
Date of assessment: 20th January 2017

Re: Dilapidation Report – No. 81 Clovelly Road, Randwick.

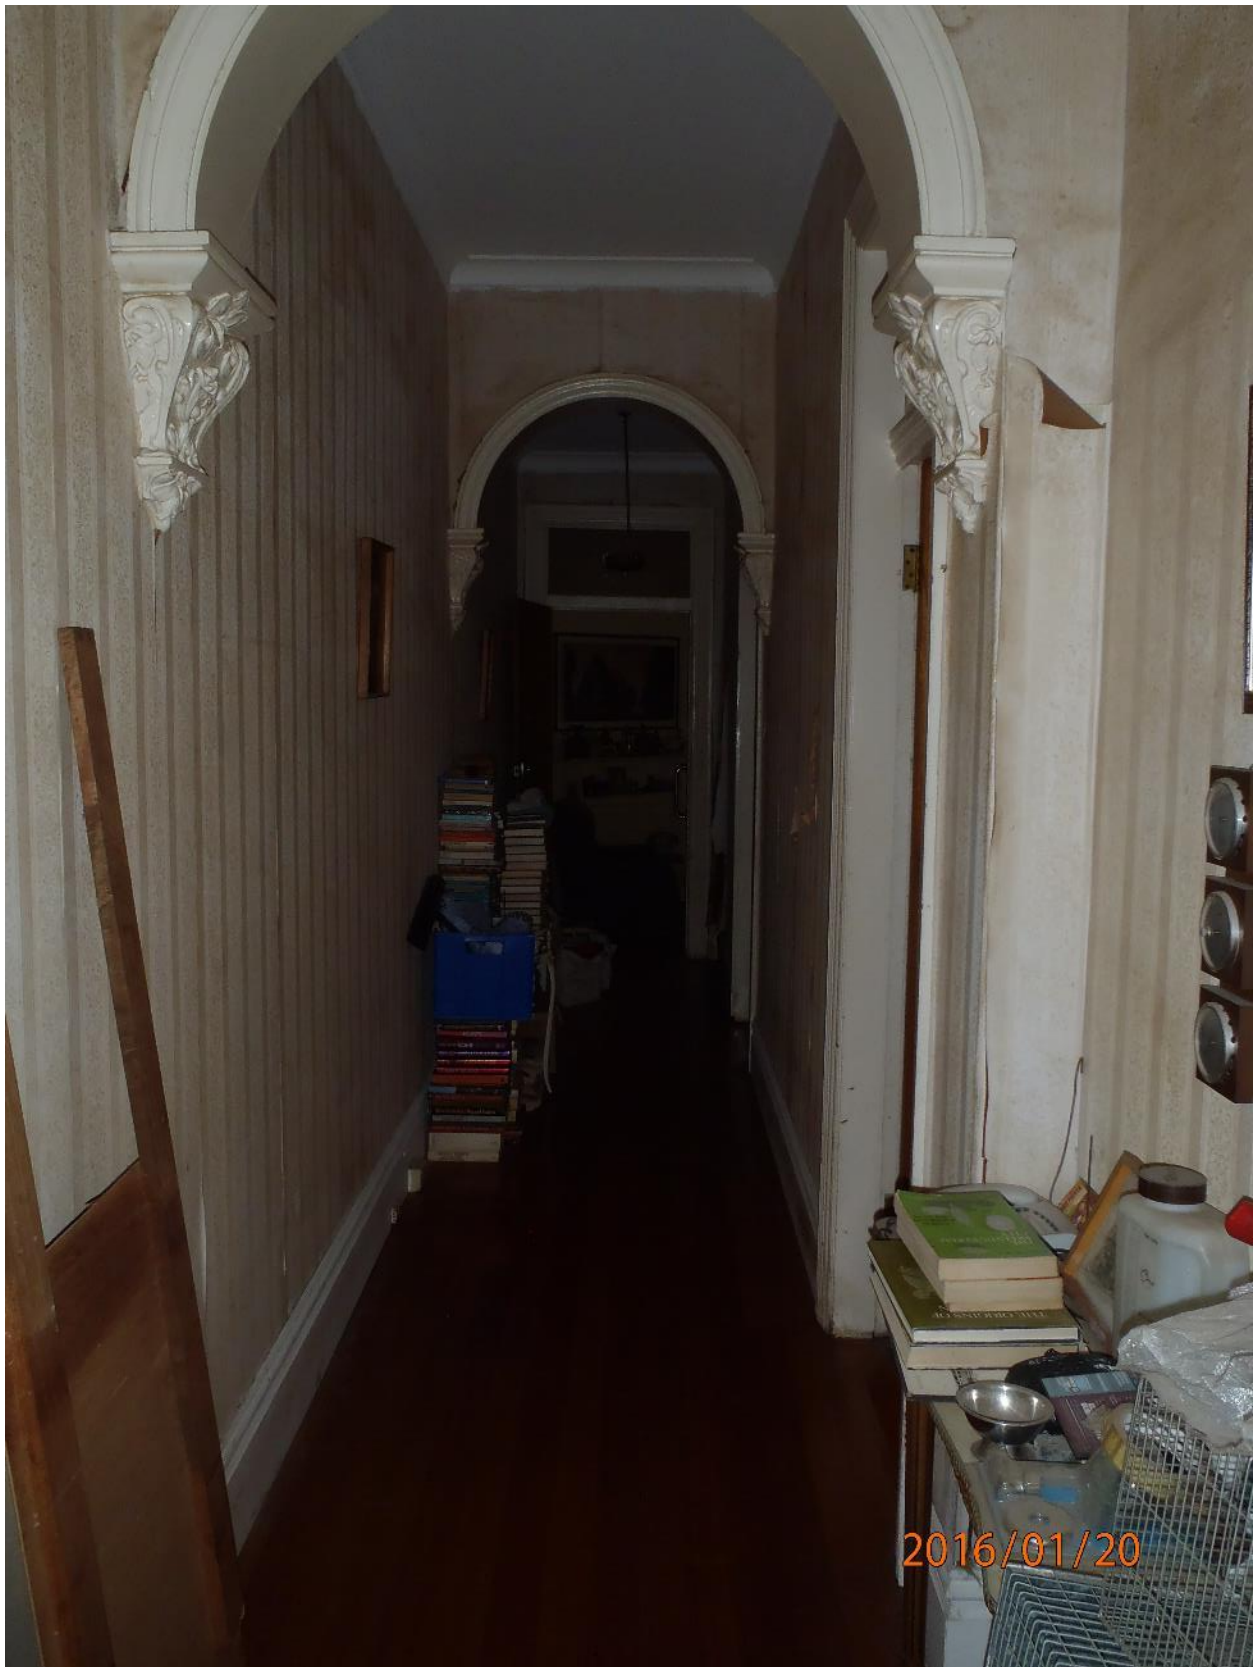
We noted that the hallway cement rendered walls were lined with wallpaper. We further noted general deterioration and staining to the wallpaper surface including along the *common* party / separation wall with the adjoining property, No. 79 Clovelly Road, Randwick. **[Photograph 18]**

Photograph 18 shows the general condition of the hallway.

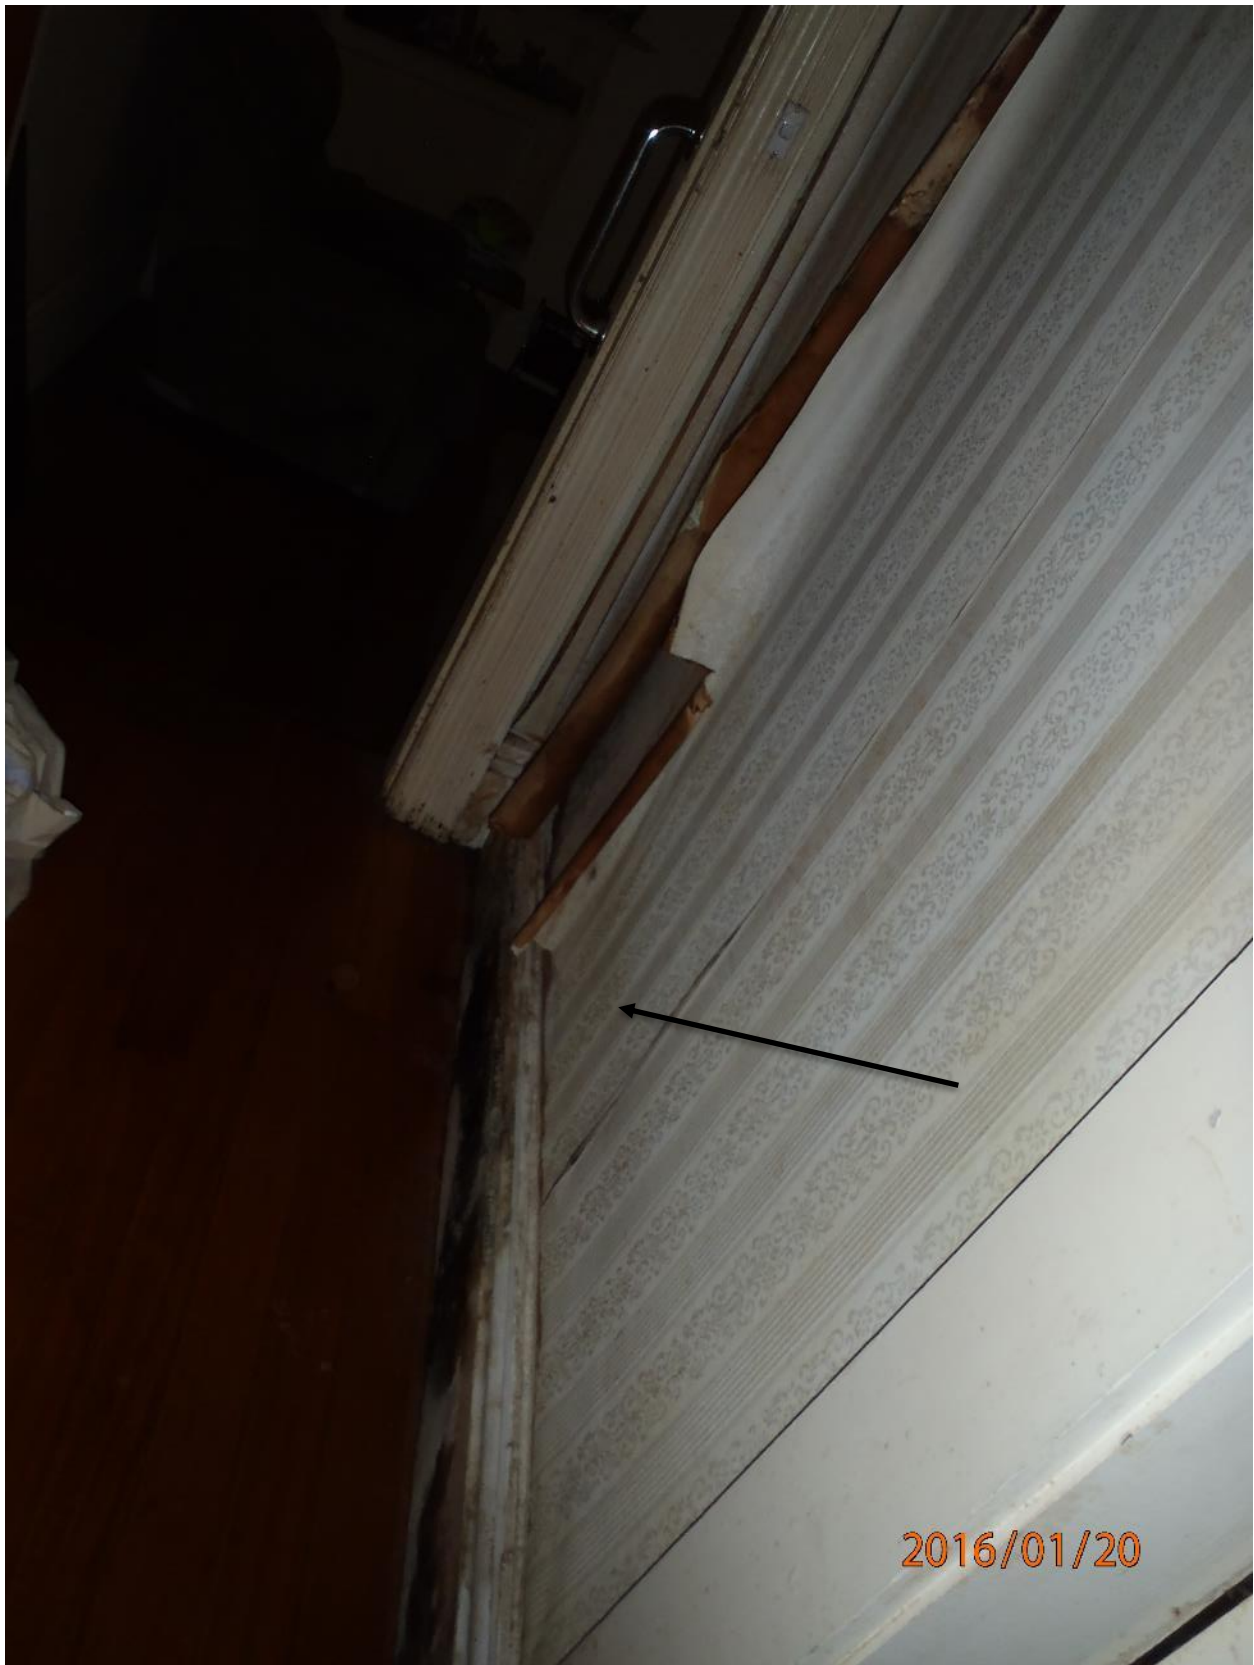
We noted areas of mould growth and lifting / flaking wallpaper to the internal wall common with Bedroom 3 / Store. This, in our experience, is consistent with rising damp. **[Photograph 19]**
We further noted that this wall was opposite to the leaking disused shower. **[Photograph 20]**

Photograph 19 shows areas of mould growth and lifting / flaking wallpaper to the internal wall common with Bedroom 3 / Store.

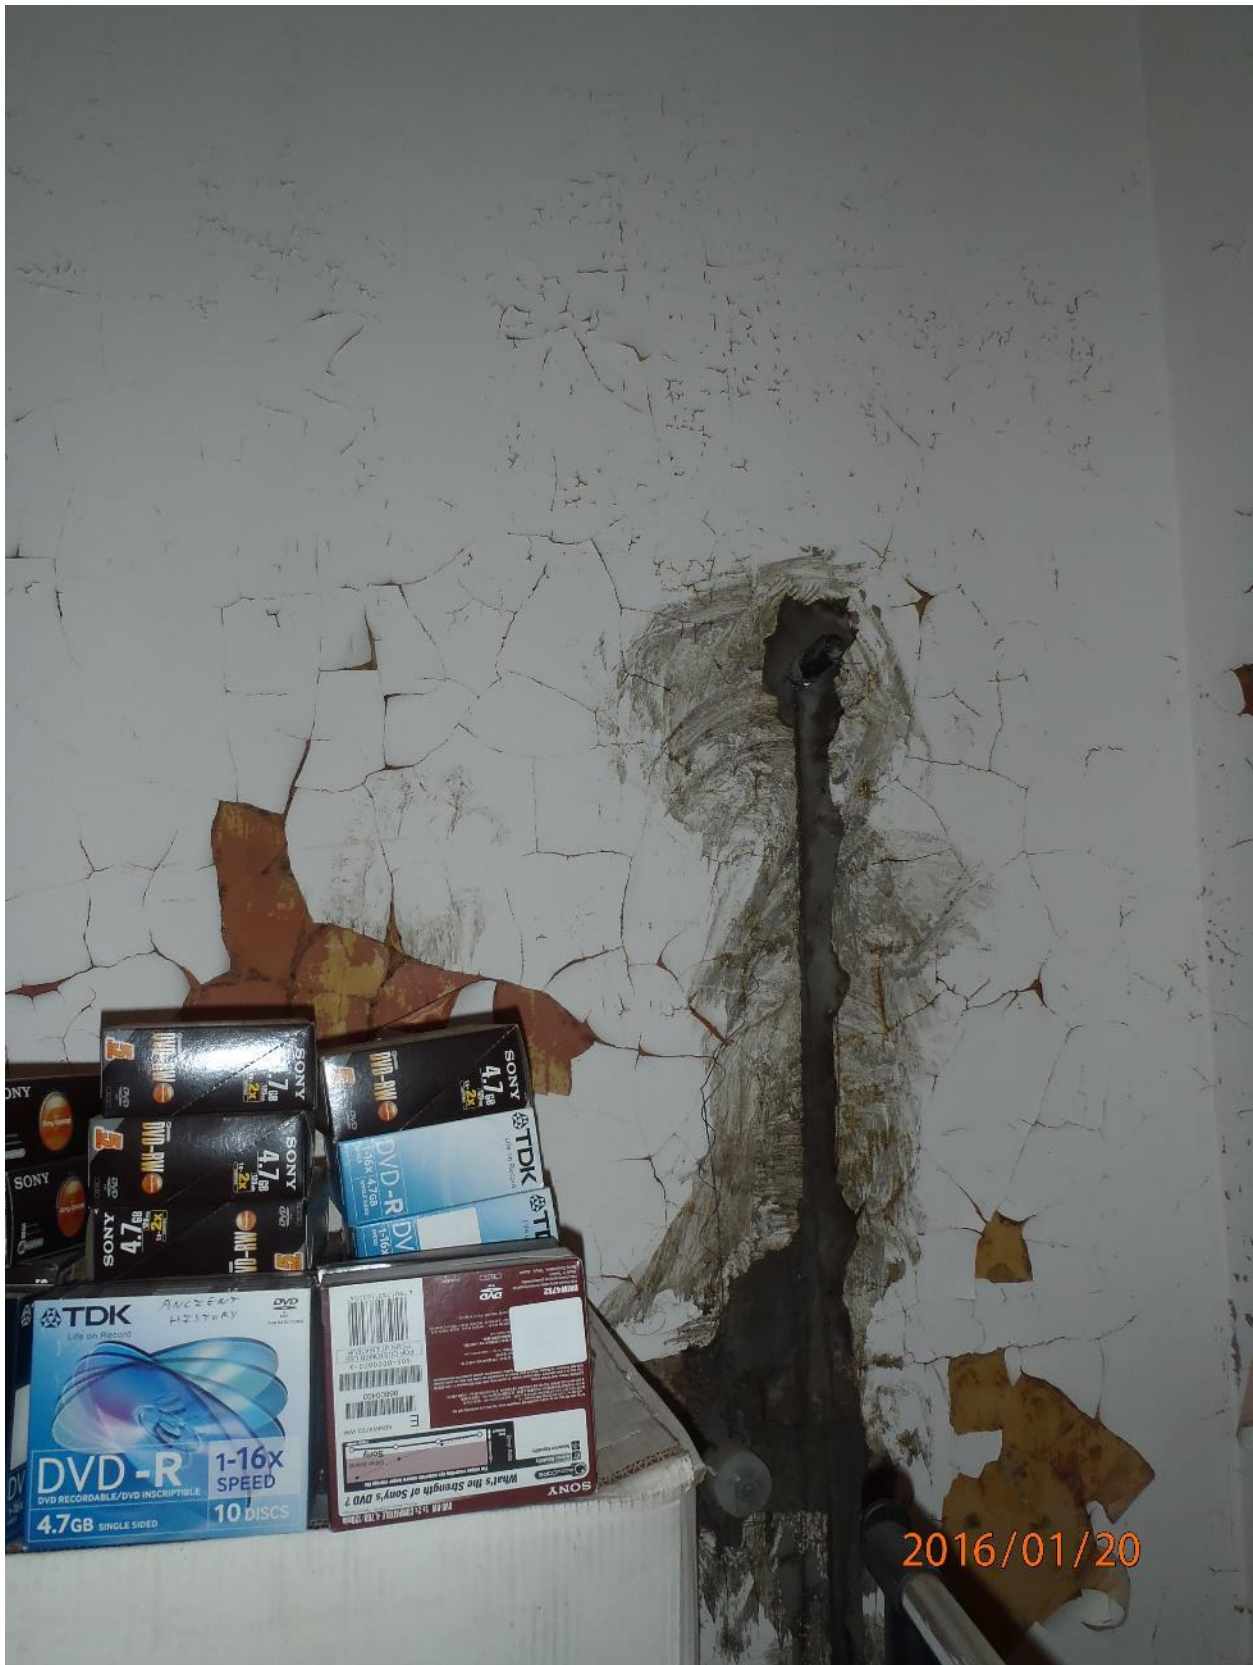
We noted a disused shower on the northern wall common with the hallway. We further noted that the shower was leaking and dripping water onto the timber flooring. **[Photograph 20]**

Photograph 20 shows the disused shower on the northern wall common with the hallway in Bedroom 3 / Store.

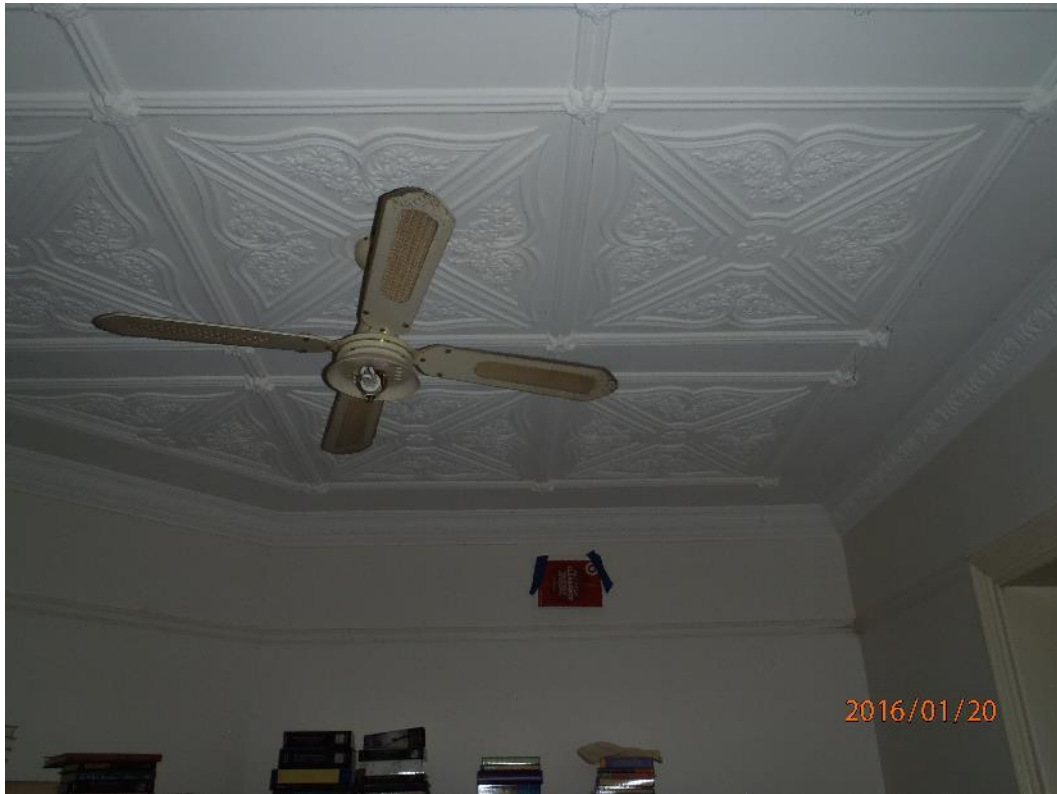
We did not observe any cracking to the cement rendered wall surfaces or to the decorative plaster ceiling or to the mitred joints in the decorative plaster cornice. **[Photograph 21]**

We noted that the wall vent on the external southern wall was sealed over. **[Photograph 21]**

Photograph 21 shows the general condition of Bedroom 1 and the wall vent sealed over.

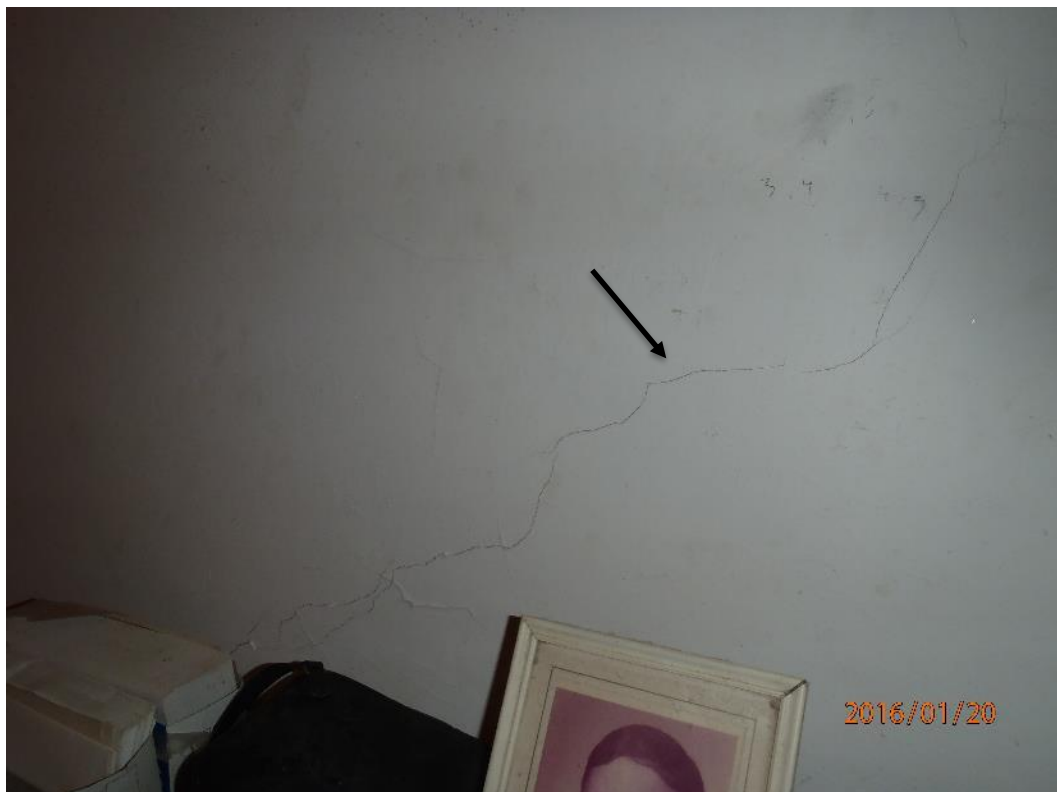
We noted radial cracking [$<1.0\text{mm}$] to the cement rendered wall surfaces on the western wall. **[Photograph 22]**

Photograph 22 shows radial cracking to the cement rendered wall surfaces on the western wall in Bedroom 2.

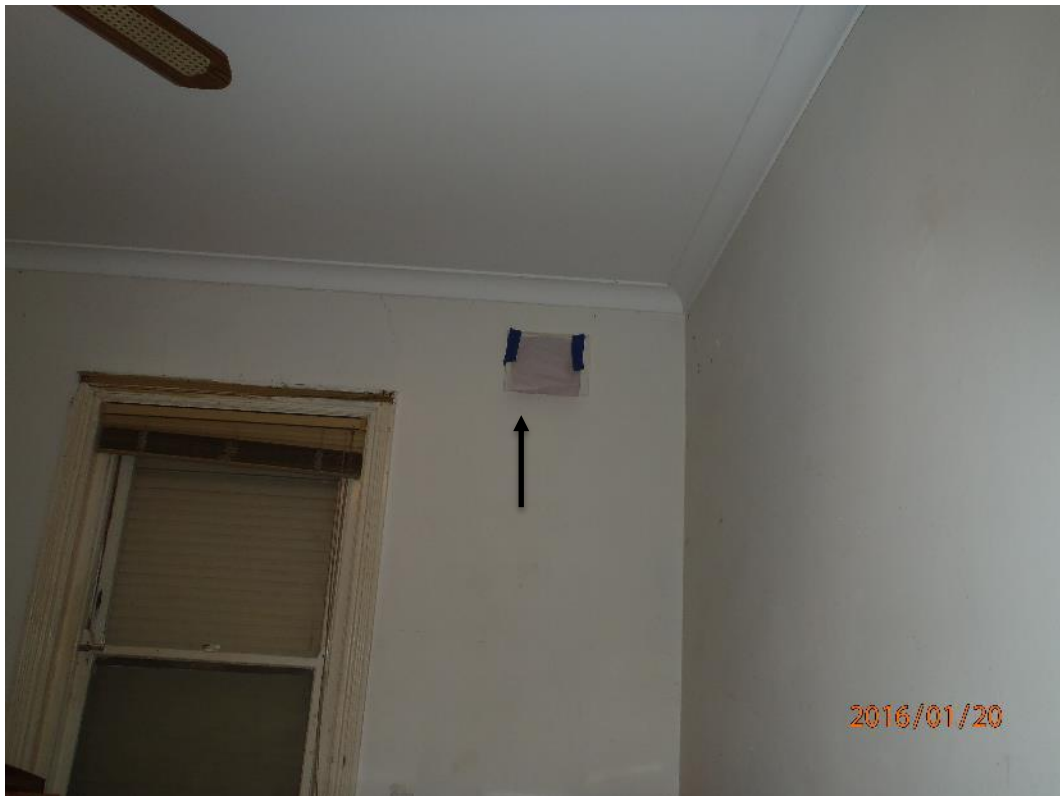
We noted that the wall vent on the external southern wall was sealed over. **[Photograph 23]**

We noted vertical cracking [$<1.0\text{mm}$] extending from the ceiling toward the window head. **[Photograph 23]**

Photograph 23 shows the wall vent sealed over in Bedroom 2.

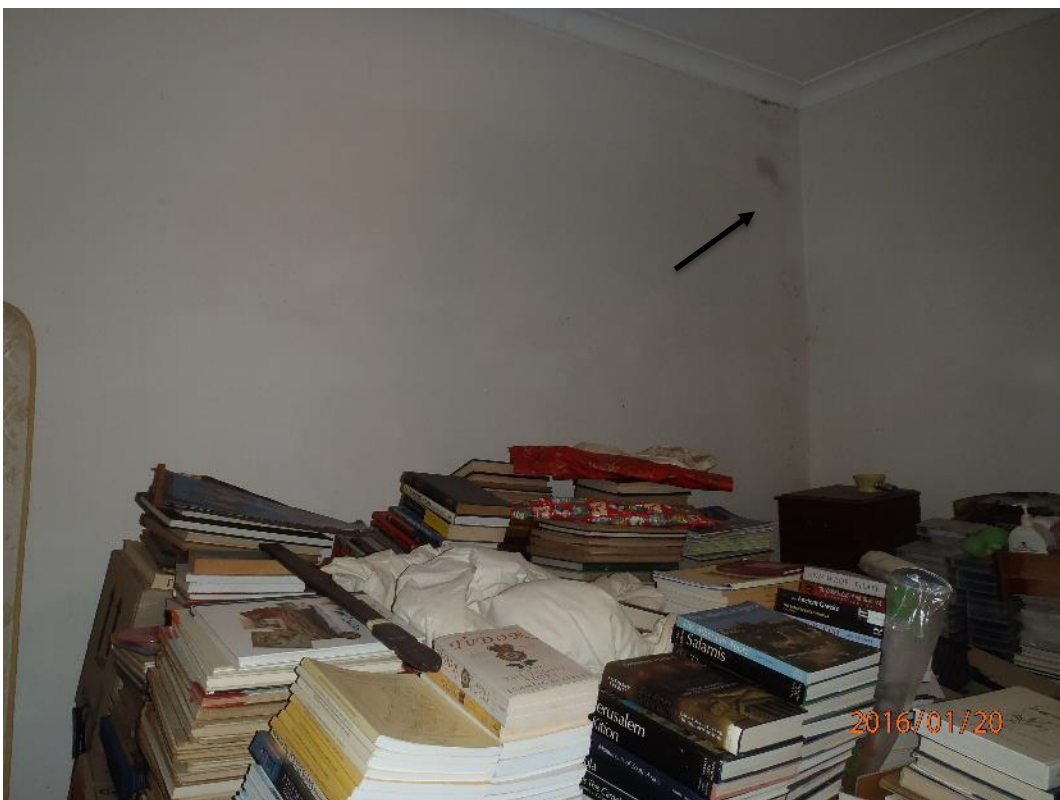
We noted staining to the cement rendered wall surfaces in the south-eastern corner. **[Photograph 24]**

Photograph 24 shows staining to the cement rendered wall surfaces in the south-eastern corner of Bedroom 2.

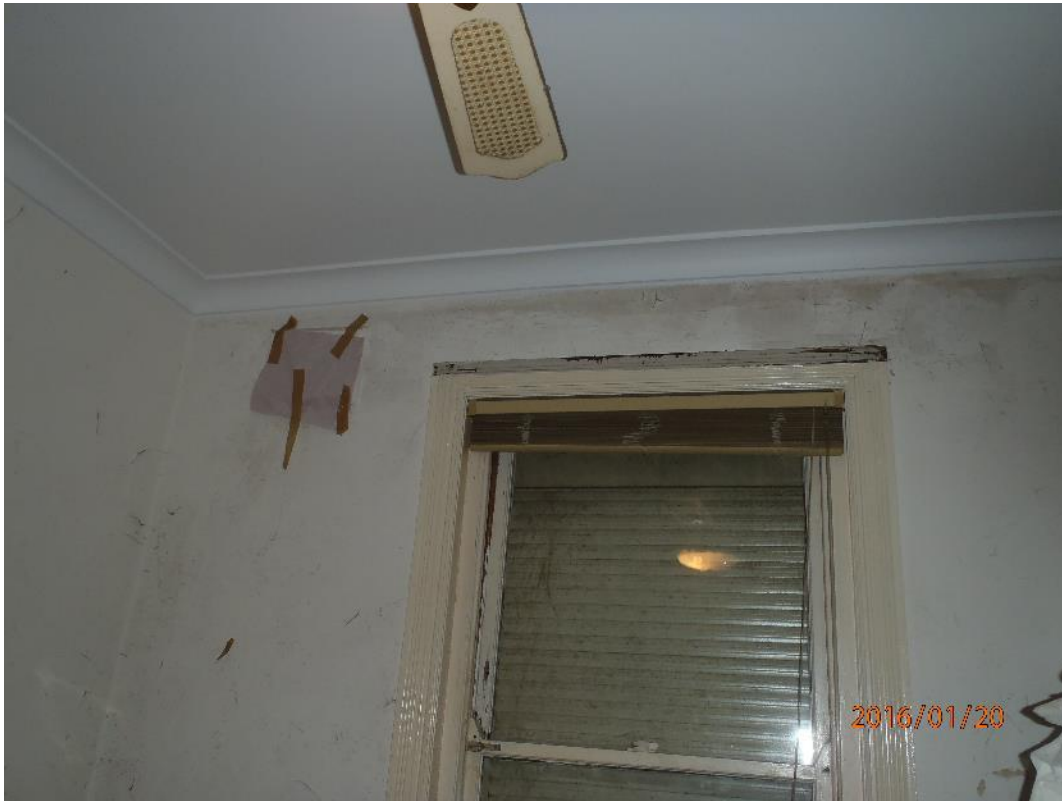
We noted flaking paint and staining to the to the cement rendered wall surfaces on the southern wall. We further noted that the wall vent on the external southern wall was sealed over **[Photograph 25]**

Photograph 25 shows flaking paint and staining to the to the cement rendered wall surfaces on the southern wall and the sealed over wall vent in Bedroom 3.

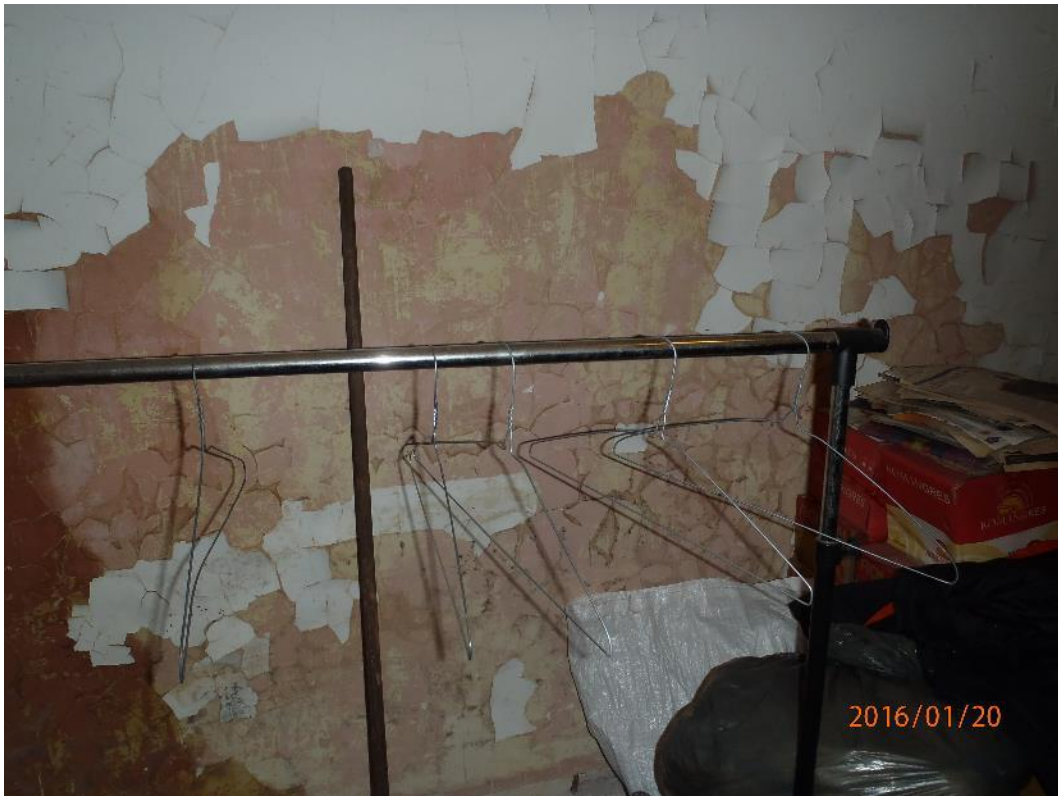
We noted flaking paint and staining to the to the cement rendered wall surfaces on the eastern wall. **[Photograph 26]**

Photograph 26 shows flaking paint and staining to the to the cement rendered wall surfaces on the eastern wall of Bedroom 3.

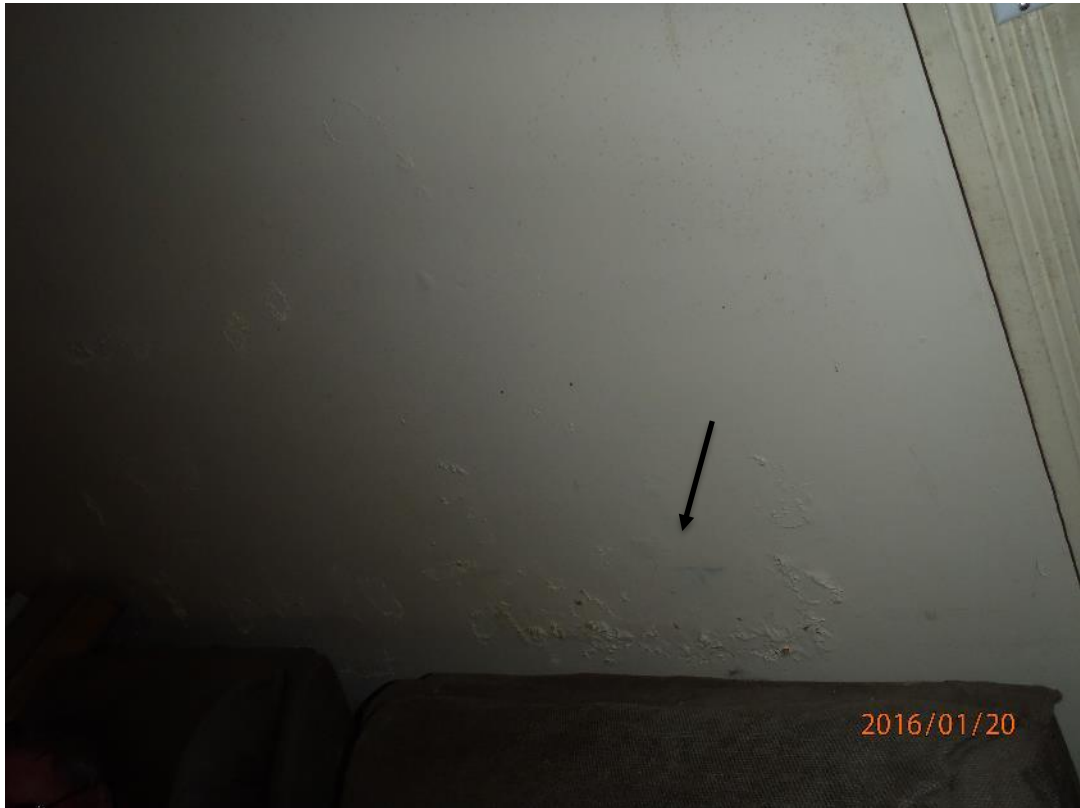
We noted areas of lifting / flaking paint to the internal wall common with Bedroom 3 / Store. This, in our experience, is consistent with rising damp. **[Photograph 27]**

Photograph 27 shows lifting / flaking paint to the internal wall common with Bedroom 3 / Store in the Lounge Room.

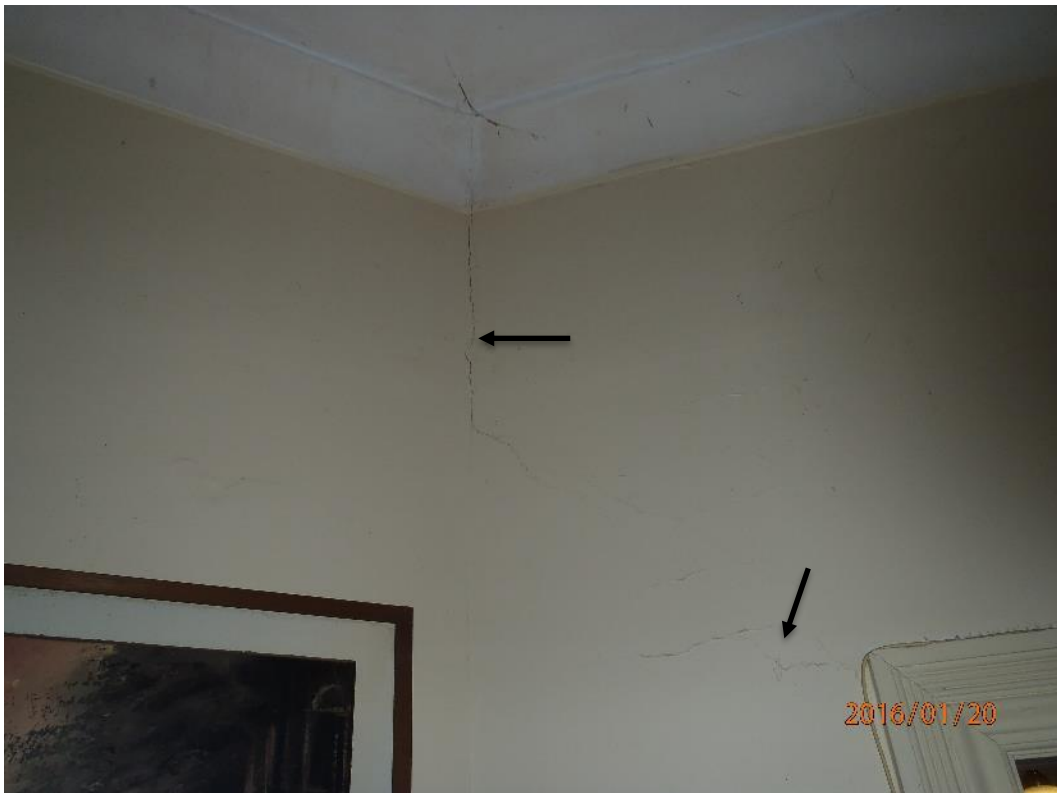
We noted vertical and radial cracking [$<1.0\text{mm}$] to the cement rendered wall surfaces on the eastern wall extending to the door head. **[Photographs 28 & 29]**

Photograph 28 shows vertical and radial cracking to the cement rendered wall surfaces on the eastern wall extending to the door head in the Lounge Room.

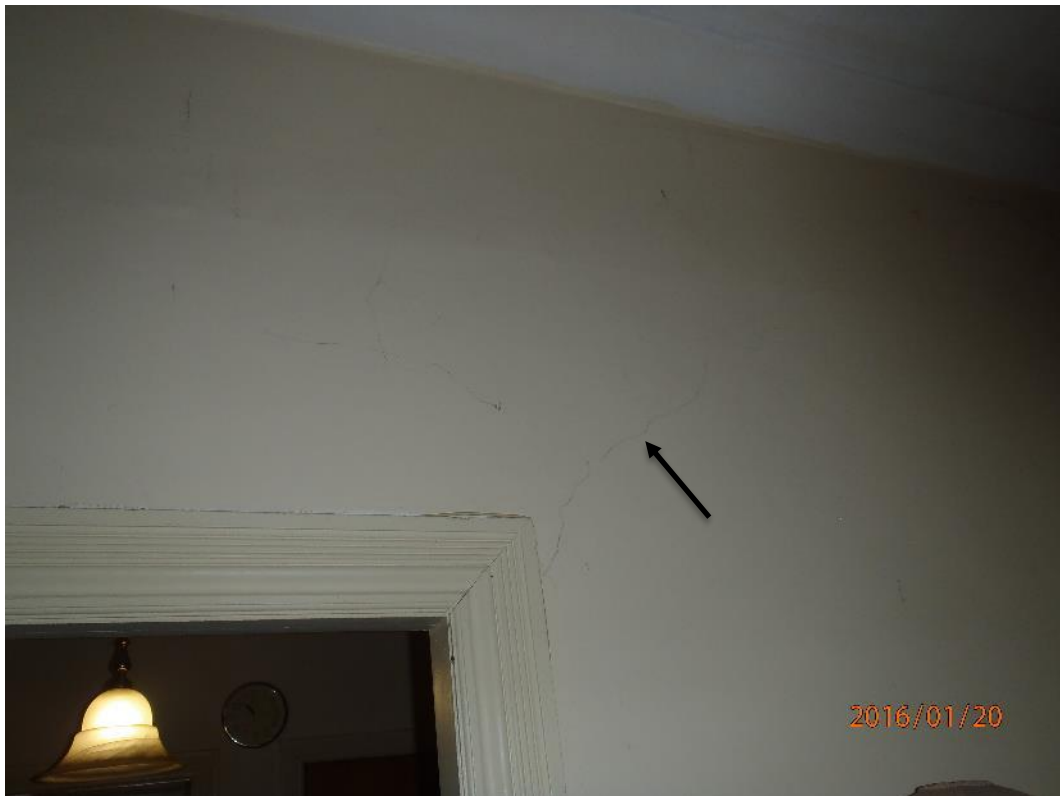
Photograph 29 shows vertical and radial cracking to the cement rendered wall surfaces on the eastern wall extending to the door head in the Lounge Room.

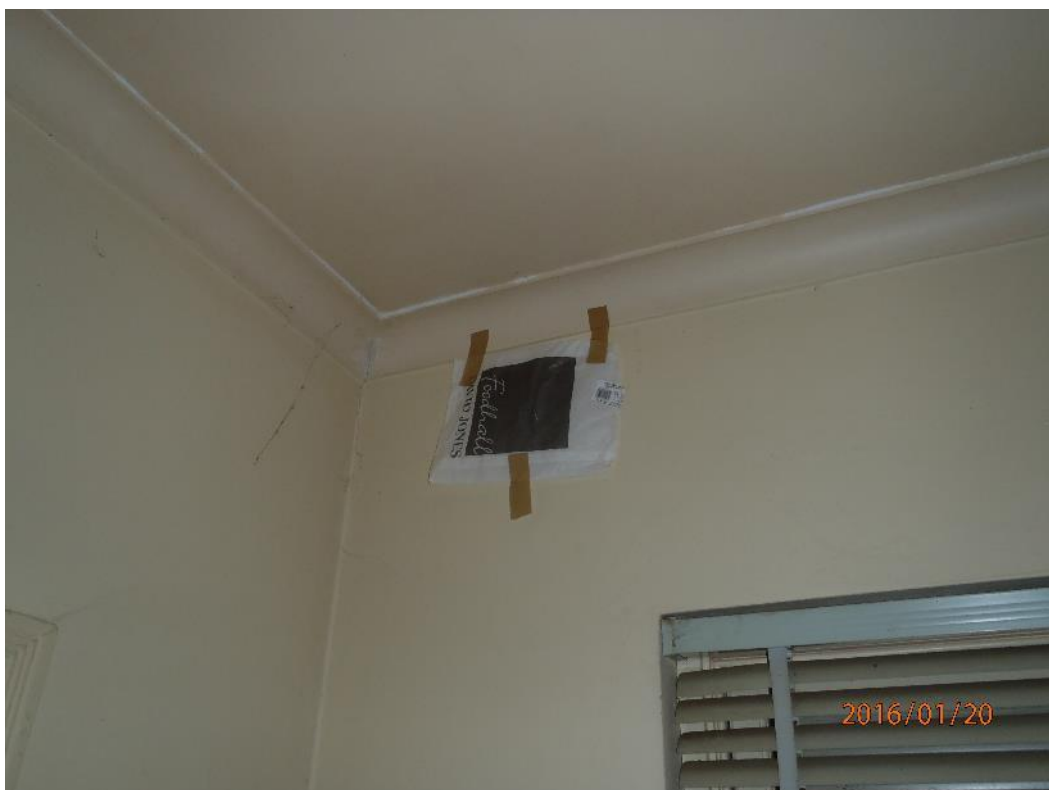
We noted that the wall vent on the external southern wall was sealed over. **[Photograph 30]**

Photograph 30 shows the wall vent on the external southern wall was sealed over in the Study / Store.

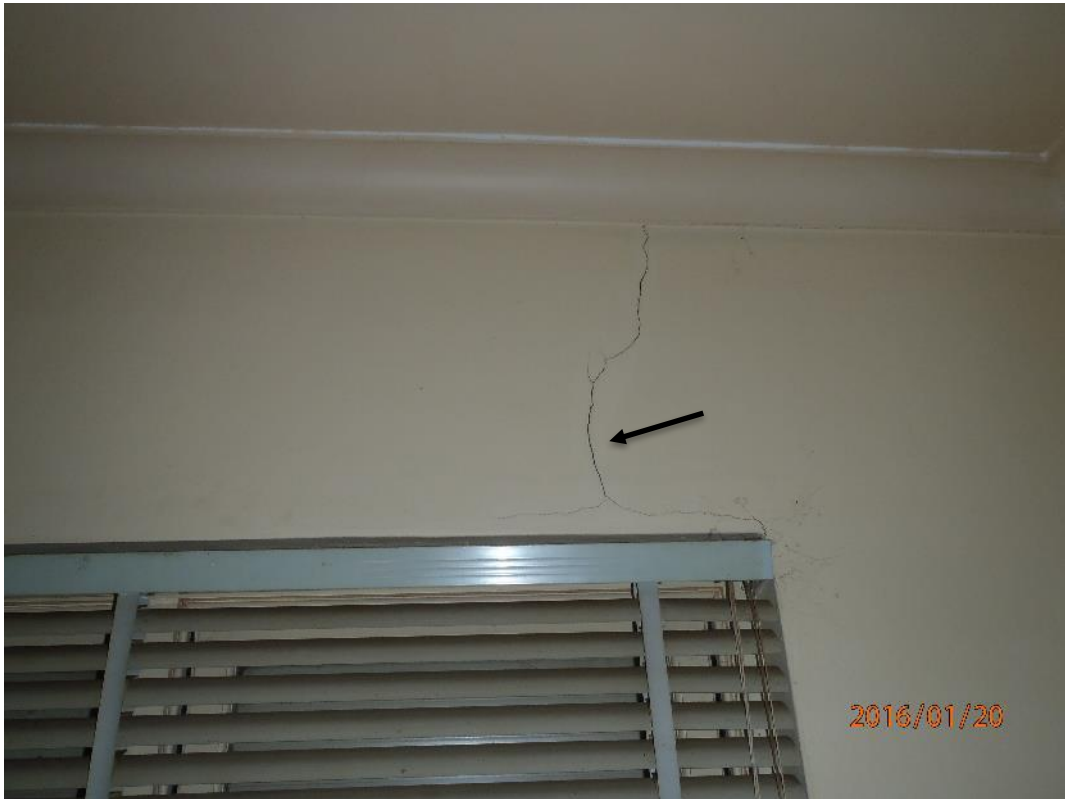
We noted vertical cracking [1.0mm – 3.0mm] extending from the ceiling toward the window head. **[Photograph 31]**

Photograph 31 shows vertical cracking extending from the ceiling toward the window head in the Study / Store.

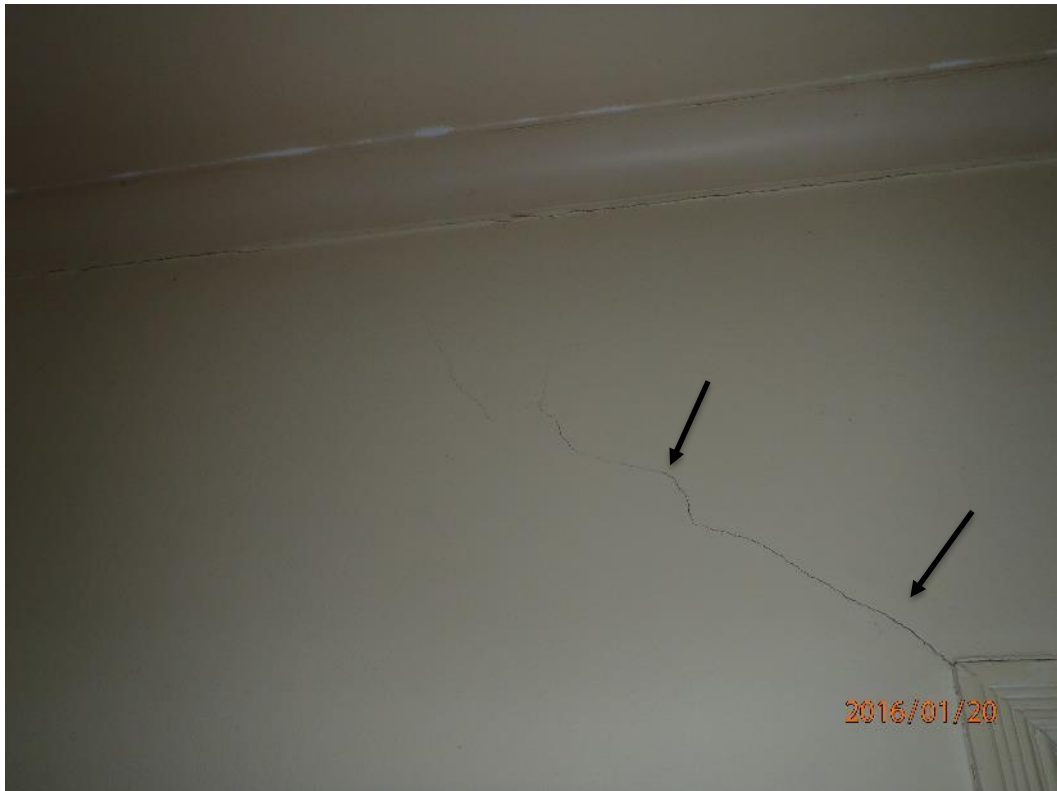
We noted radial cracking [$<1.0\text{mm}$] to the cement rendered wall surfaces on the western wall extending from the door head toward the ceiling. **[Photograph 32]**

Photograph 32 shows radial cracking to the cement rendered wall surfaces on the western wall extending from the door head toward the ceiling in the Study / Store.

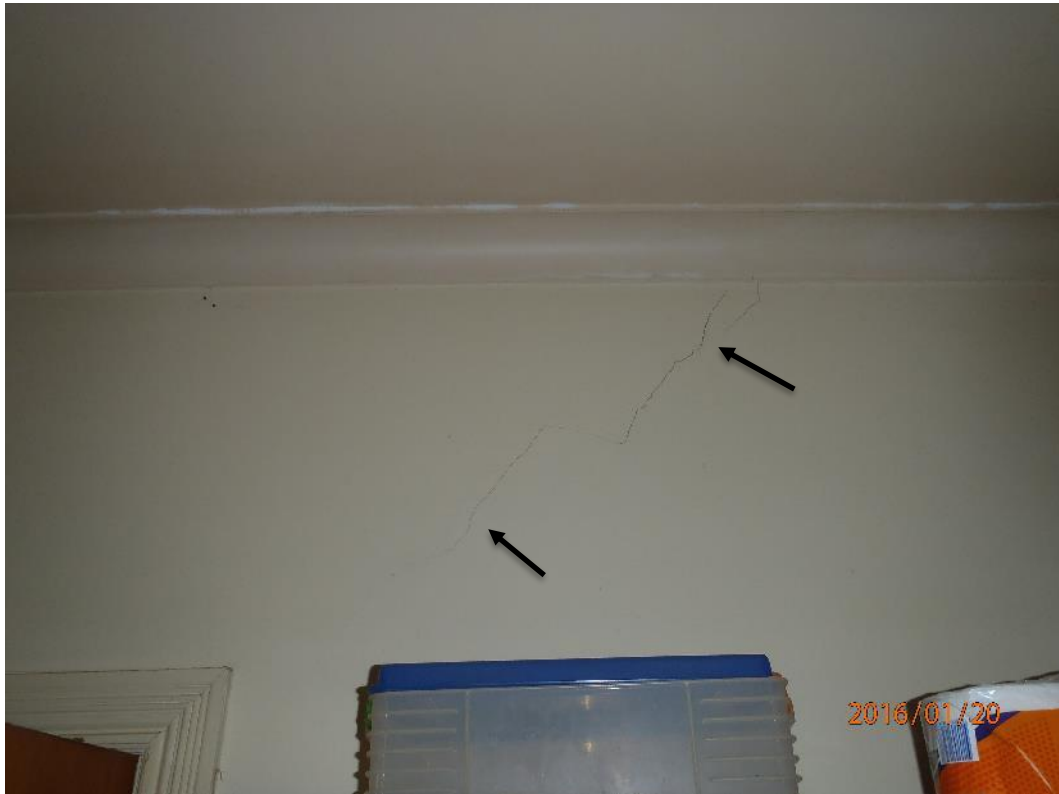
We noted radial cracking [$<1.0\text{mm}$] to the cement rendered wall surfaces on the western wall extending toward the door head. **[Photograph 33]**

Photograph 33 shows radial cracking to the cement rendered wall surfaces on the western wall extending from the door head toward the ceiling in the Study / Store.

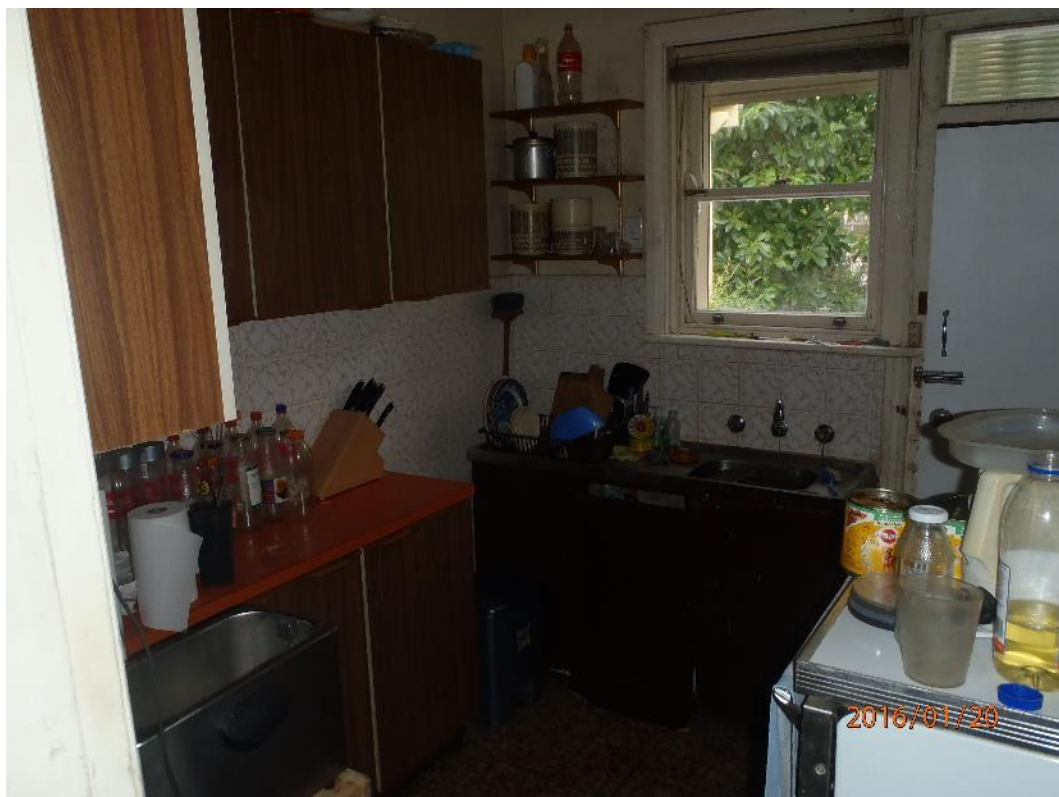
We noted that the grout to the wall and floor tiles is complete and that the wall and floor tiles when randomly “tap” tested appeared to be sound. We did not observe any recent cracking to the tile grout at the wall / wall, wall / floor junctions. **[Photograph 34]**

Photograph 34 shows the general condition of the Kitchen.

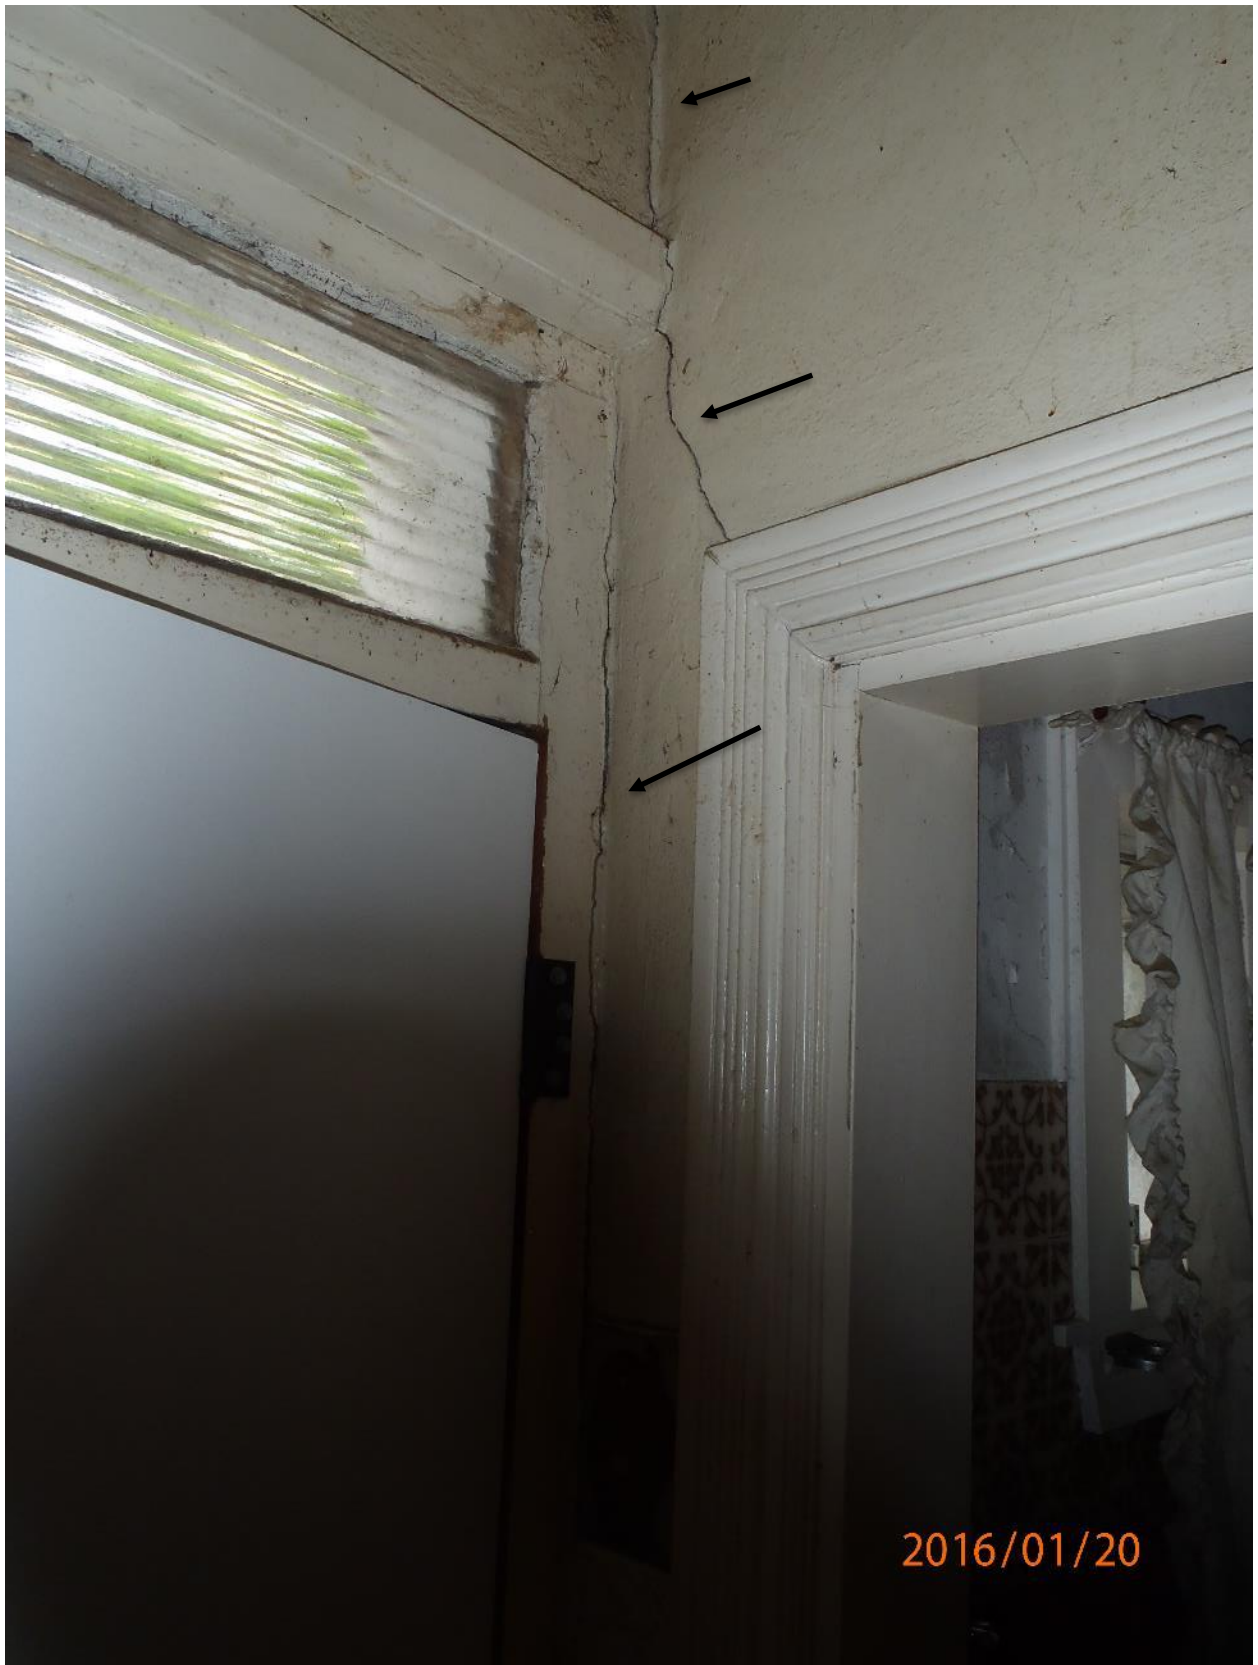
We noted vertical cracking [1.0mm – 3.0mm] extending from the ceiling toward the door head. **[Photograph 35]**

Photograph 35 shows vertical cracking extending from the ceiling toward the door head in the Kitchen.

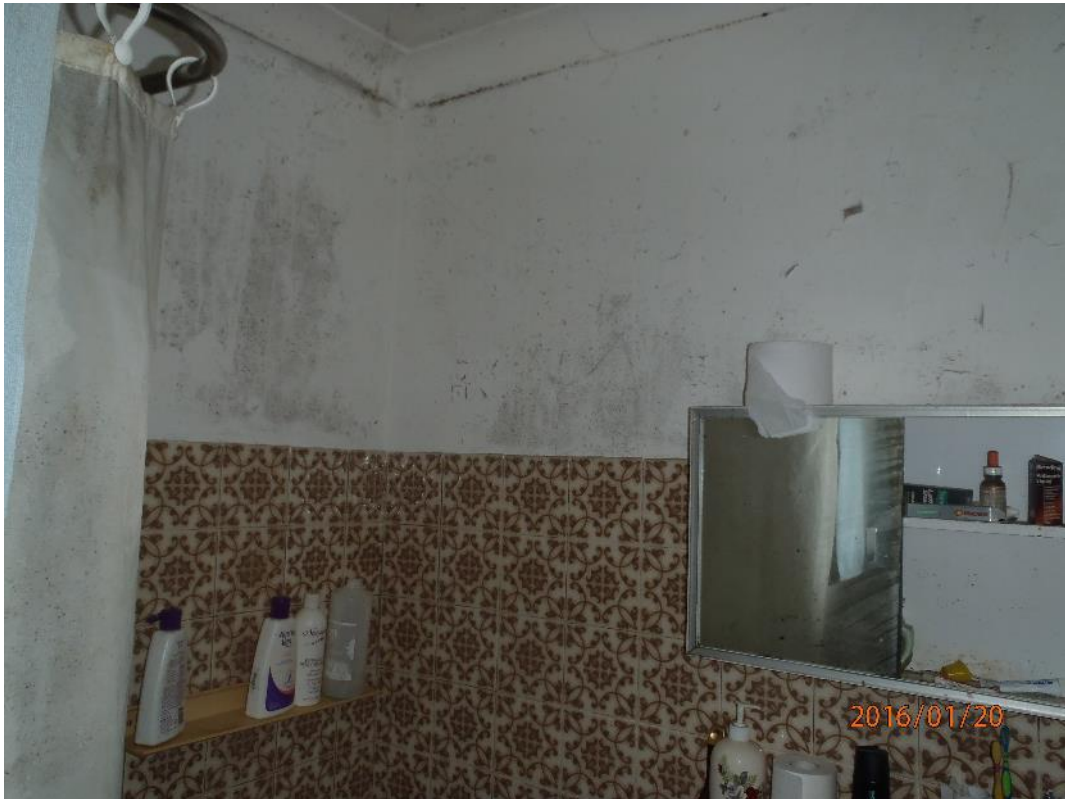
We noted flaking paint and mould growth to the to the cement rendered wall surfaces, plasterboard ceiling and cove profiled plaster cornices. **[Photographs 36, 37 and 38]**

Photograph 36 shows flaking paint and mould growth to the to the cement rendered wall surfaces, plasterboard ceiling and cove profiled plaster cornices in the Bathroom.
