Dilapidation Assessment Report

Prepared for: Cape Cod Australia Pty. Limited
Job address: No. 81 Clovelly Road, Randwick.
Property Owner/s: Mr. Kevin Hayes.
Report reference: **RANDWICK CITY COUNCIL**
Development Application No: not available
Date of assessment: 20th January 2017

Re: Dilapidation Report – No. 81 Clovelly Road, Randwick.

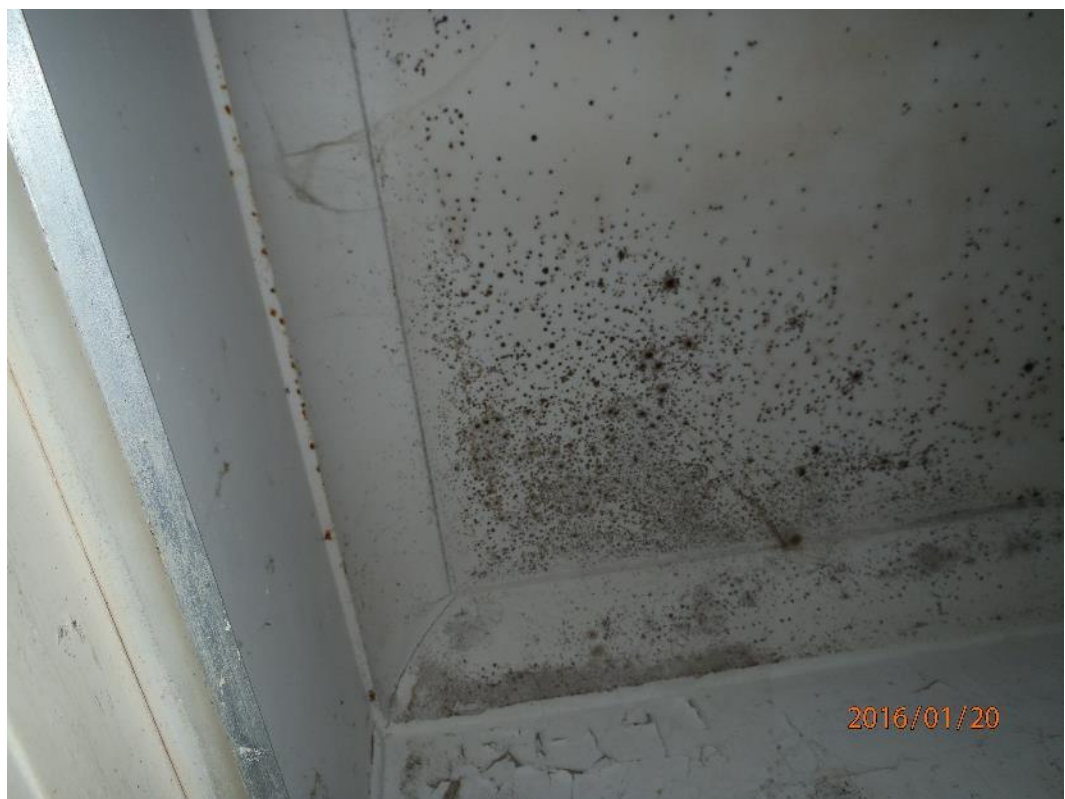
We noted flaking paint and mould growth to the to the cement rendered wall surfaces, plasterboard ceiling and cove profiled plaster cornices. **[Photographs 36, 37 and 38]**

Photograph 37 shows flaking paint and mould growth to the to the cement rendered wall surfaces, plasterboard ceiling and cove profiled plaster cornices in the Bathroom.

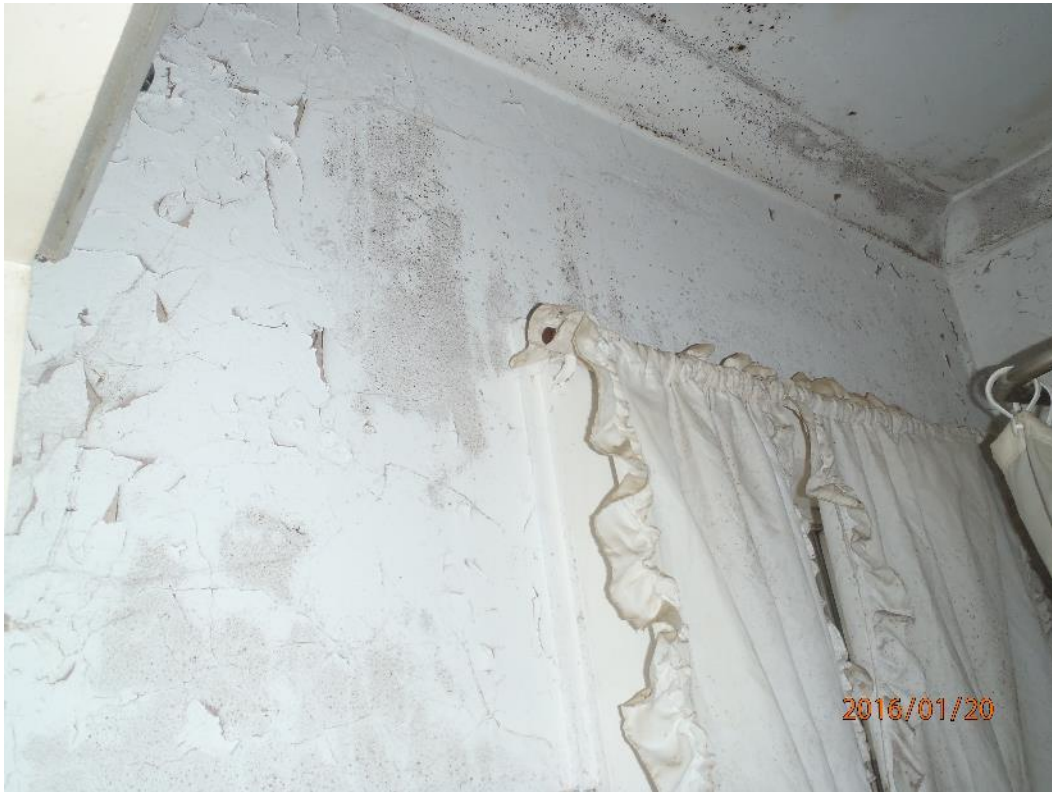
Photograph 38 shows flaking paint and mould growth to the to the cement rendered wall surfaces, plasterboard ceiling and cove profiled plaster cornices in the Bathroom.
