Dilapidation Assessment Report

Prepared for: Cape Cod Australia Pty. Limited
Job address: 184 Malabar Road, SOUTH COOGEE.
Property Owner/s: Fiona Mackie and Simon Mears
Report reference: **RANDWICK CITY COUNCIL**
Development Application No: not available
Date of assessment: 28th July 2016

Re: Dilapidation Report

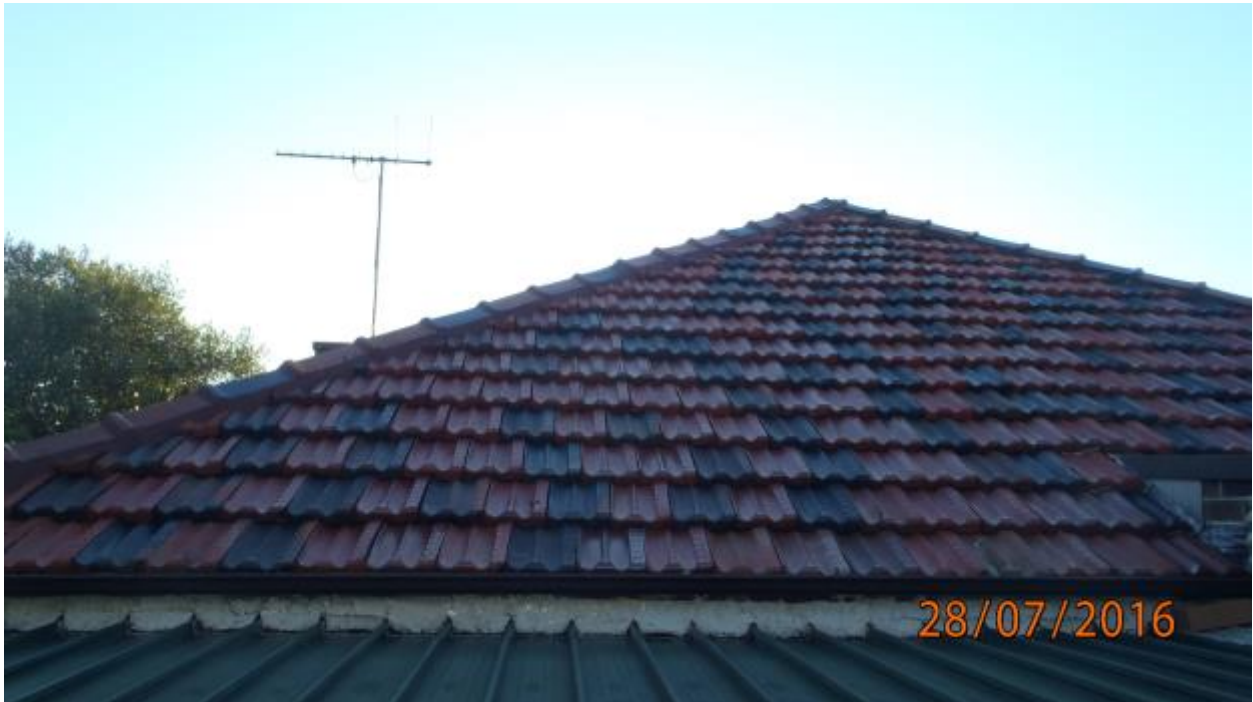
We observed that the terra cotta roof tiles to the original roof surfaces are generally interlinked and securely bedded, in our opinion forming a weather resistant cover to the residence. **[Photograph 1]**

Photograph 1 shows the general condition of the terracotta roof tiles to the rear section of the common roof surface.

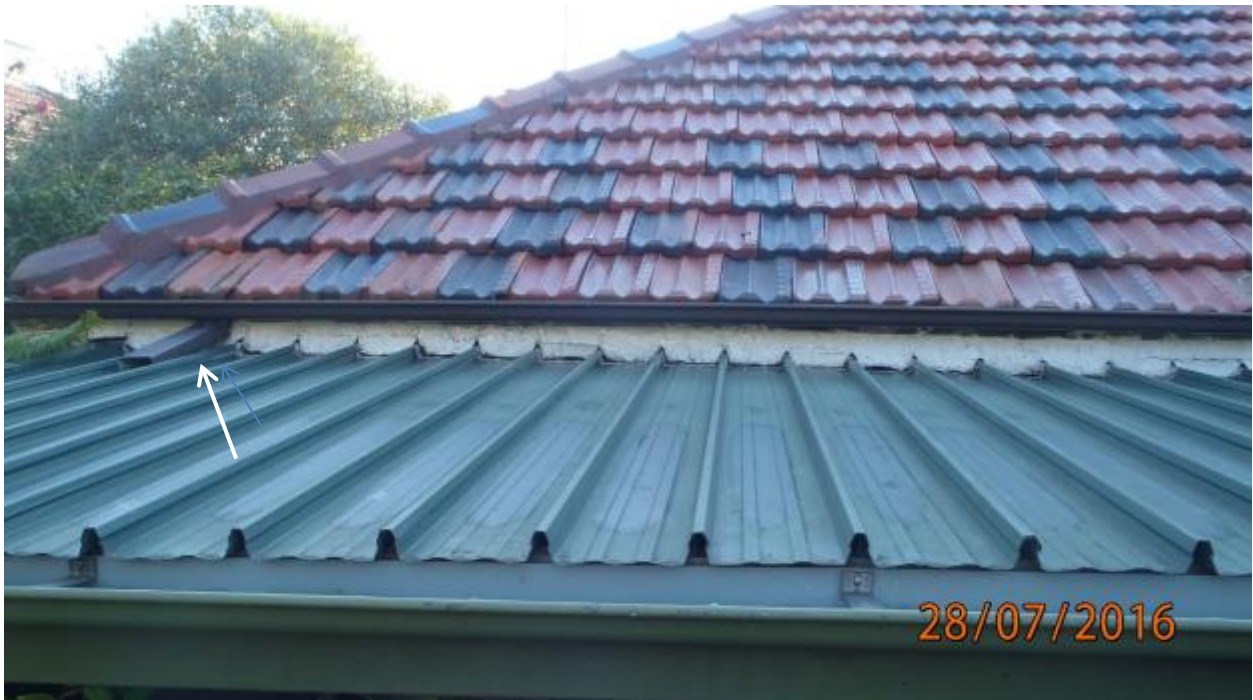
We noted that the pan profile sheet metal roofing to the rear addition roof surfaces is in good condition and is securely fixed, in our opinion forming a weather resistant cover to the rear addition. **[Photograph 2]**

We noted that the surface water from the pitched section of the rear addition roof discharges directly onto the skillion roof section over the Laundry area. **[Photograph 2]**

Photograph 2 shows the general condition of the sheet metal roofing and that the common roof discharges directly onto the skillion roof surface.

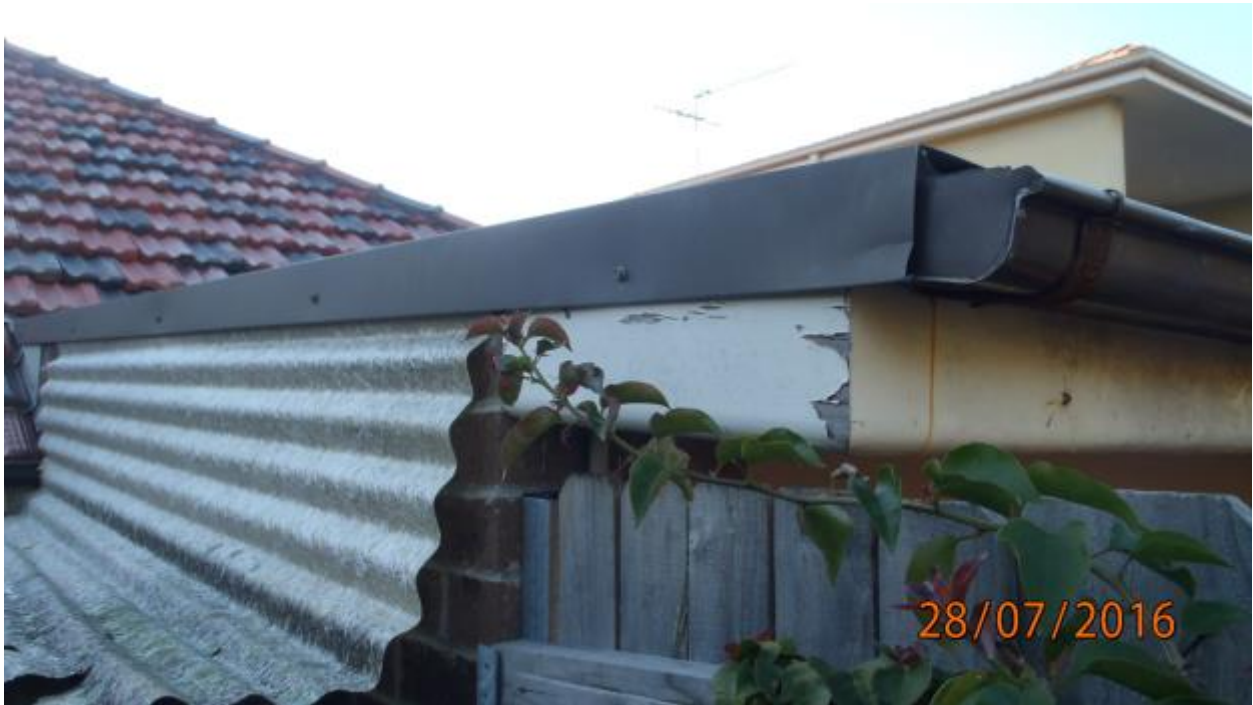
We also noted that the side flashing (corrugated fibreglass sheeting) between the metal roof and the brick wall of rear addition of the adjoining property, No. 186 Malabar Road, South Coogee is damaged and that it was held down with a brick **[Photograph 3 and 4]**

Photograph 3 shows the general condition of the fibreglass flashing to the rear skillion roof.

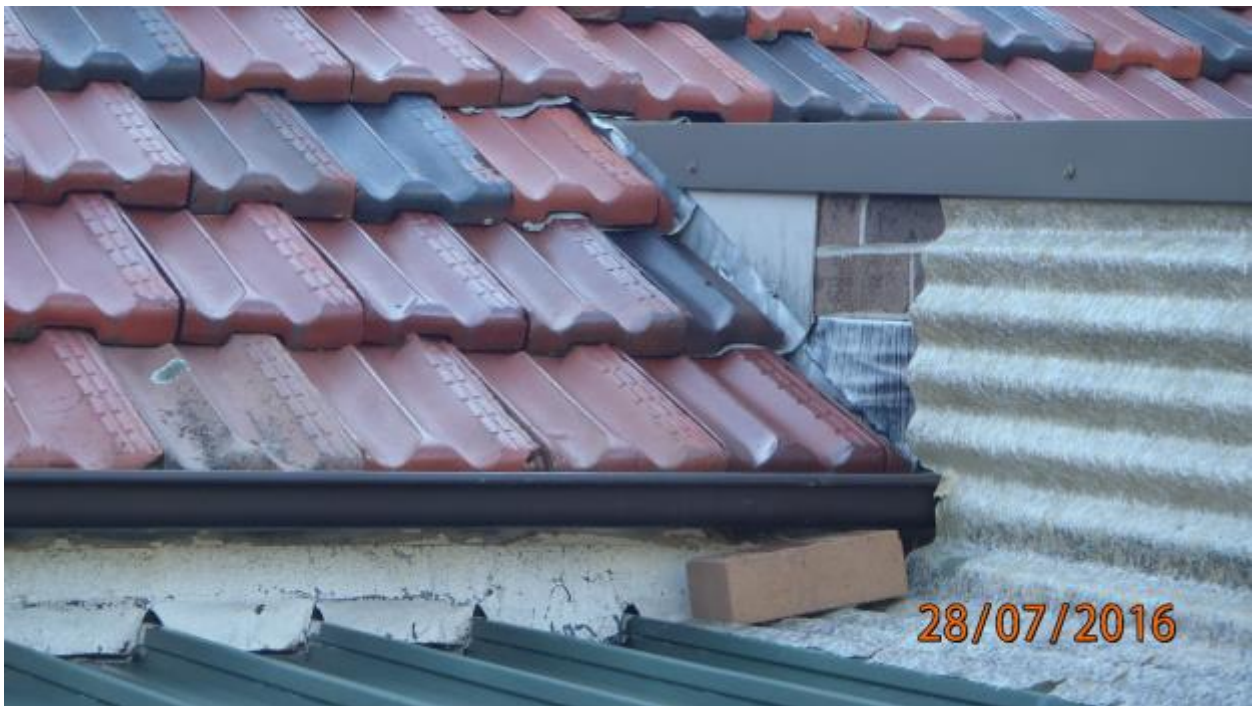
Photograph 4 shows the fibreglass flashing to the rear skillion roof held down with a brick.

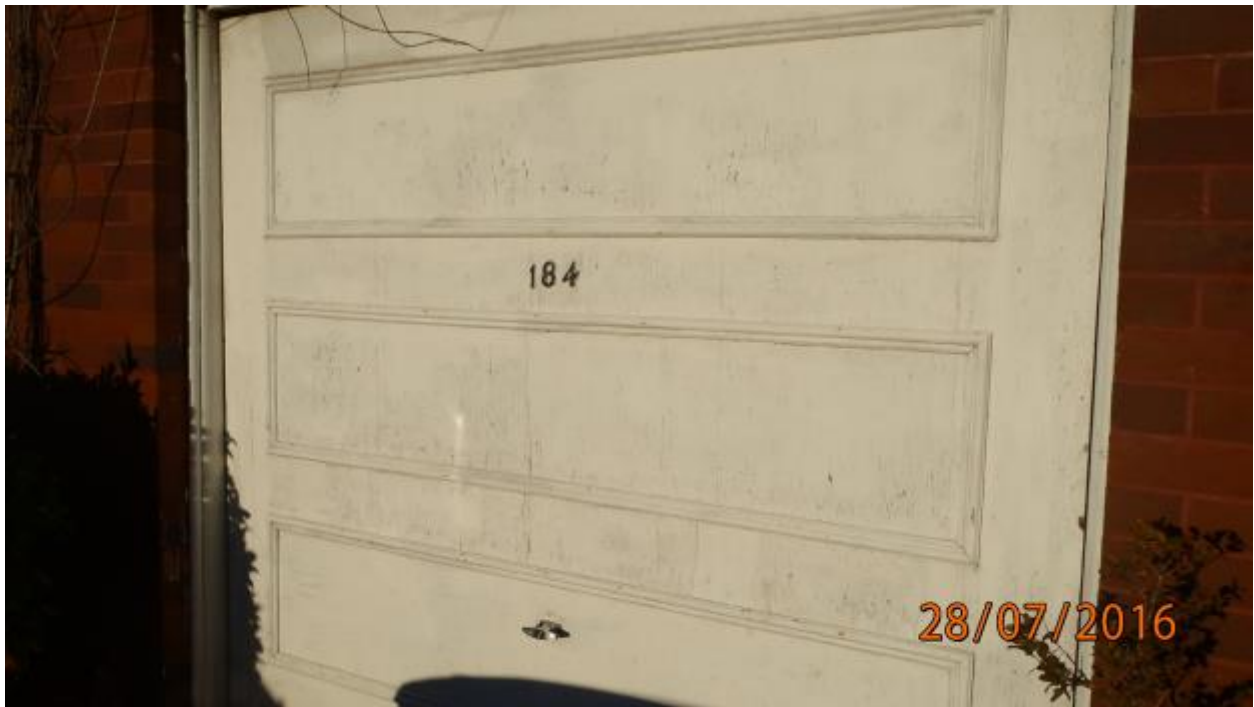
We noted flaking and blistering to the surface coating of the garage entry door **[Photograph 5]**

Photograph 5 shows the general condition of the garage door.

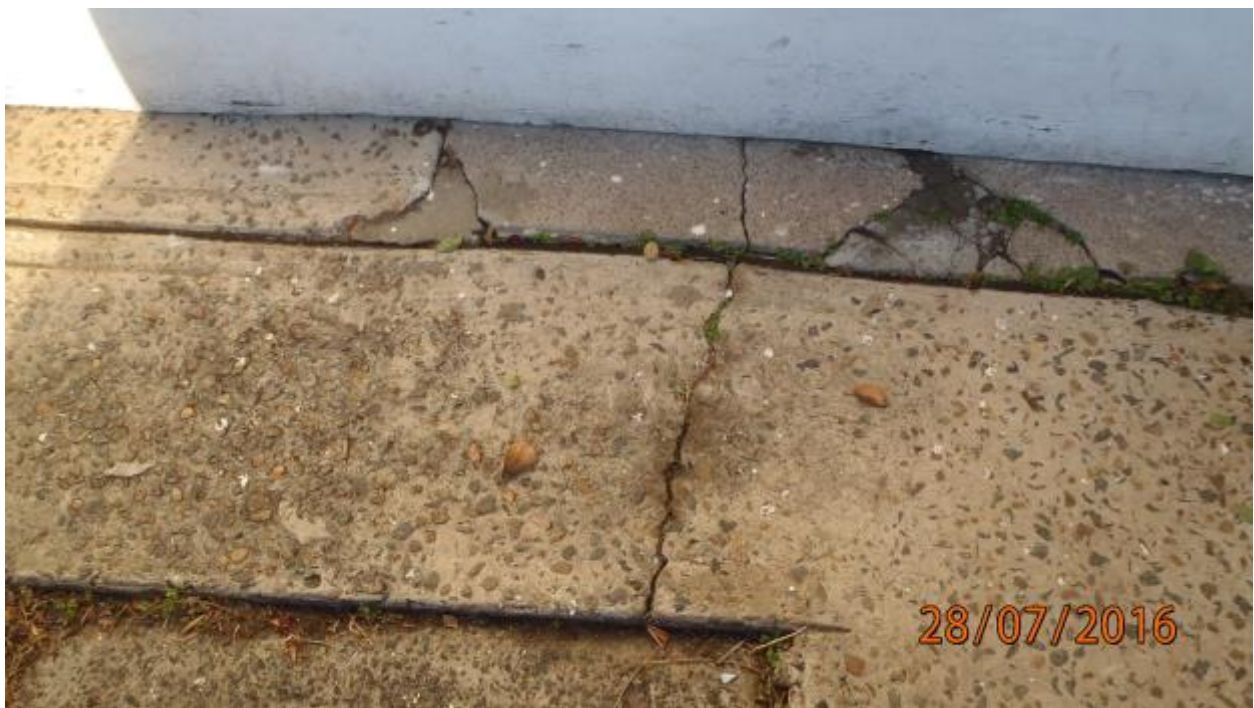
We noted cracking to the concrete driveway outside the garage door **[Photograph 6]**

Photograph 6 shows cracks to the concrete driveway outside the garage door.

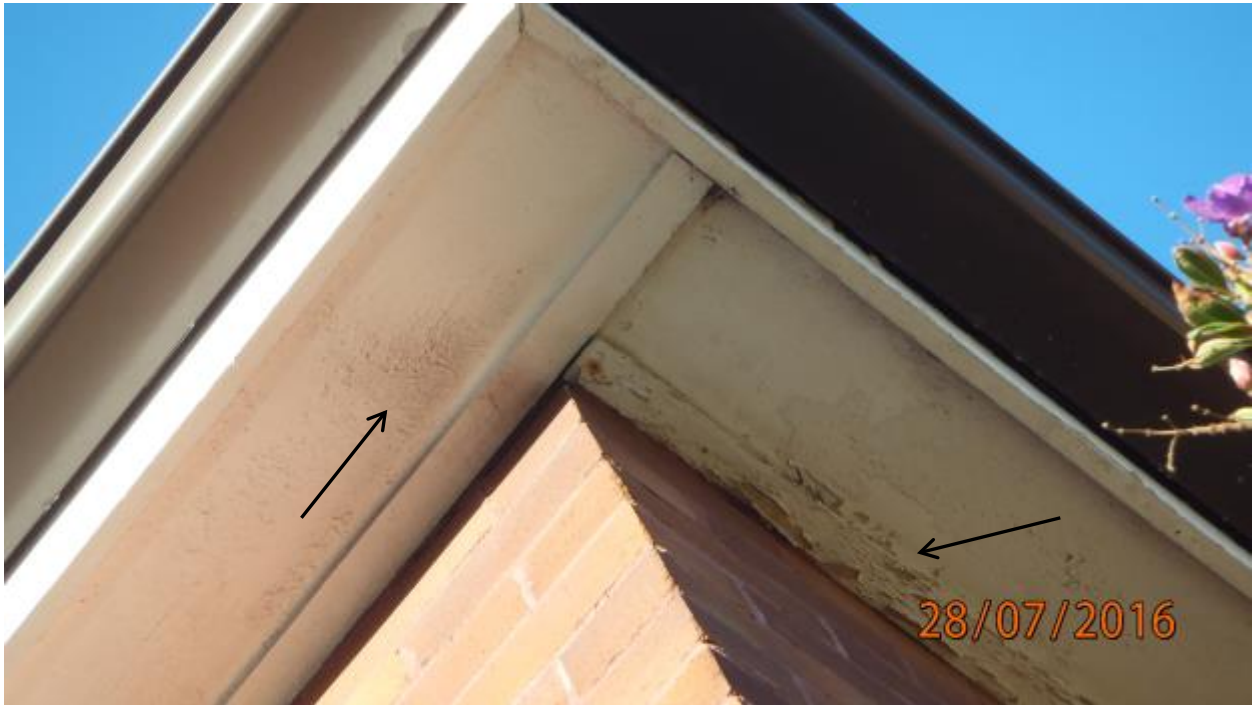
We noted flaking and blistering to the surface coating of the eave soffit lining and trim. **[Photograph 7]**

Photograph 7 shows flaking and blistering surface coating

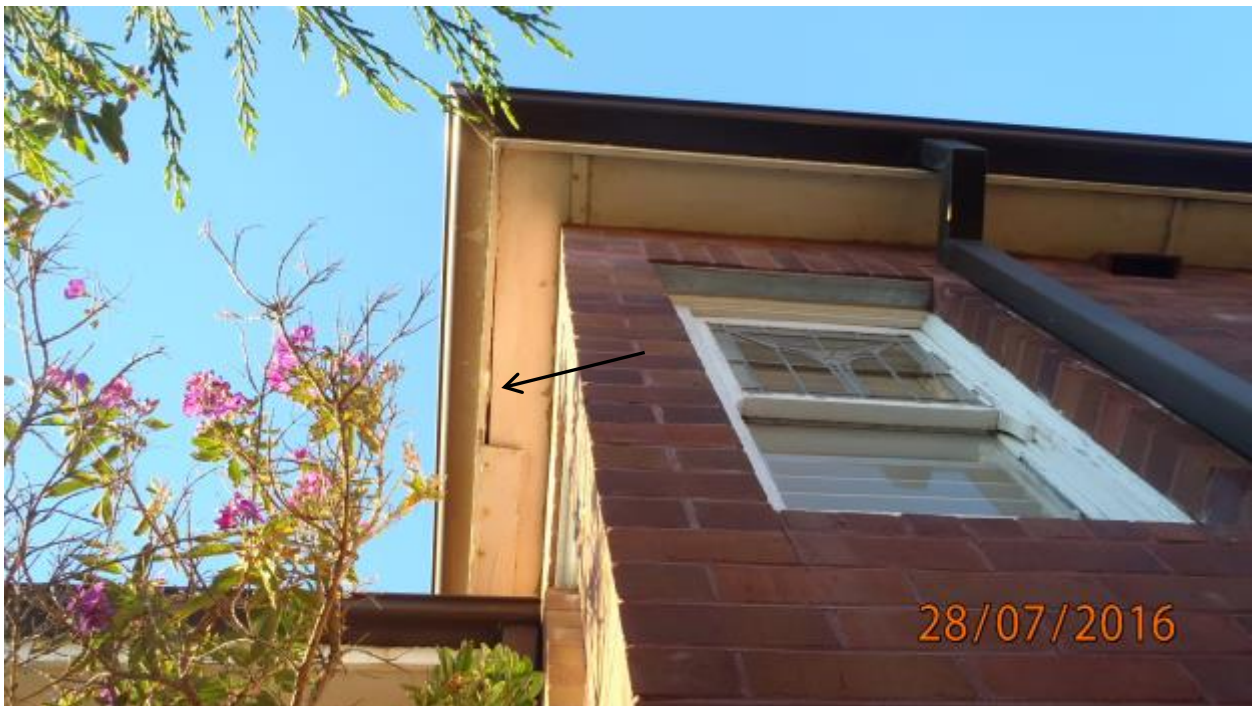
We noted a gap between the eave soffit lining and the fascia board above the sunroom **[Photograph 8]**

Photograph 8 shows the gap in the eave soffit lining

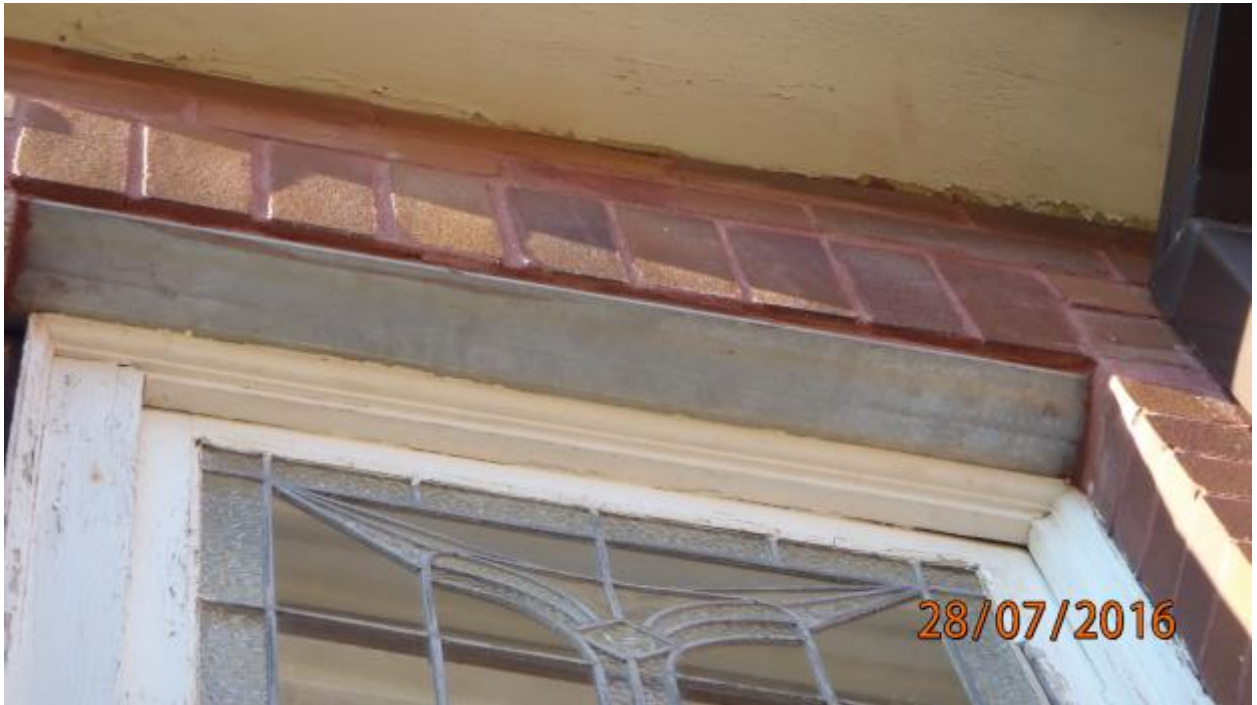
We noted that the lintels have been replaced to the front windows on the northern aspect and that there had been a general repointing of the brickwork to the front of the original residence to the entry. **[Photograph 9]**

Photograph 9 shows replaced lintel and repointed brickwork.

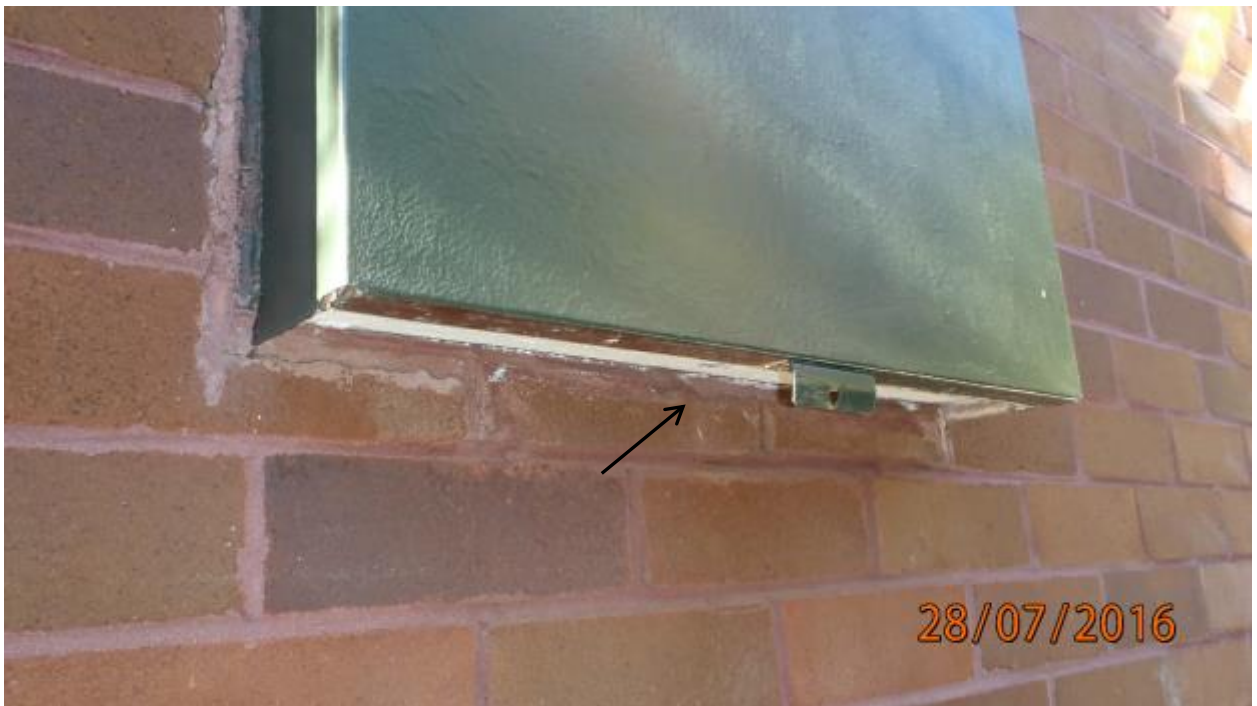
We noted cracking and previous repairs under the electrical meter board [**Photograph 10**]

Photograph 10 shows repointed brickwork and a step crack under the electrical meter board.

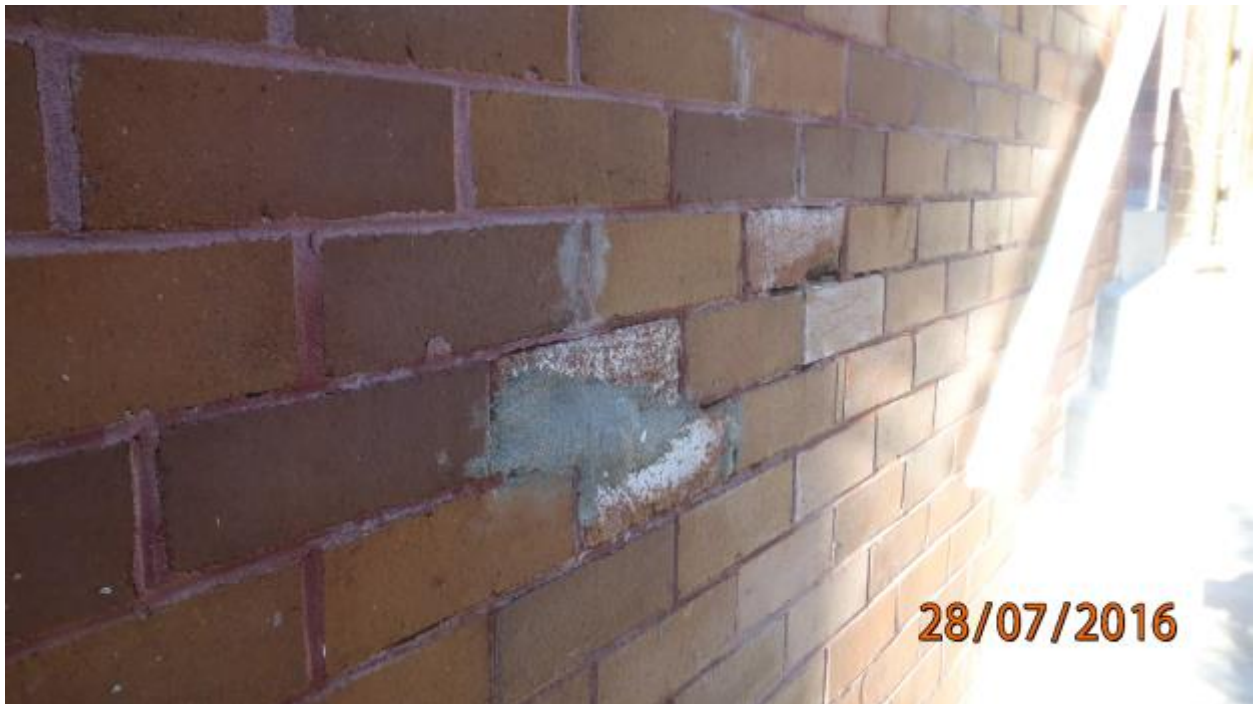
We noted step cracking and previous repairs adjacent to the pathway steps [**Photograph 11**]

Photograph 11 shows repointed brickwork and a previous repair

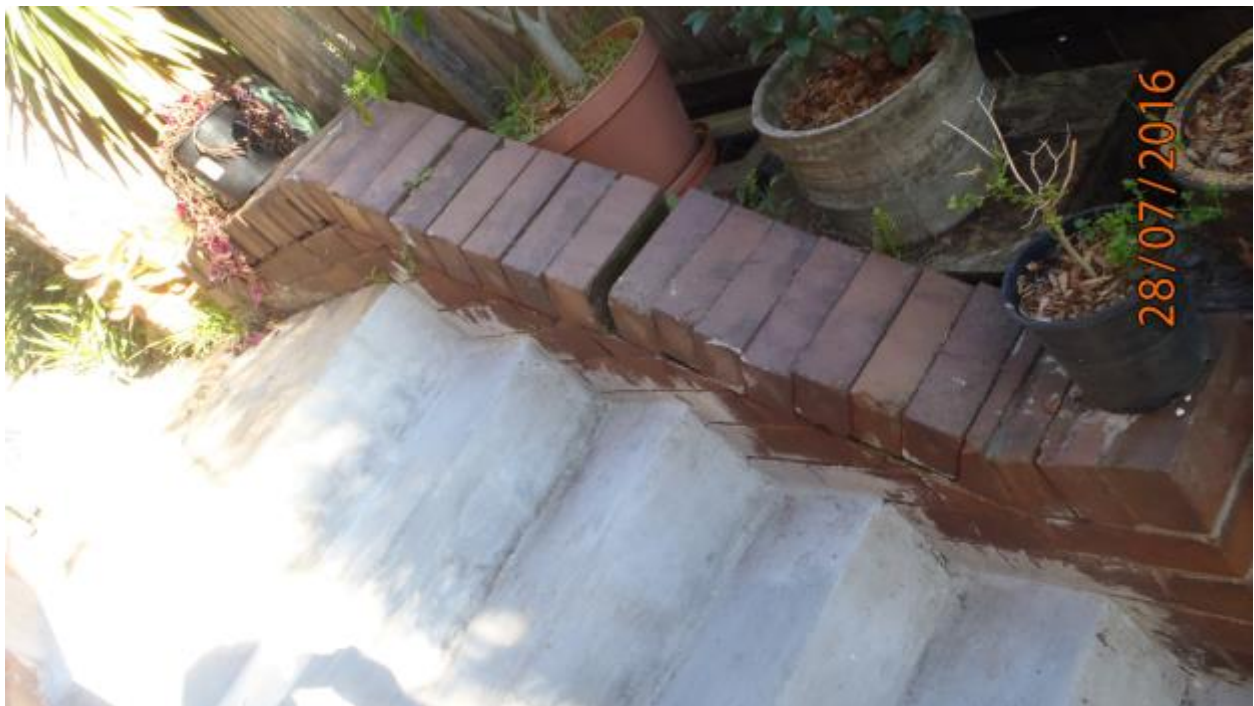
We noted dislodged bricks to the step wall head and displaced mortar [**Photograph 12**]

Photograph 12 shows dislodged bricks to the step wall head and displaced mortar

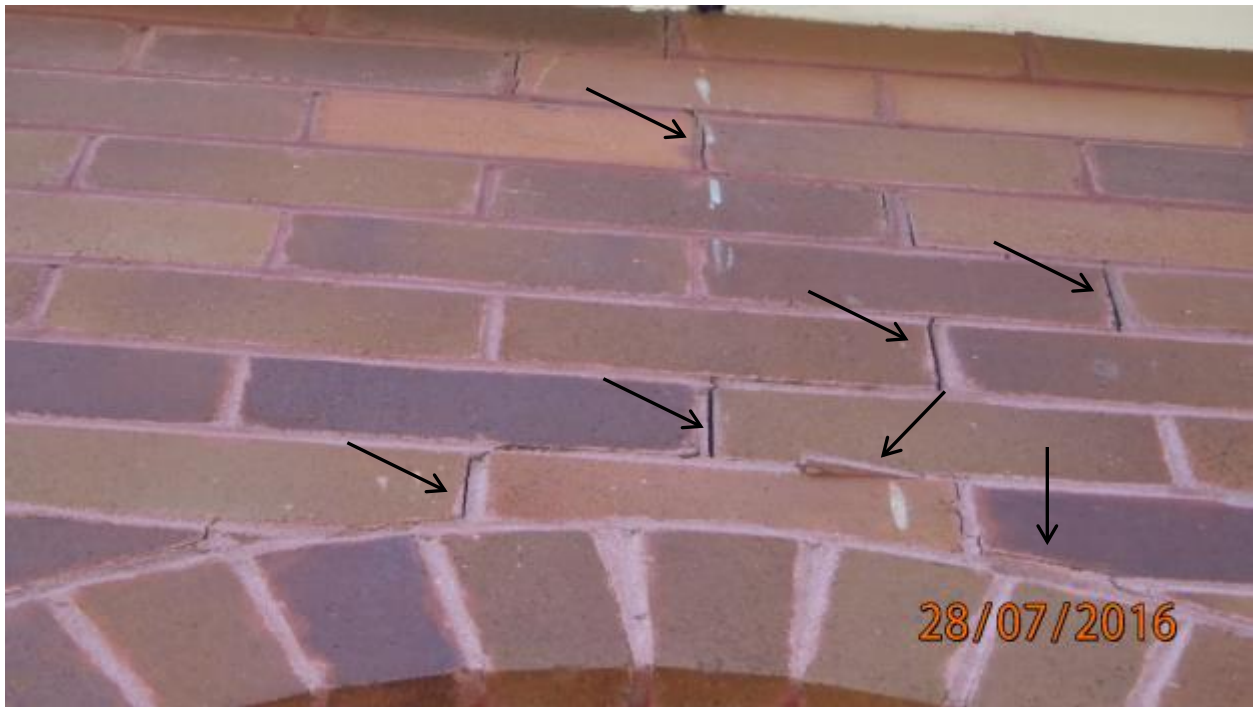
We noted step cracking and displaced mortar above the entry archway [**Photograph 13**]

Photograph 13 shows step cracking and displaced mortar above the entry arch way

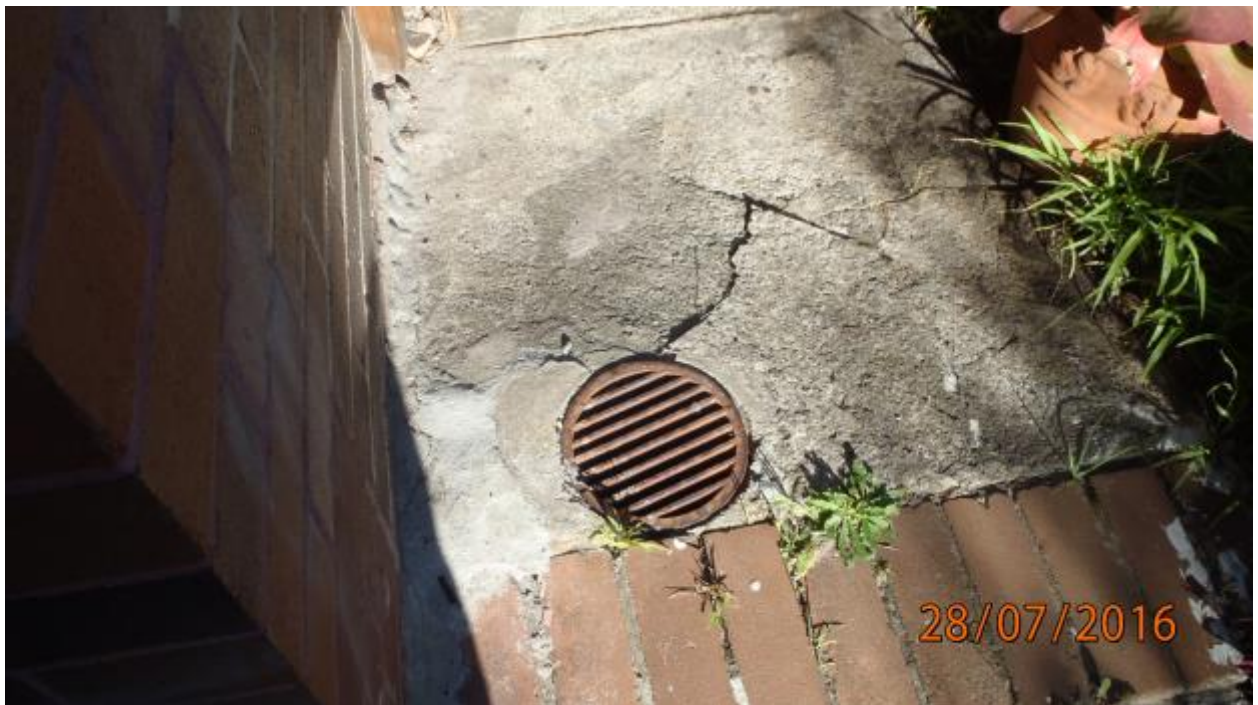
We noted cracking to the concrete path adjacent to the sewer pipe [**Photograph 14**]

Photograph 14 shows cracking to the concrete path

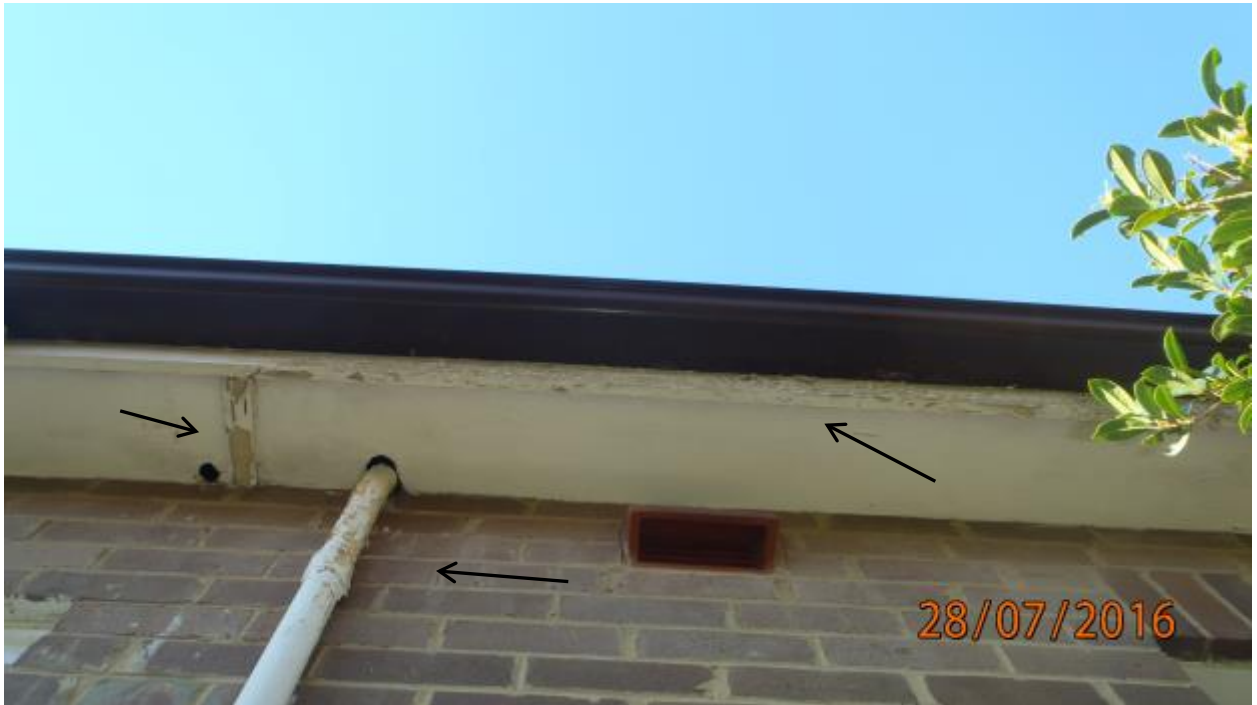
We noted rust to the pipe and flaking paint to the eave and barge above the Lounge Room window. We also noted a step crack adjacent to the pipe extending under the eave [**Photograph 15**]

Photograph 15 shows rust to the pipe and flaking paint to the eave and barge. Also showing a step crack adjacent to the pipe extending under the eave.

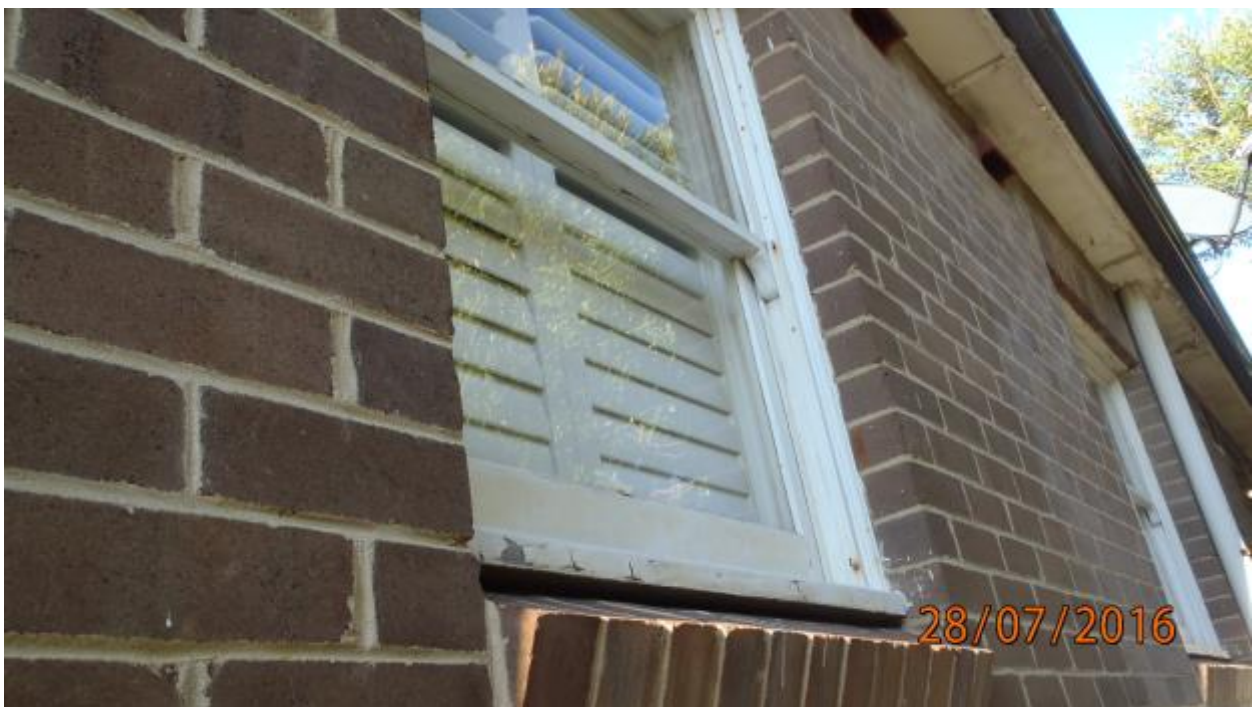
We noted flaking and blistered paint to the window sill outside the Bedroom 2 window [**Photograph 16**]

Photograph 16 shows flaking and blistered paint to the window.

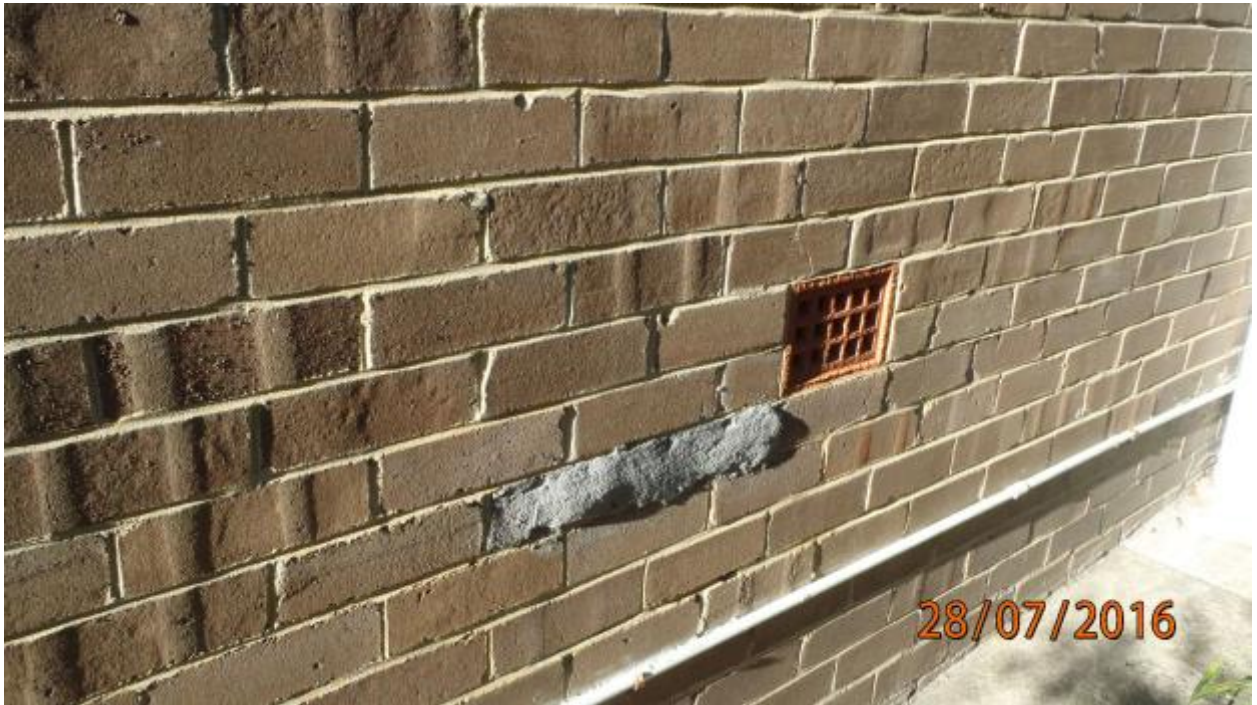
We noted step cracking and previous repairs adjacent to the wall vent under the Lounge Room window [**Photograph 17**]

Photograph 17 shows step cracking and a previous repair.

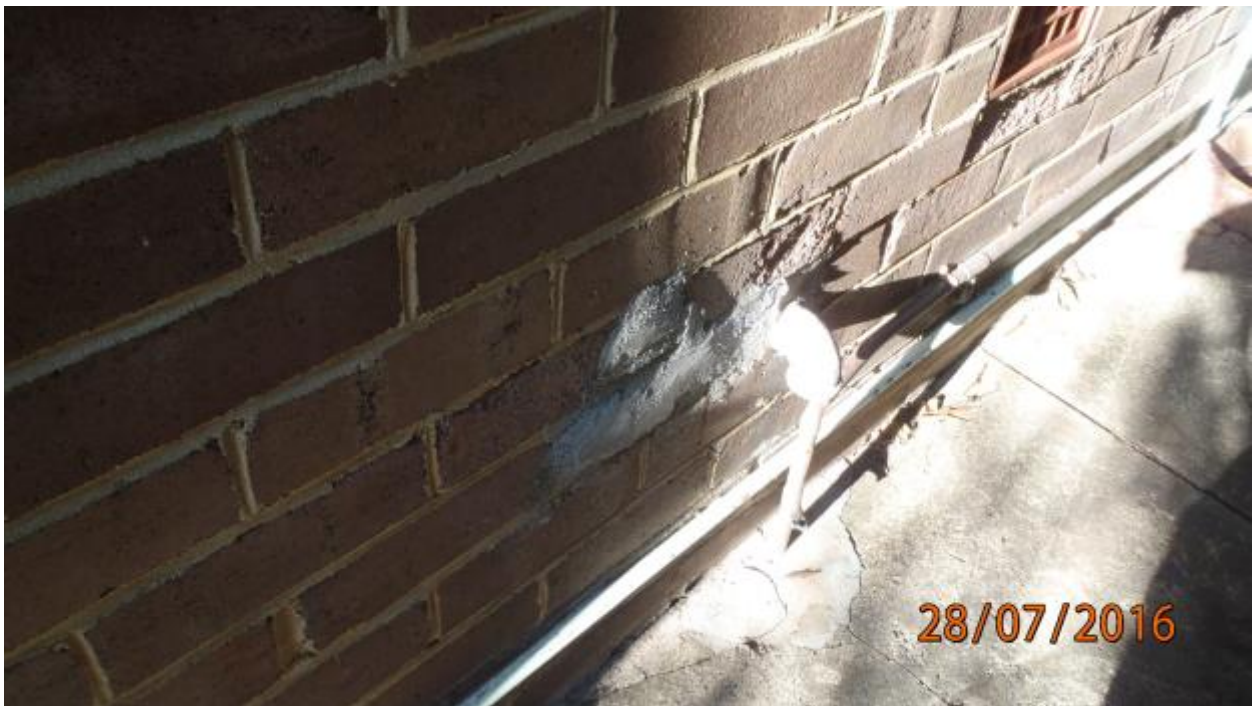
We noted step cracking and previous repairs to the wall outside the Lounge room window [**Photograph 18**]

We noted cracking and previous repairs to the concrete path under the Lounge room window [**Photograph 18**]

Photograph 18 shows step cracking, displaced mortar and a previous repair. Also showing repairs to the concrete path.

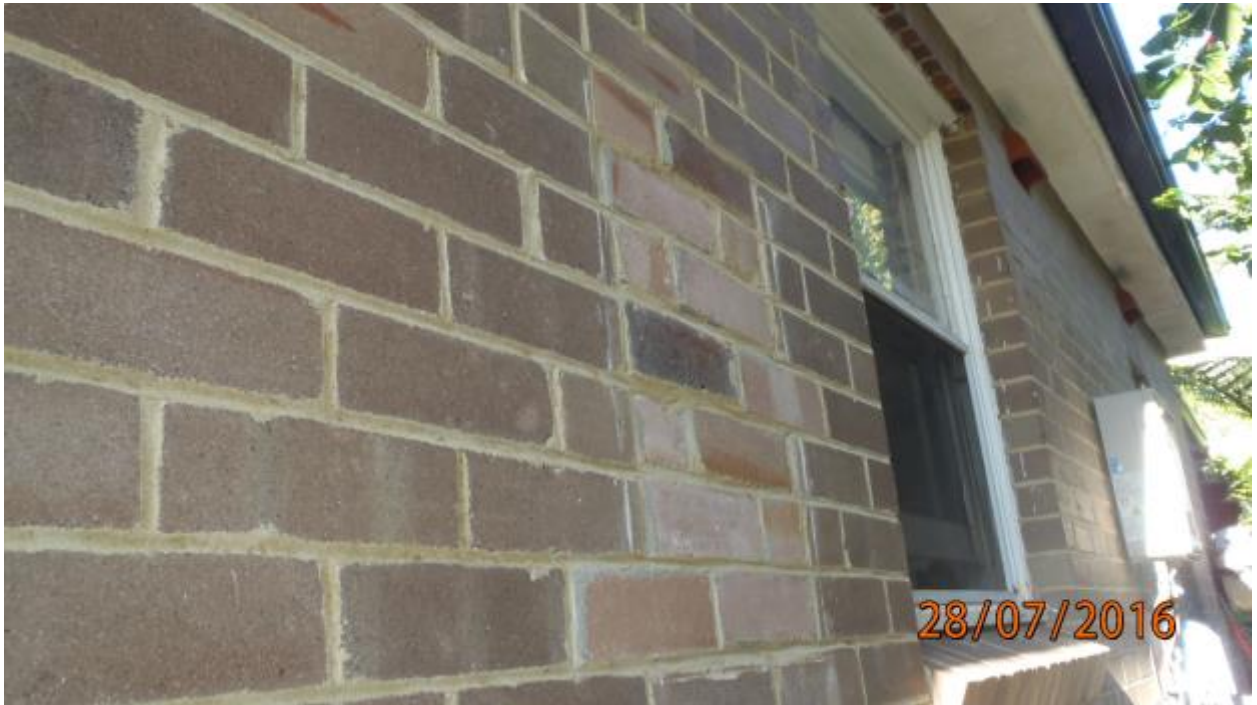
We noted previous repairs to the brickwork outside the Kitchen [**Photograph 19**]

Photograph 19 shows a previous repair to the brickwork outside the Kitchen.

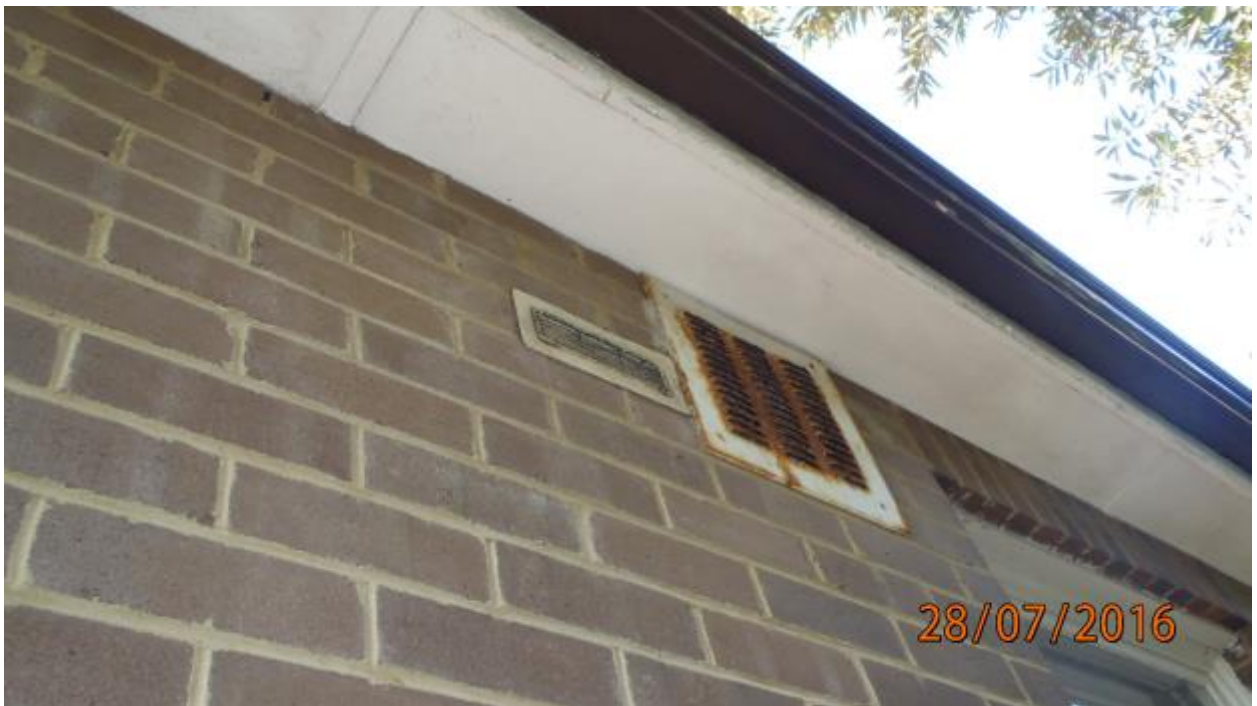
We noted rusting to the exhaust vent outside the Kitchen [**Photograph 20**]

Photograph 20 shows rust to the exhaust vent outside the Kitchen.

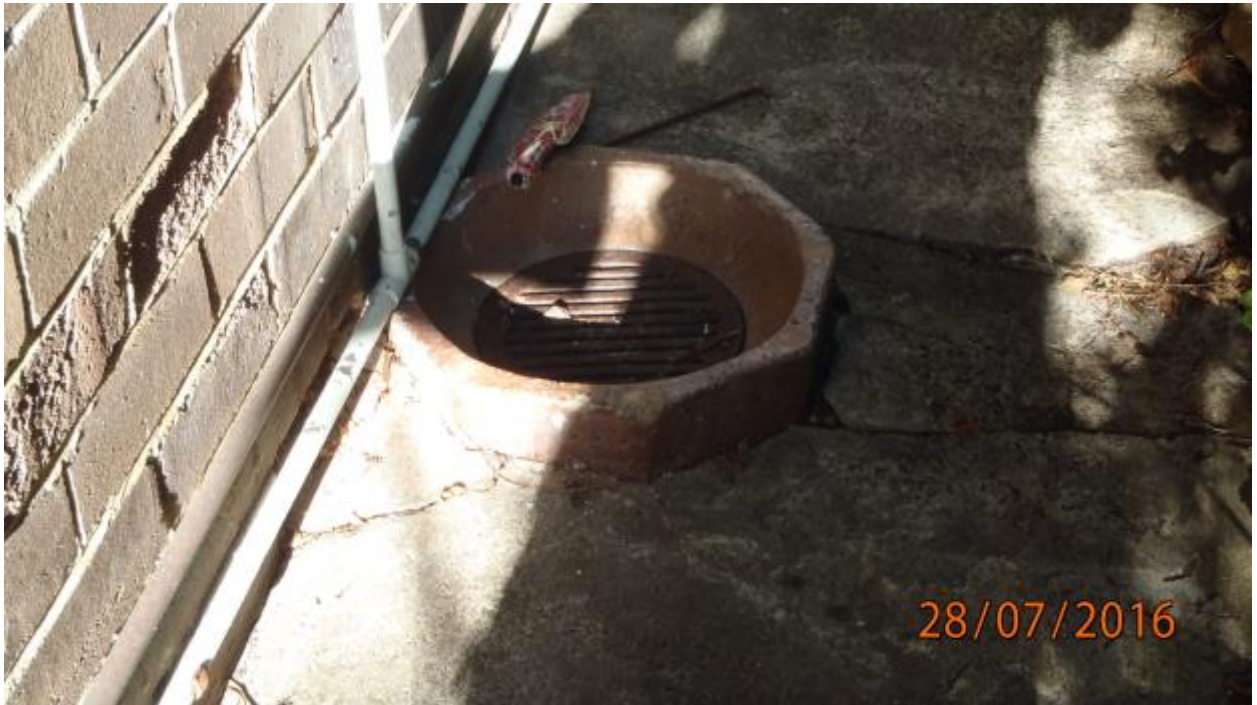
We noted cracking to the concrete path adjacent to the sewer drain [**Photograph 21**]

Photograph 21 shows cracking to the concrete path.

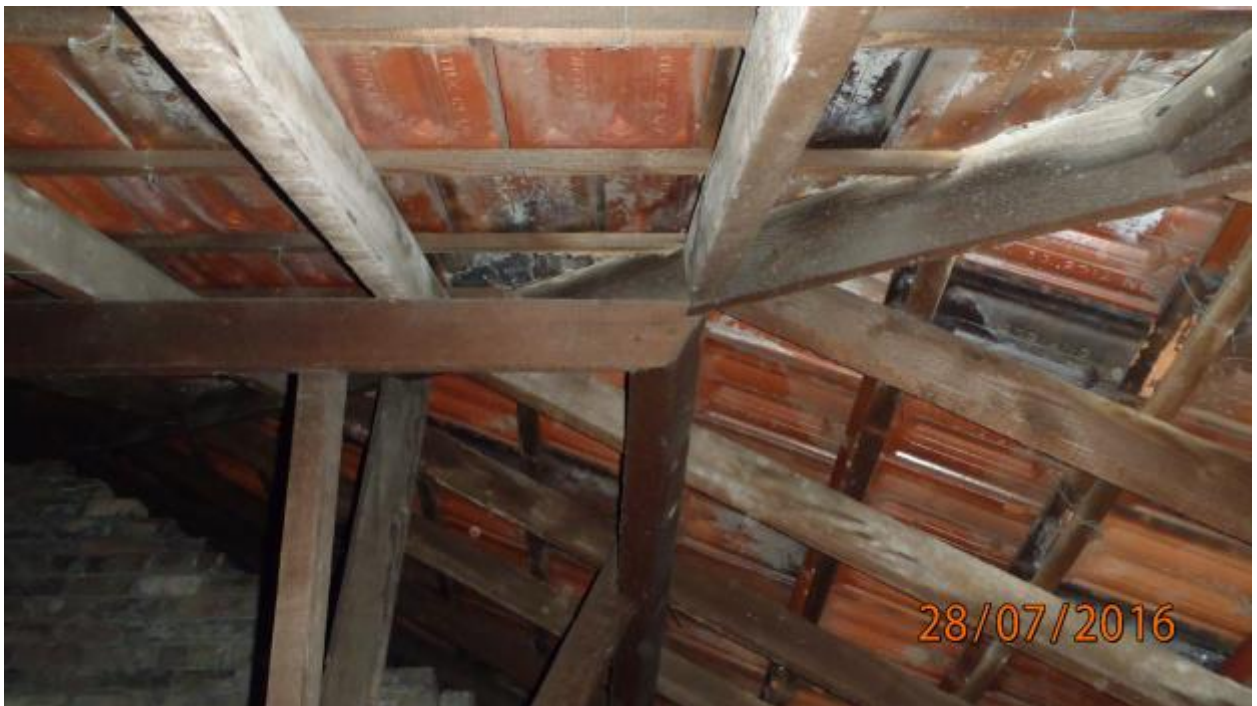
We noted that there is no sarking to the underside of the roofing tiles and the that underside of the terracotta tiles had started to breakdown **[Photograph 22]**

We observed that the roof and ceiling timbers that are accessible are generally in good condition. **[Photograph 22]**

Photograph 22 shows the general condition of the roofing timbers and the underside of the roof tiles.

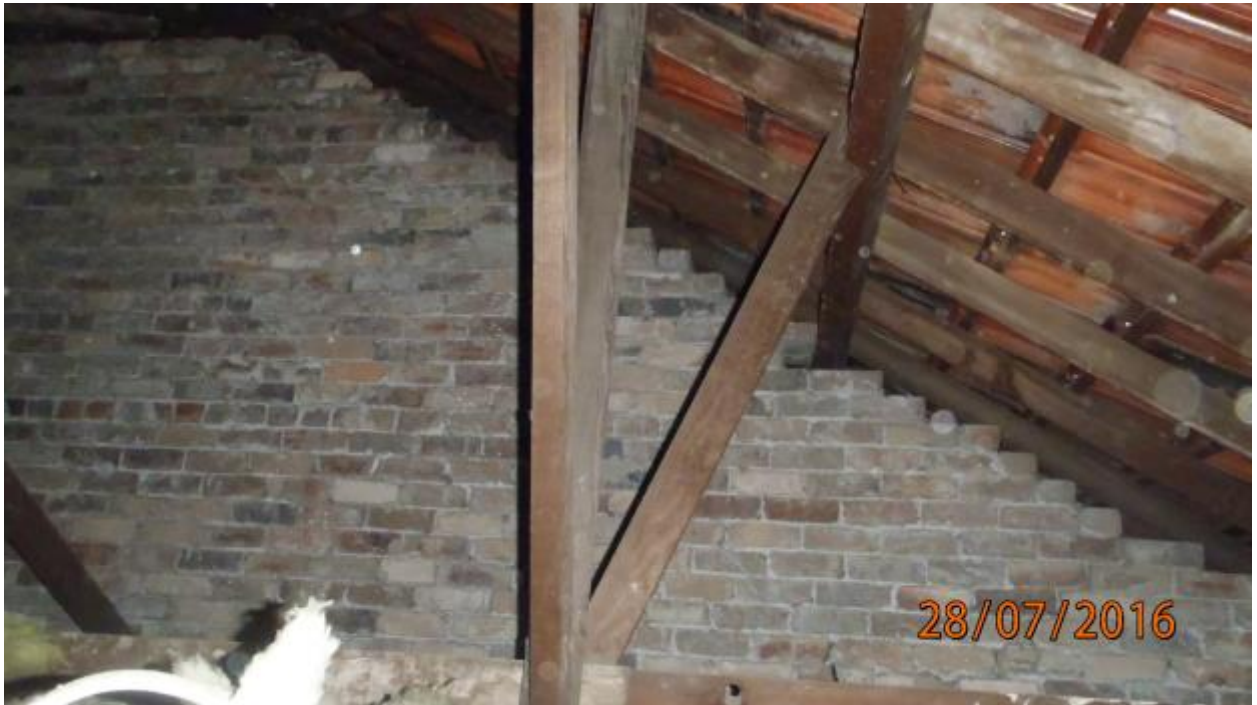
We also noted that the clay brick *common party* wall extends to the underside of the rafters. **[Photograph 23]**

Photograph 23 shows the general condition of the *common party wall* in the roof space.

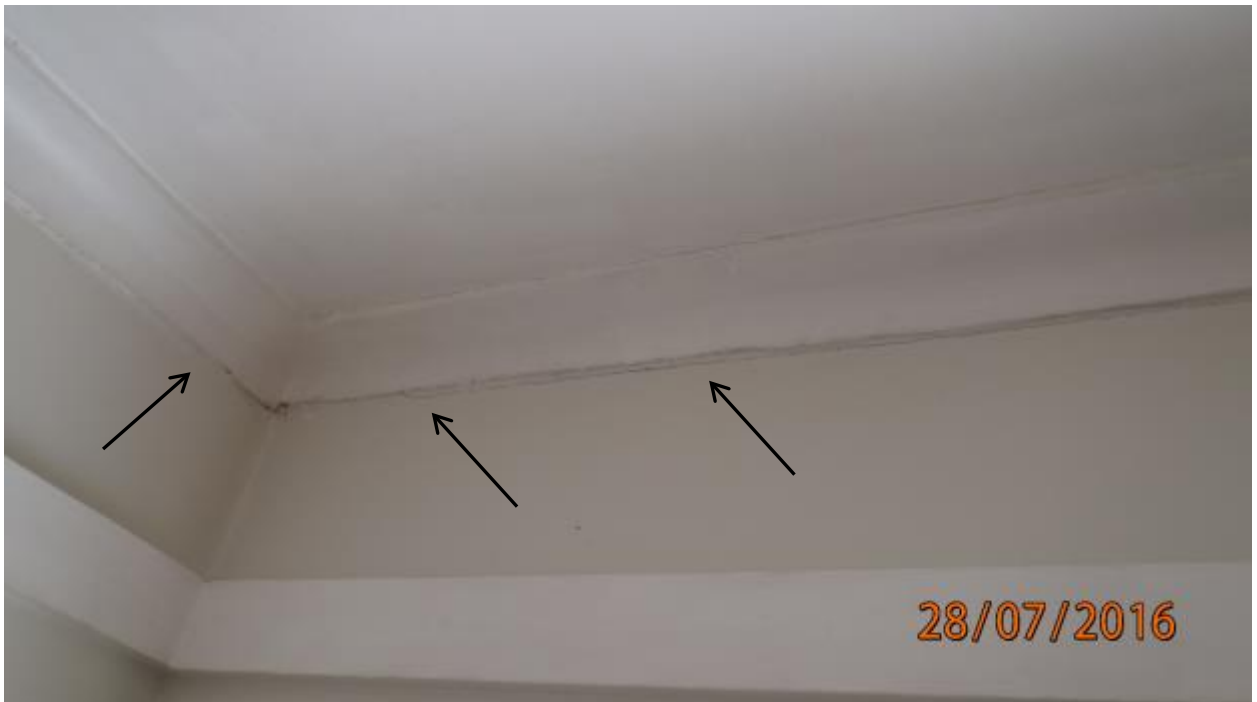
We did observe a hairline separation crack to the wall/cornice junction in the northern corner **[Photograph 24]**

Photograph 24 shows separation cracking to the wall/cornice junction in the Sunroom.
