Dilapidation Assessment Report

Prepared for: Cape Cod Australia Pty. Limited
Job address: 184 Malabar Road, SOUTH COOGEE.
Property Owner/s: Fiona Mackie and Simon Mears
Report reference: **RANDWICK CITY COUNCIL**
Development Application No: not available
Date of assessment: 28th July 2016

Re: Dilapidation Report

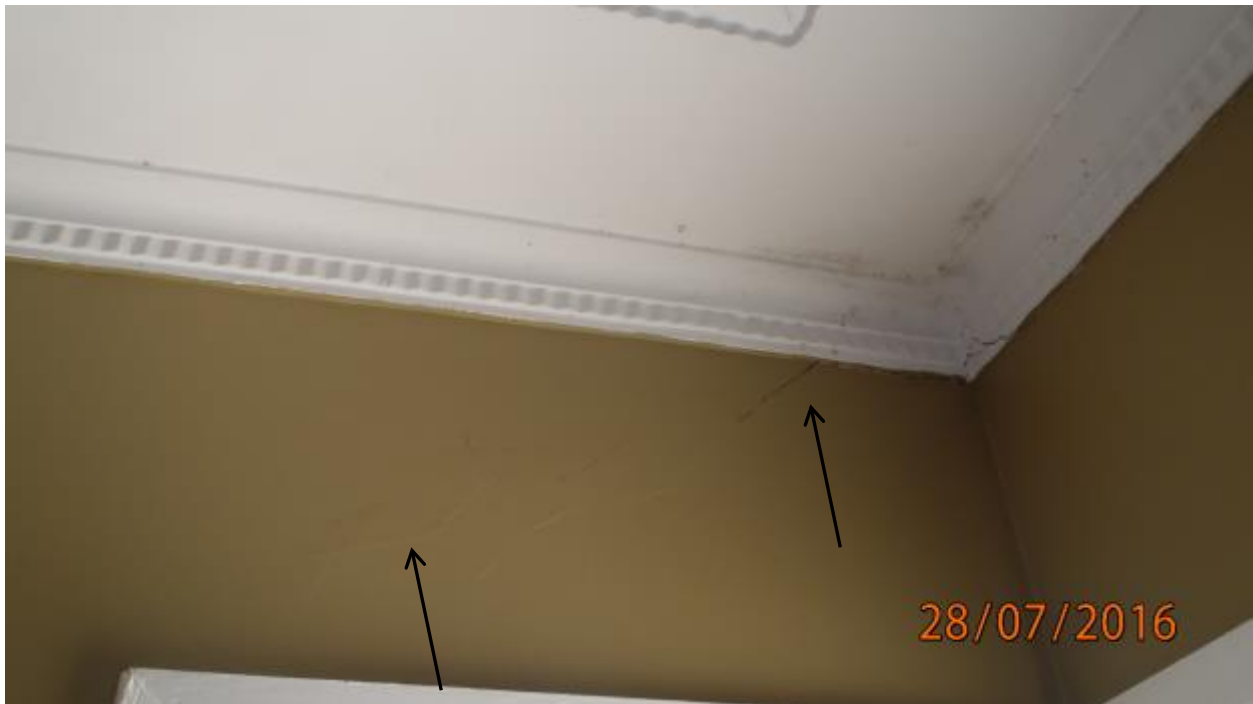
We noted radial cracking and a previous repair from under the cornice in the northern corner, extending to the left hand side window head **[Photograph 25]**

Photograph 25 shows radial cracking from the wall/wall junction in Bedroom 1.

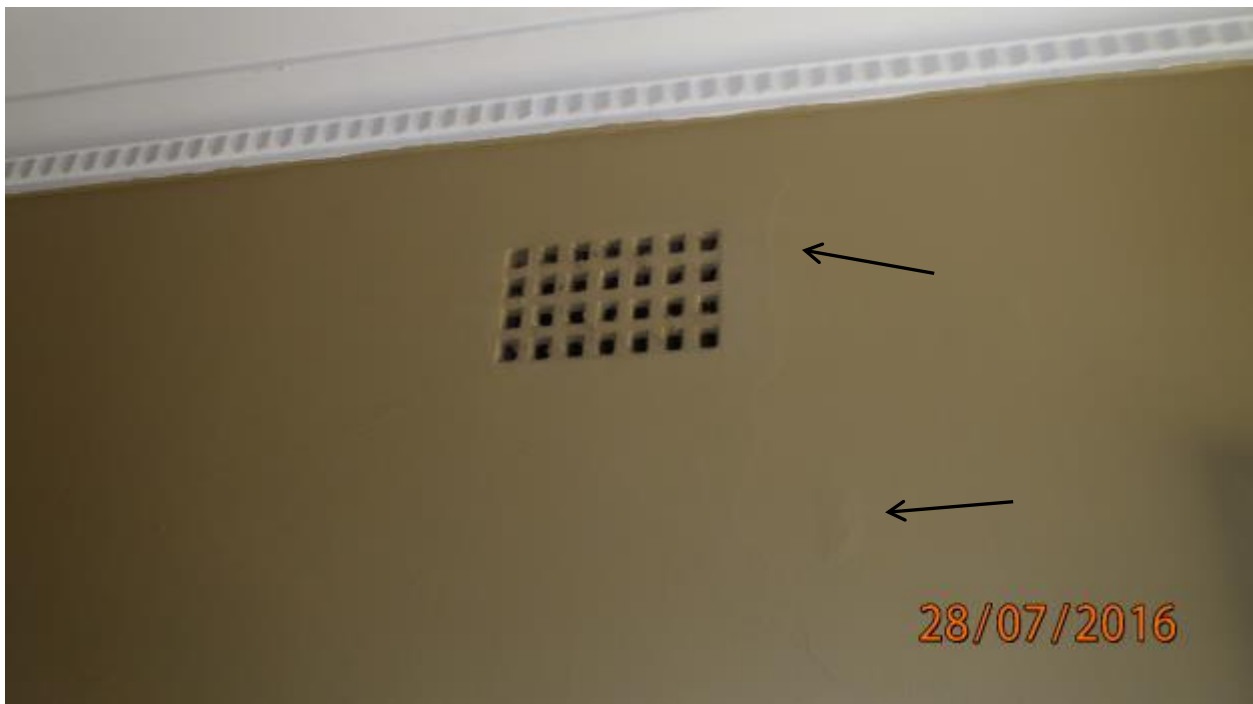
We noted evidence of a previous repair (different surface texture) around the wall vent on the north western wall **[Photograph 26]**

Photograph 26 shows evidence of a previous repair in Bedroom 1.

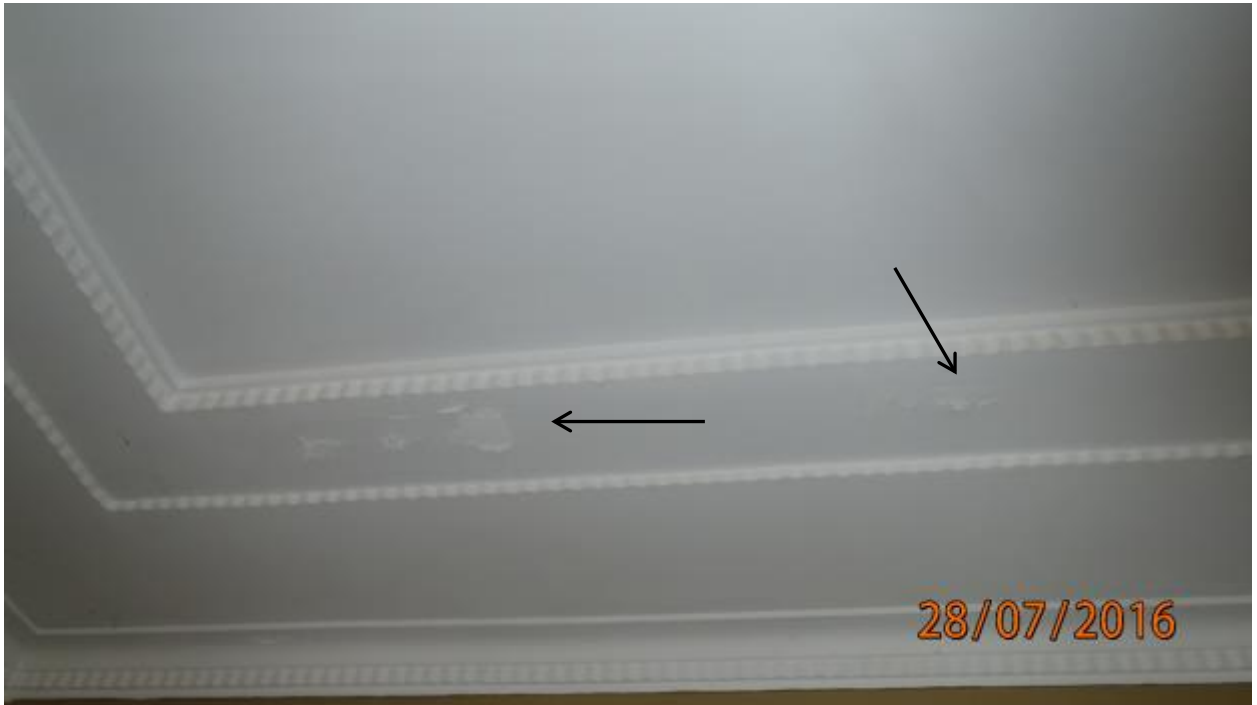
We noted flaking and blistering paint to the decorative ceiling **[Photograph 27]**

Photograph 27 shows flaking and blistering paint in Bedroom 1.

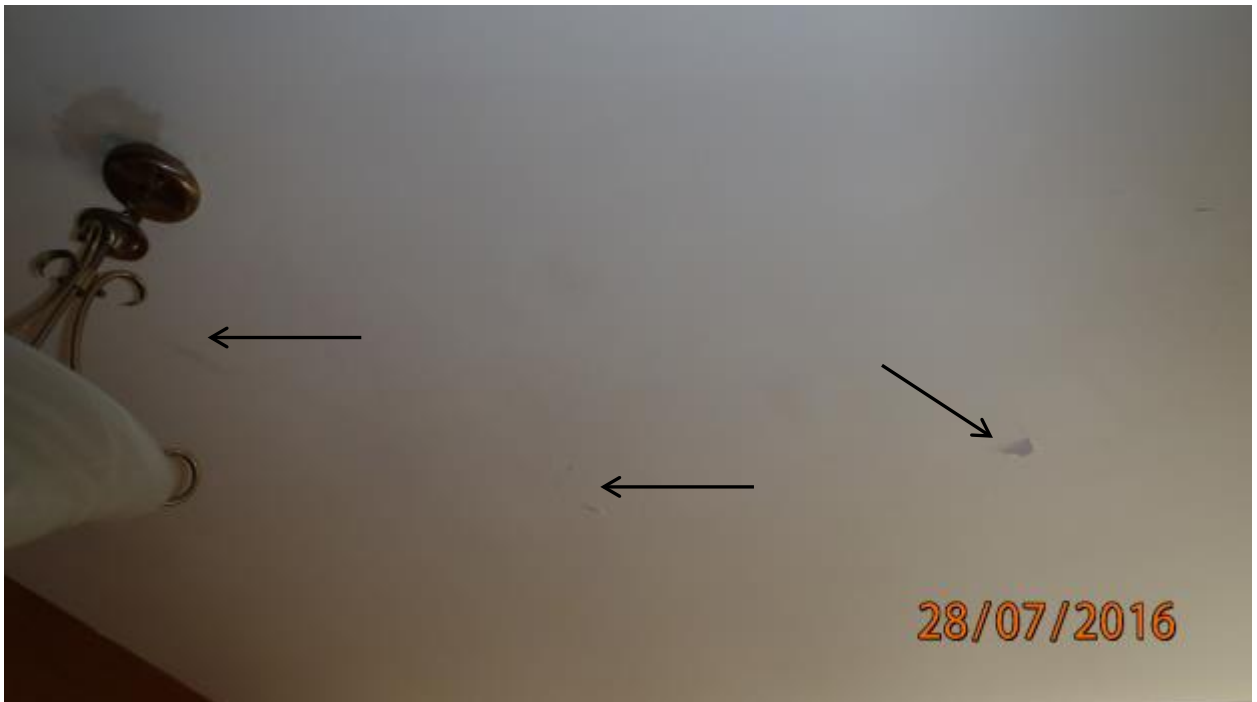
We noted flaking and blistering paint to the ceiling adjacent to the light fixture **[Photograph 28]**

Photograph 28 shows flaking and blistering paint in Bedroom 1.

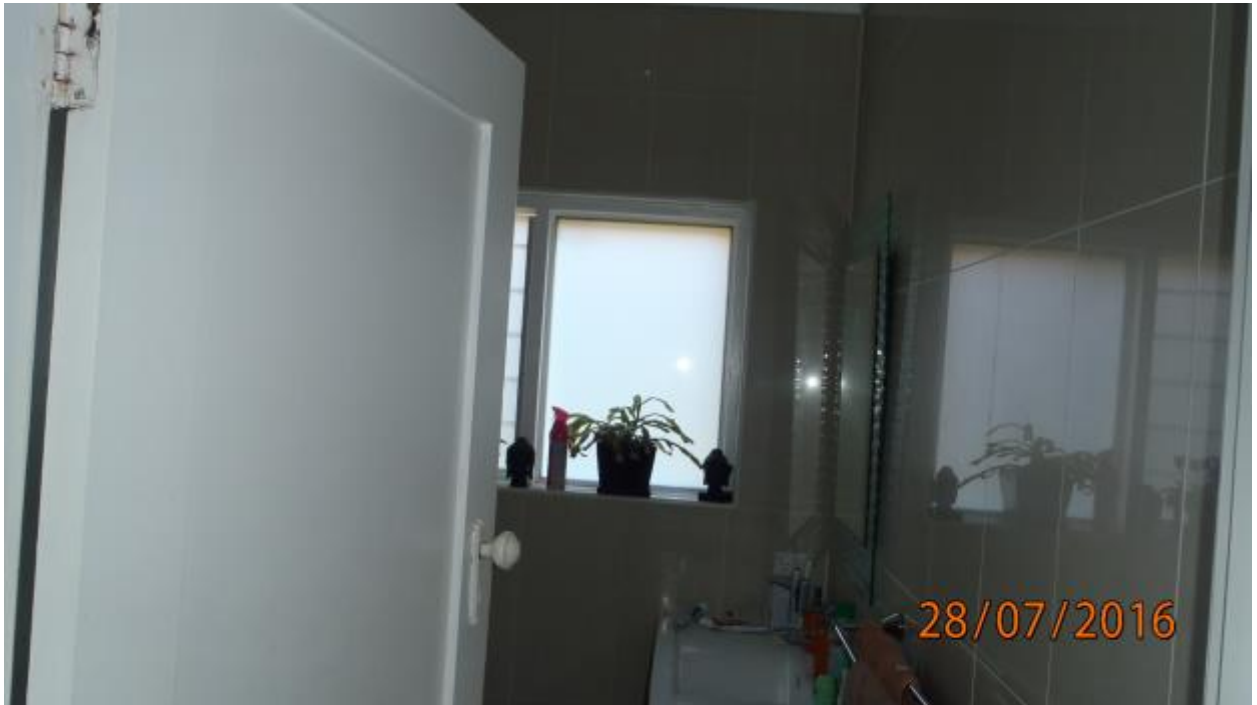
We noted that the grout to the wall and floor tiles is complete and that the wall and floor tiles when randomly “tap” tested appeared to be sound. We did not observe any recent cracking to the tile grout at the wall / wall, wall / floor junctions. **[Photograph 29] 675**

Photograph 29 shows the general condition of the Bathroom.

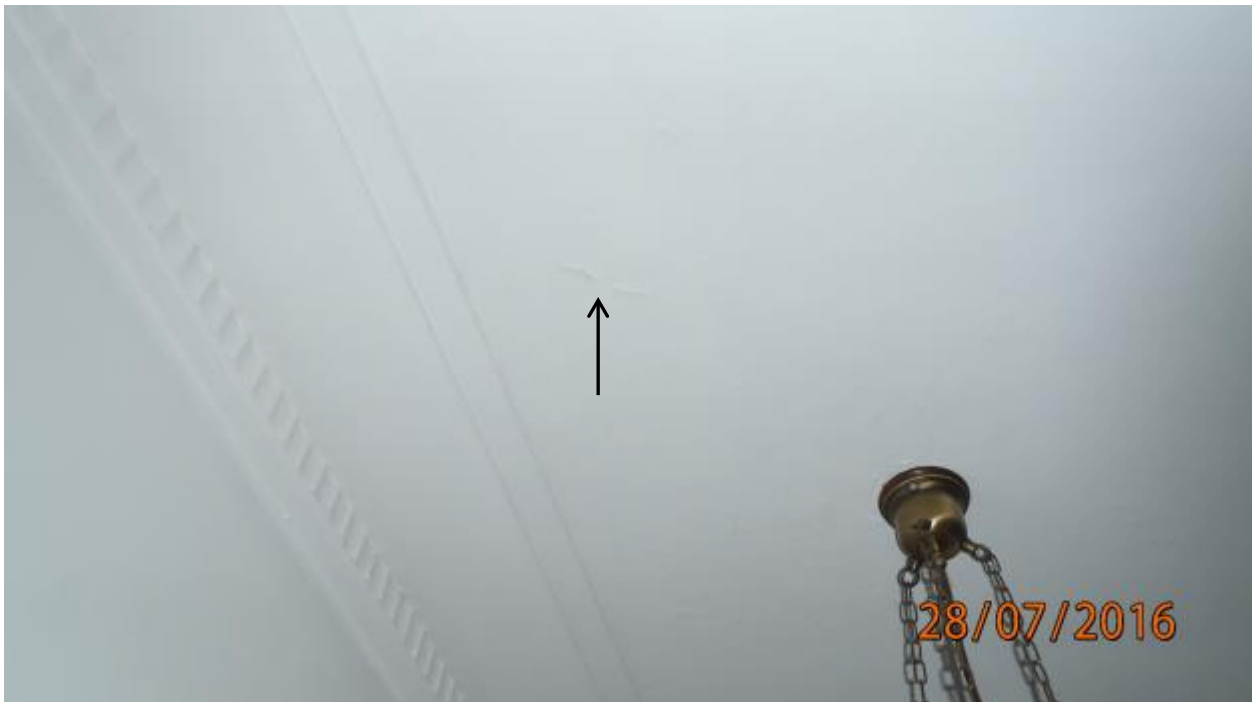
We noted flaking and blistering paint to the ceiling adjacent to the light fixture [**Photograph 30**]

Photograph 30 shows flaking and blistering paint in the Hallway.

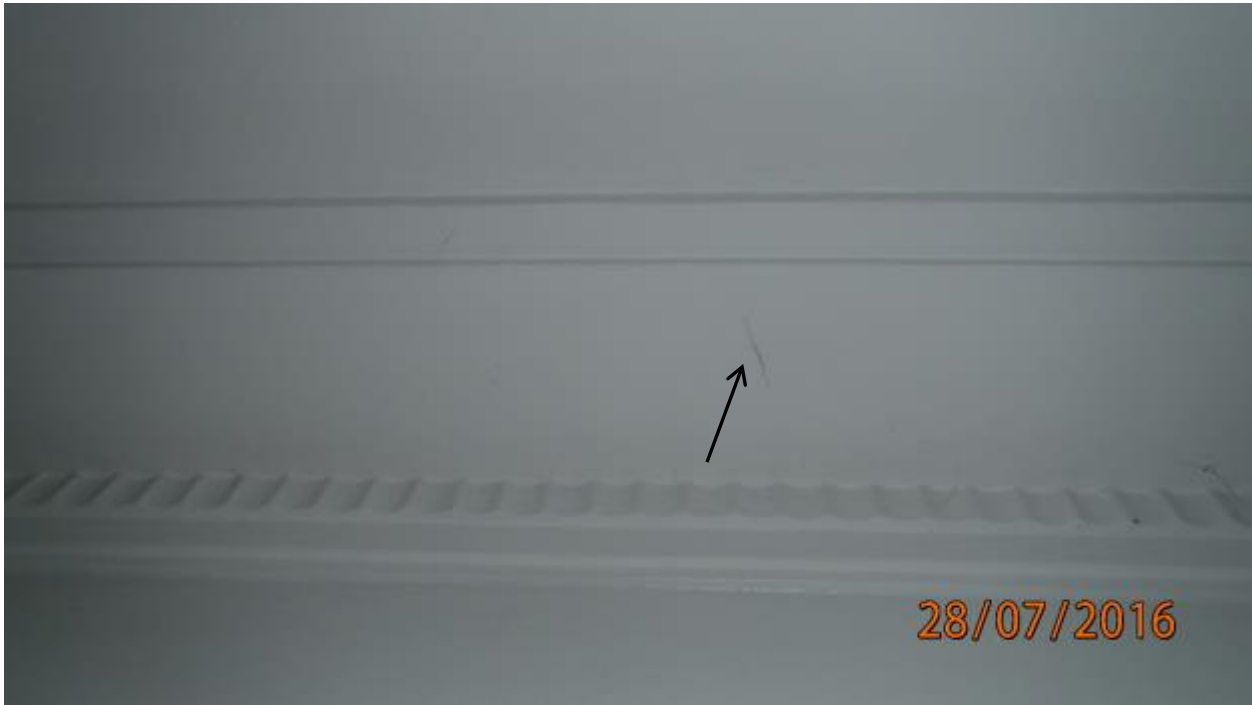
We noted flaking and blistering paint to the decorative plaster cornice adjacent to the common party wall [**Photograph 31**]

Photograph 31 shows flaking and blistering paint in the Hallway.

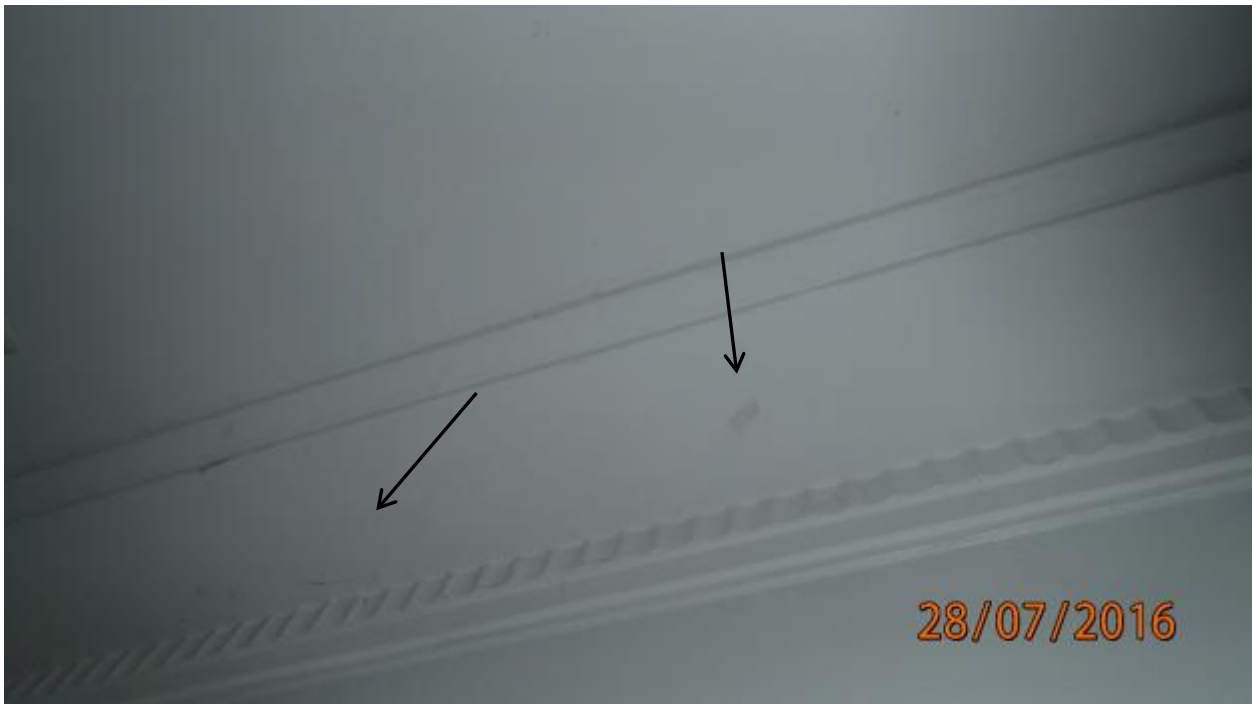
We noted flaking and blistering paint to the decorative plaster cornice adjacent to the common party wall [**Photograph 32**]

Photograph 32 shows flaking and blistering paint in the Hallway.

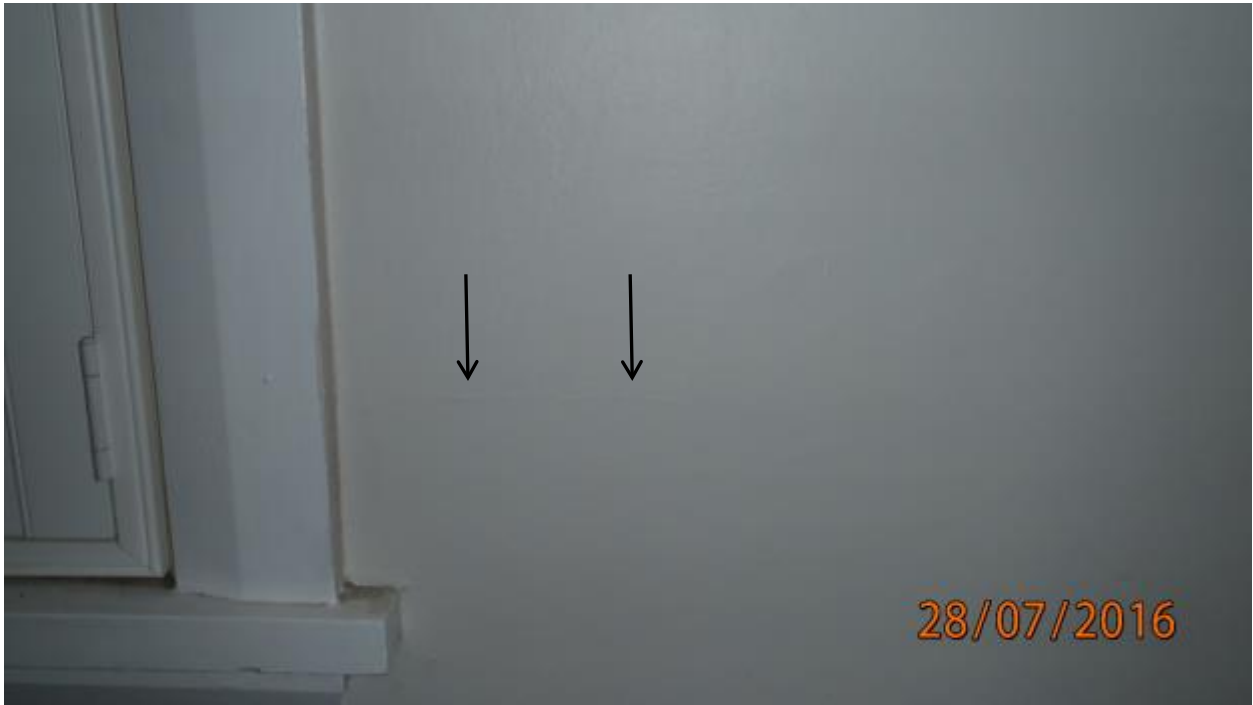
We noted a previous horizontal repair extending from the right hand side window jamb [**Photograph 33**]

Photograph 33 shows evidence of a previous horizontal repair in Bedroom 2.

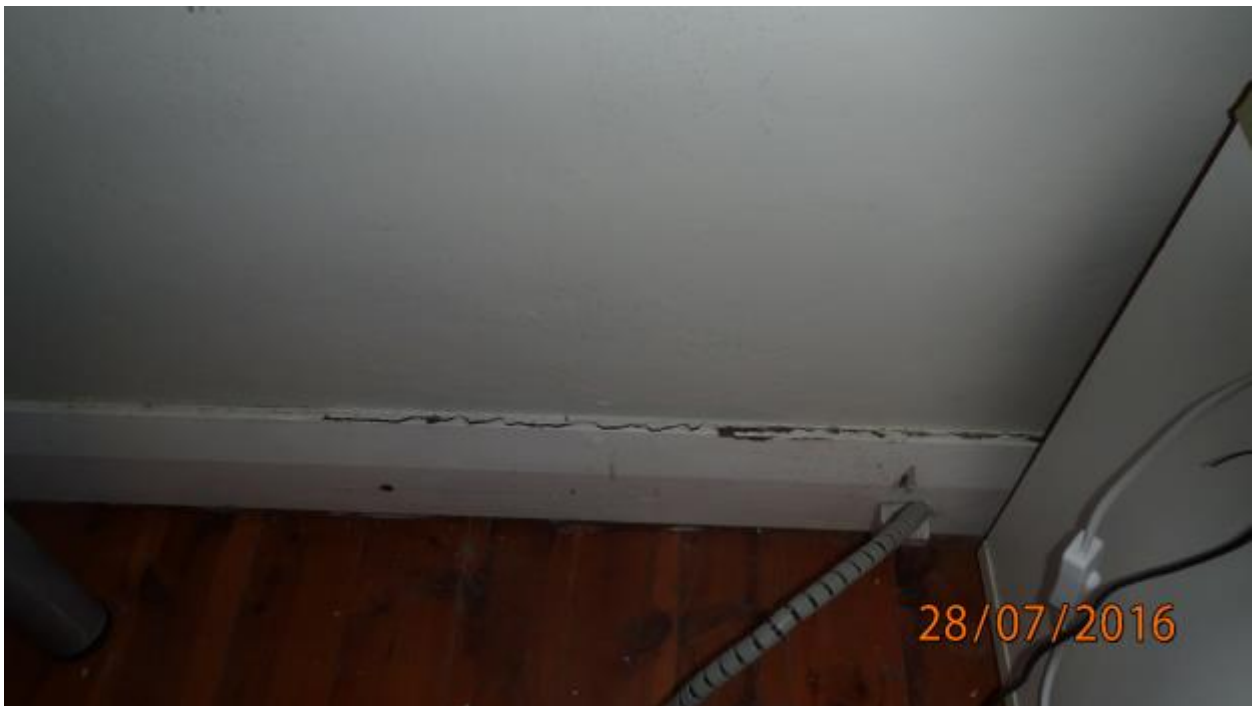
We note a separation crack from the skirting/wall junction on the south western wall [**Photograph 34**]

Photograph 34 shows a separation crack between the skirting and wall in Bedroom 2.

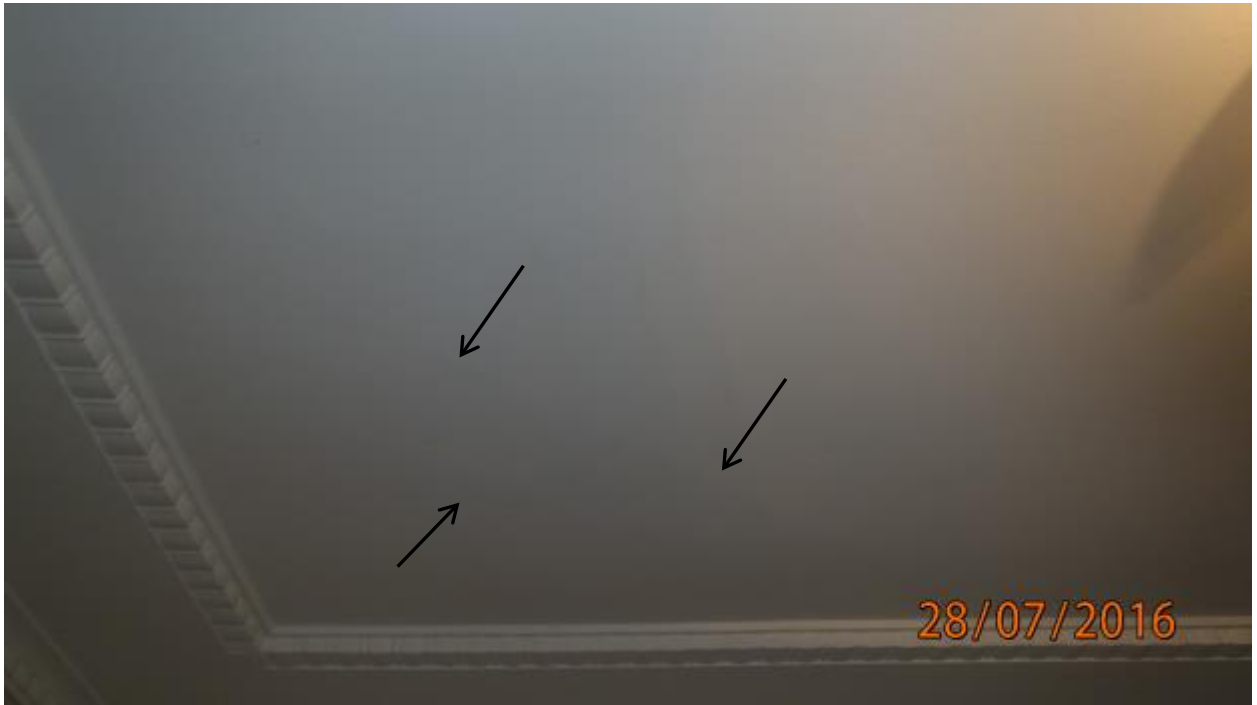
We noted radial cracking to the ceiling lining in the south western corner [**Photograph 35**]

Photograph 35 shows radial cracking to the ceiling lining in Bedroom 2.

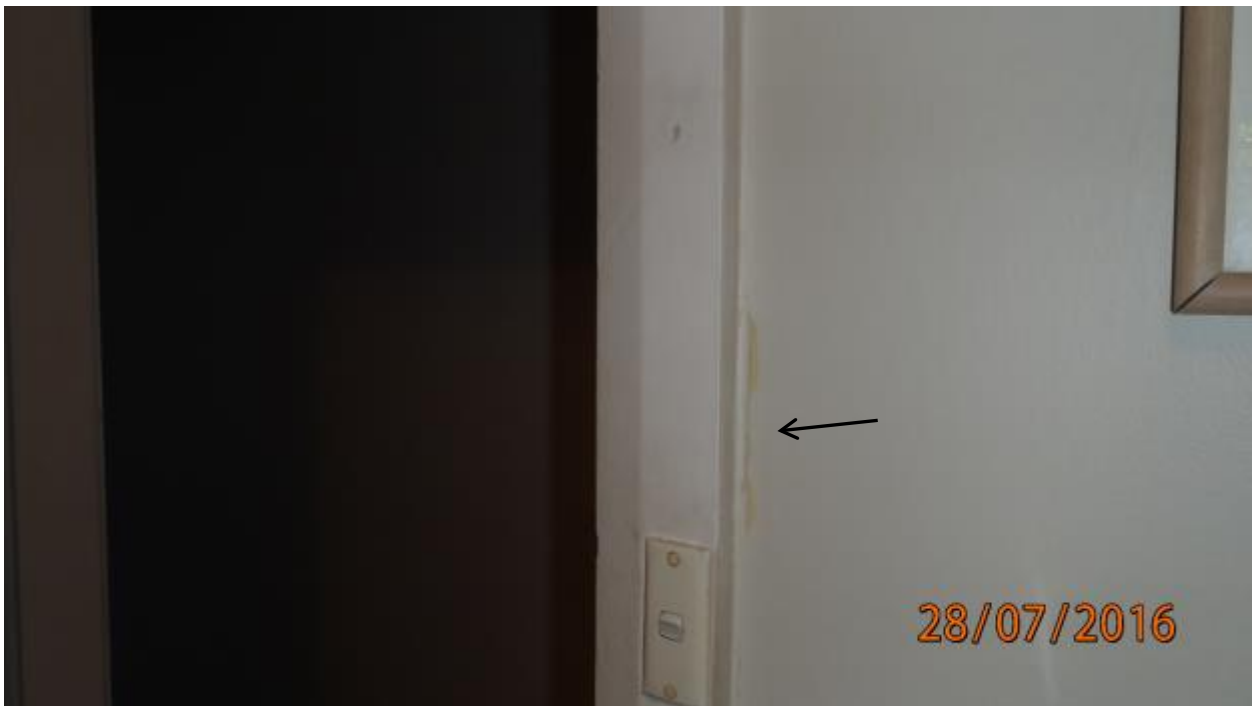
We note a separation cracking and flaking paint from around the door jamb [**Photograph 36**]

Photograph 36 shows separation cracking and flaking / blistering paint in Bedroom 2.
