HAZARDOUS MATERIALS ASSESSMENT REPORT

Job details: Owner/s: Mr. G. Shalvi & Ms. M. Hechtman
Location: 7 Oceanview Avenue, Dover Heights

Date of assessment: 20th June 2014

Our reference: HM03130614

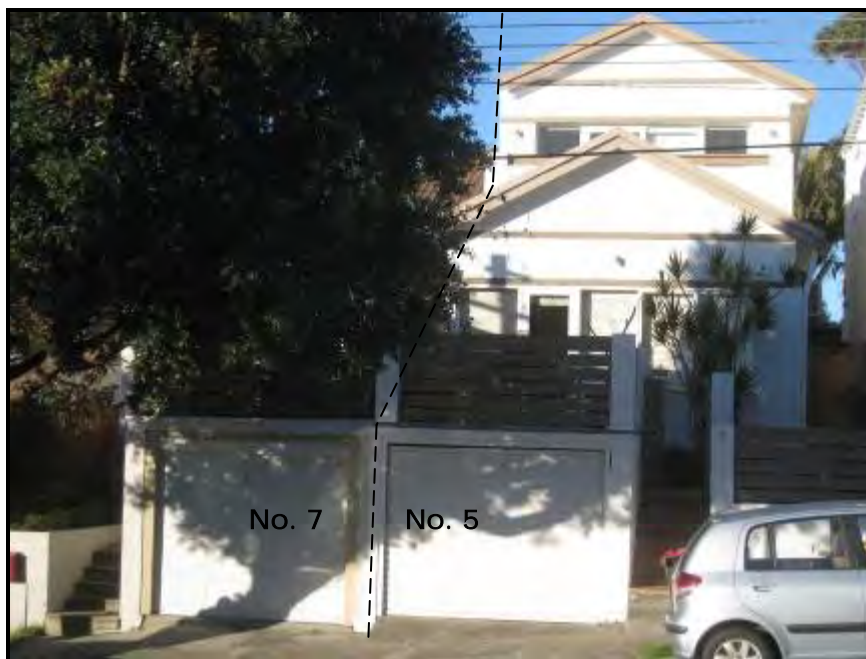
Front northern elevation of the adjoining properties;
No. 5 & No. 7 Oceanview Avenue, Dover Heights
