HAZARDOUS MATERIALS ASSESSMENT REPORT

Client: Cape Cod Australia Pty. Limited

Job details: Owner: Mr. A Scarpin
Location: 22 Balbeek Avenue, Blacktown.

Our reference: HM05130916

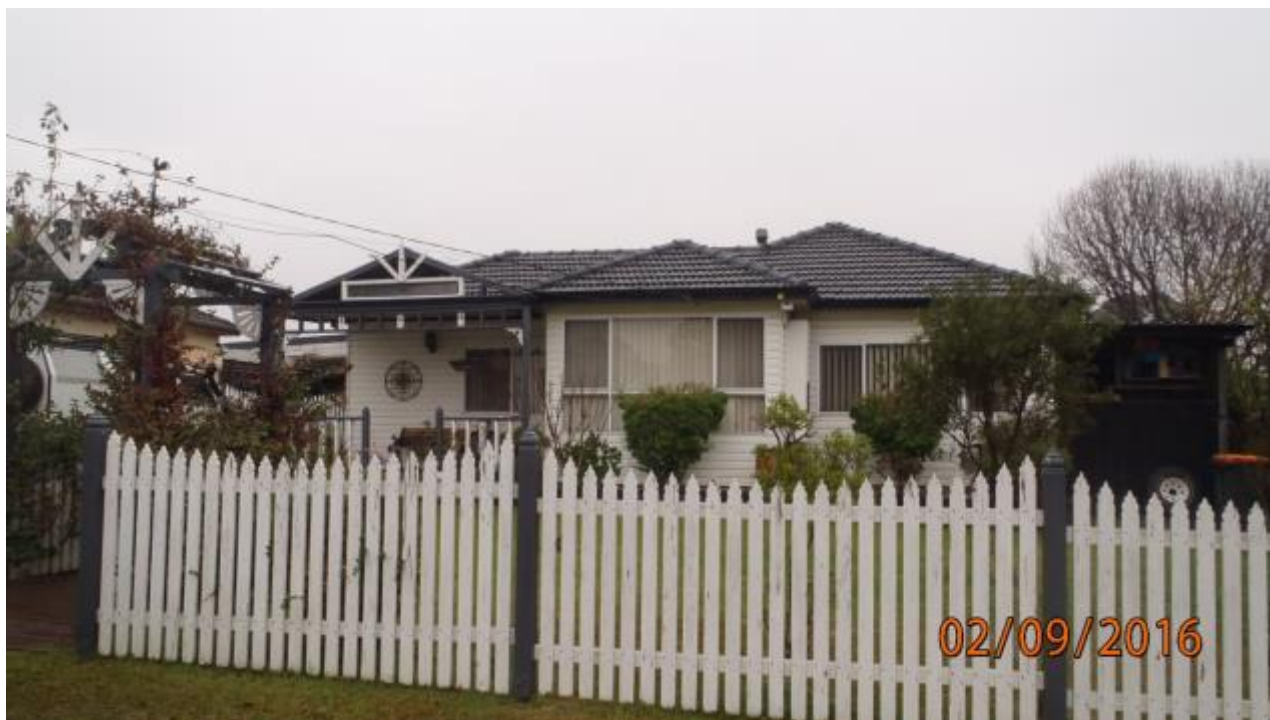
Front eastern elevation of the residence
