HAZARDOUS MATERIALS ASSESSMENT REPORT

Job details: Owner: Mr. G. & Mrs. C. Soalheiro.
Location: 65 Koorungal Avenue, Thornleigh.

Date of assessment: 20th December 2016

Our reference: HM05421216

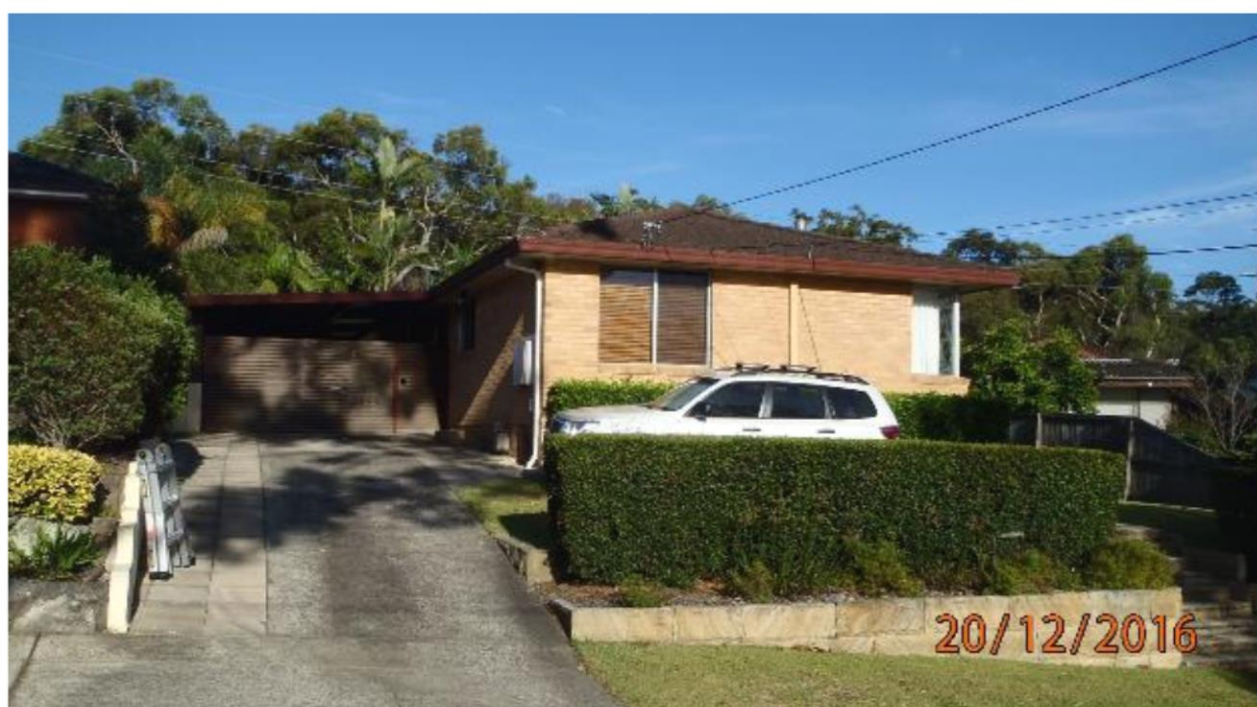
Front eastern elevation of the residence
