HAZARDOUS MATERIALS ASSESSMENT REPORT

Job details: Owner: Mr. M. Jones. & Mrs. R. Critchard Jones.
Location: 23 Bay Street, Botany.

Date of assessment: 3rd May 2017

Our reference: HM05630517

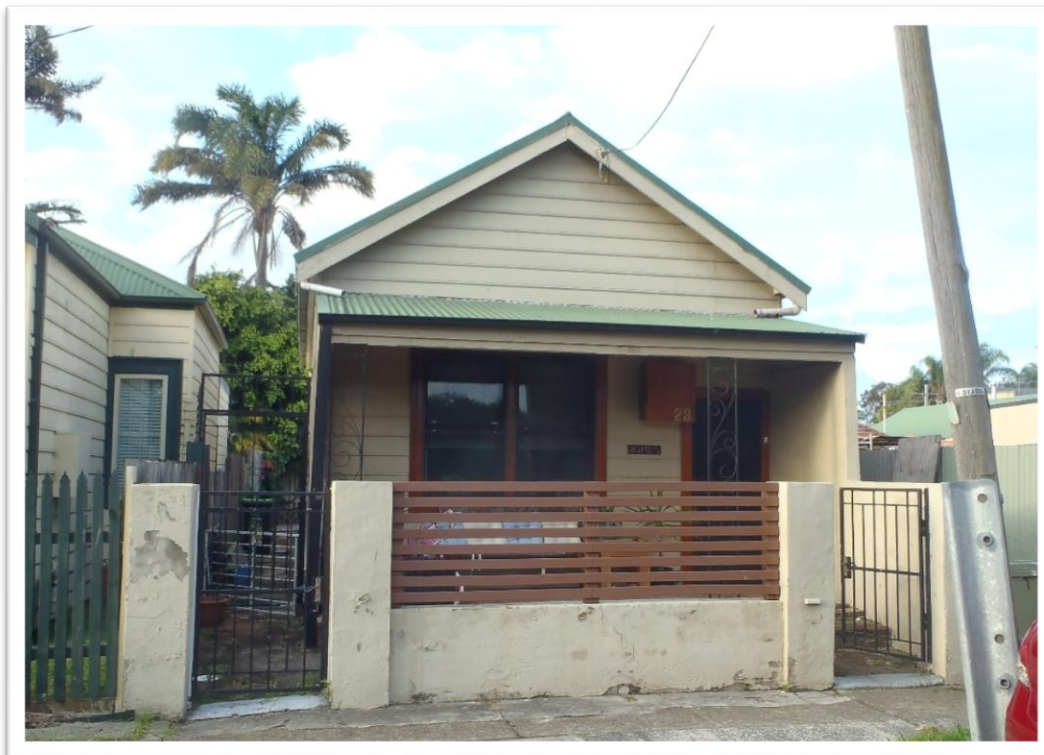
Front northern elevation of the residence
