HAZARDOUS MATERIALS ASSESSMENT REPORT

Job details: Owner: Mrs. T. Galea
Location: 6 Dudley Street, Randwick NSW

Our reference: HM04530116

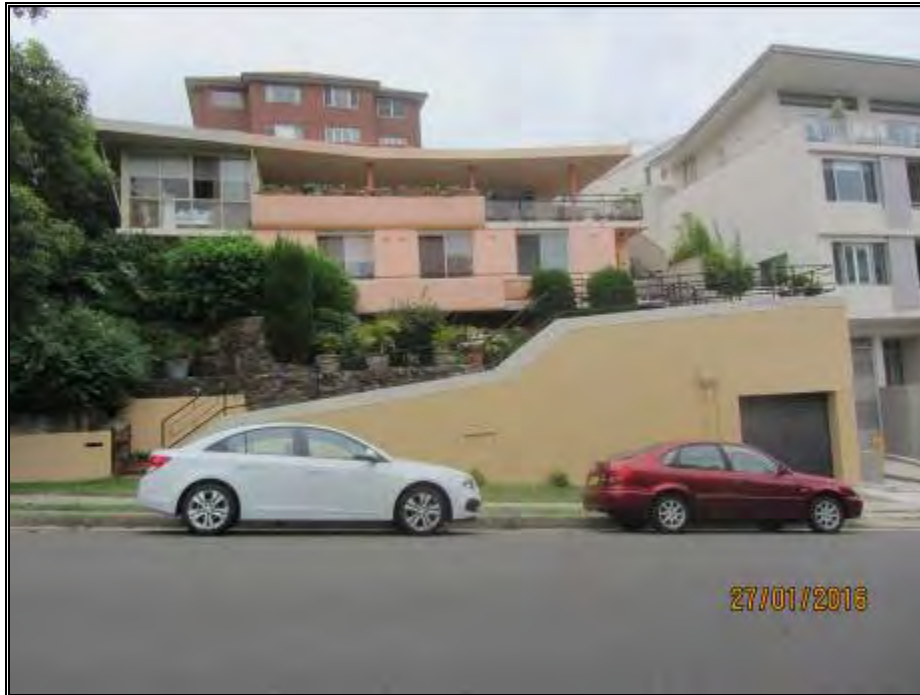
Front north eastern elevation of the residence
