HAZARDOUS MATERIALS ASSESSMENT REPORT

Job details: Owner: Mr. P. Sheehy & Ms. L. Hayes.
Location: 17 Brook Street, Coogee. NSW.

Date of assessment: 4th November 2016

Our reference: HM05261116

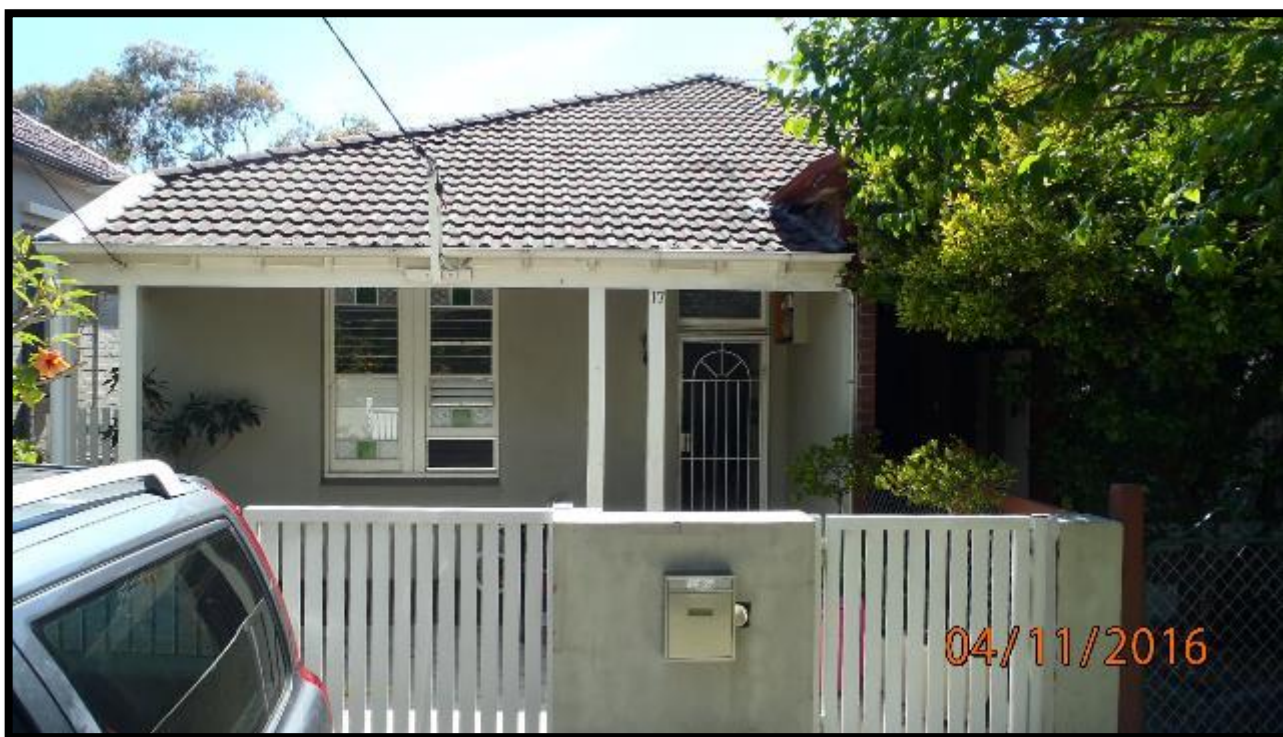
Front south western elevation of the residence
