Dilapidation Assessment Report

Prepared for: Cape Cod Australia Pty. Limited
Job address: 49 Onslow Street, Rose Bay.
Property Owner/s: Mrs. Stephanie Rea.
Report reference: **WAVERLEY COUNCIL**
Development Application No: not available
Date of assessment: 13th September 2016

Re: Dilapidation Report

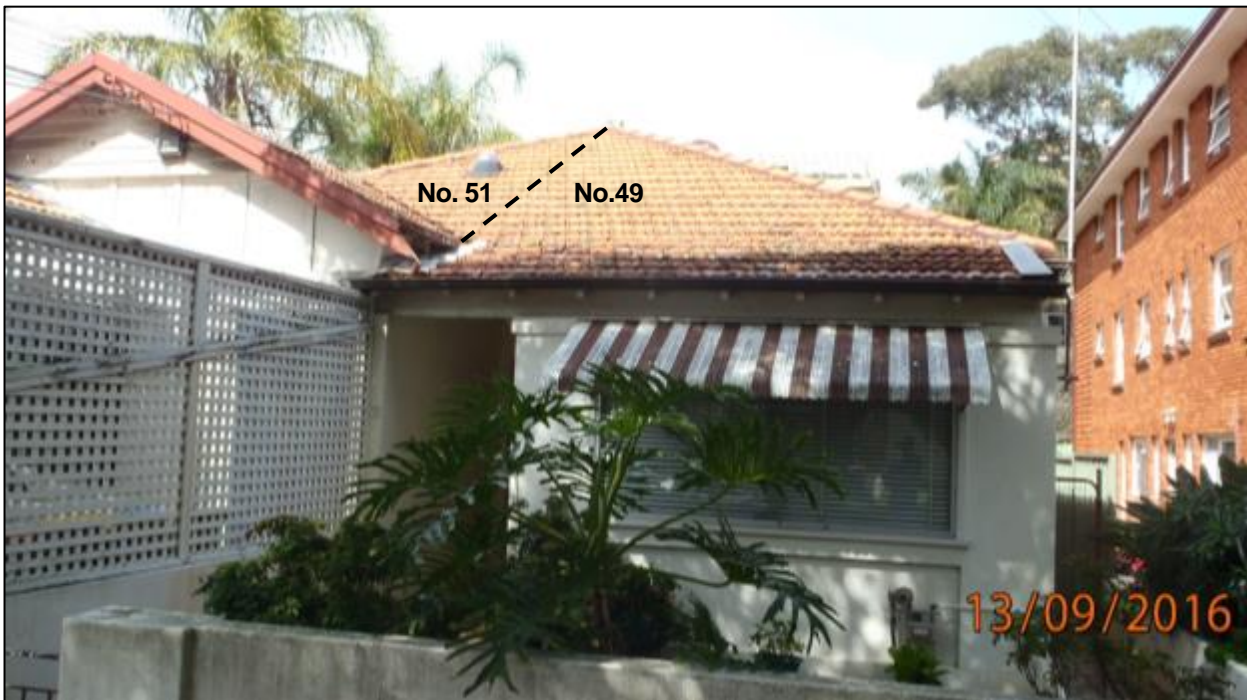
Shows the front northern elevation of the adjoining properties:
No.49 and No.51 Onslow Street, Rose Bay.

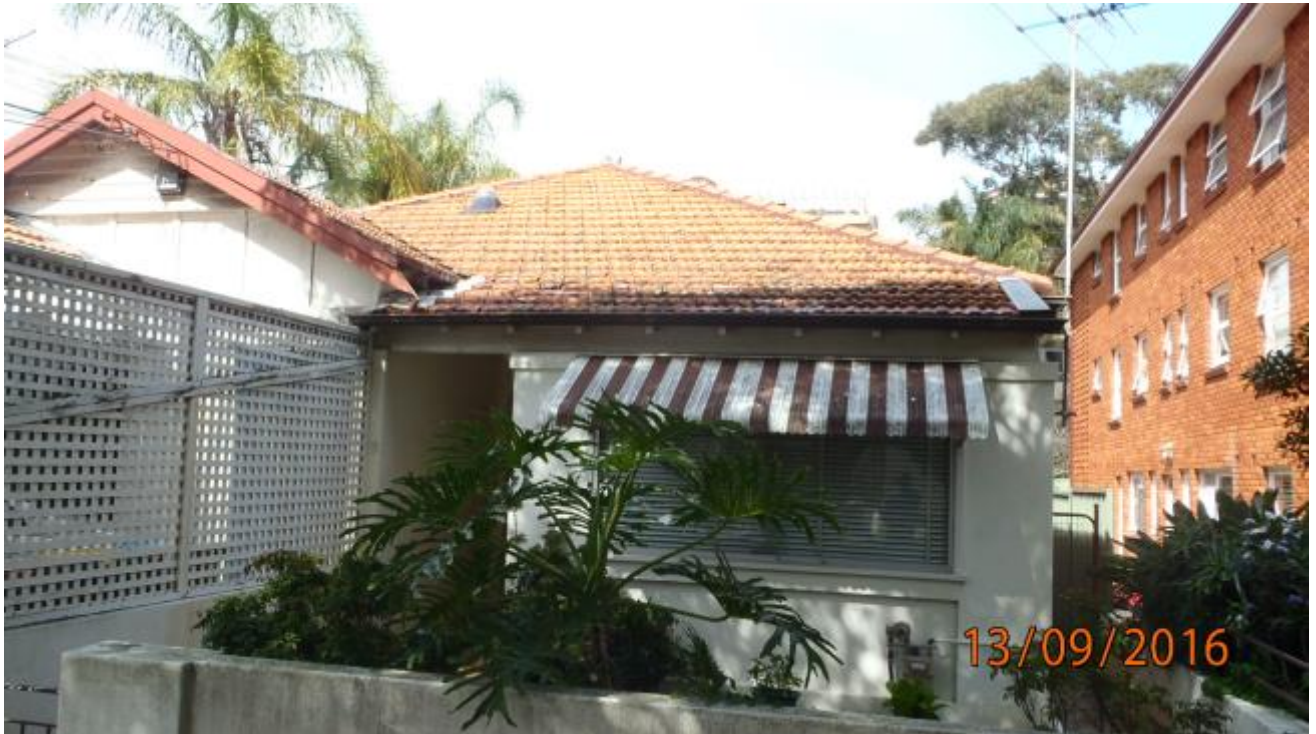
We observed that the terra cotta roof tiles to the roof surface are generally interlinked but show signs of deterioration. **[Photographs 1 and 2]**

We did not observe any recent cracking to the surface coated cement rendered brickwork. **[Photograph 1]**

Photograph 1 shows the general condition of the front *common* roof surface and the front elevation of the residence.

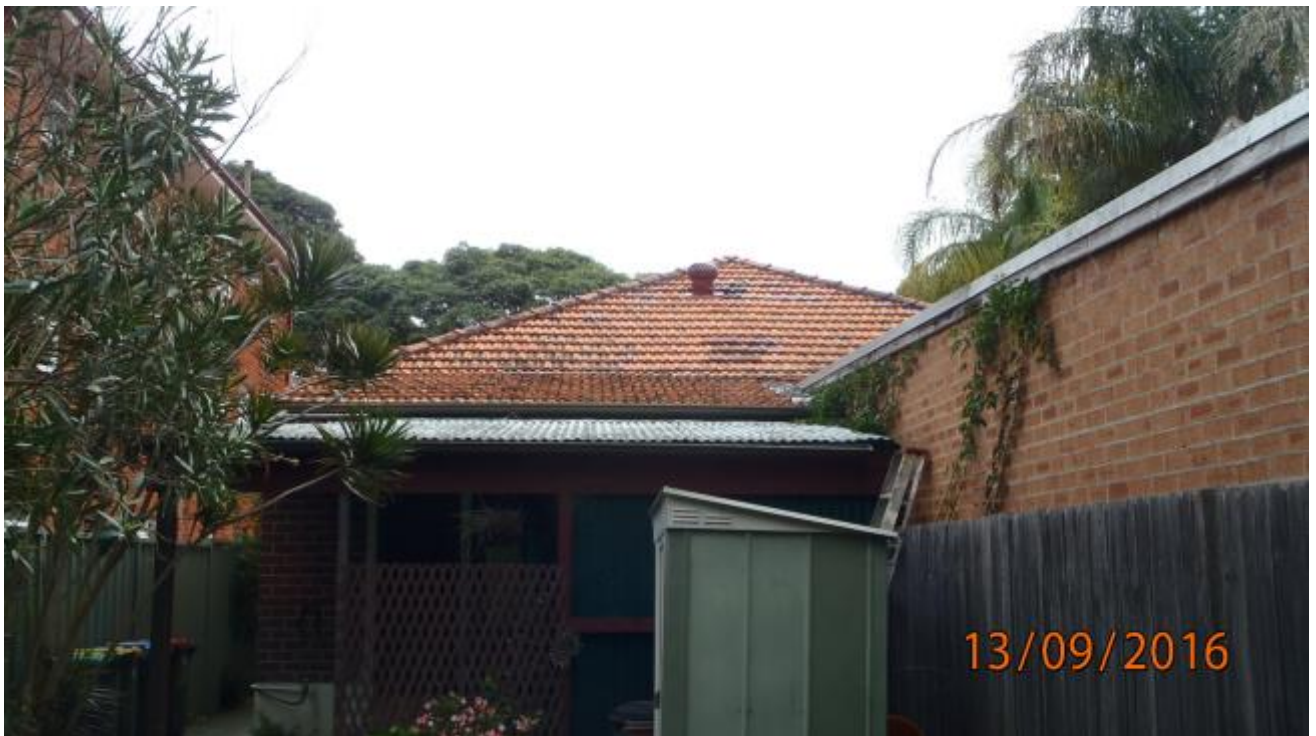
We noted that the rear of the residence has an attached timber framed pergola structure with corrugated profile fibreglass sheet roofing. **[Photograph 2]**

Photograph 2 shows the general condition of the rear *common* roof surface and the rear elevation of the residence.

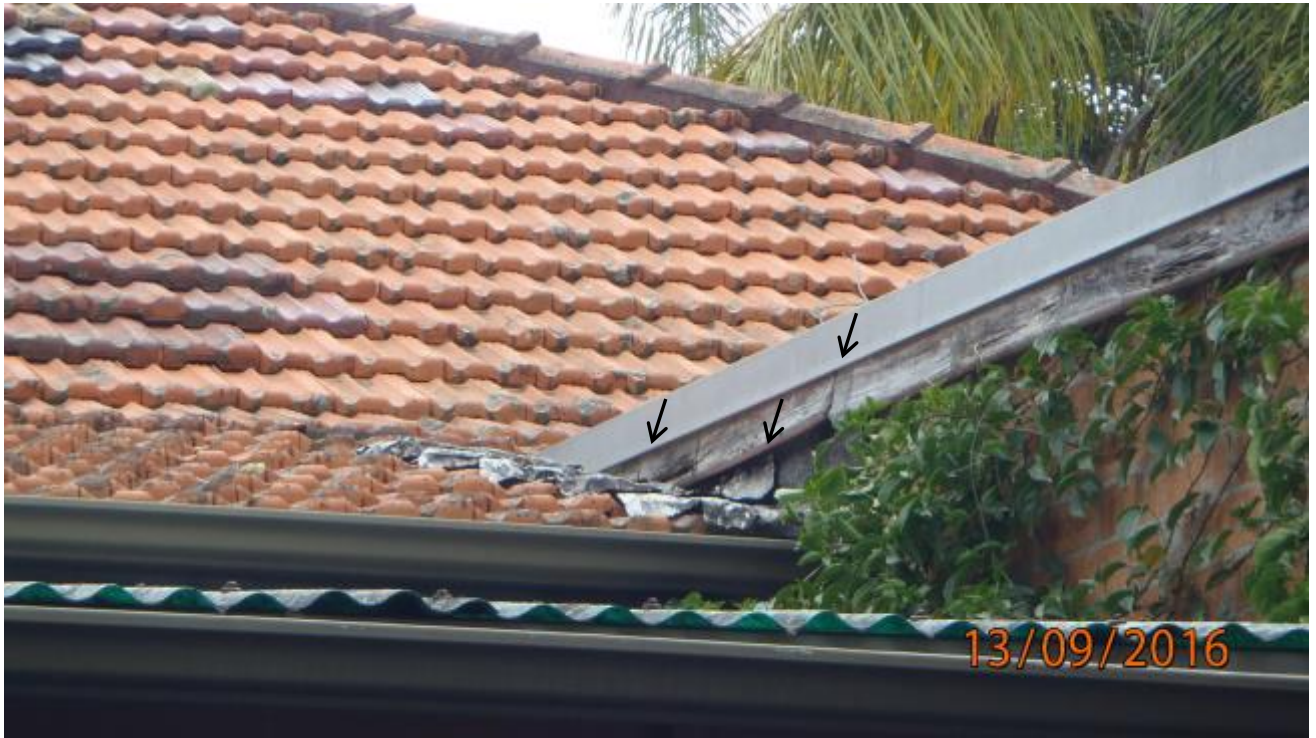
We noted that the flashing to the rear extension wall of the adjoining property No. 51 Onslow Street and the tiled skillion roof surface is generally complete but the timber barge board is damaged and rotted. **[Photograph 3]**

Photograph 3 shows the flashing to the rear extension wall of the adjoining property No. 51 Onslow Street. Note: the condition of the barge board.

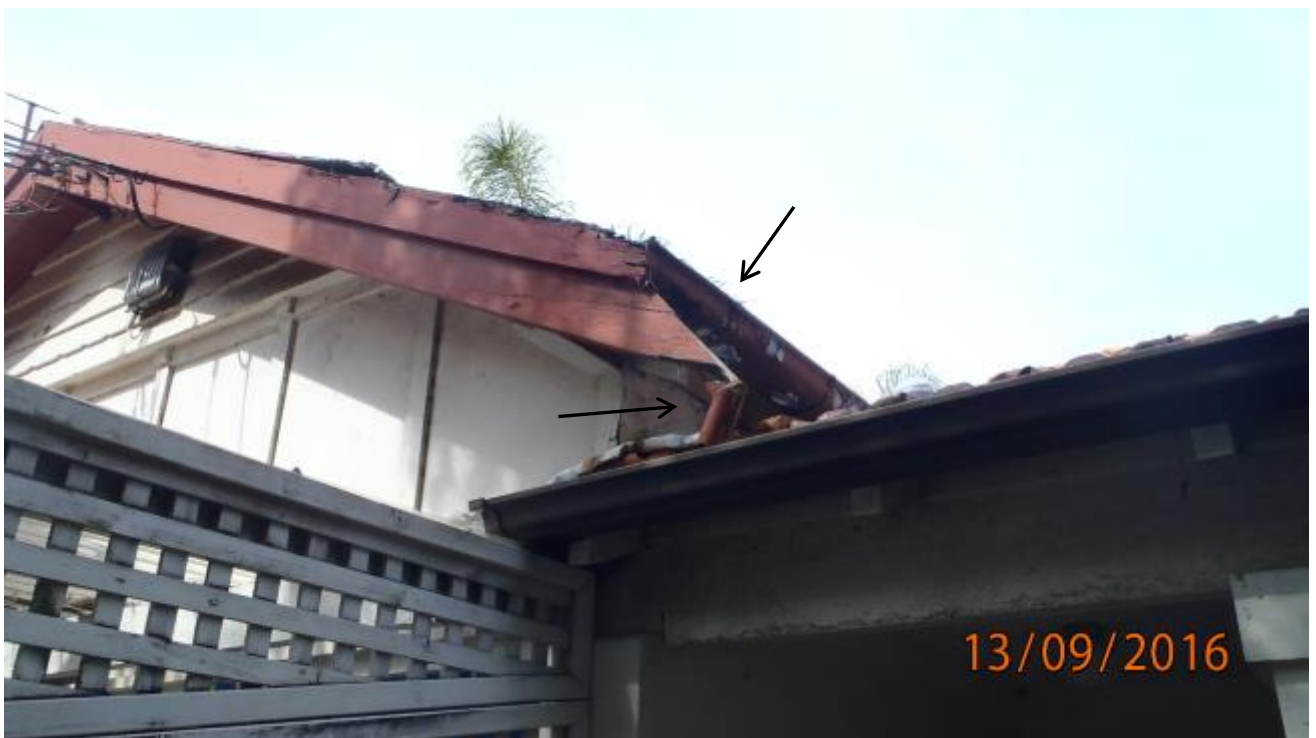
We noted that the guttering system to the front north western corner of the adjoining property No. 51 Onslow Street is rusted through, allowing the roof surface water to discharge directly on to the tiled roof surface above the sunroom **[Photograph 4]**

Photograph 4 shows the condition of the front gutter and downpipe at No. 51 Onslow Street. Note: roof surface water to discharge directly on to the tiled roof surface above the sunroom.

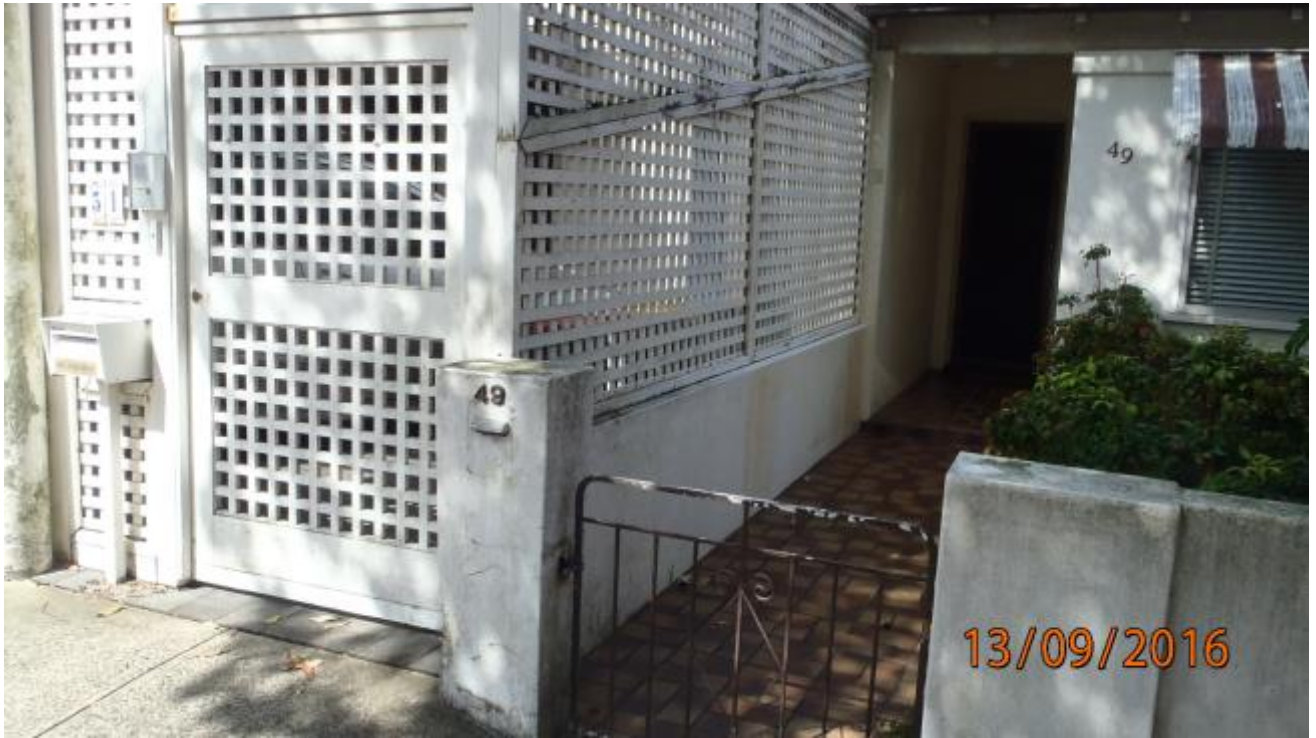
We noted that the front common boundary fence with No. 51 Onslow Street, Rose Bay is surface coated cement rendered brickwork with a timber lattice extension. **[Photograph 5]**

Photograph 5 shows the condition of the front common boundary fence with No. 51 Onslow Street.

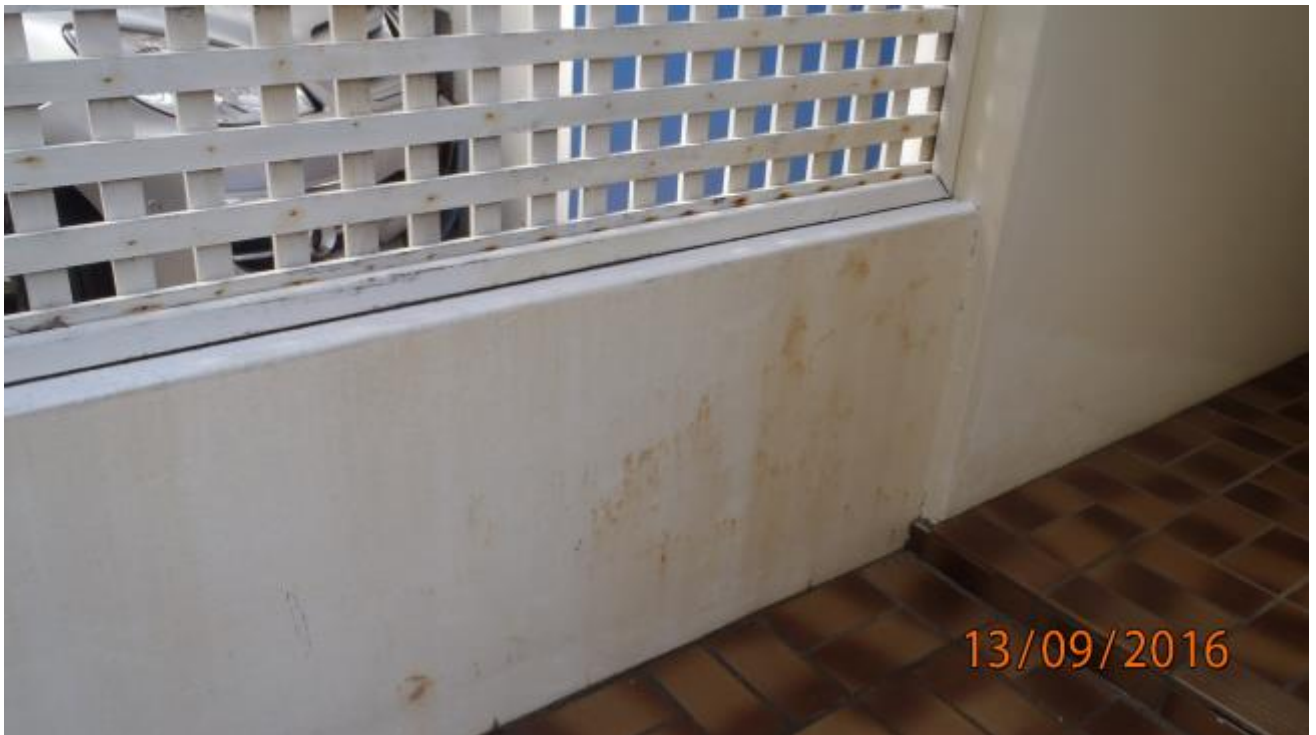
We noted staining and mould growth to the cement rendered surface. **[Photographs 6 and 7]**

Photograph 6 shows staining to the cement rendered front common boundary fence with No. 51 Onslow Street, Rose Bay

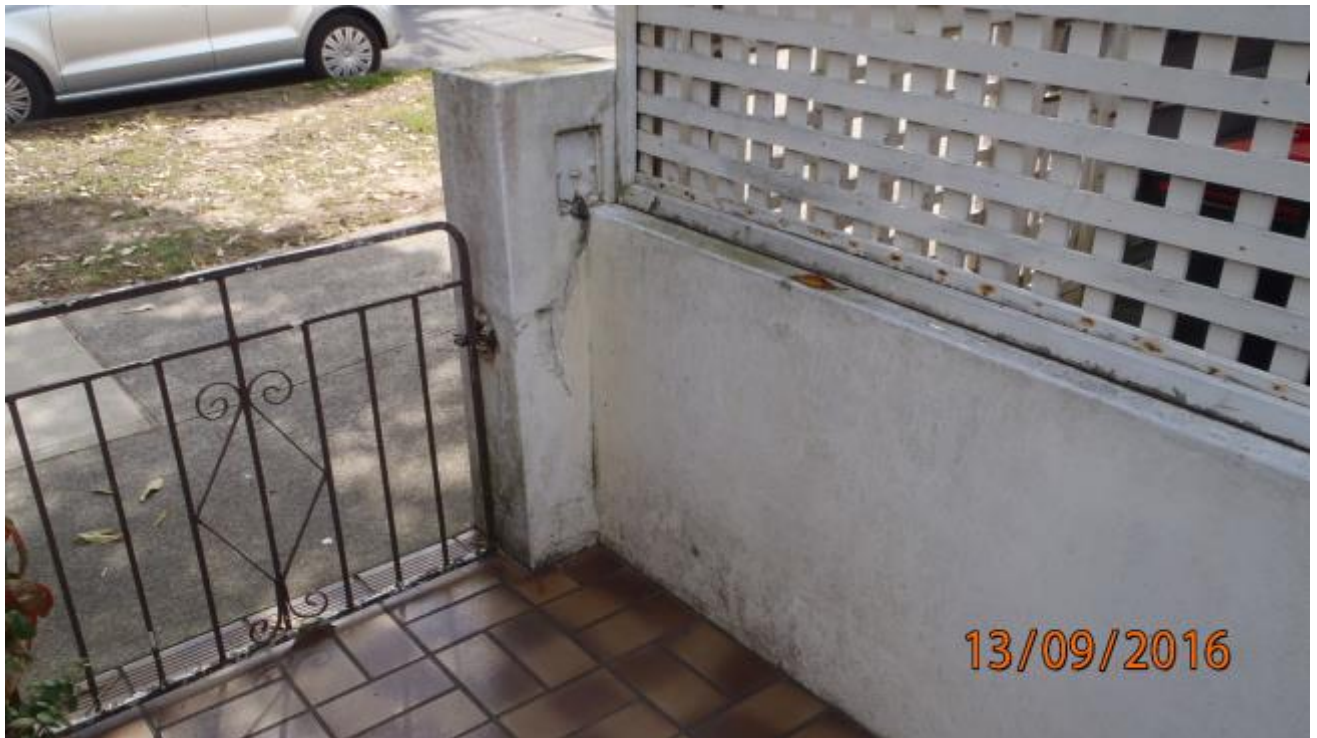
Photograph 7 shows mildew growth to the cement rendered front common boundary fence with No. 51 Onslow Street, Rose Bay.

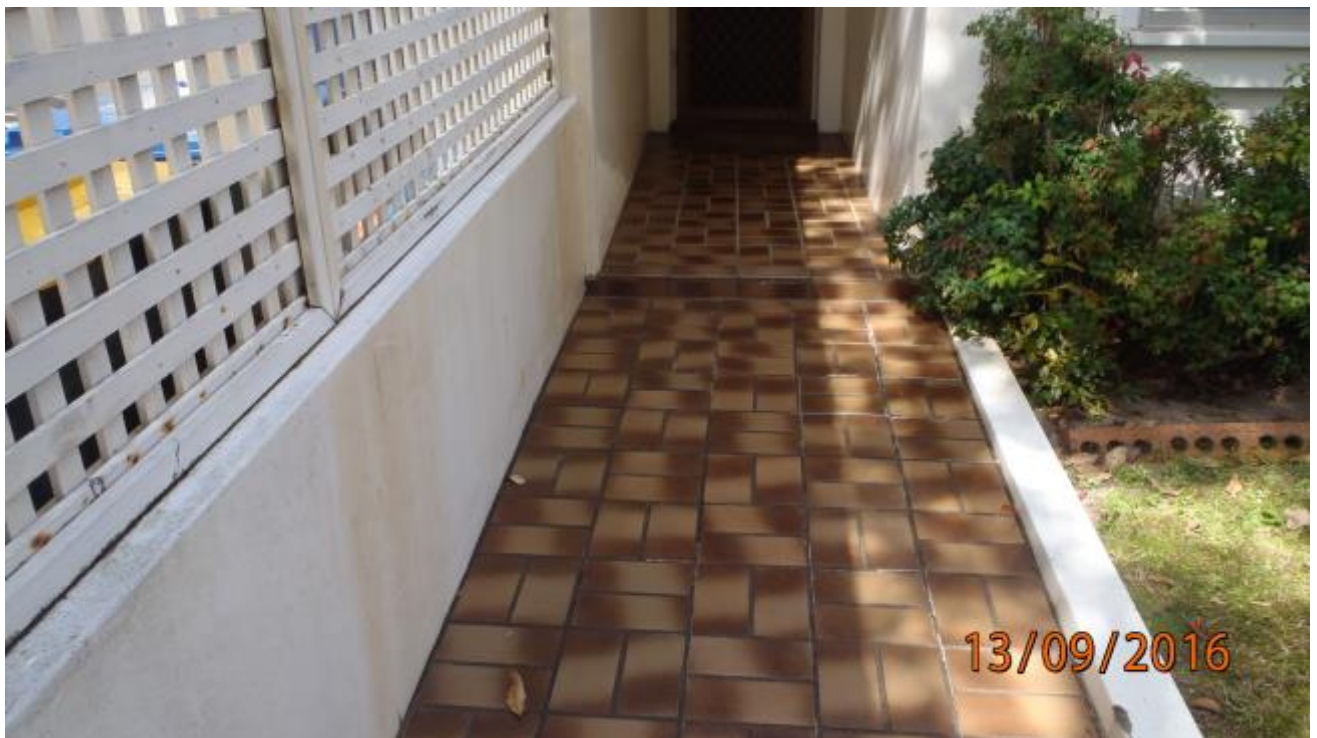
We noted that the front pathway is tiled with ceramic tiles. We did not observe any recent cracking to the ceramic tiles and noted that the grout is complete. **[Photograph 8]**

Photograph 8 shows the general condition of the tiled front pathway.

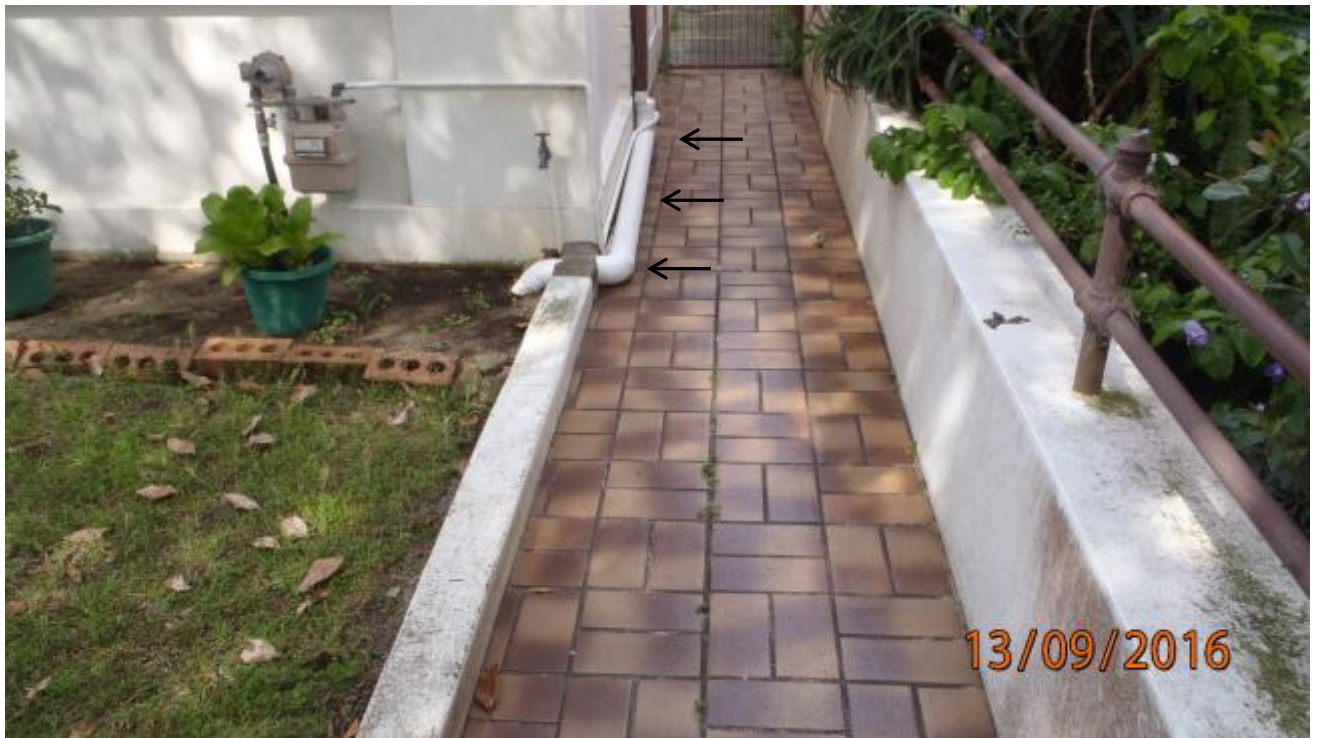
We noted that the side pathway is also tiled with ceramic tiles. We did not observe any recent cracking to the ceramic tiles but did observe vegetation growth through the grout. **[Photograph 9]**

We noted evidence of rising damp to the external brickwork on the front north western corner of the cement rendered brickwork. We also noted that the roof surface water originally discharged directly to the ground adjacent to this corner. Recent work has extended the stormwater to the street system. **[Photograph 9 and 10]**

We did not assess the condition of / or the adequacy of the storm water drainage system, but did note that the stormwater and gutter system had recently been extended at the front north western corner of the residence. **[Photograph 9]**

Photograph 9 shows the general condition of the tiled side pathway and the extension to the downpipe to the stormwater system.

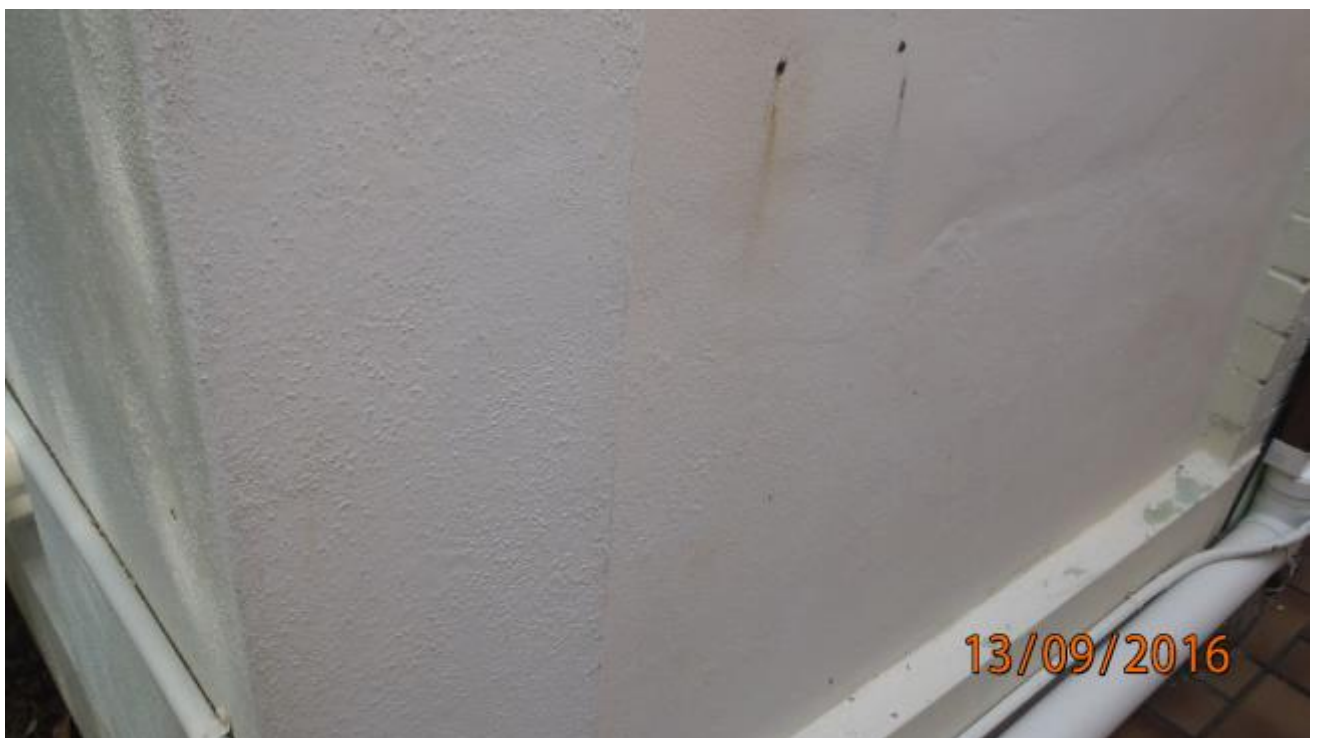
Photograph 10 shows evidence of rising damp to the external brickwork on the front north western corner of the cement rendered brickwork.

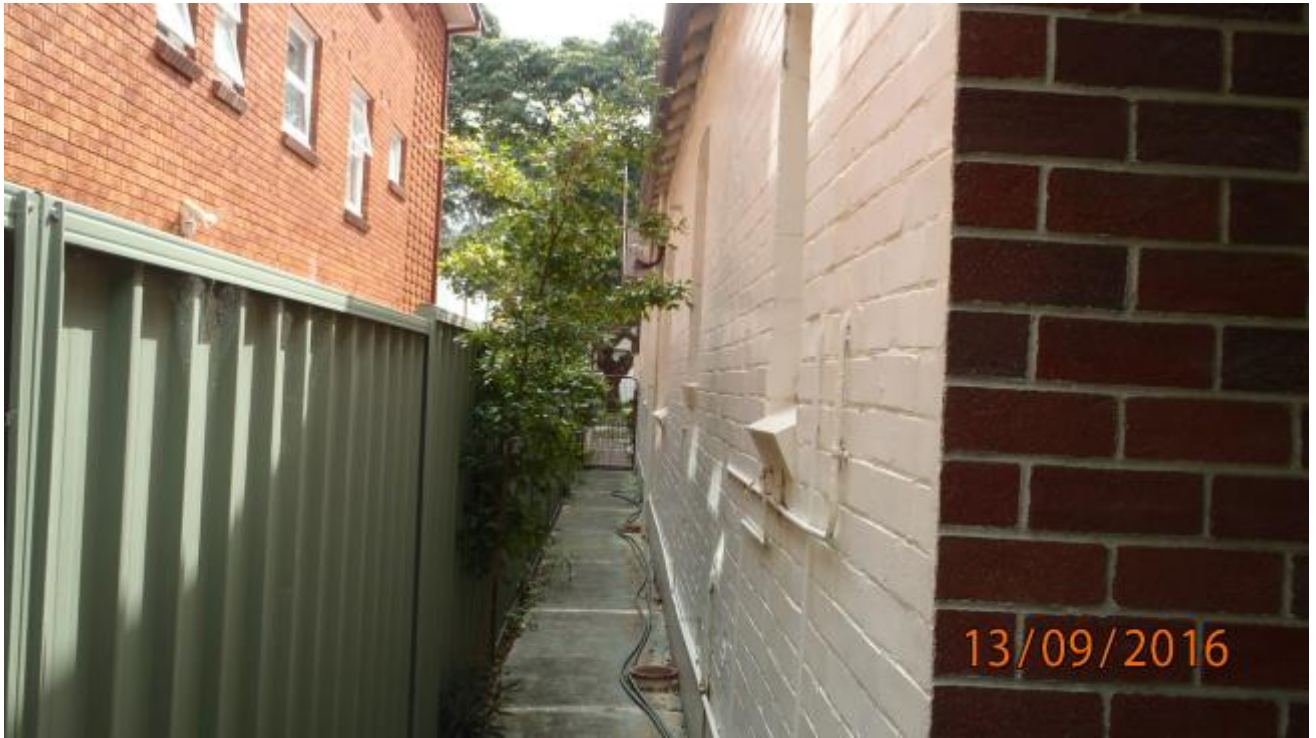
We noted that the side western elevation is surface coated clay masonry brickwork. **[Photograph 11]**

We noted that the side of the residence is covered with a concrete pathway. **[Photograph 11]**

Photograph 11 shows the general condition of the western elevation of the residence.

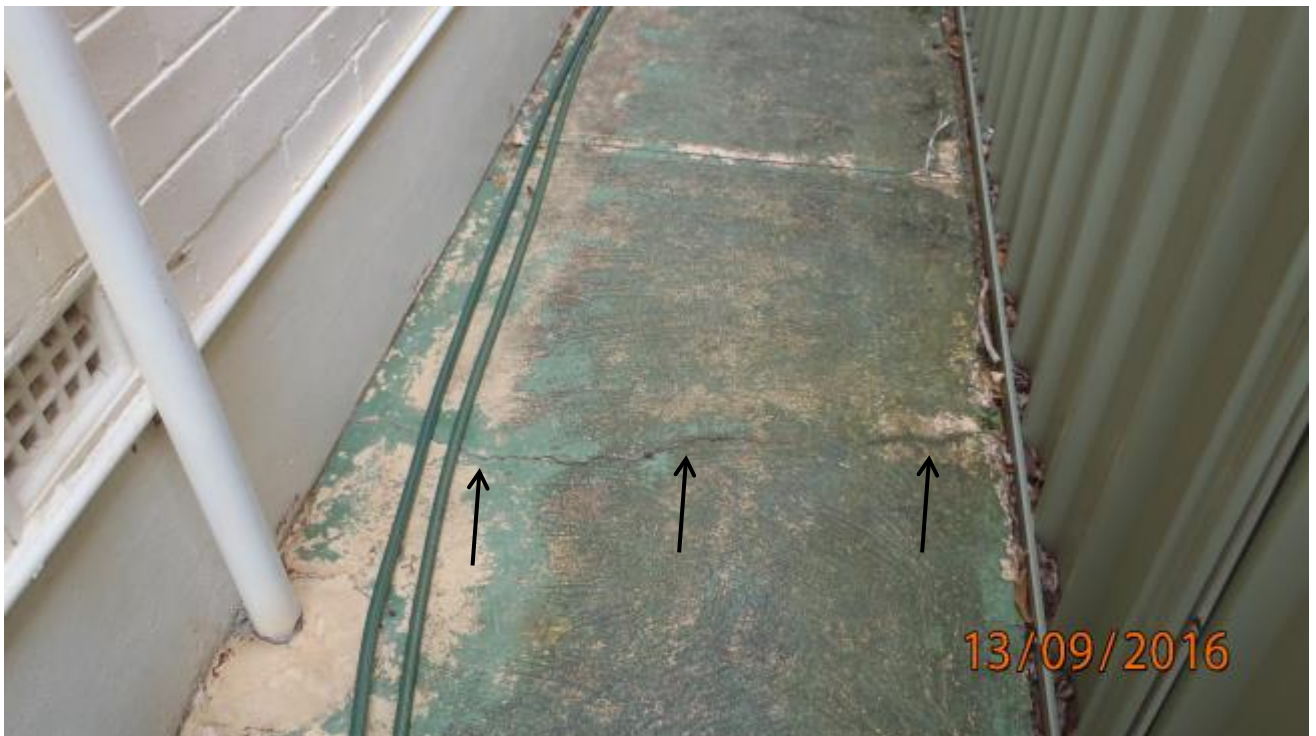
We noted hairline radial cracking [$<1.0\text{mm}$] to the pathway outside the kitchen window. **[Photograph 12]**

Photograph 12 shows a crack to the concrete path outside the Kitchen window.

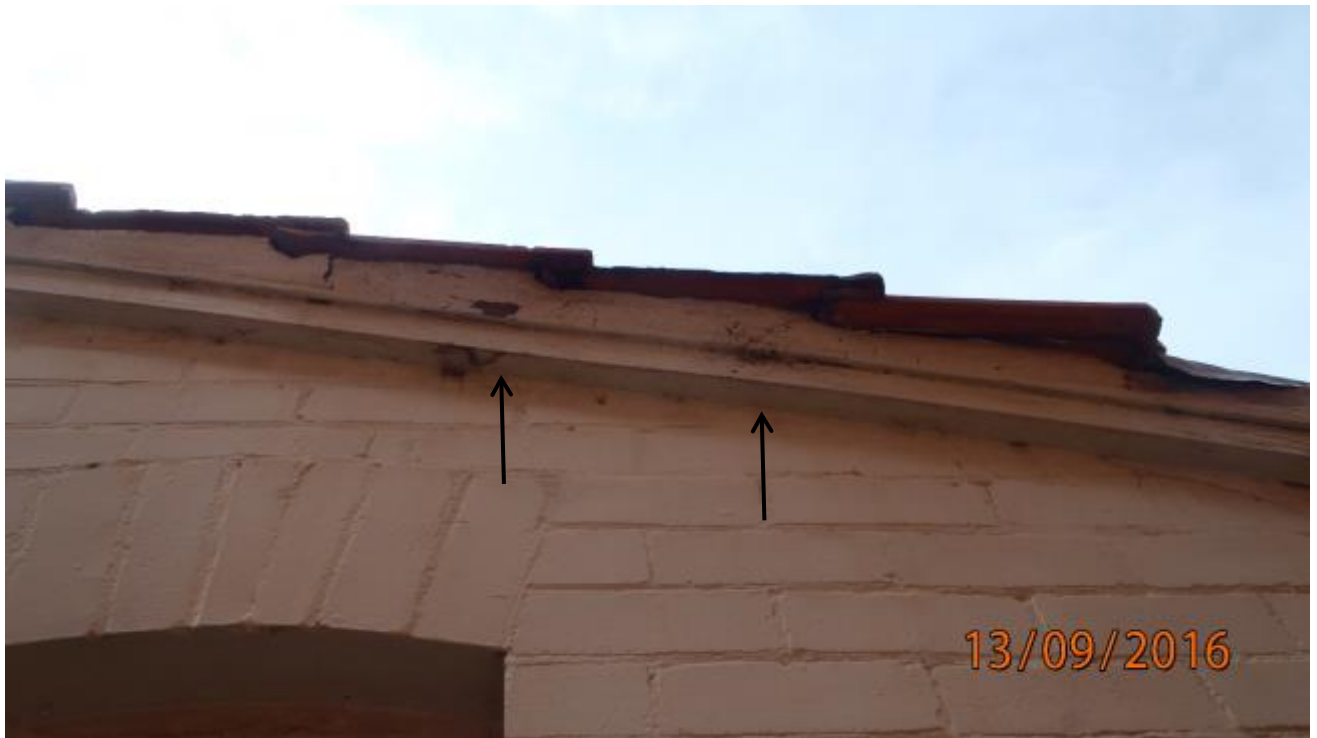
We noted flaking to the surface coating on the barge board above the laundry window **[Photograph 13]**

Photograph 13 shows deterioration and flaking of the surface coating to the barge outside the Laundry

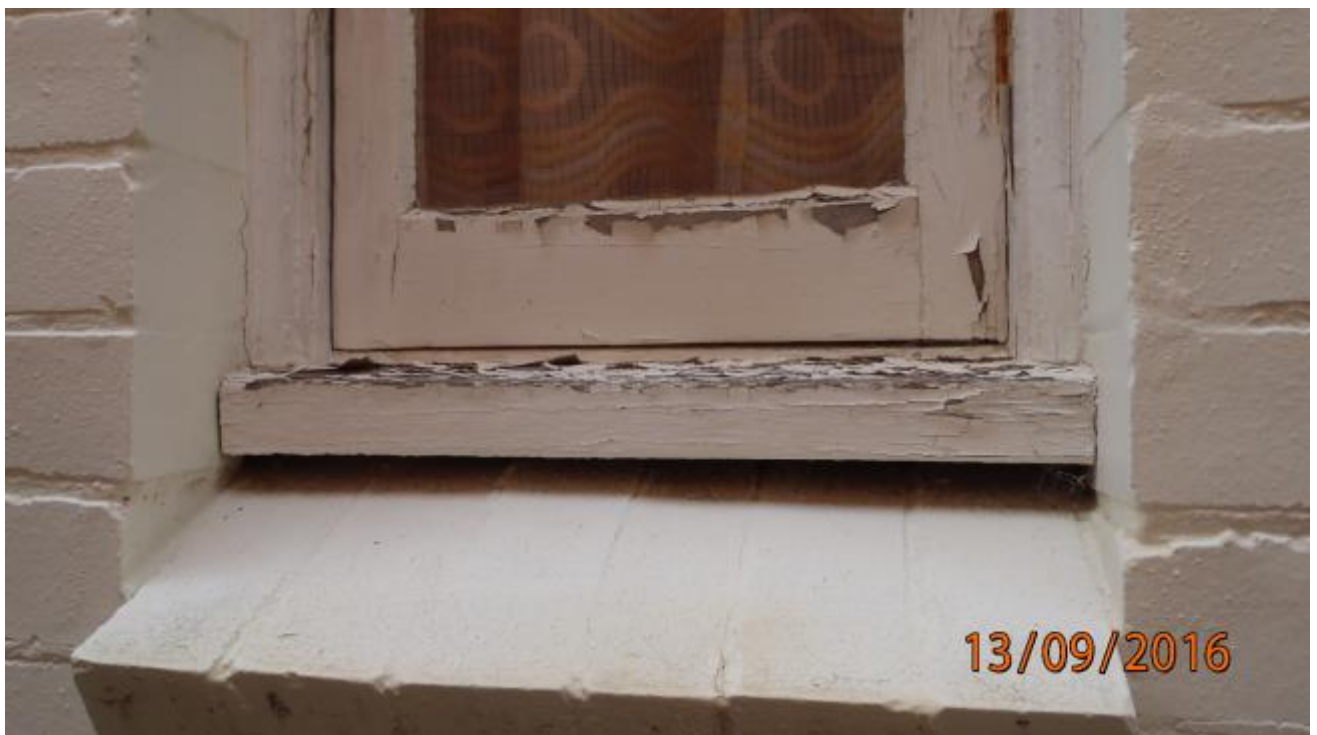
We noted flaking to the surface coating on the Laundry window sill and window **[Photograph 14]**

Photograph 14 shows deterioration and flaking of the surface coating to the Laundry window.

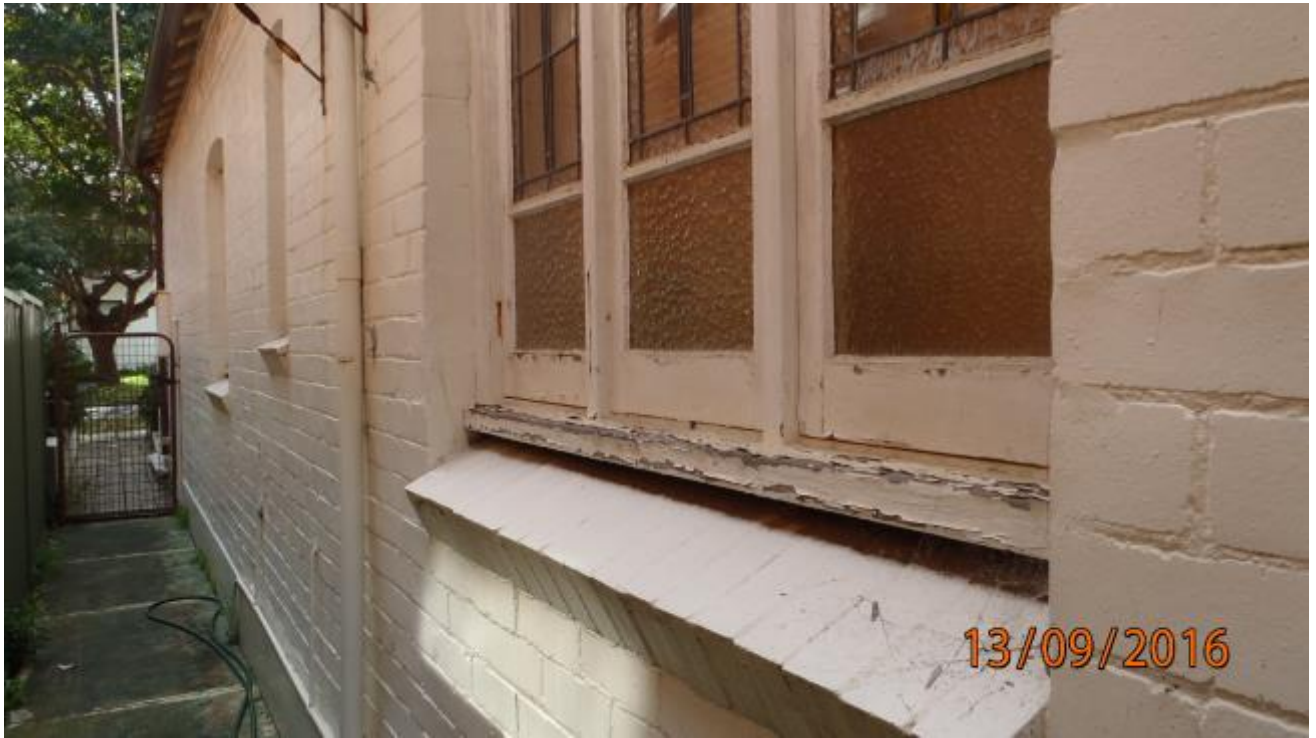
We noted flaking to the surface coating on the Lounge Room window sill and window **[Photograph 15]**

Photograph 15 shows deterioration and flaking of the surface coating to the Lounge Room window.

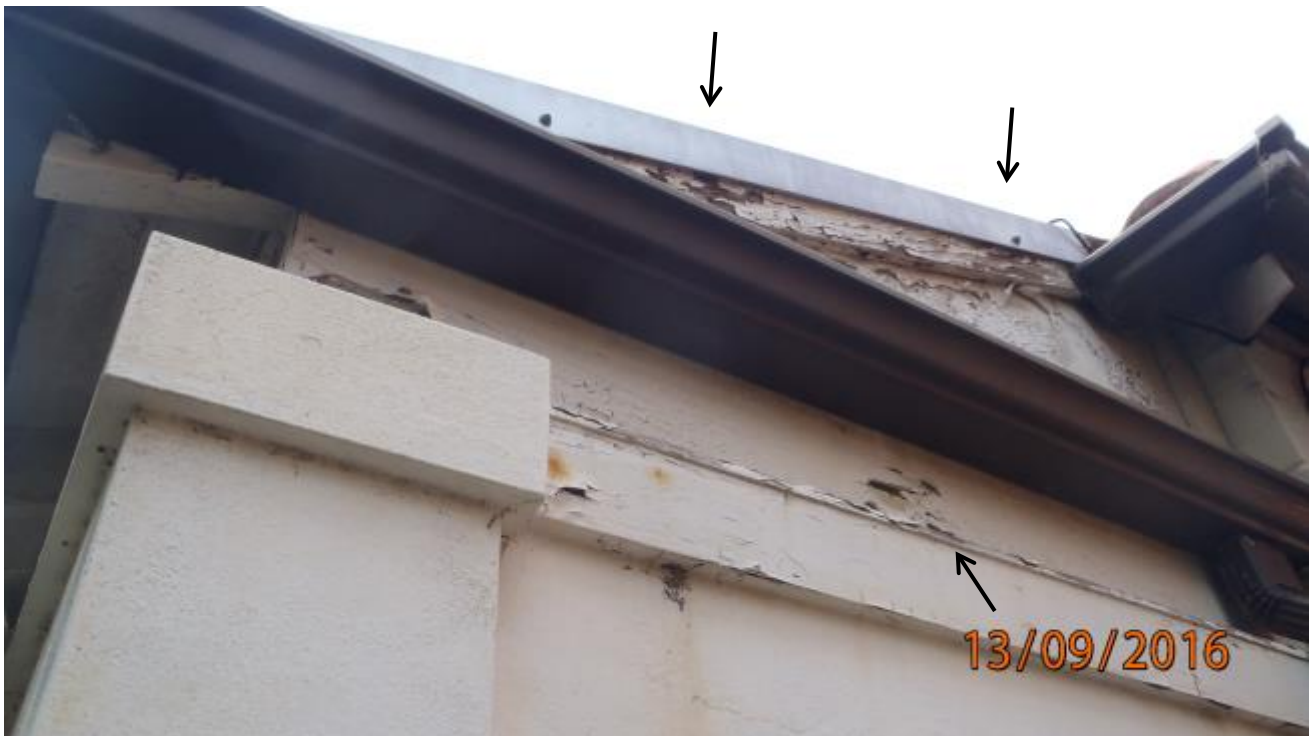
We noted flaking to the surface coating on the barge board and fascia above the Sunroom **[Photograph 16]**

Photograph 16 shows deterioration and flaking of the surface coating to the north west corner of the residence.

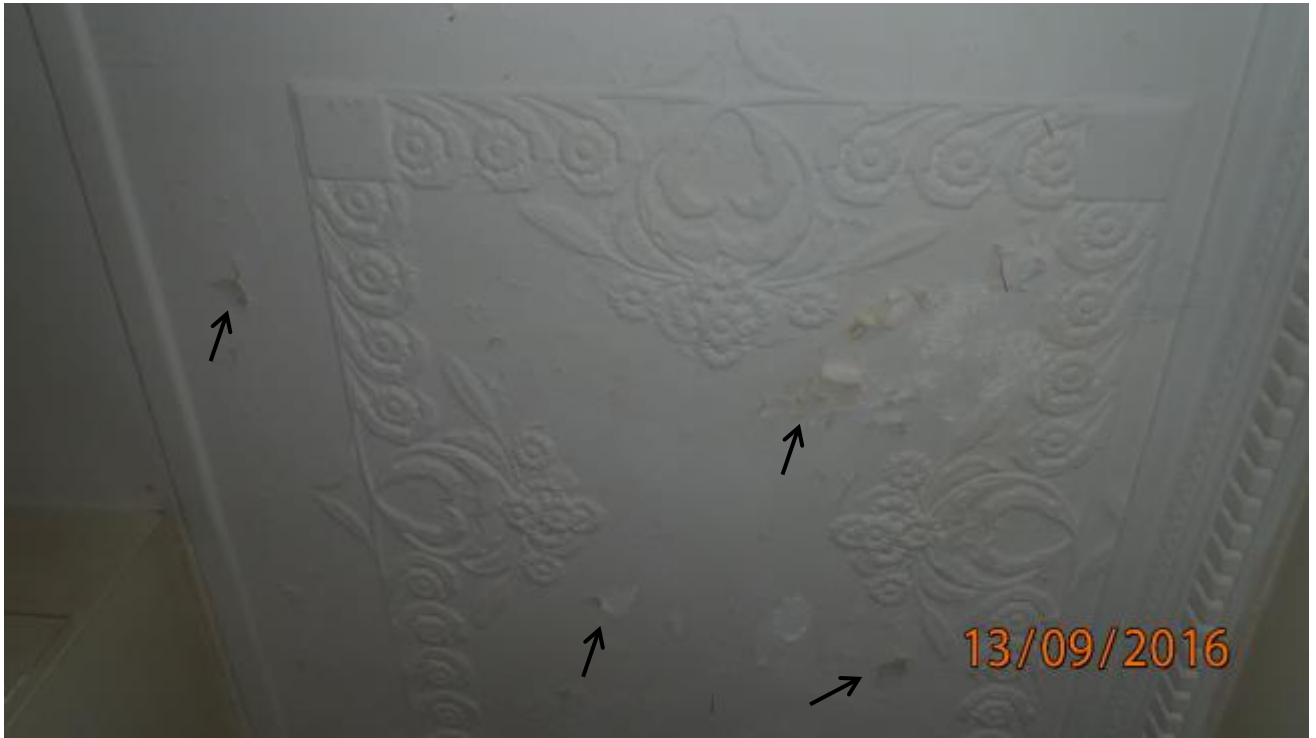
We observed general flaking paint to the decorative fibrous plaster ceiling. **[Photograph 17]**

Photograph 17 shows flaking paint to the ceiling in the Hallway.

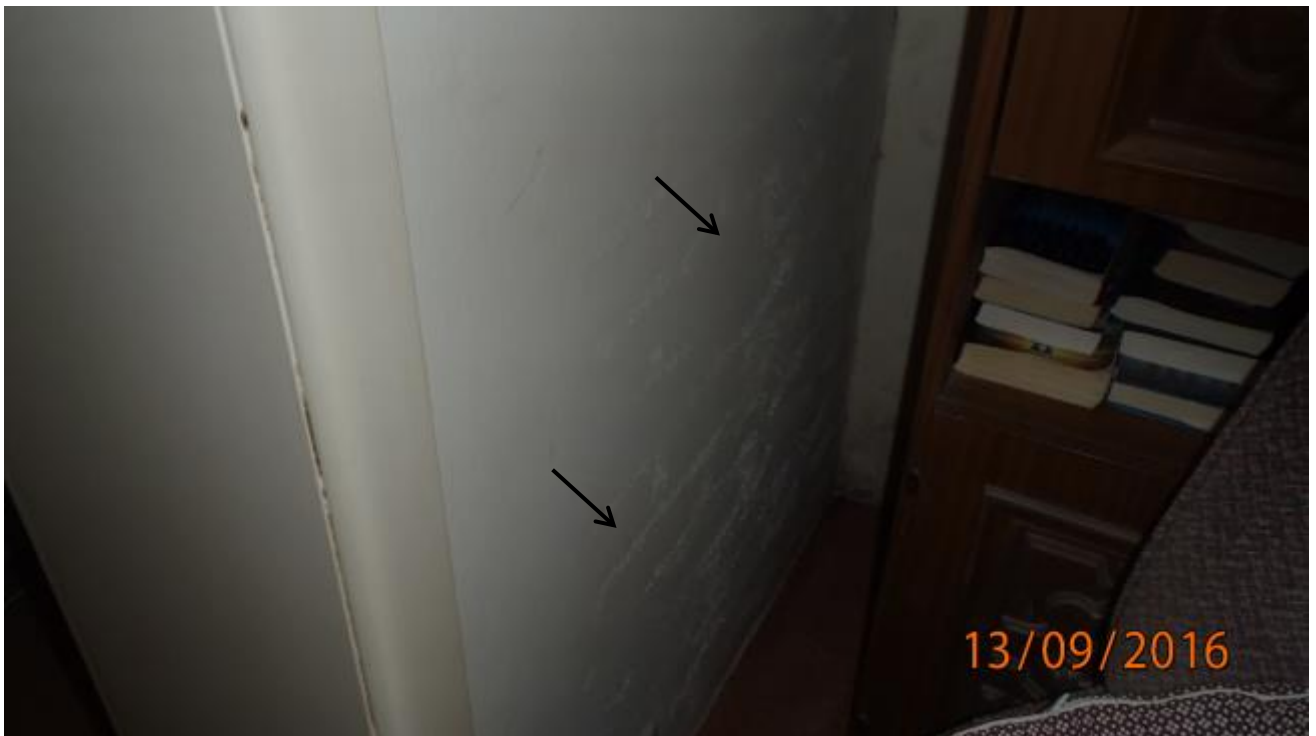
We noted areas of flaking / lifting paint to the external north western wall and internal wall common with the Main Bedroom. This, in our experience, is consistent with rising damp. **[Photograph 18 & 19]**

Photograph 18 shows evidence of rising damp to the wall common with the Main Bedroom in the Sunroom.

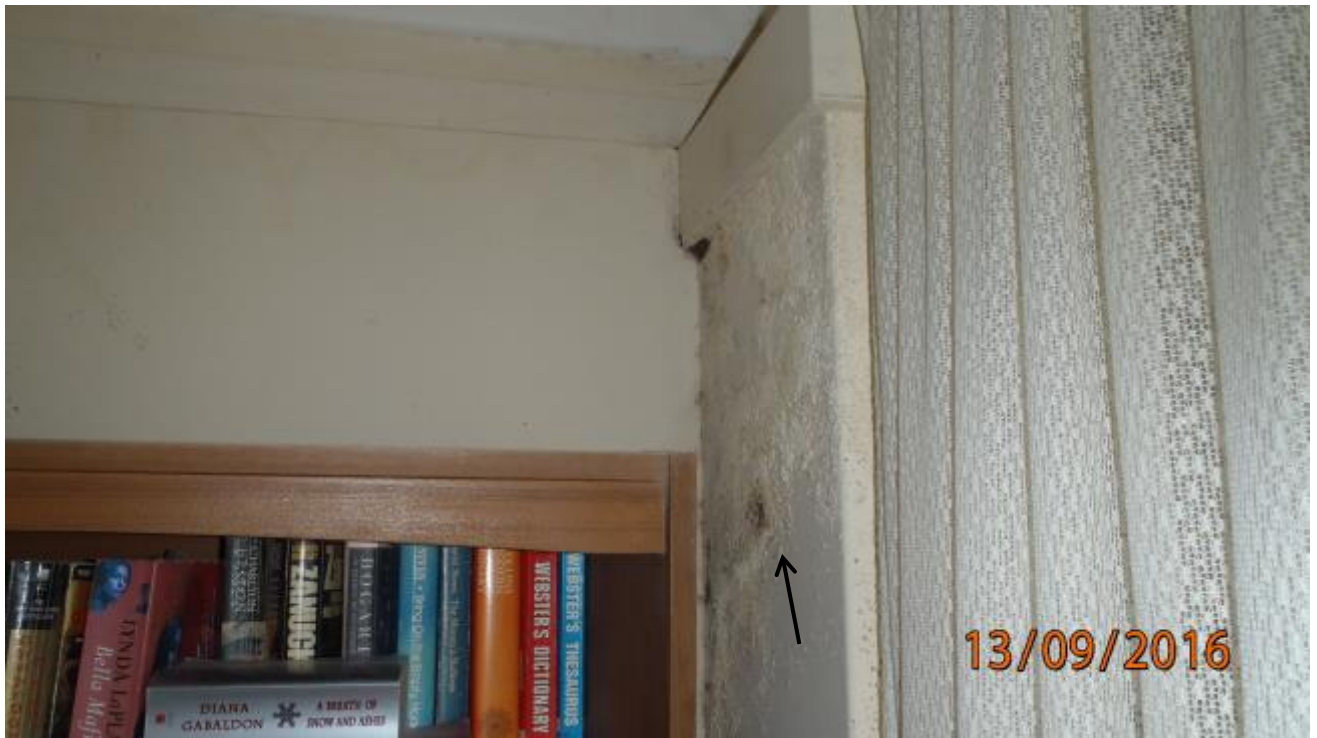
Photograph 19 shows evidence of rising damp to the external north western wall in the Sunroom.

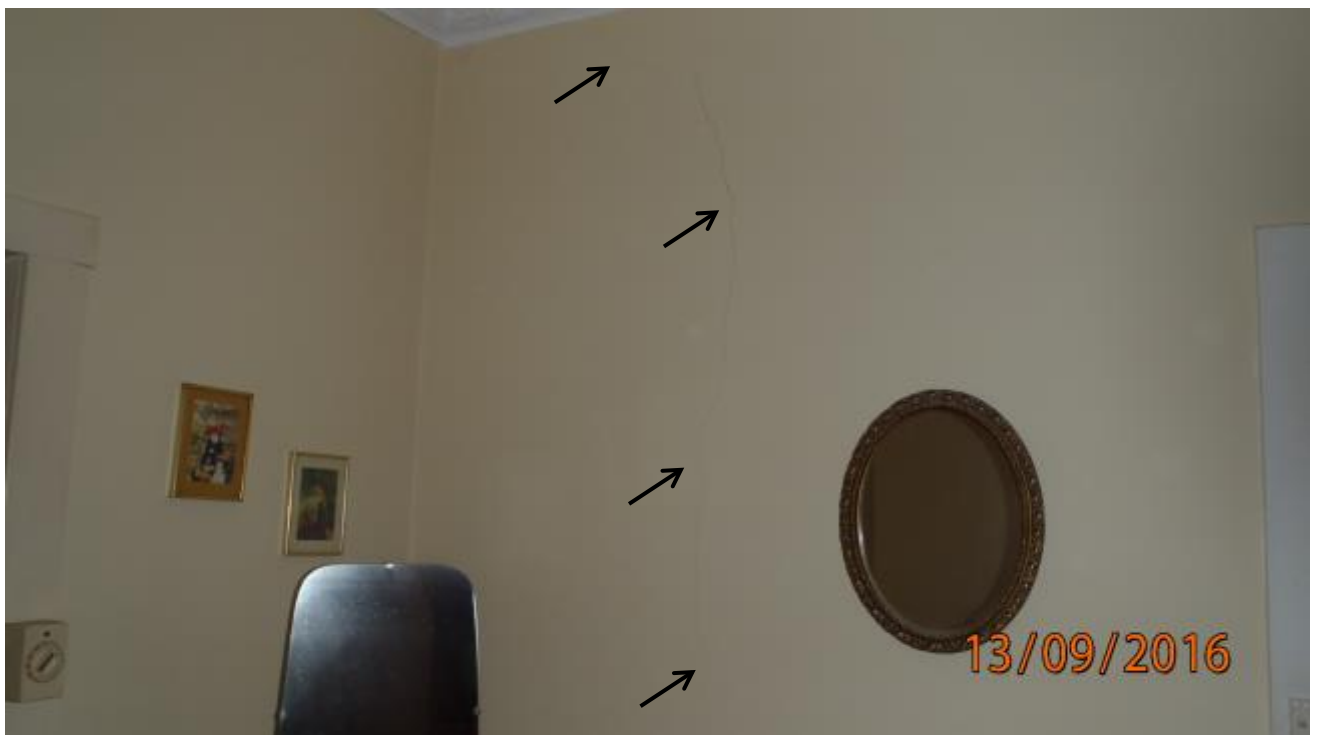
We noted hairline radial cracking [$<1.0\text{mm}$] extending from the decorative profile cornice toward the floor on the eastern wall. **[Photograph 20]**

Photograph 20 shows hairline radial cracking on the eastern wall in the Main Bedroom.

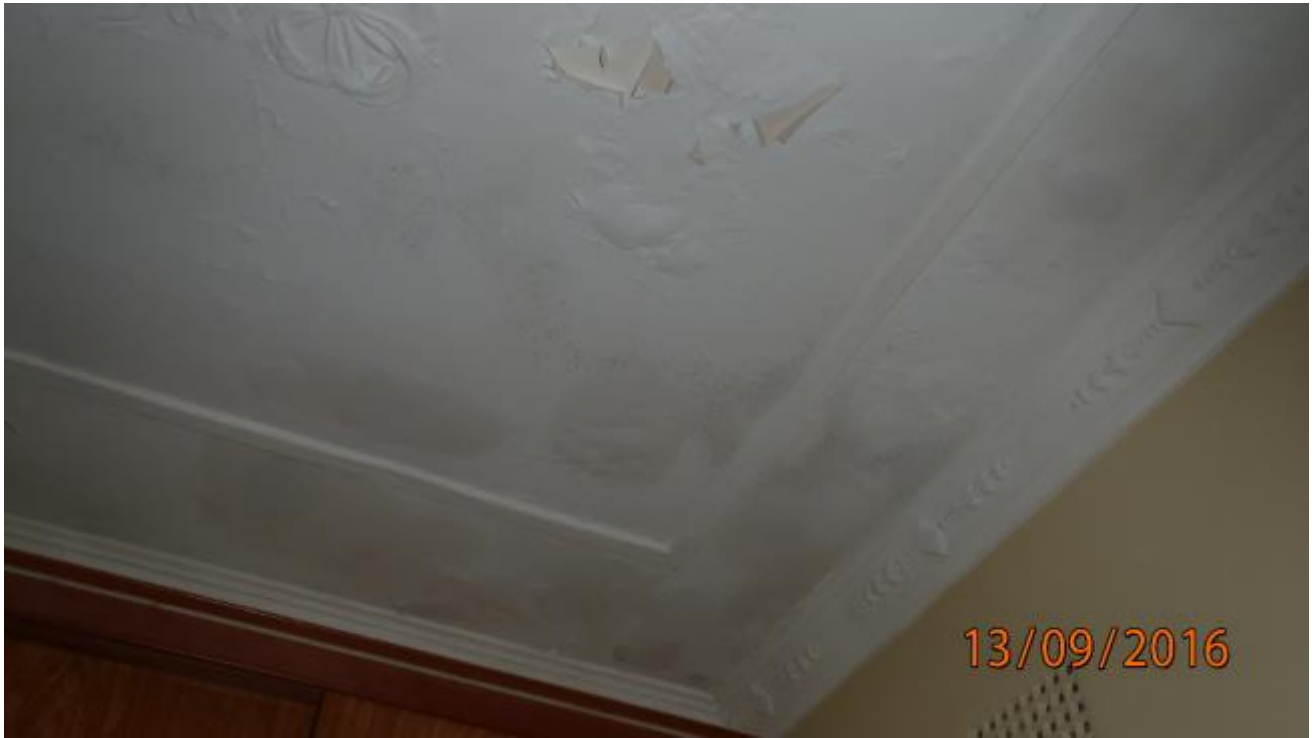
We observed general flaking paint, mildew/mould growth and staining to the decorative fibrous plaster ceiling. **[Photograph 21]**

Photograph 21 shows flaking paint, mildew/mould growth and staining in the Main Bedroom.
