Dilapidation Assessment Report

Prepared for: Cape Cod Australia Pty. Limited
Job address: 49 Onslow Street, Rose Bay.
Property Owner/s: Mrs. Stephanie Rea.
Report reference: **WAVERLEY COUNCIL**
Development Application No: not available
Date of assessment: 13th September 2016

Re: Dilapidation Report

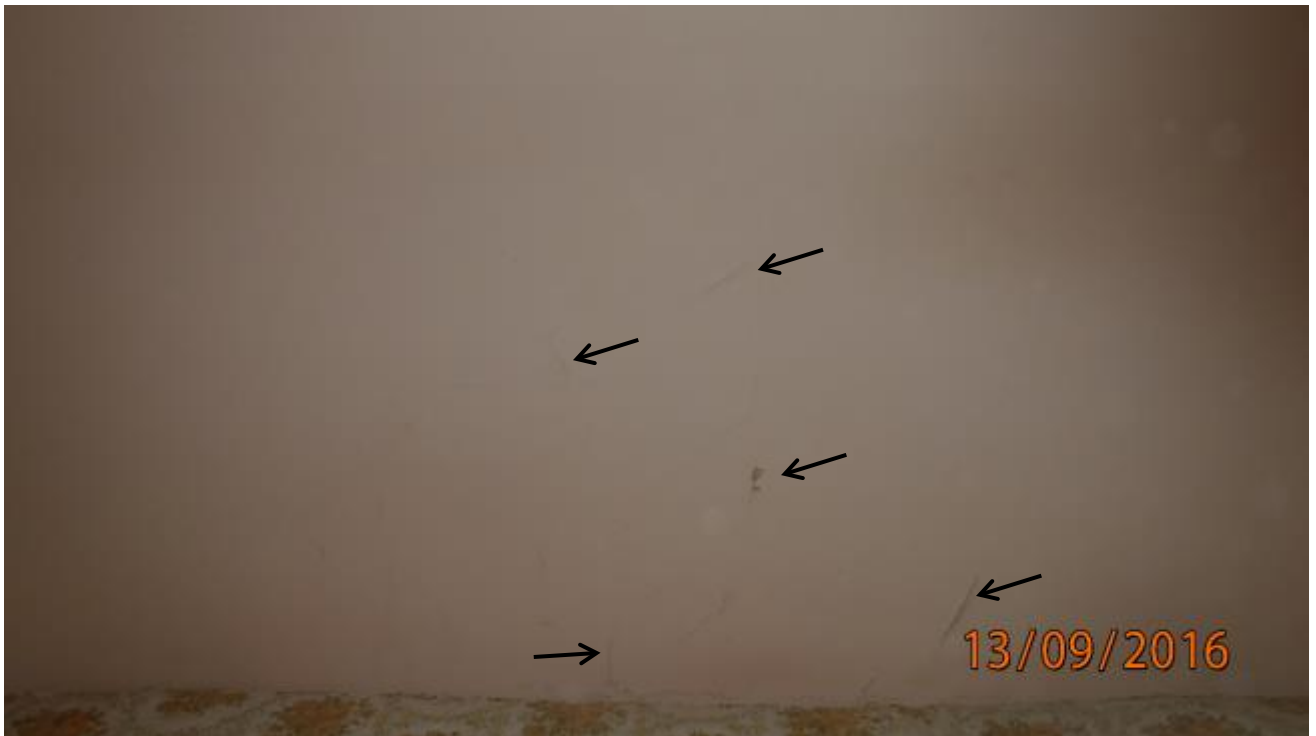
We noted flaking paint and hairline radial cracking [$<1.0\text{mm}$] to the southern wall common with the Bathroom. **[Photograph 22]**

Photograph 22 shows flaking paint and hairline radial cracking to the southern wall common with the Bathroom in the Bedroom 2.

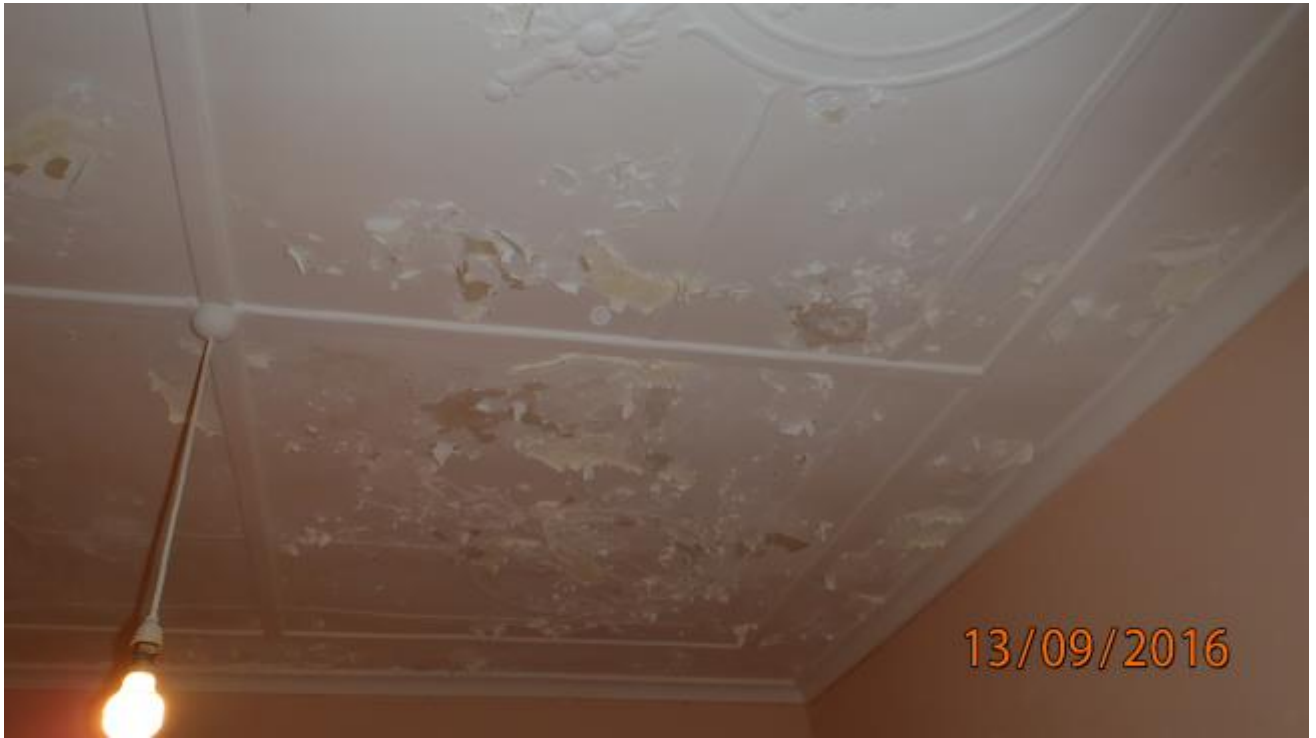
We observed general flaking paint to the decorative fibrous plaster ceiling. **[Photograph 23]**

Photograph 23 shows flaking paint to the ceiling in the Bedroom 2.

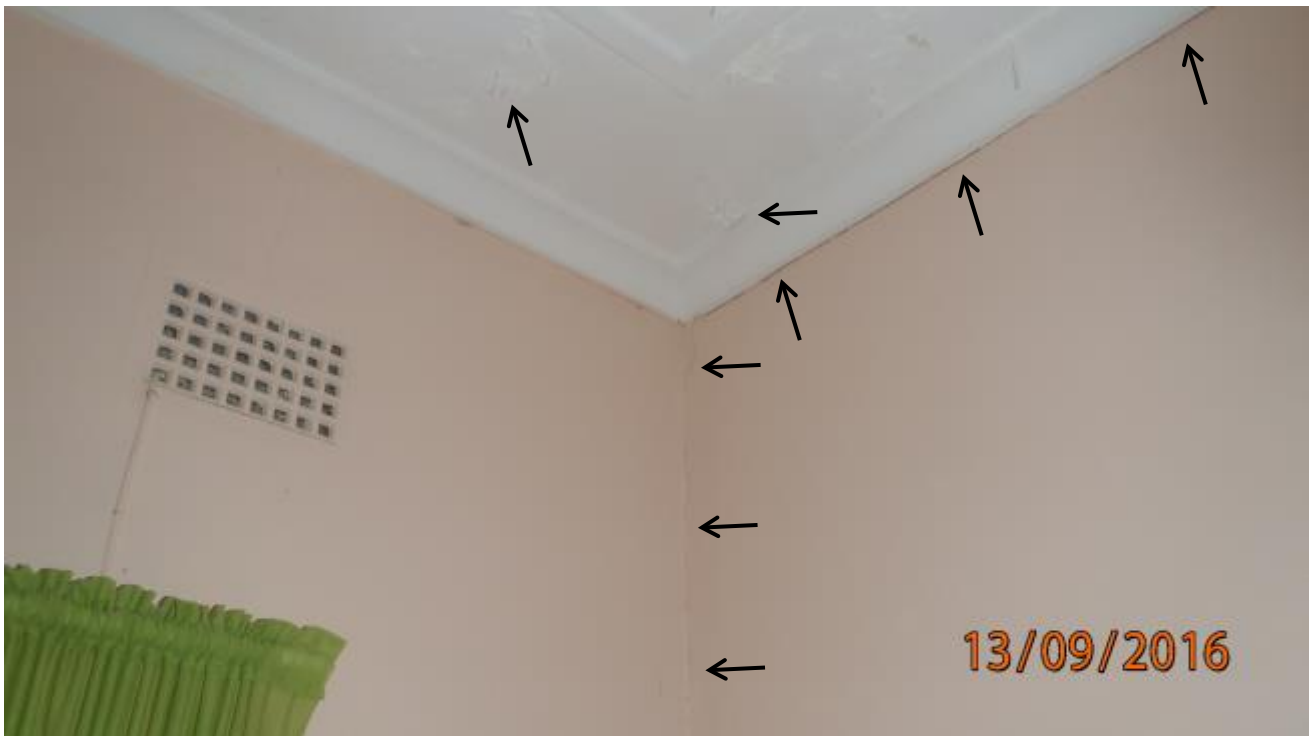
We noted hairline vertical cracking [$<1.0\text{mm}$] at the wall / wall junction in the north western corner. **[Photograph 24]**

We noted separation cracking [$<1.0\text{mm}$] at the wall / cornice junction in the north western corner. **[Photograph 24]**

Photograph 24 shows flaking paint to the plaster ceiling lining, hairline vertical cracking at the wall / wall junction and separation cracking to the wall / cornice junction in the north western corner.

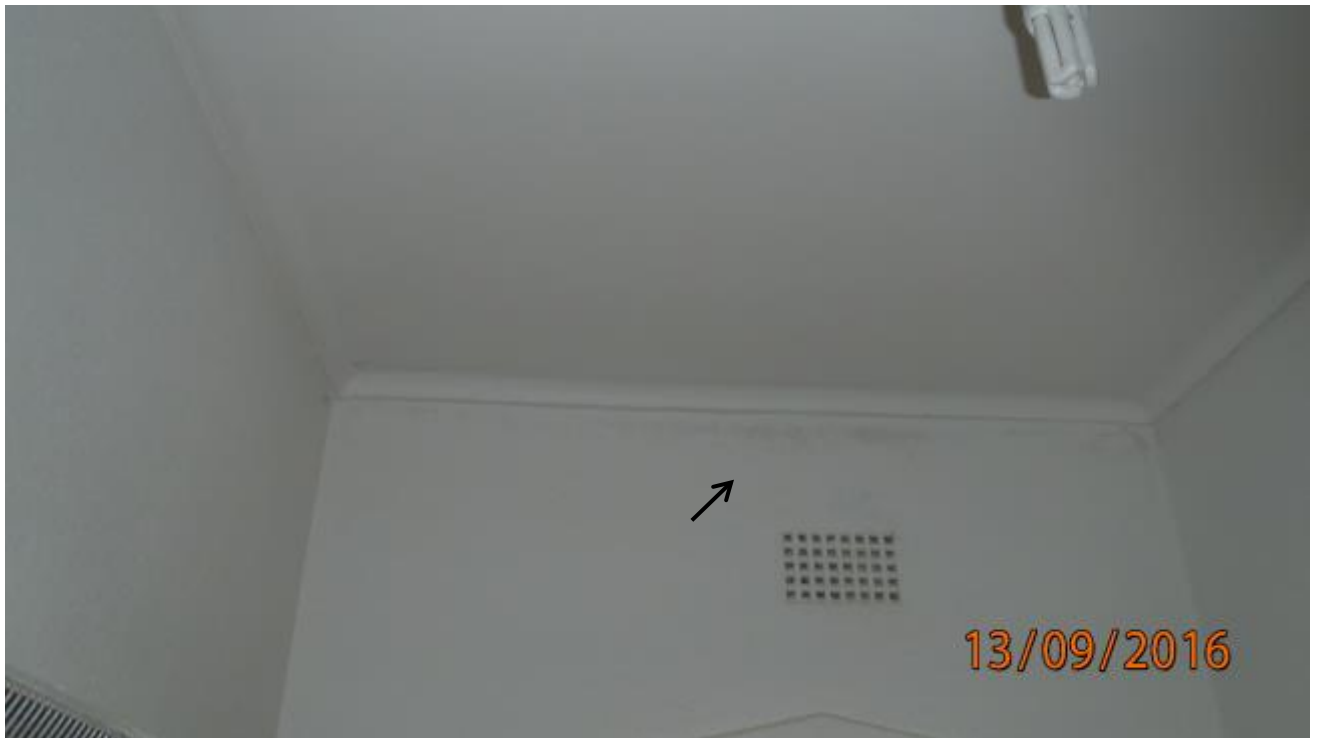
We noted mildew/mould growth to the painted cement rendered external wall above the window. **[Photograph 25]**

Photograph 25 shows noted mildew/mould growth in the Bathroom.

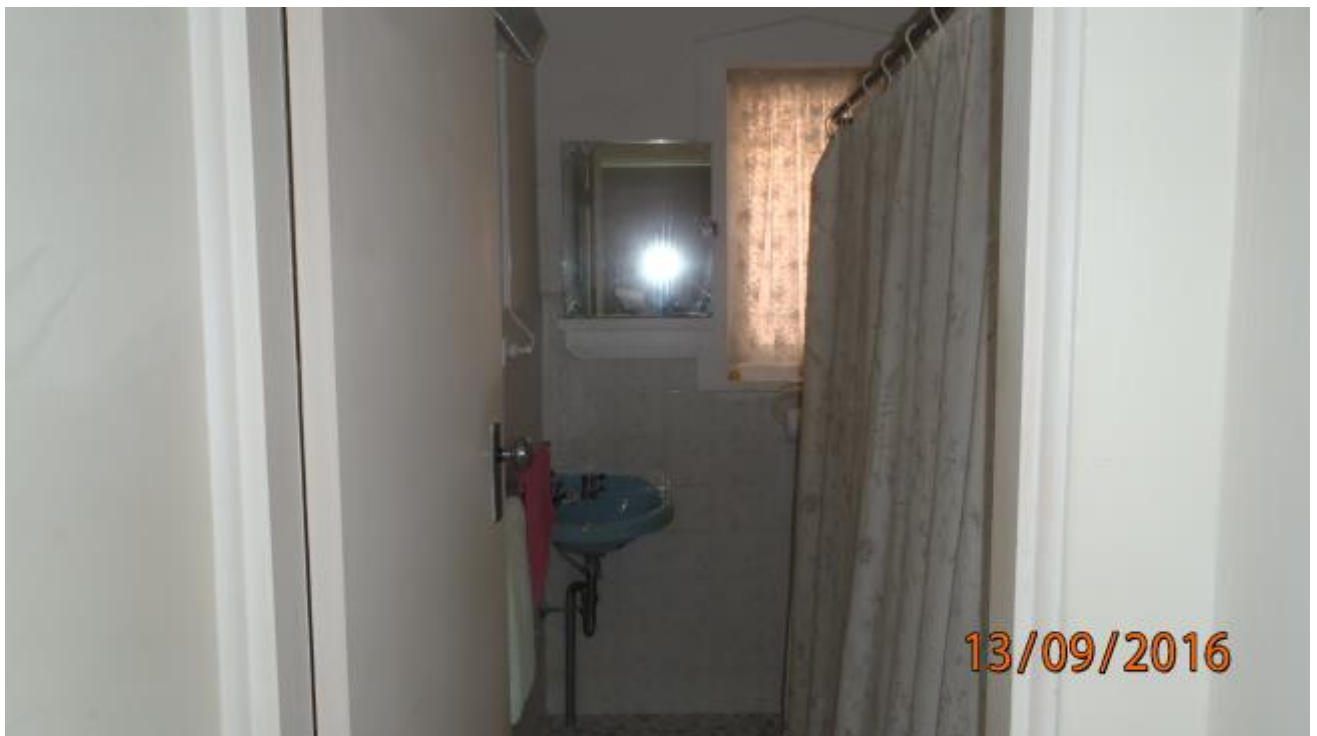
We noted that the grout to the wall and floor tiles is complete and that the wall and floor tiles when randomly "tap" tested appeared to be sound. We did not observe any recent cracking to the tile grout at the wall / wall, wall / floor junctions. **[Photograph 26]**

Photograph 26 shows the general layout of the Bathroom.

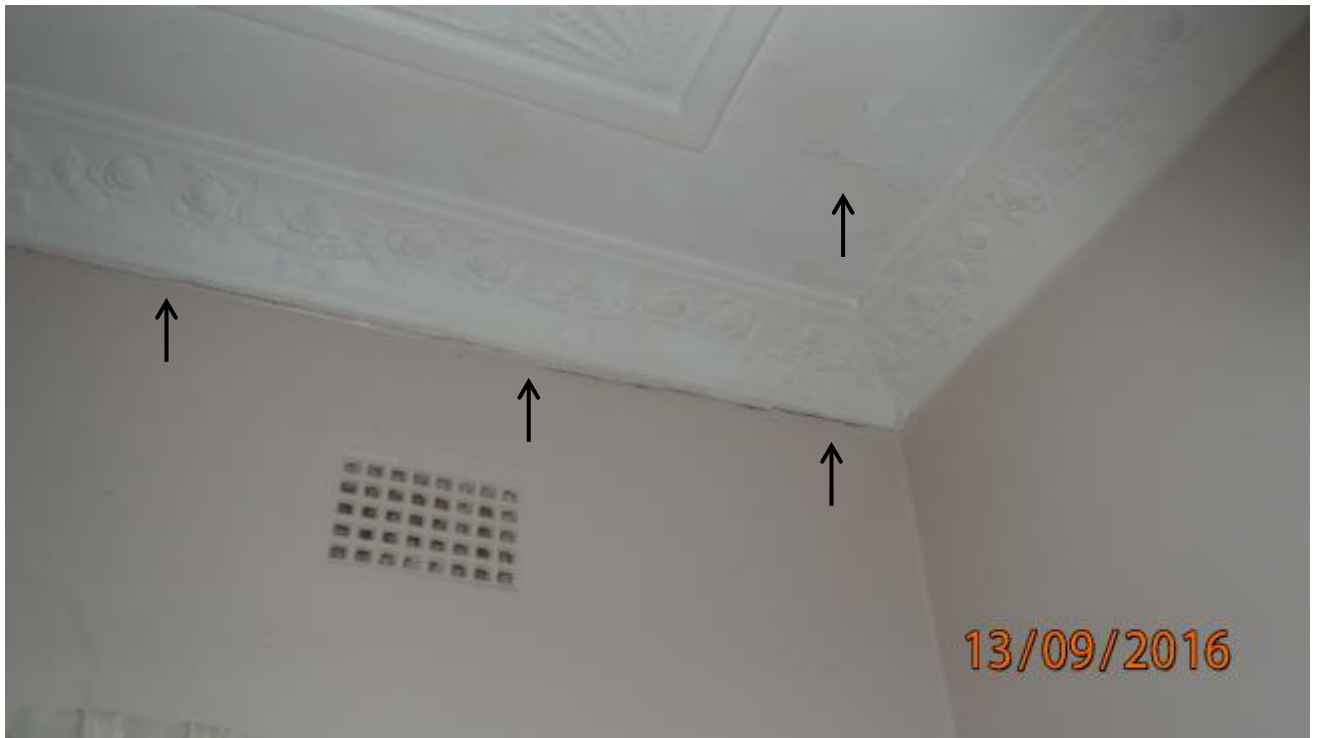
We noted separation cracking [$<1.0\text{mm}$] at the wall / cornice junction on the western wall. **[Photograph 27]**

We noted flaking paint overall to the decorative plaster ceiling. **[Photographs 27 & 28]**

Photograph 27 shows flaking paint and separation cracking at the wall / cornice junction on the western wall in the Lounge Room.

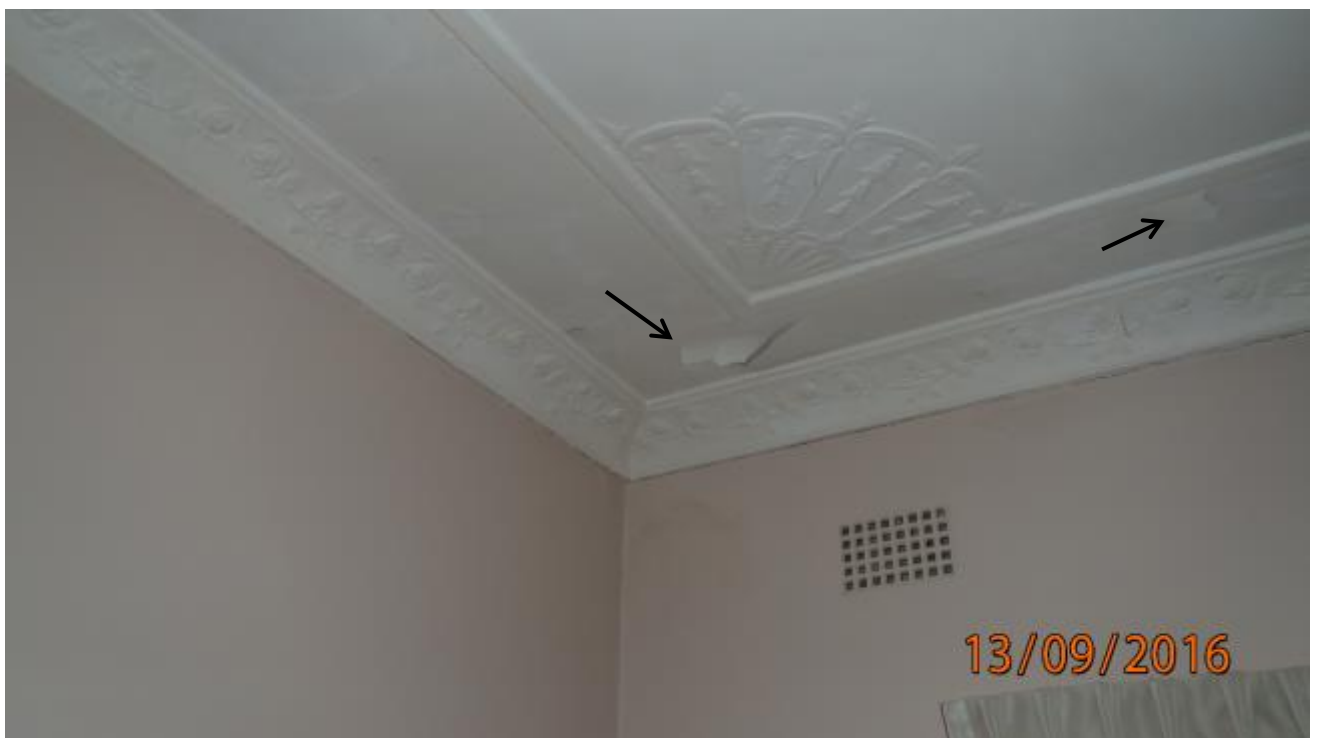
We noted separation cracking [$<1.0\text{mm}$] at the wall / cornice junction in the south western corner. **[Photograph 28]**

Photograph 28 shows flaking paint to the plaster ceiling in the Lounge Room.

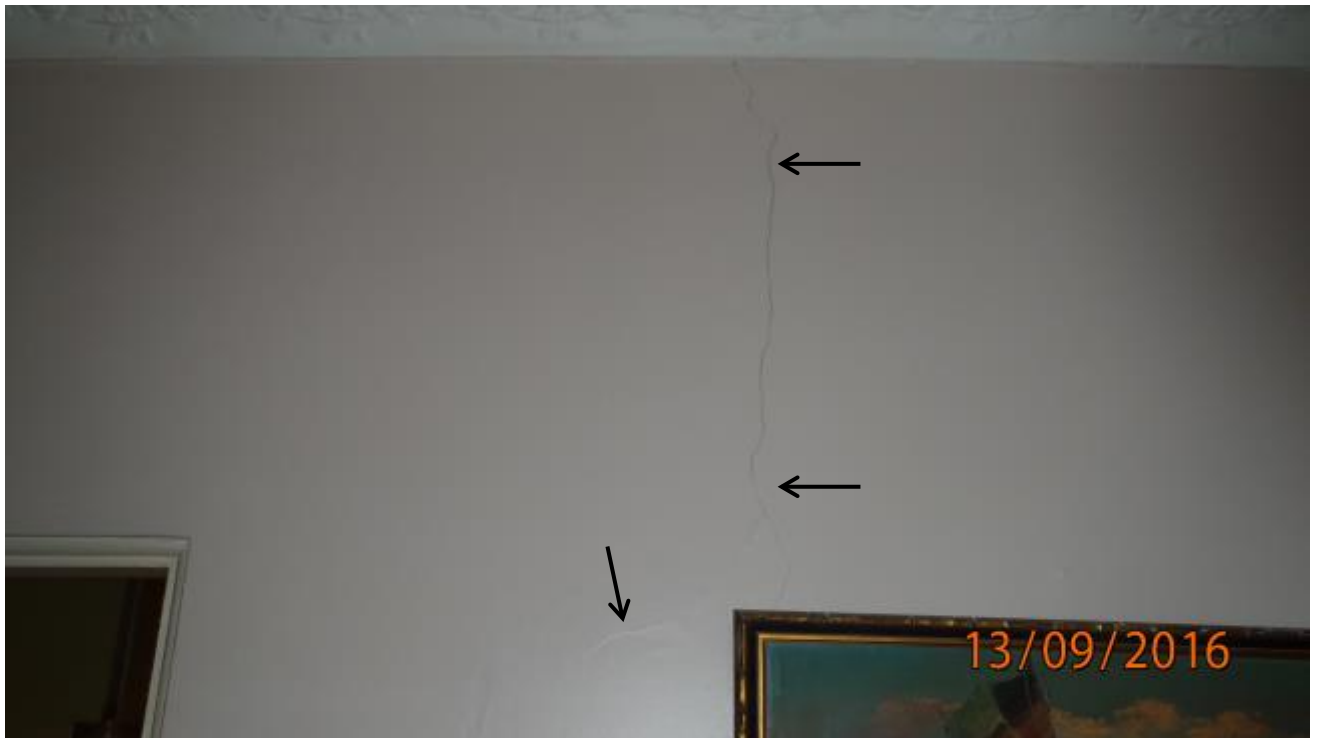
We noted vertical and radial cracking [$1.0\text{mm} - 3.0\text{mm}$] extending from the decorative profile cornice toward the floor on the southern wall. **[Photograph 29]**

Photograph 29 shows vertical and radial cracking on the southern wall in the Lounge Room.

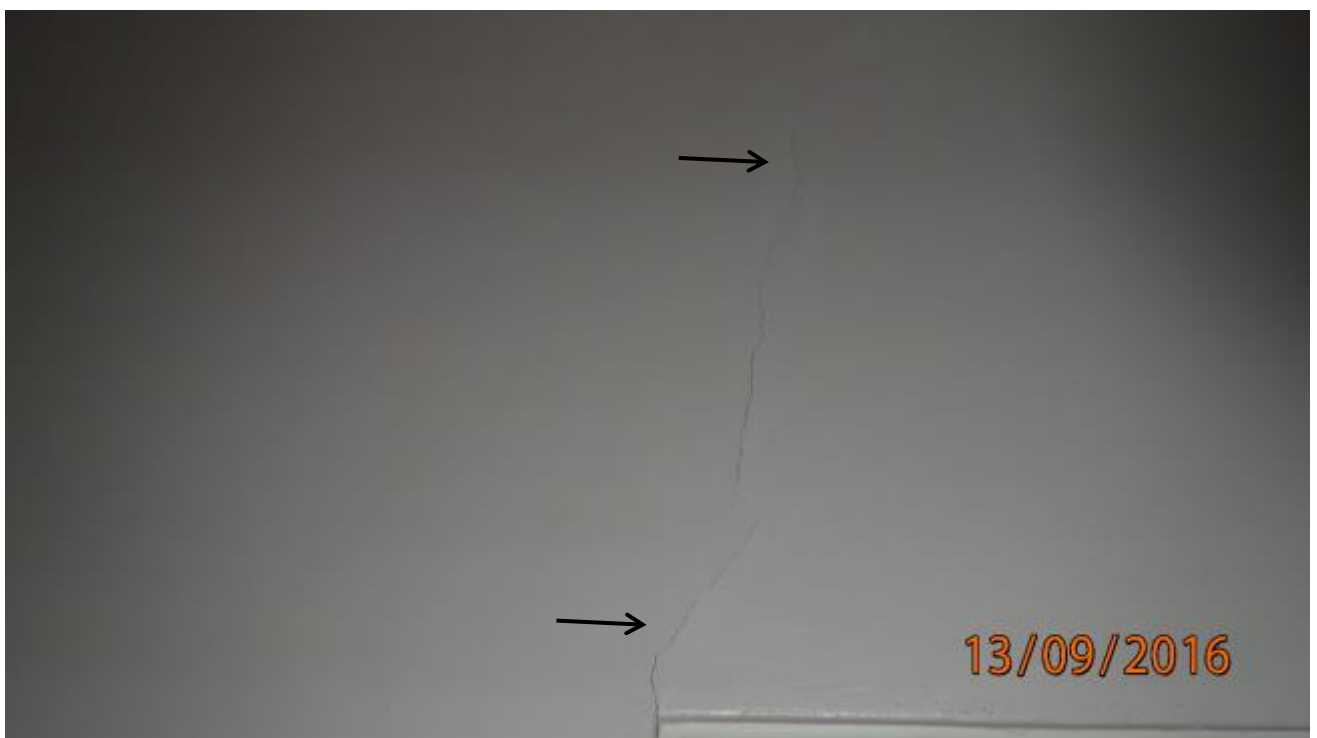
We noted vertical and radial cracking [$<1.0\text{mm}$] extending from the decorative profile cornice toward the door head on the southern wall adjacent to the redundant fireplace. **[Photograph 30]**

Photograph 30 shows vertical and radial cracking extending from the decorative profile cornice toward the door head on the southern wall adjacent to the redundant fireplace in the Lounge Room.

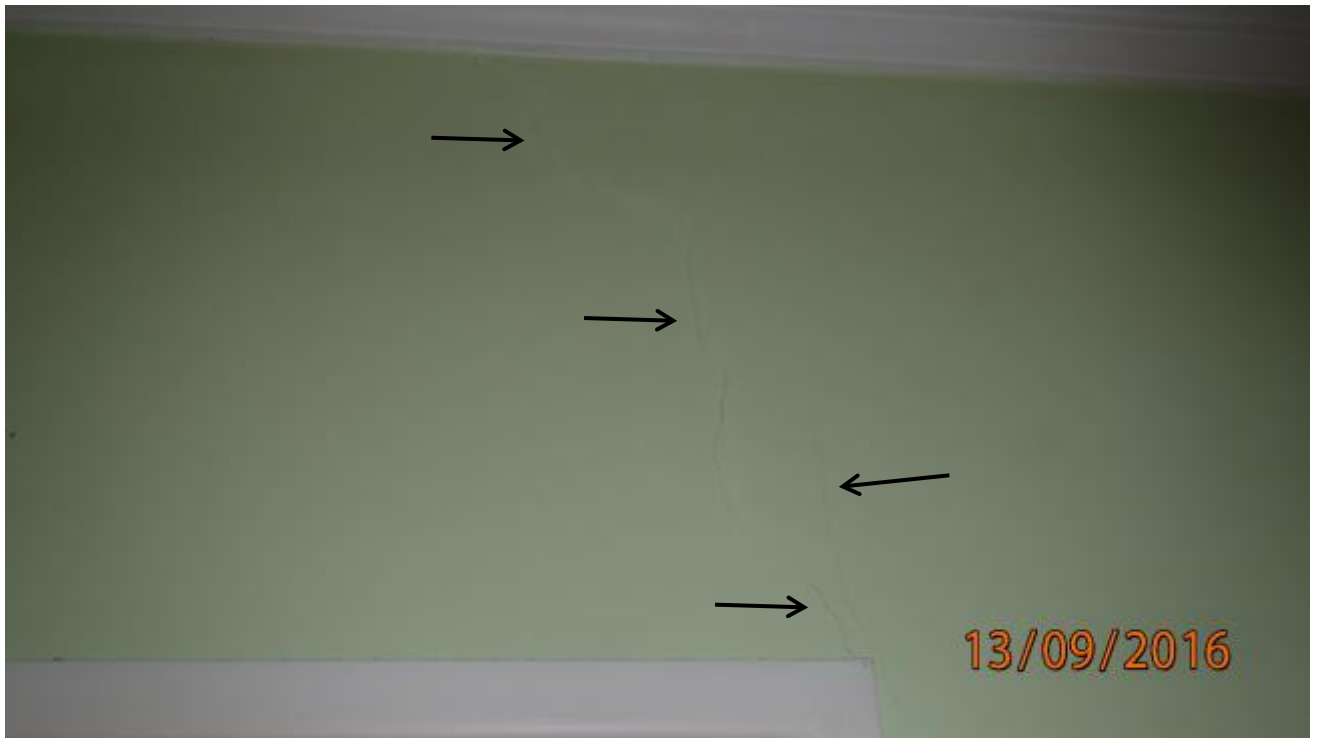
We noted vertical and radial cracking [$<1.0\text{mm}$] extending from the decorative profile cornice toward the door head on the northern wall adjacent (opposite Photograph 30). **[Photograph 31]**

Photograph 31 shows vertical and radial cracking extending from the decorative profile cornice toward the door head on the northern wall in the Dining Room.

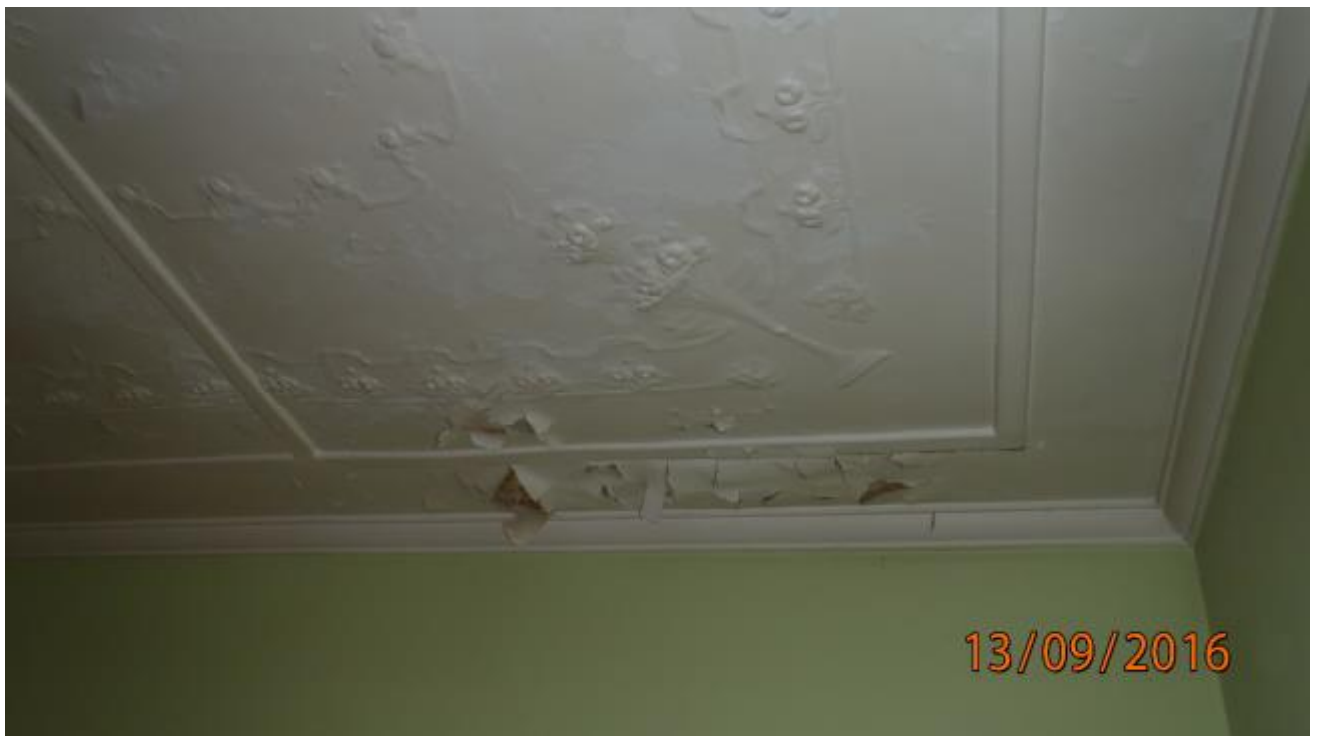
We noted flaking paint overall to the decorative plaster ceiling. **[Photographs 32]**

Photograph 32 shows flaking paint overall to the decorative plaster ceiling in the Dining Room.

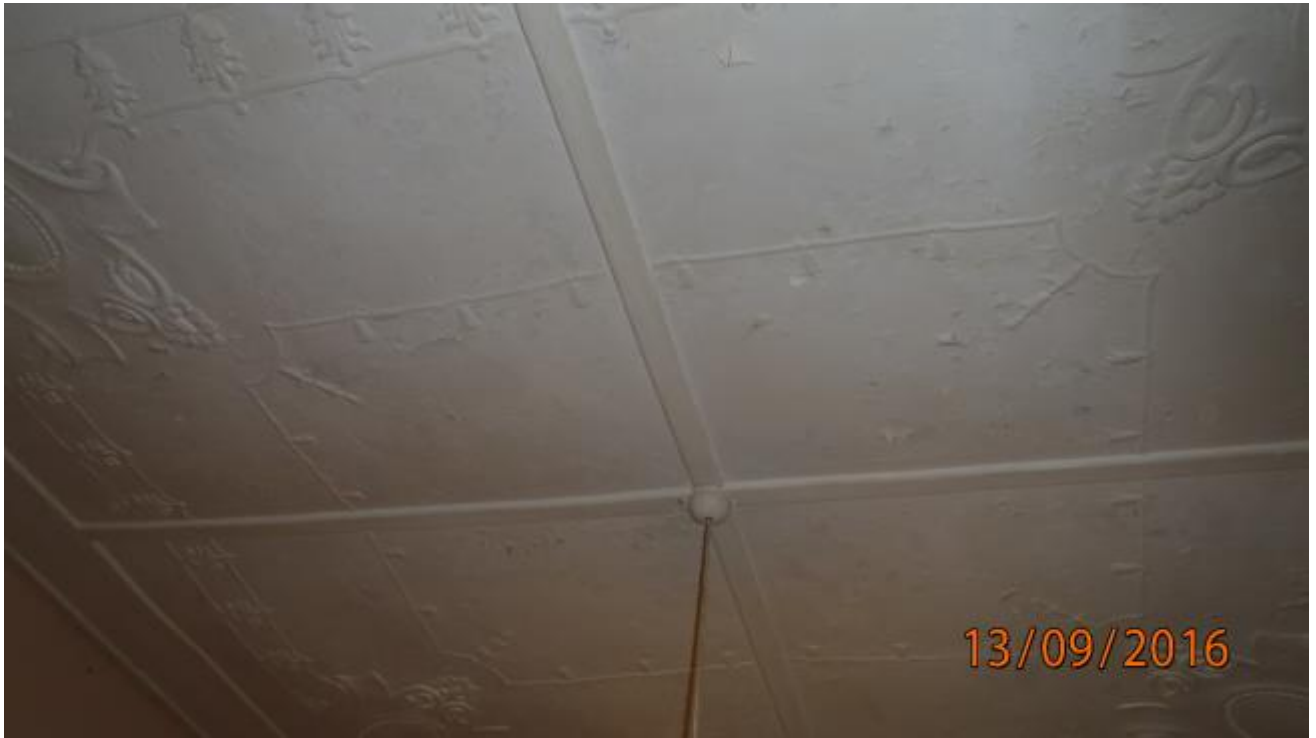
We noted that the ceiling was raked and further noted flaking paint overall to the decorative plaster ceiling. **[Photographs 33]**

Photograph 33 shows flaking paint overall to the decorative plaster ceiling in the Bedroom 3.

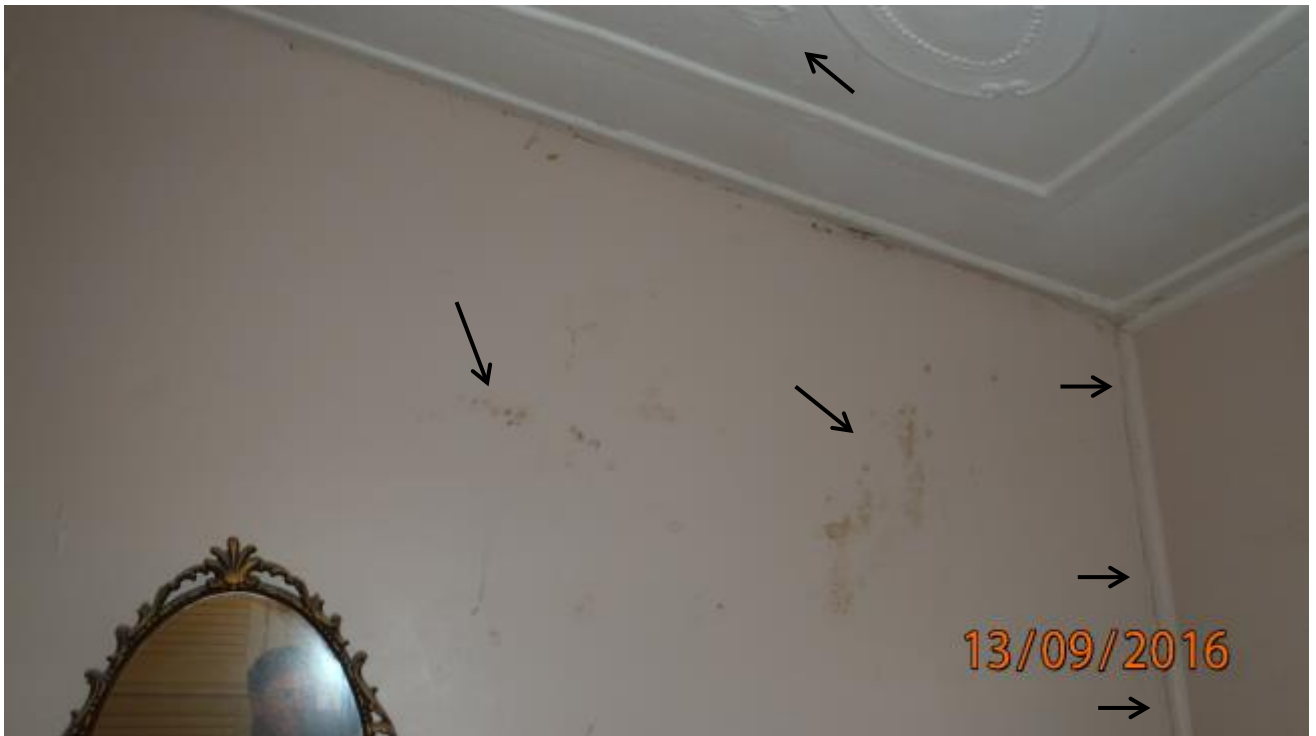
We noted hairline vertical cracking [$<1.0\text{mm}$] at the wall / wall junction in the south eastern corner. **[Photograph 34]**

We noted staining to the surface coated cement rendered wall on the eastern wall. Note: *common party / separation* wall with No. 51 Onslow Street, Rose Bay. **[Photograph 34]**

Photograph 34 shows flaking paint, hairline vertical cracking at the wall / wall junction in the south eastern corner and staining to the surface coated cement rendered wall.

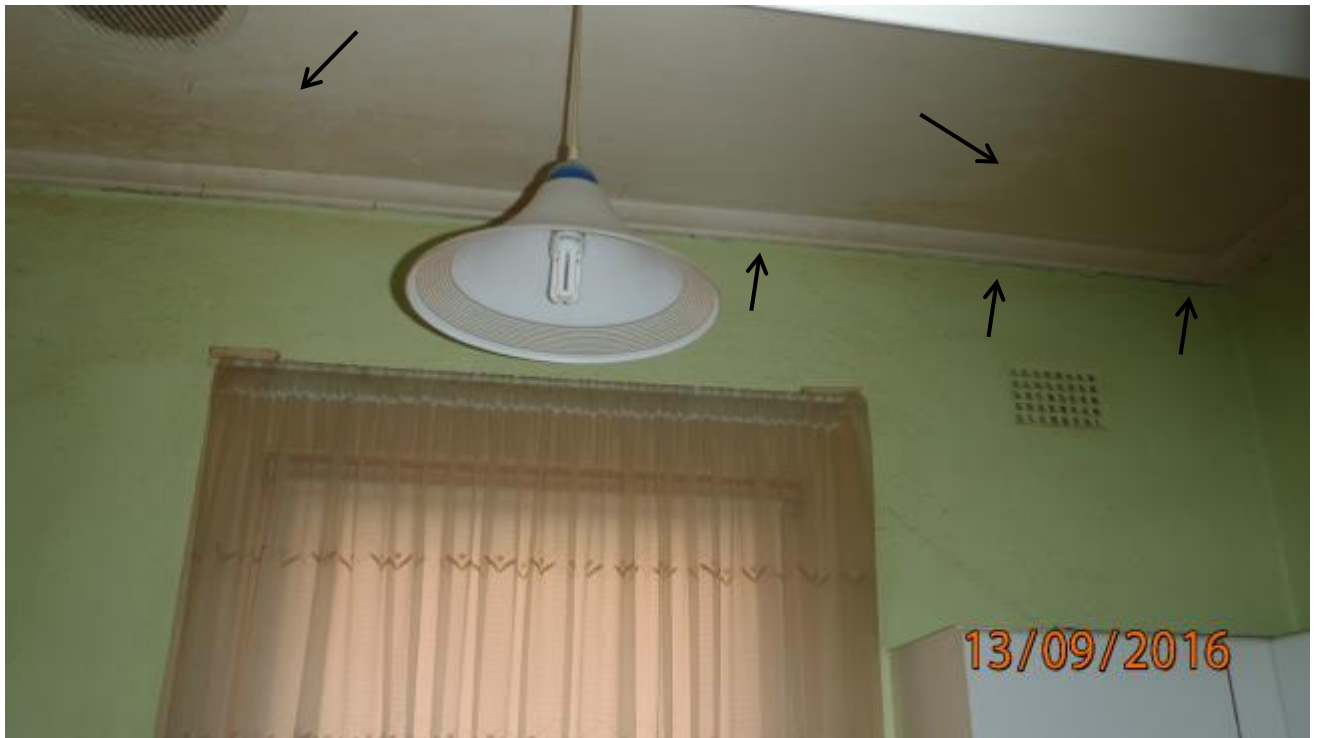
We noted separation cracking [$<1.0\text{mm}$] at the wall / cornice junction on the western external wall. **[Photograph 35]**

We noted staining to the plaster ceiling lining above the window **[Photograph 35]**

Photograph 35 shows separation cracking at the wall / cornice junction on the western external wall and staining to the plaster ceiling in the Kitchen.

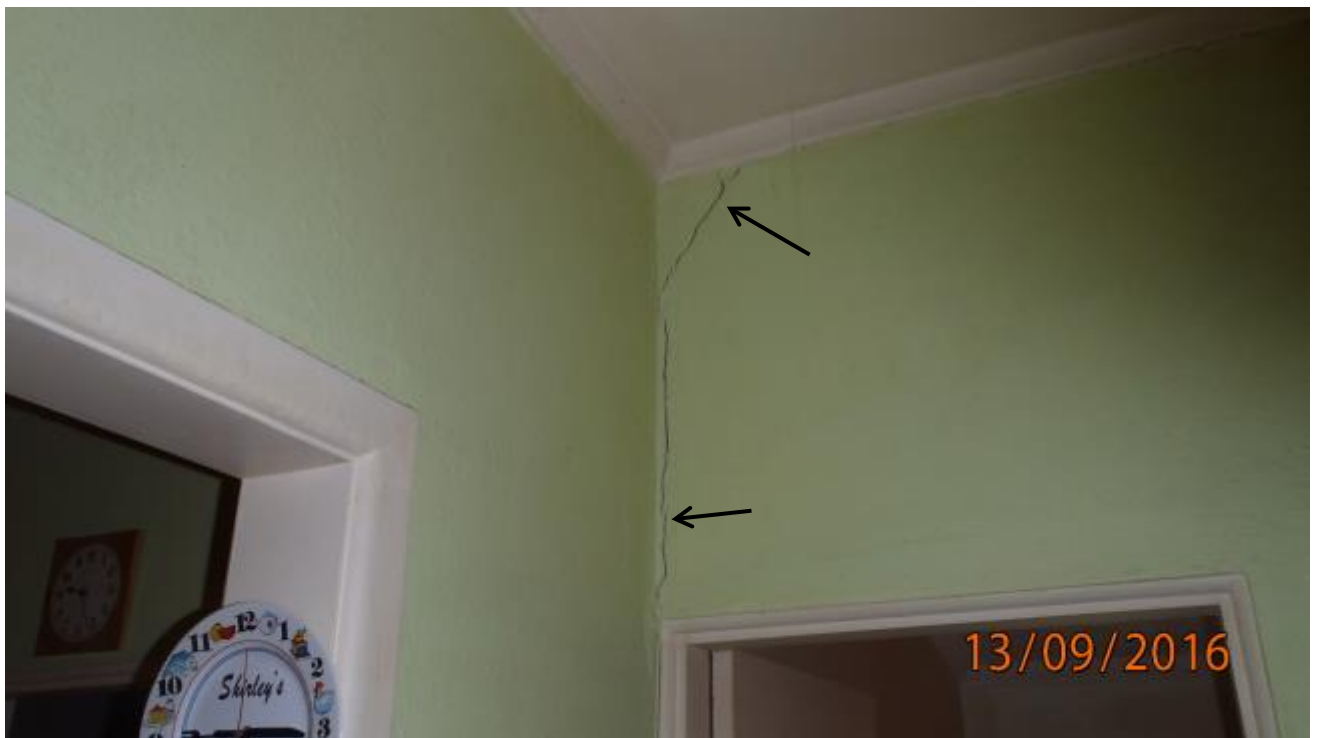
We noted vertical and radial cracking [$<1.0\text{mm}$] extending from the Laundry door head on the southern wall to the cove profile cornice. **[Photograph 36]**

Photograph 36 shows vertical and radial cracking extending from the Laundry door head on the southern wall **of the Kitchen**.

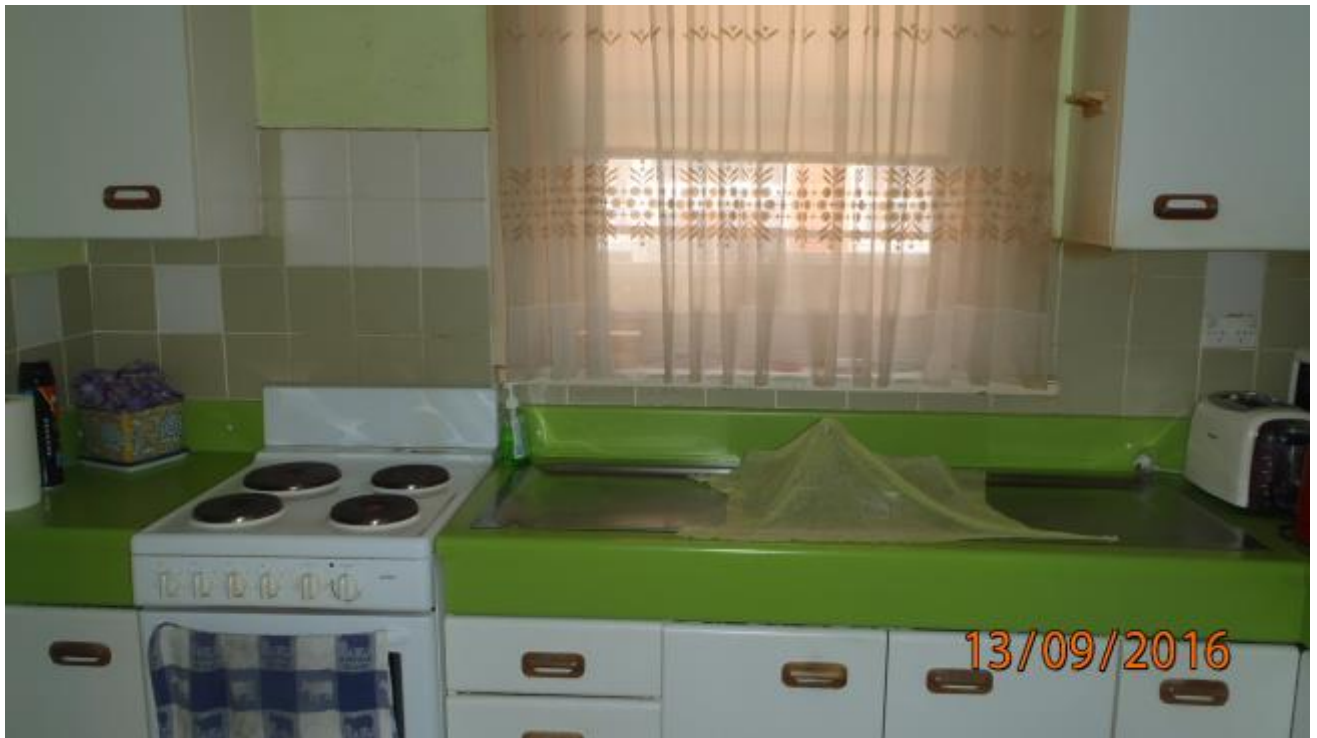
We noted that the grout to the wall tiles is complete and that the tiles when randomly “tap” tested appeared to be sound. We did not observe any recent cracking to the tile grout at the junctions. **[Photograph 37]**

Photograph 37 shows the general layout of the Kitchen.

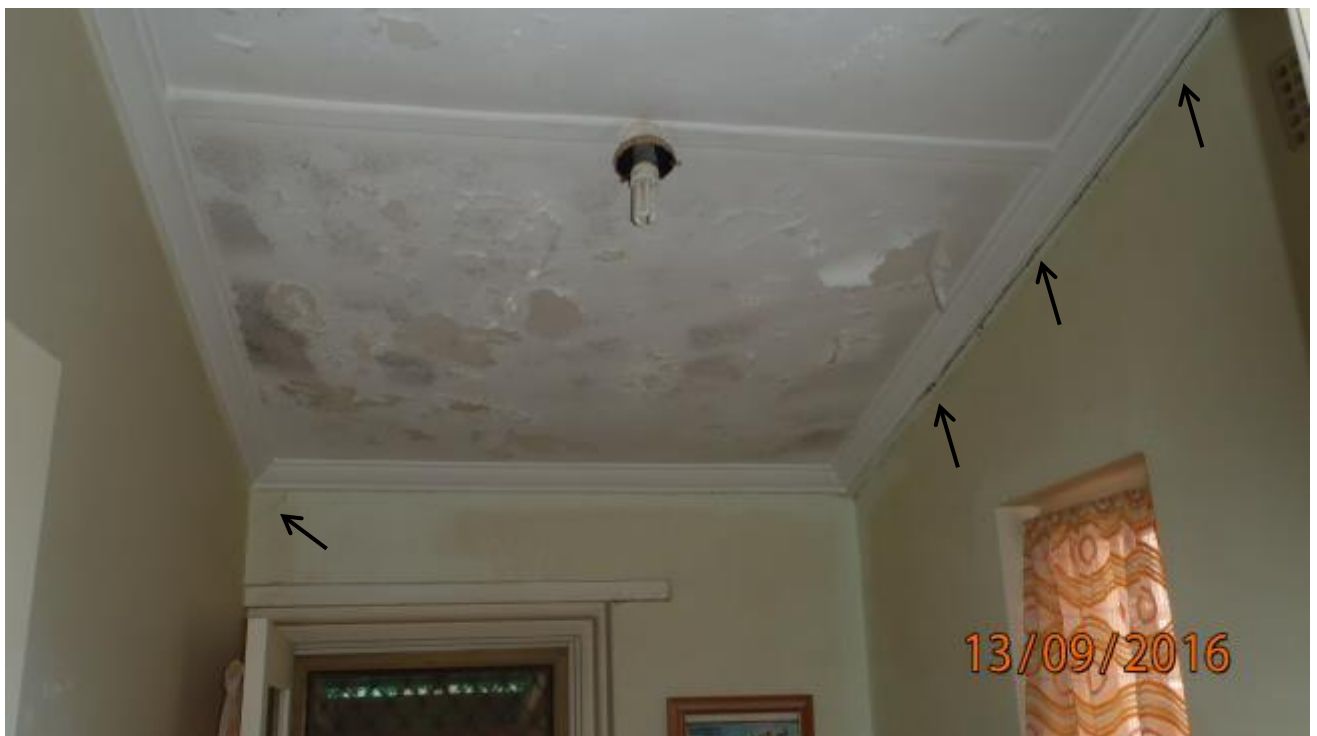
We noted that the ceiling was raked and further noted flaking paint overall to the plaster ceiling lining. **[Photographs 38]**

We noted radial cracking [$<1.0\text{mm}$] extending from the Laundry door head on the southern wall to the cove profile cornice. **[Photograph 38]**

We noted separation cracking [$<1.0\text{mm}$] at the wall / cornice junction on the western external wall. **[Photograph 38]**

Photograph 38 shows flaking paint to the ceiling, radial cracking extending from the Laundry door head on the southern wall and separation cracking at the wall / cornice junction on the western external wall in the Laundry.
