HAZARDOUS MATERIALS ASSESSMENT REPORT

Client: Cape Cod Australia Pty. Limited

Job Details: Owner/s: Mr. N. & Mrs. J. Keenan
Location: 35 Lawson Street, Bondi Junction

Date of Assessment: 19th January 2011

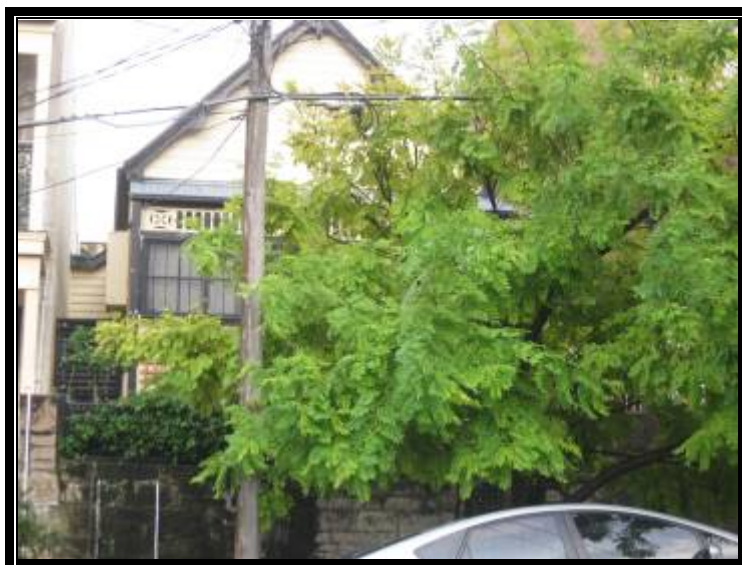
Front eastern elevation of the residence
