HAZARDOUS MATERIALS ASSESSMENT REPORT

Job details: Owner: Mr. B. & Mrs. D. Rock.
Location: 52 Donovan Avenue, Maroubra.

Date of assessment: 1st February 2017

Our reference: HM05500117

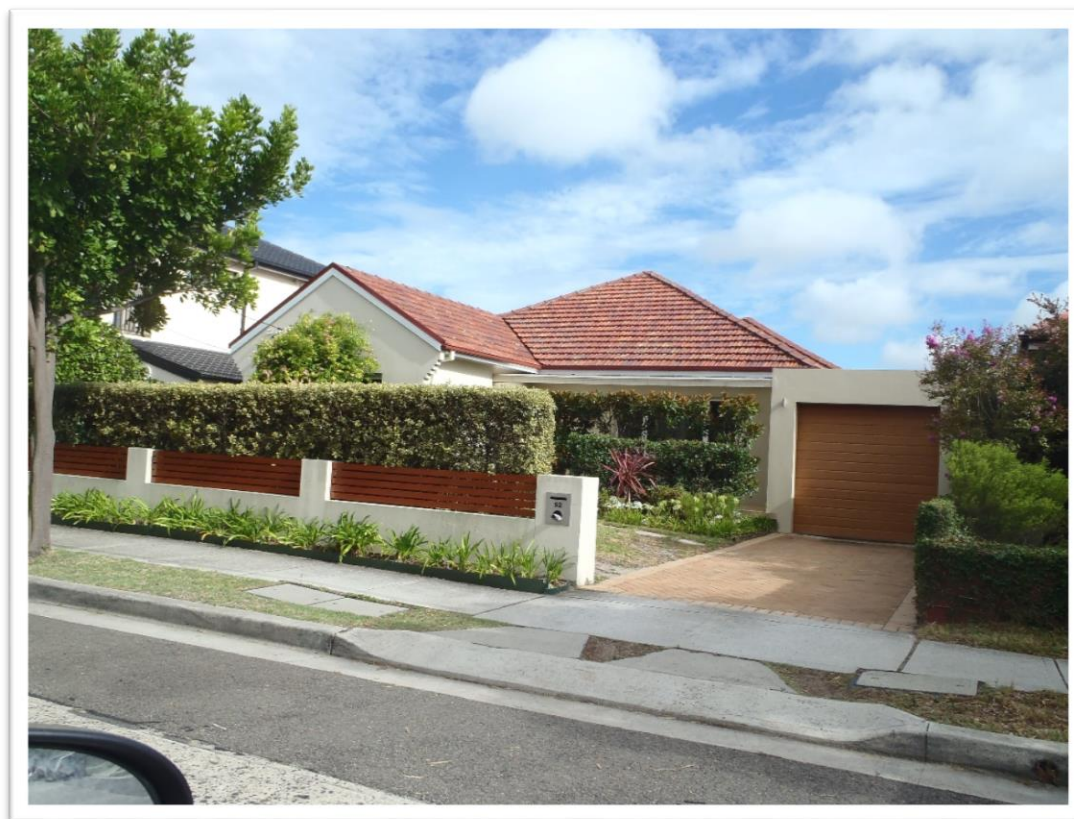
Front southern elevation of the residence
