HAZARDOUS MATERIALS ASSESSMENT REPORT

Client: Cape Cod Australia Pty. Limited

Job details: Owner/s: Mr. P. & Mrs. K. Bury
Location: 3 Warragal Road, Turramurra NSW

Our reference: HM04650216

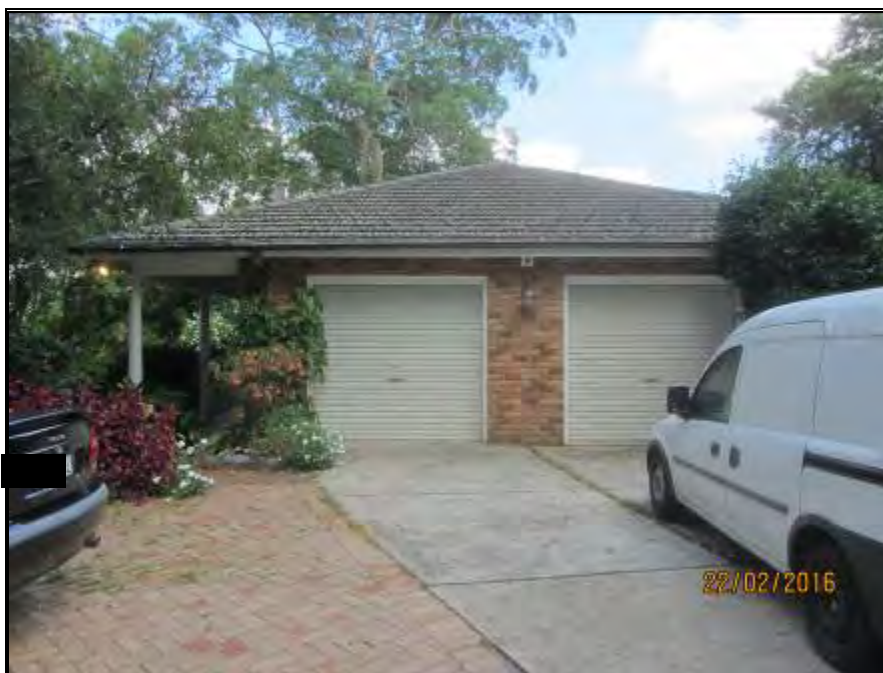
Front south eastern elevation of the residence
