Dilapidation Assessment Report

Prepared for: Cape Cod Australia Pty. Limited
Job address: 2 Raleigh Street, Coogee.
Property Owner/s: Mr James Thompson.
Report reference: **RANDWICK CITY COUNCIL**
Development Application No: not available
Date of assessment: 15th February 2017

Re: Dilapidation Report – No. 2 Raleigh Street, Coogee.

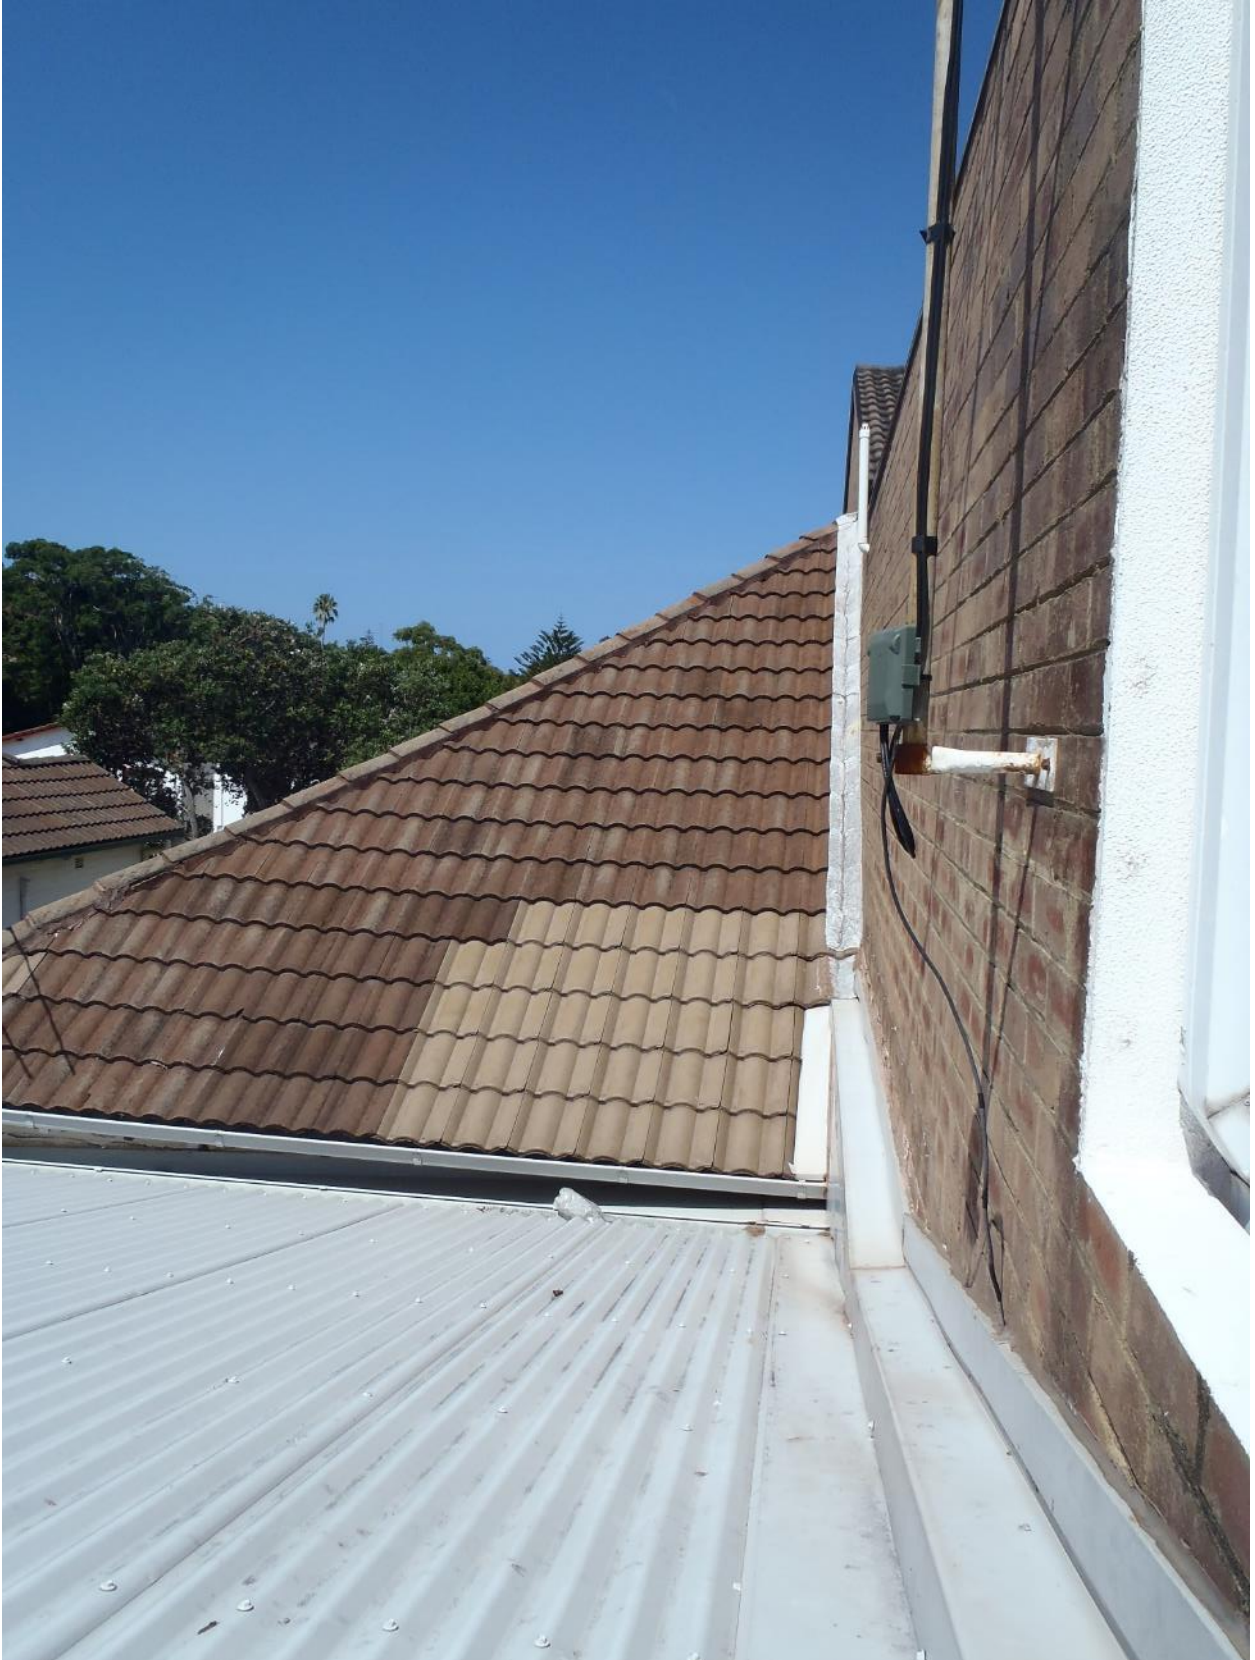
We noted that the side flashing between the brick wall of upper floor addition and the sheet metal roof of the adjoining property, No. 4 Raleigh Street is generally intact and forming a weather resistant seal between the wall and the roof surface. **[Photograph 1]**

Photograph 1 shows the general condition of the side flashing between the first-floor extension of the adjoining properties.

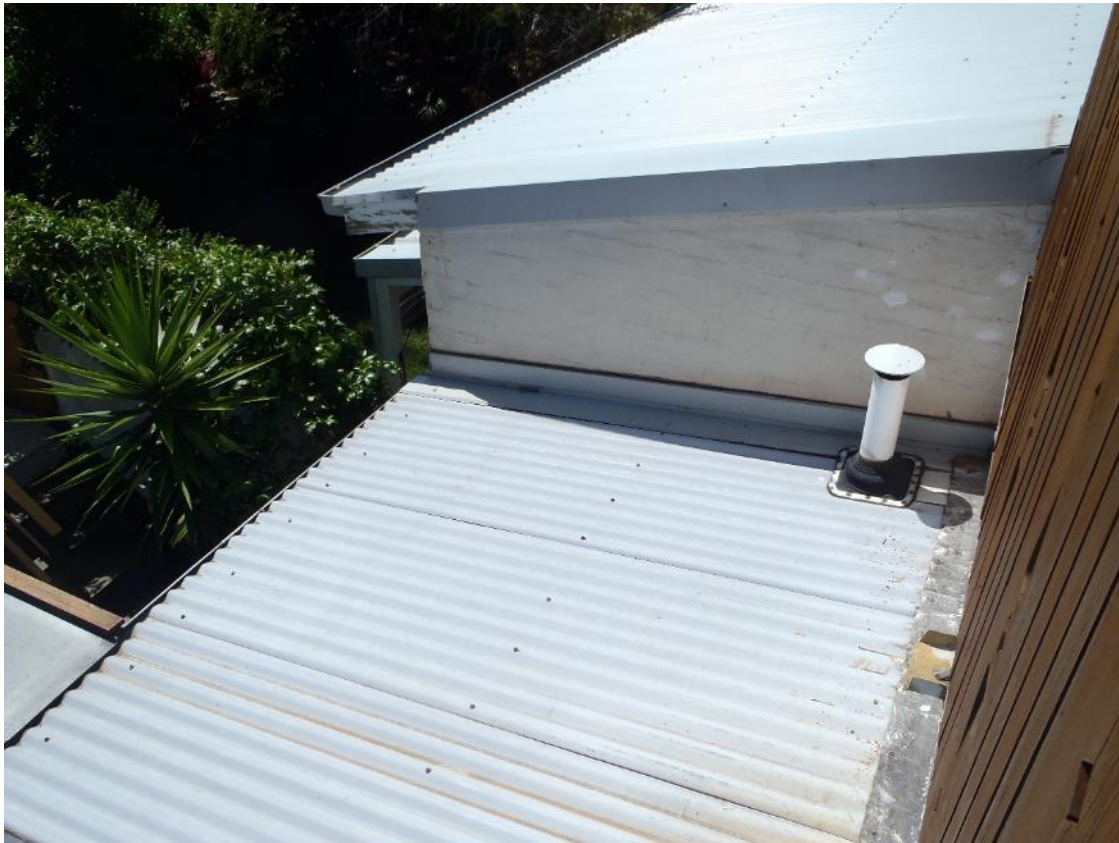
We noted that the side flashing between the brick wall of the rear addition of the adjoining property, No. 4 Raleigh Street and the sheet metal roofing to the rear of this residence is generally intact and forming a weather resistant seal between the wall and the roof surface. **[Photograph 2]**

We noted that the corrugated profile sheet metal roofing to the rear roof surface, above Laundry is in good condition and is securely fixed, in our opinion forming a weather resistant cover to the rear addition. **[Photograph 2]**

Photograph 2 shows the general condition of the side flashing between the rear extension of the adjoining properties and the rear skillion roof surface.

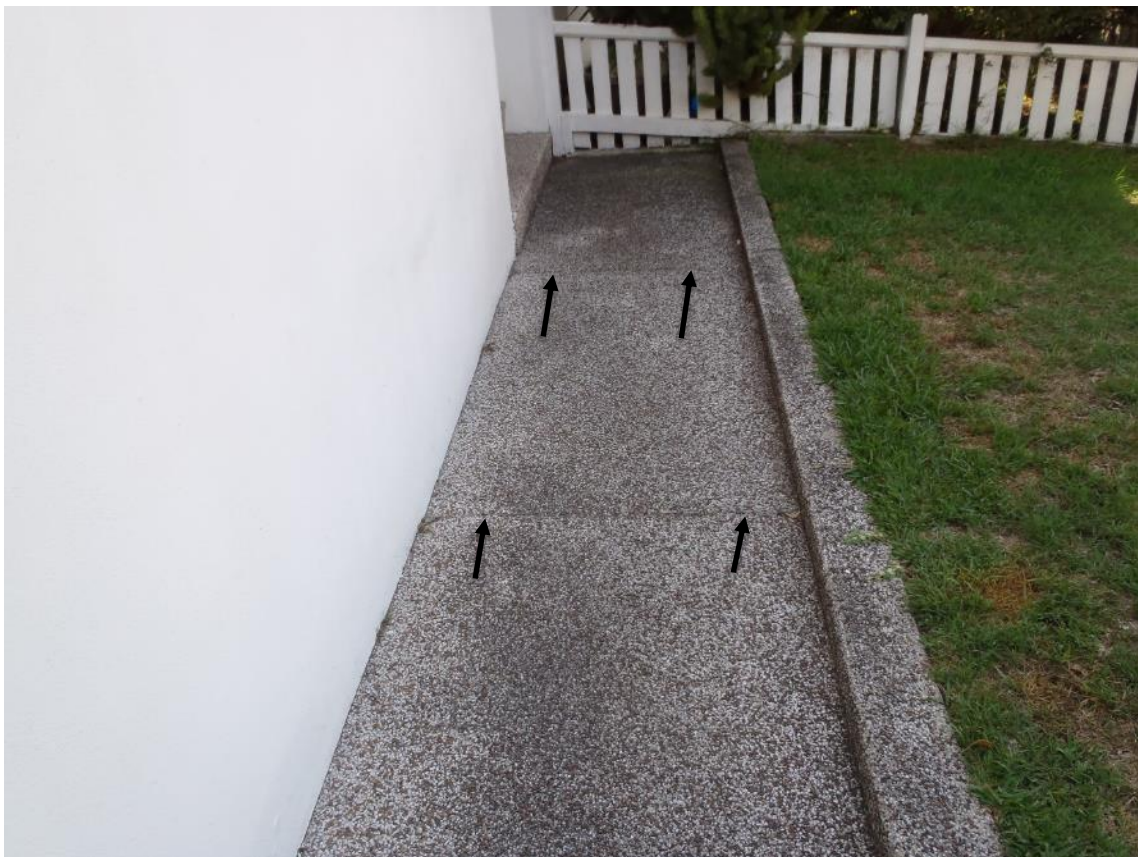
We noted hairline shrinkage cracking to the exposed aggregate concrete path at the front of the residence. **[Photograph 3]**

Photograph 3 shows hairline shrinkage cracking to the front concrete path.

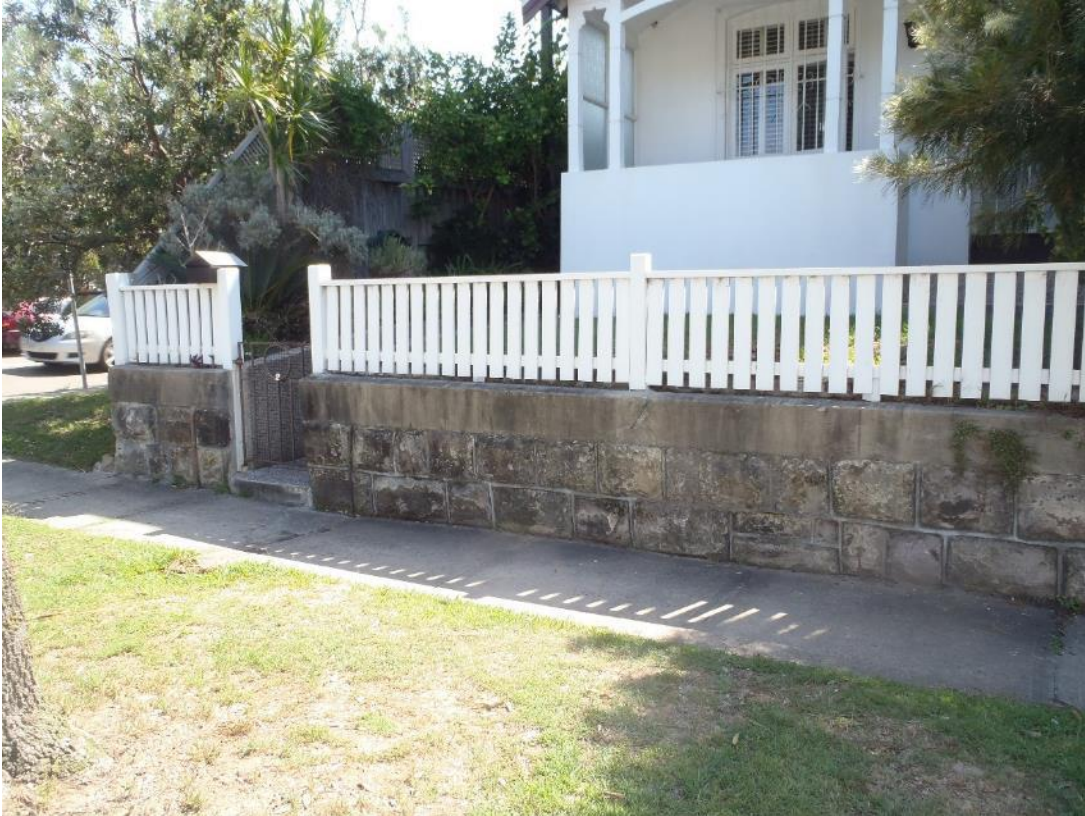
We noted that the front boundary wall is constructed of sandstone blocks with a post and rail picket style fence built on top. We further noted that the wall and fence was in good condition with no evident cracking. **[Photograph 4]**

Photograph 4 shows the general condition of the front boundary fence.

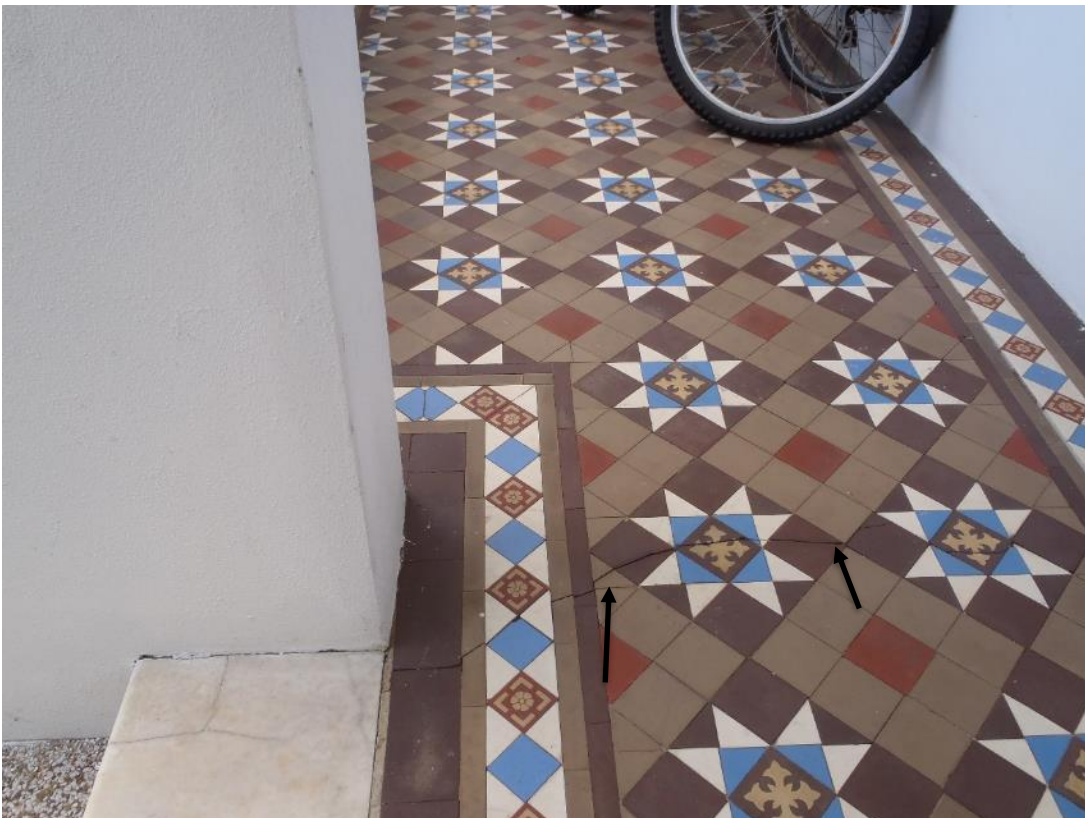
We noted cracking [1mm – 3mm] to the patterned vitrified clay tiles on the front verandah. We further noted displaced grout and loose tiles. **[Photograph 5]**

Photograph 5 shows cracking to the patterned vitrified clay tiles on the front verandah.

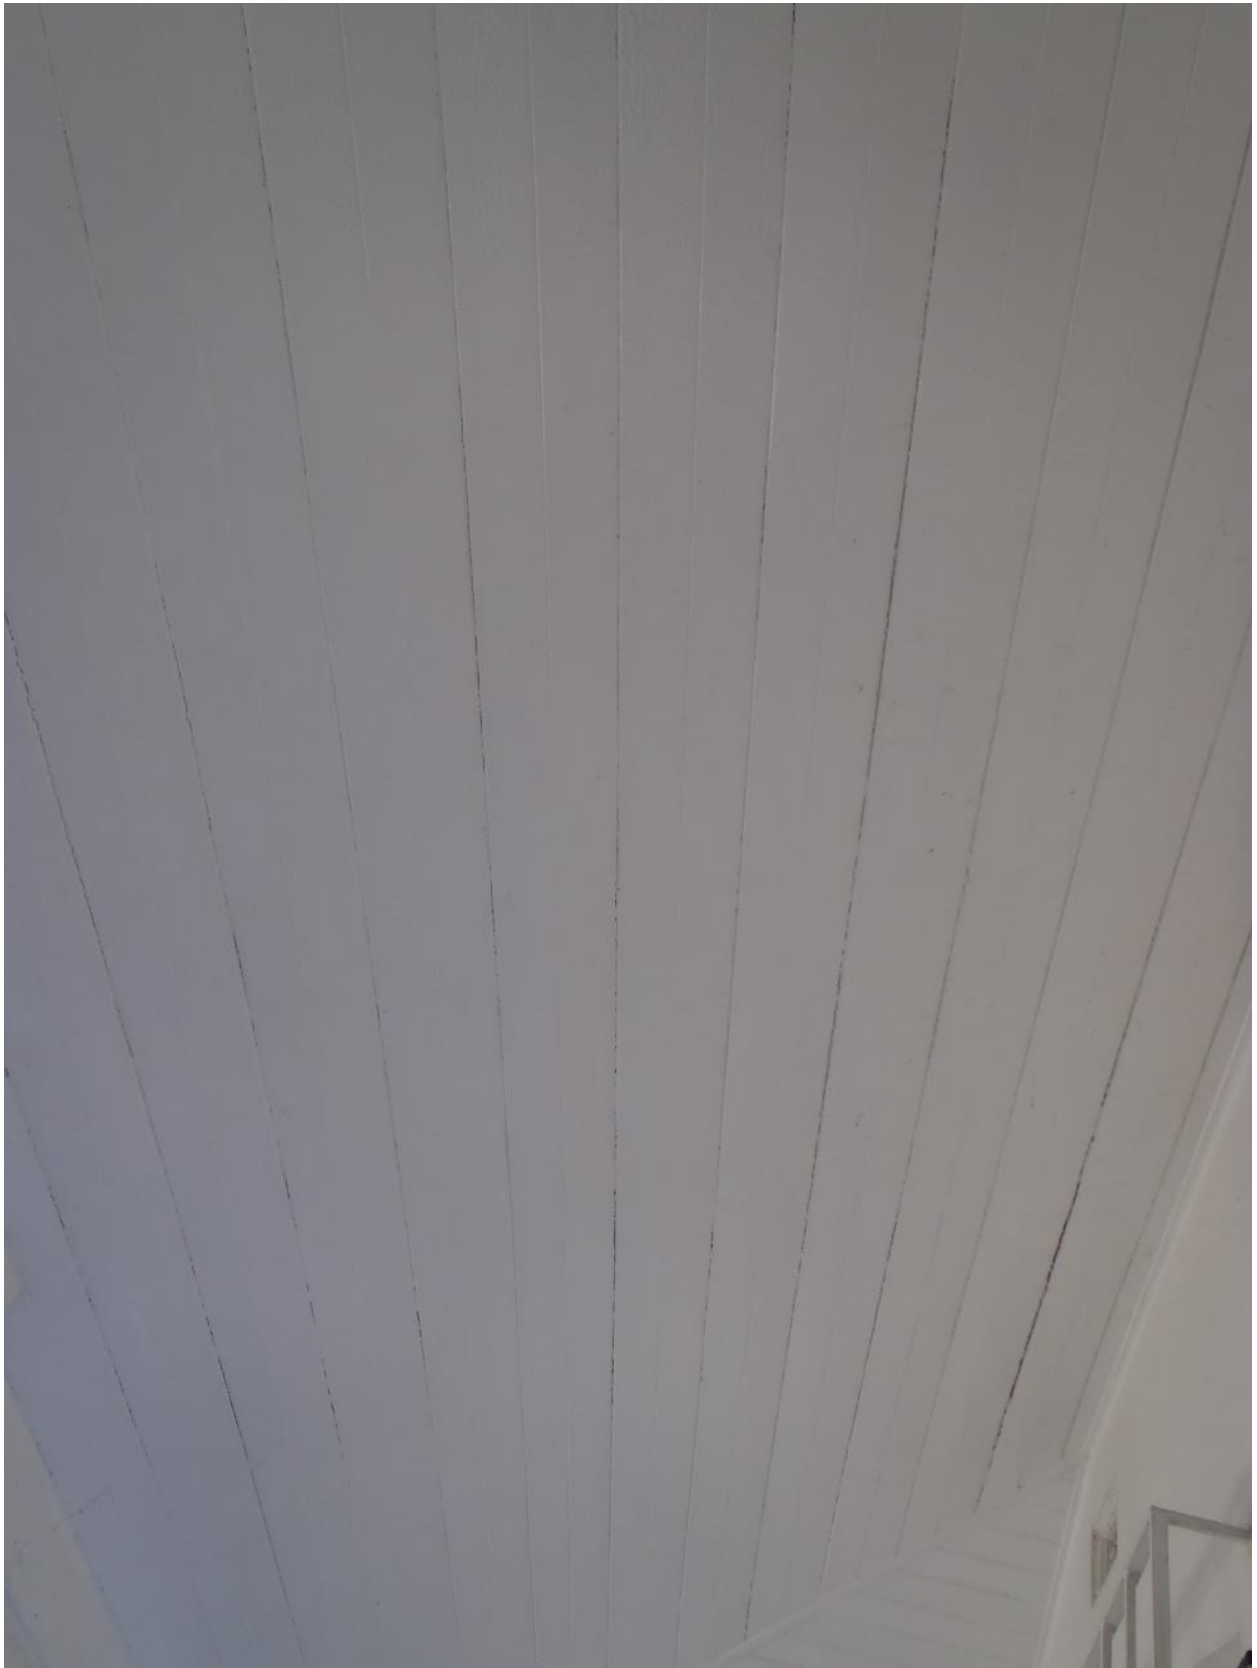
We observed that the front porch soffit was lined with surface coated timber boards. **[Photograph 6]**

Photograph 6 shows the general condition of the verandah soffit lining.

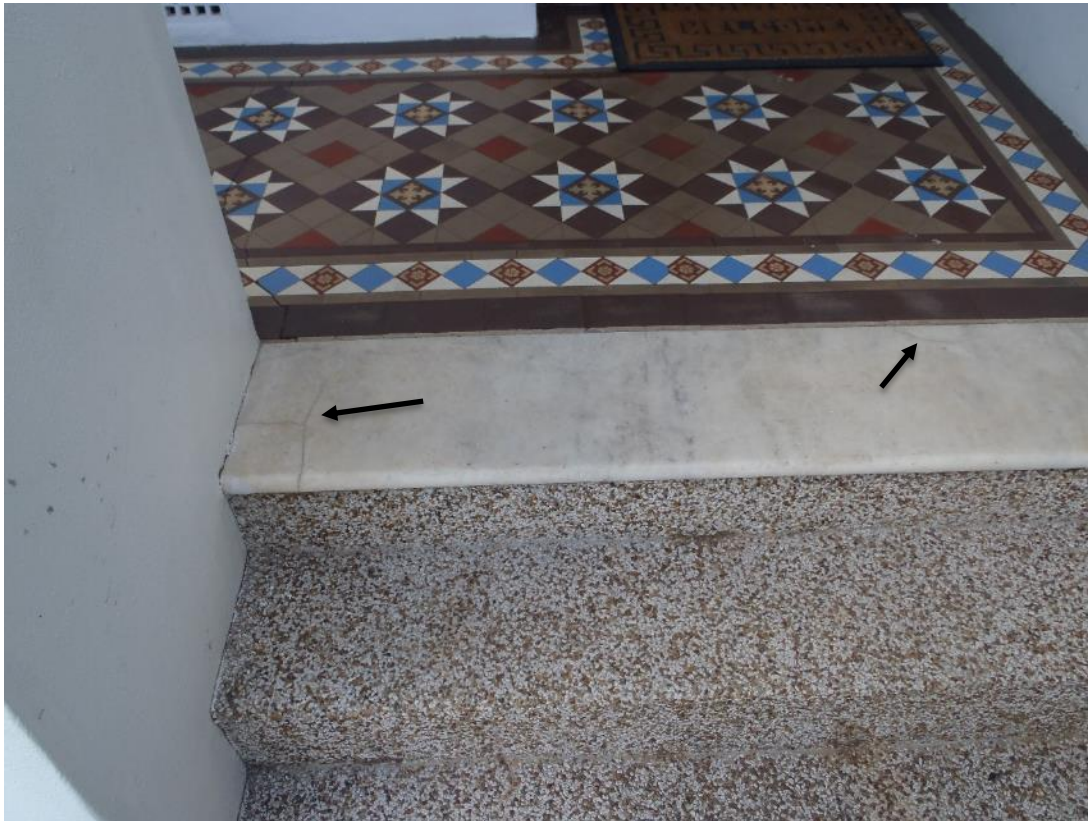
We noted hairline cracking to the front threshold step. **[Photograph 7]**

Photograph 7 shows cracking to the front threshold step.

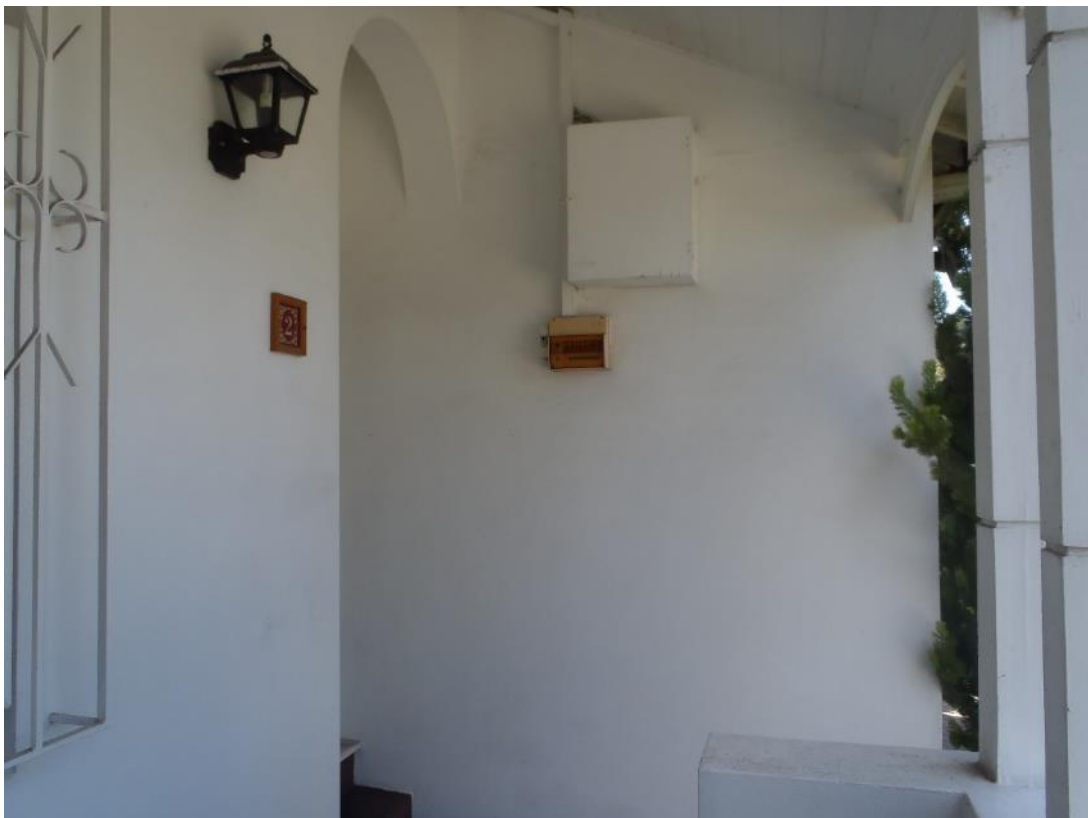
We noted there was a surface coated clay masonry brick *common* privacy wall between the adjoining properties. **[Photograph 8]**. We further noted evidence of a previous repair to the surface coated clay masonry *common* privacy wall adjacent to the electrical meter box. **[Photograph 9]**

Photograph 8 shows the general condition of the clay masonry brick *common* privacy wall between the adjoining properties.

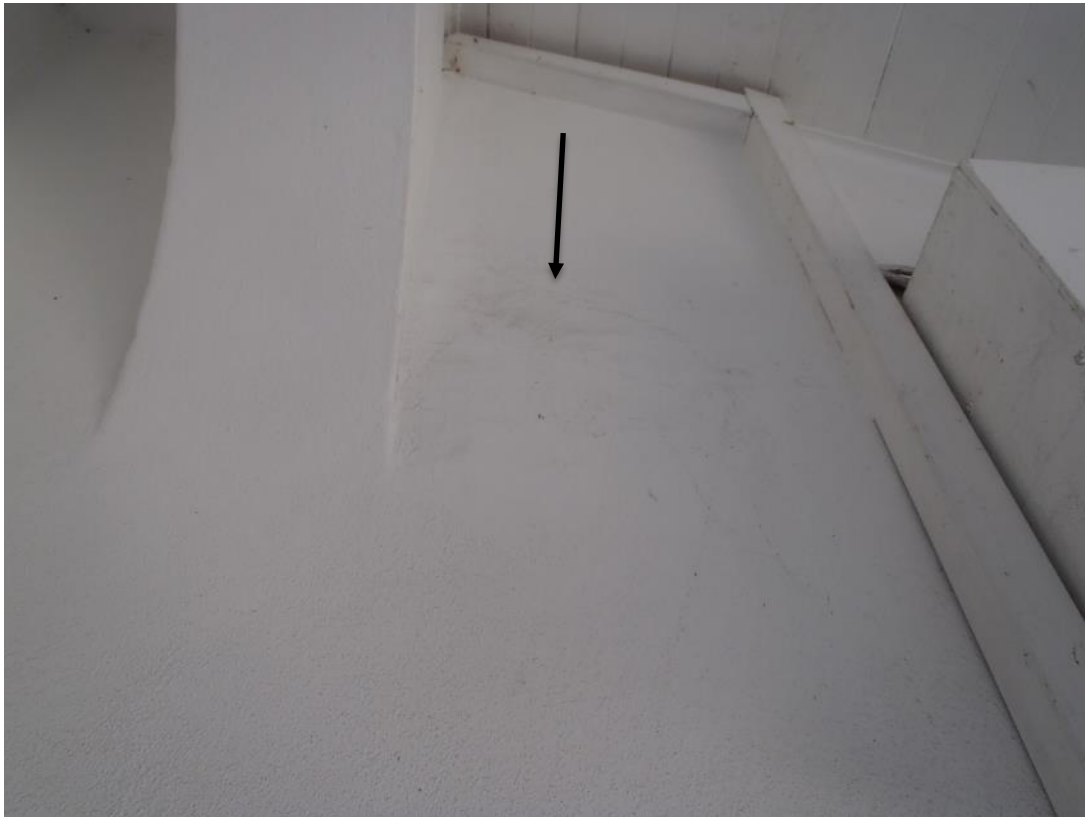
Photograph 9 shows evidence of a previous repair to the surface coated clay masonry *common* privacy wall adjacent to the electrical meter box.

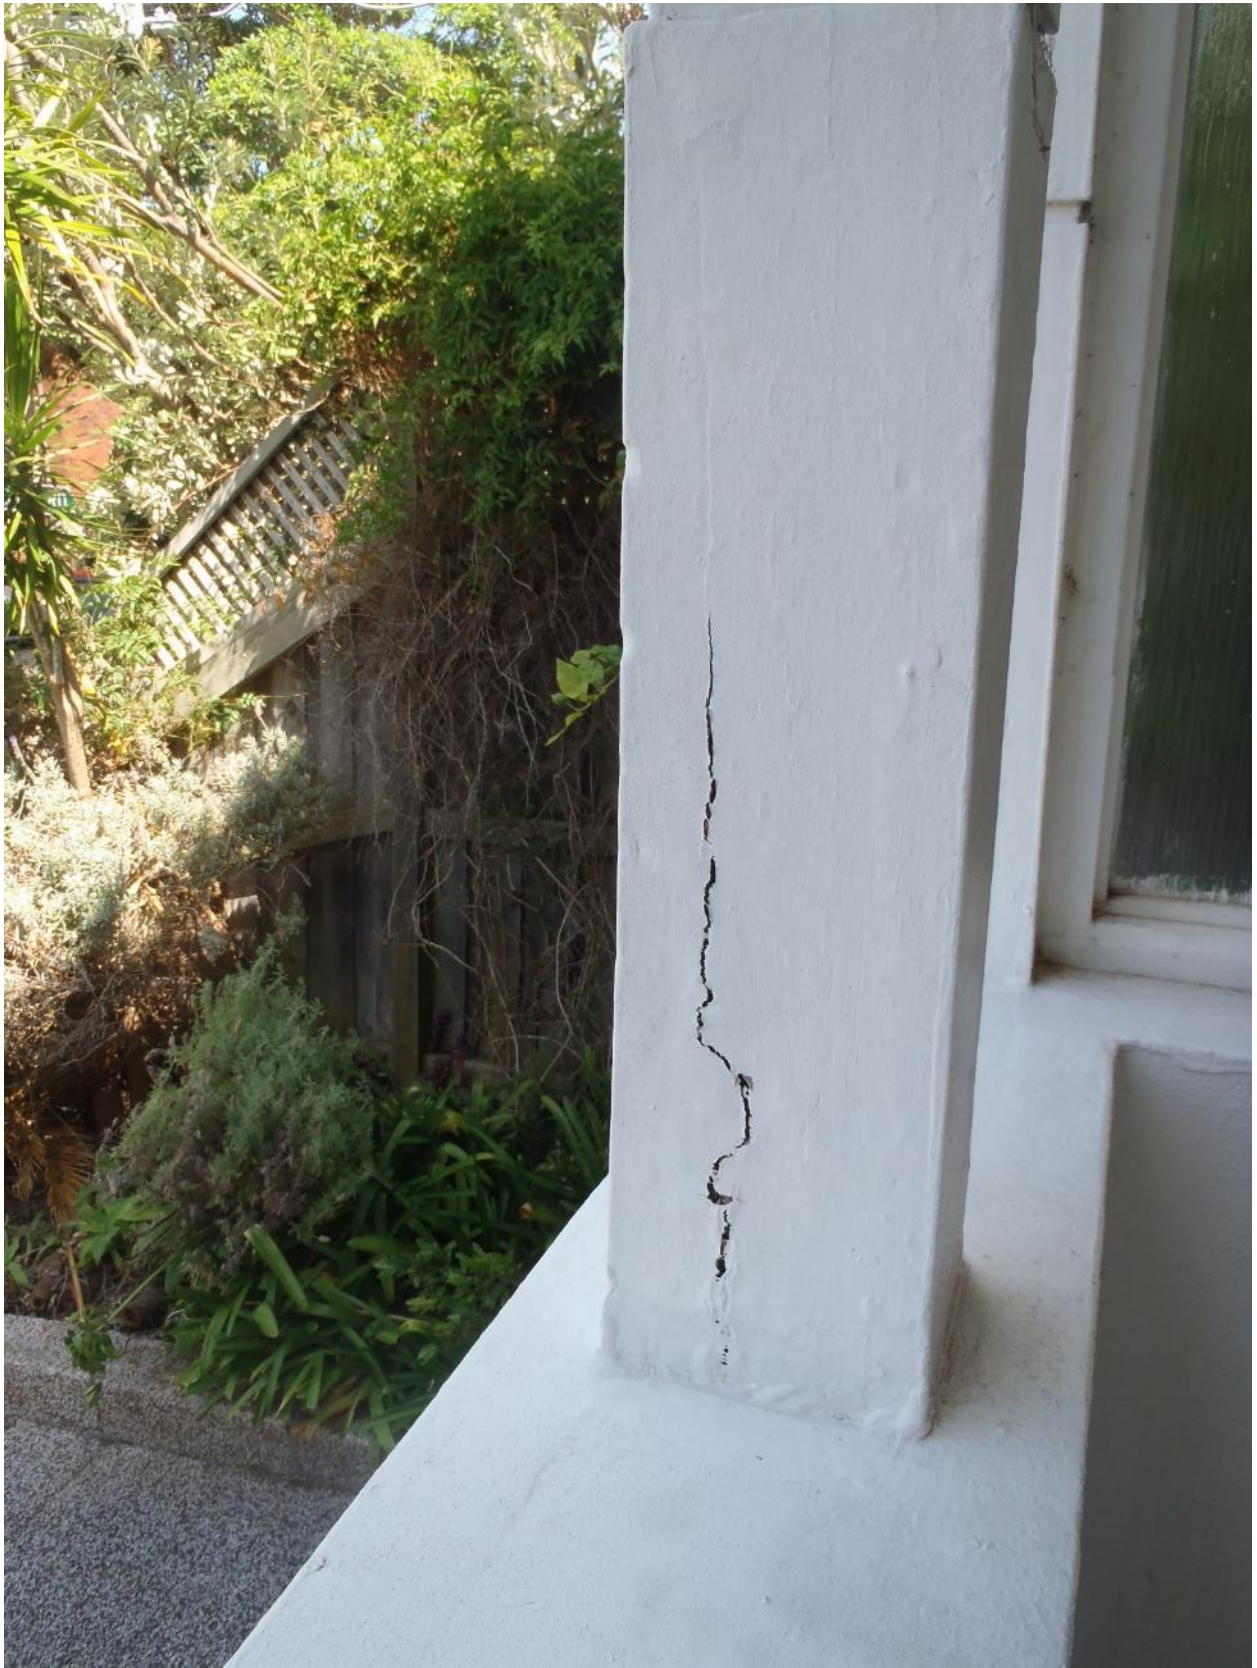
We noted cracking [1mm – 3mm] to the timber support post in the south-eastern corner of the front verandah. **[Photograph 10]**

Photograph 10 shows cracking to the timber support post in the south-eastern corner of the front verandah.

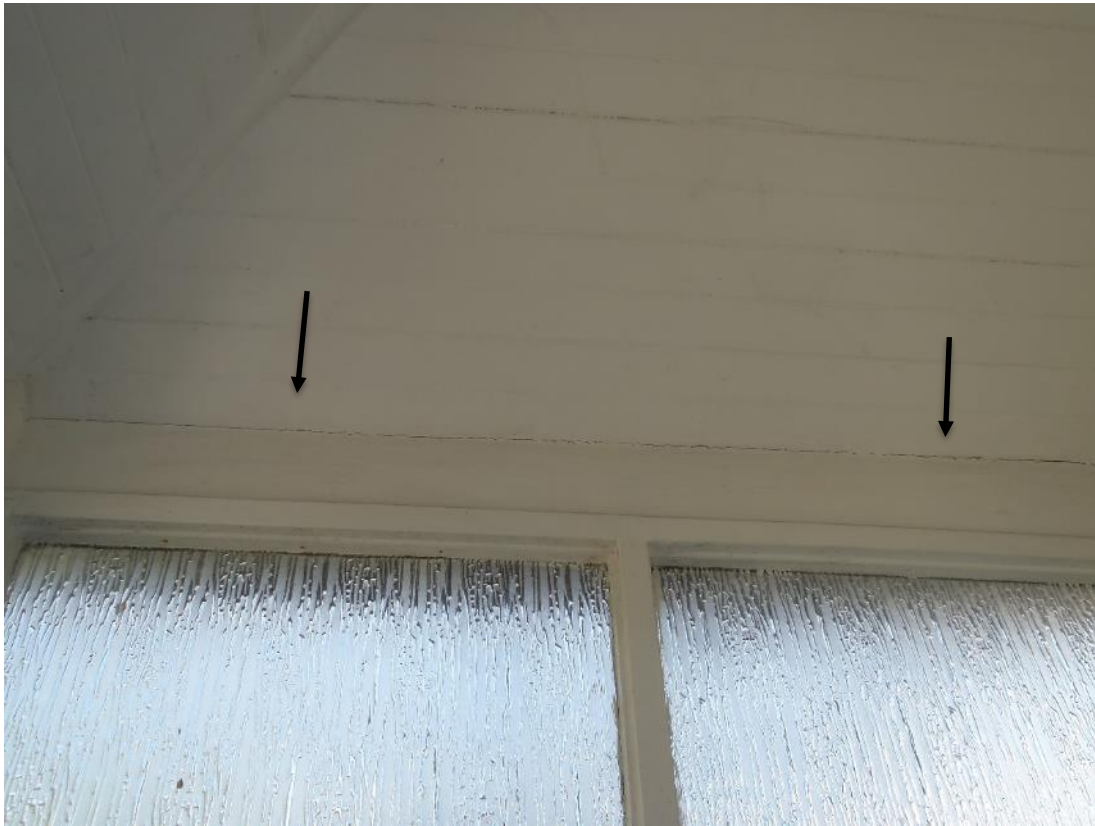
We noted separation cracking between the timber lined soffit and the wall above the window in the southern end of the verandah. **[Photograph 11]**

Photograph 11 shows separation cracking between the timber lined soffit and the wall above the window in the southern end of the verandah

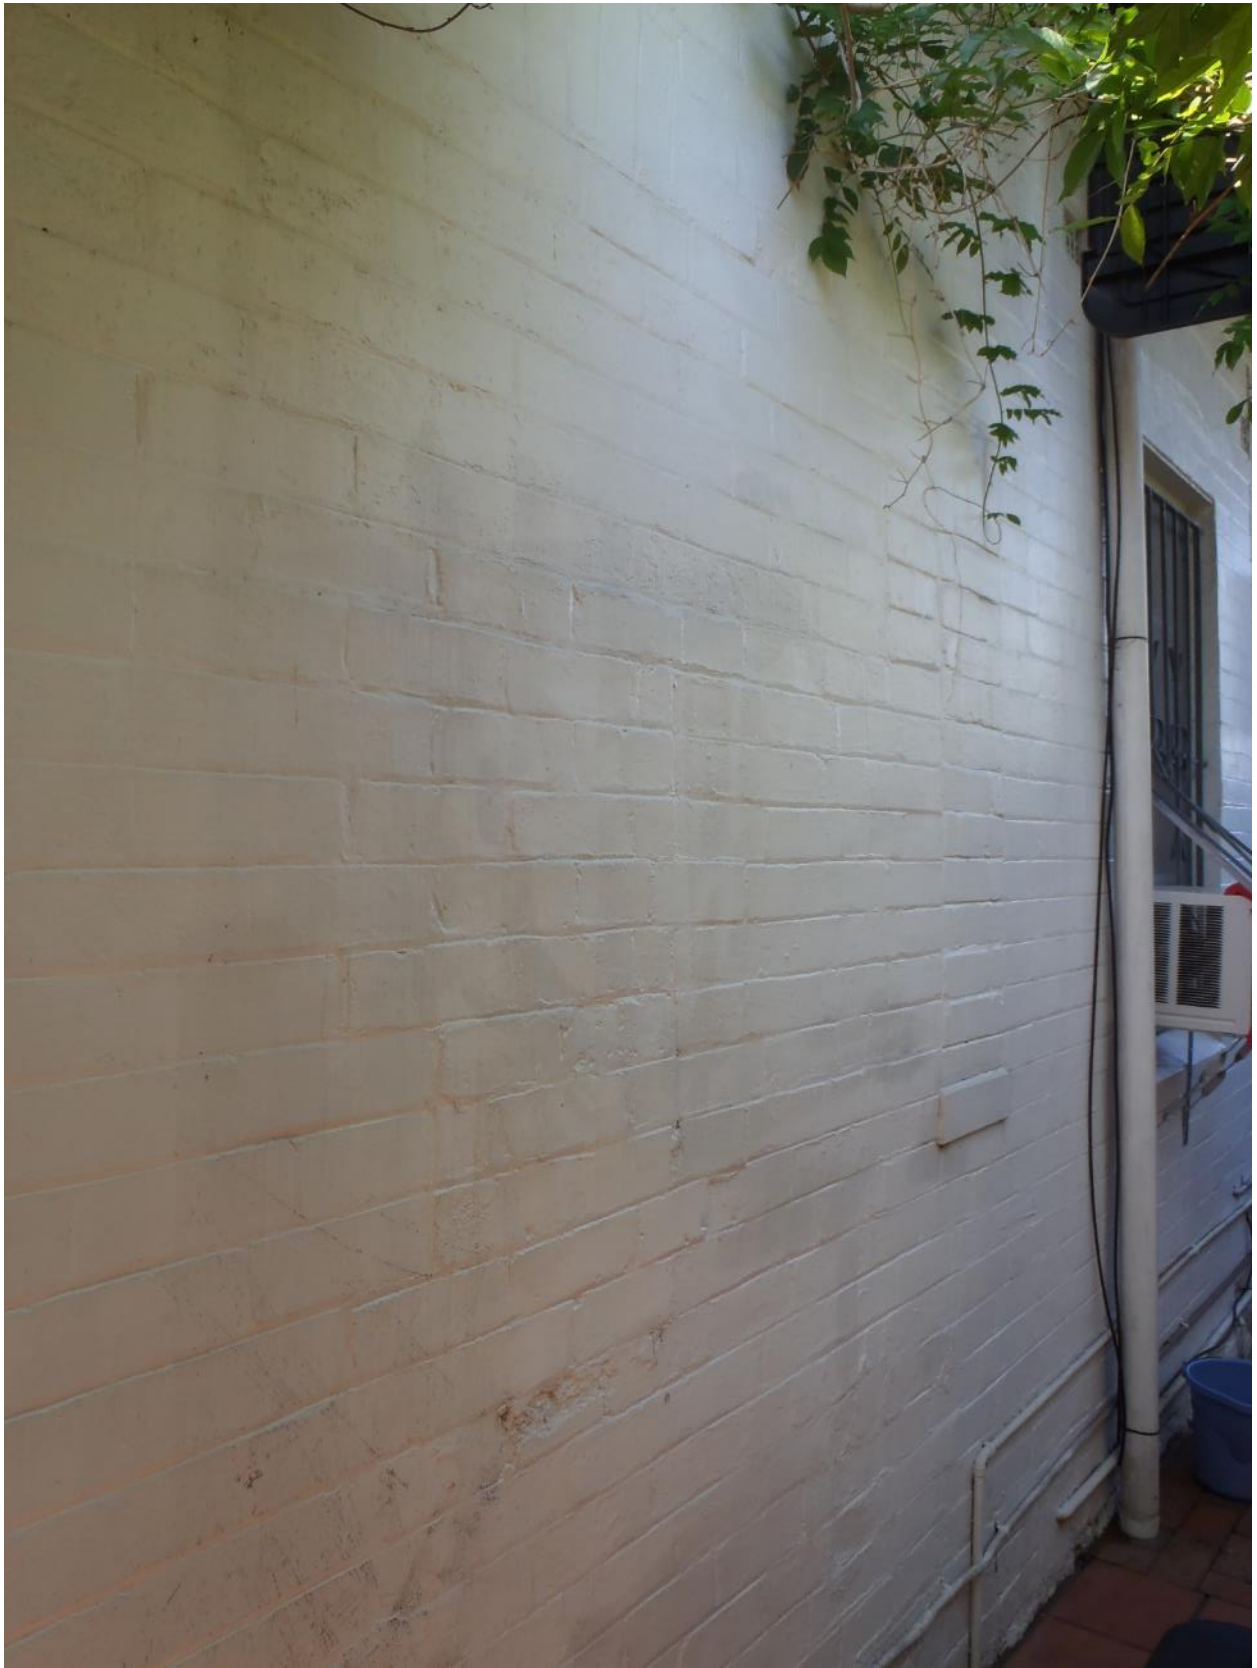
We noted evidence of previous repairs to the surface coated clay masonry brickwork to the rear south-western corner. **[Photograph 12]**

Photograph 12 shows evidence of previous repairs to the surface coated clay masonry brickwork to the rear south-western corner.

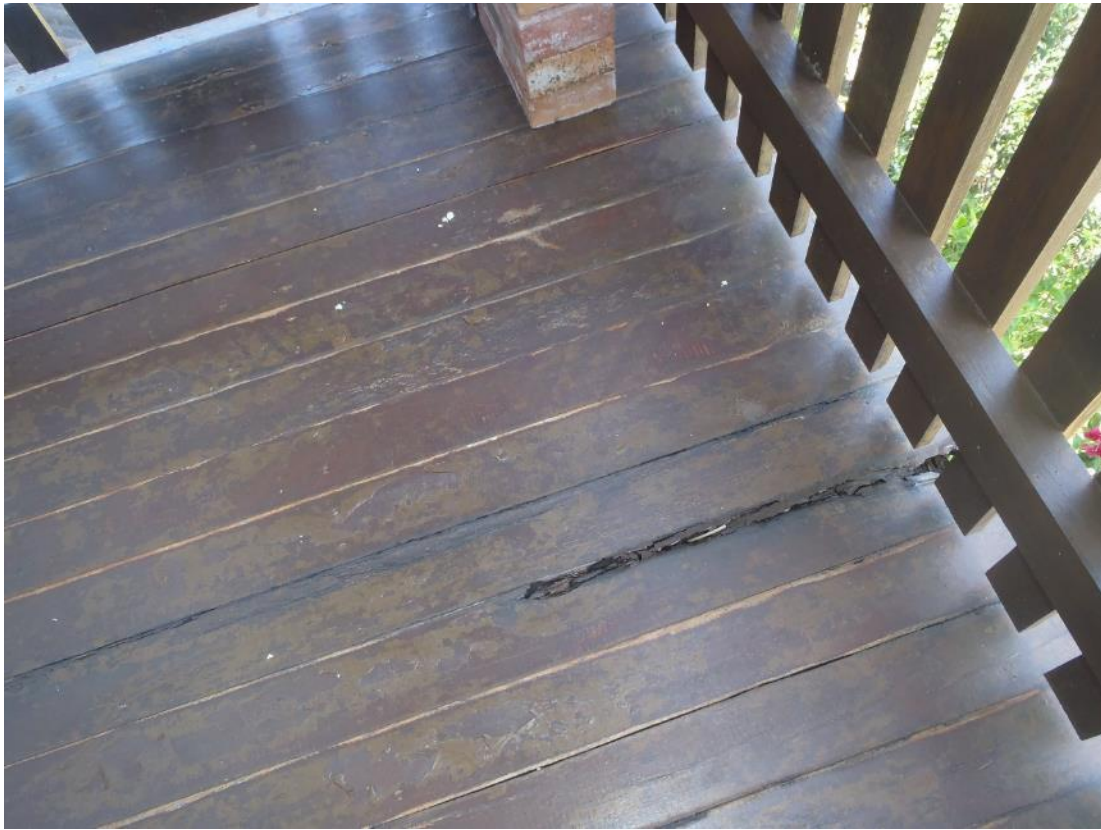
We noted rotted timber to the balcony deck in the south-eastern corner. **[Photograph 13]**

Photograph 13 shows rotted timber to the balcony deck in the south-eastern corner.

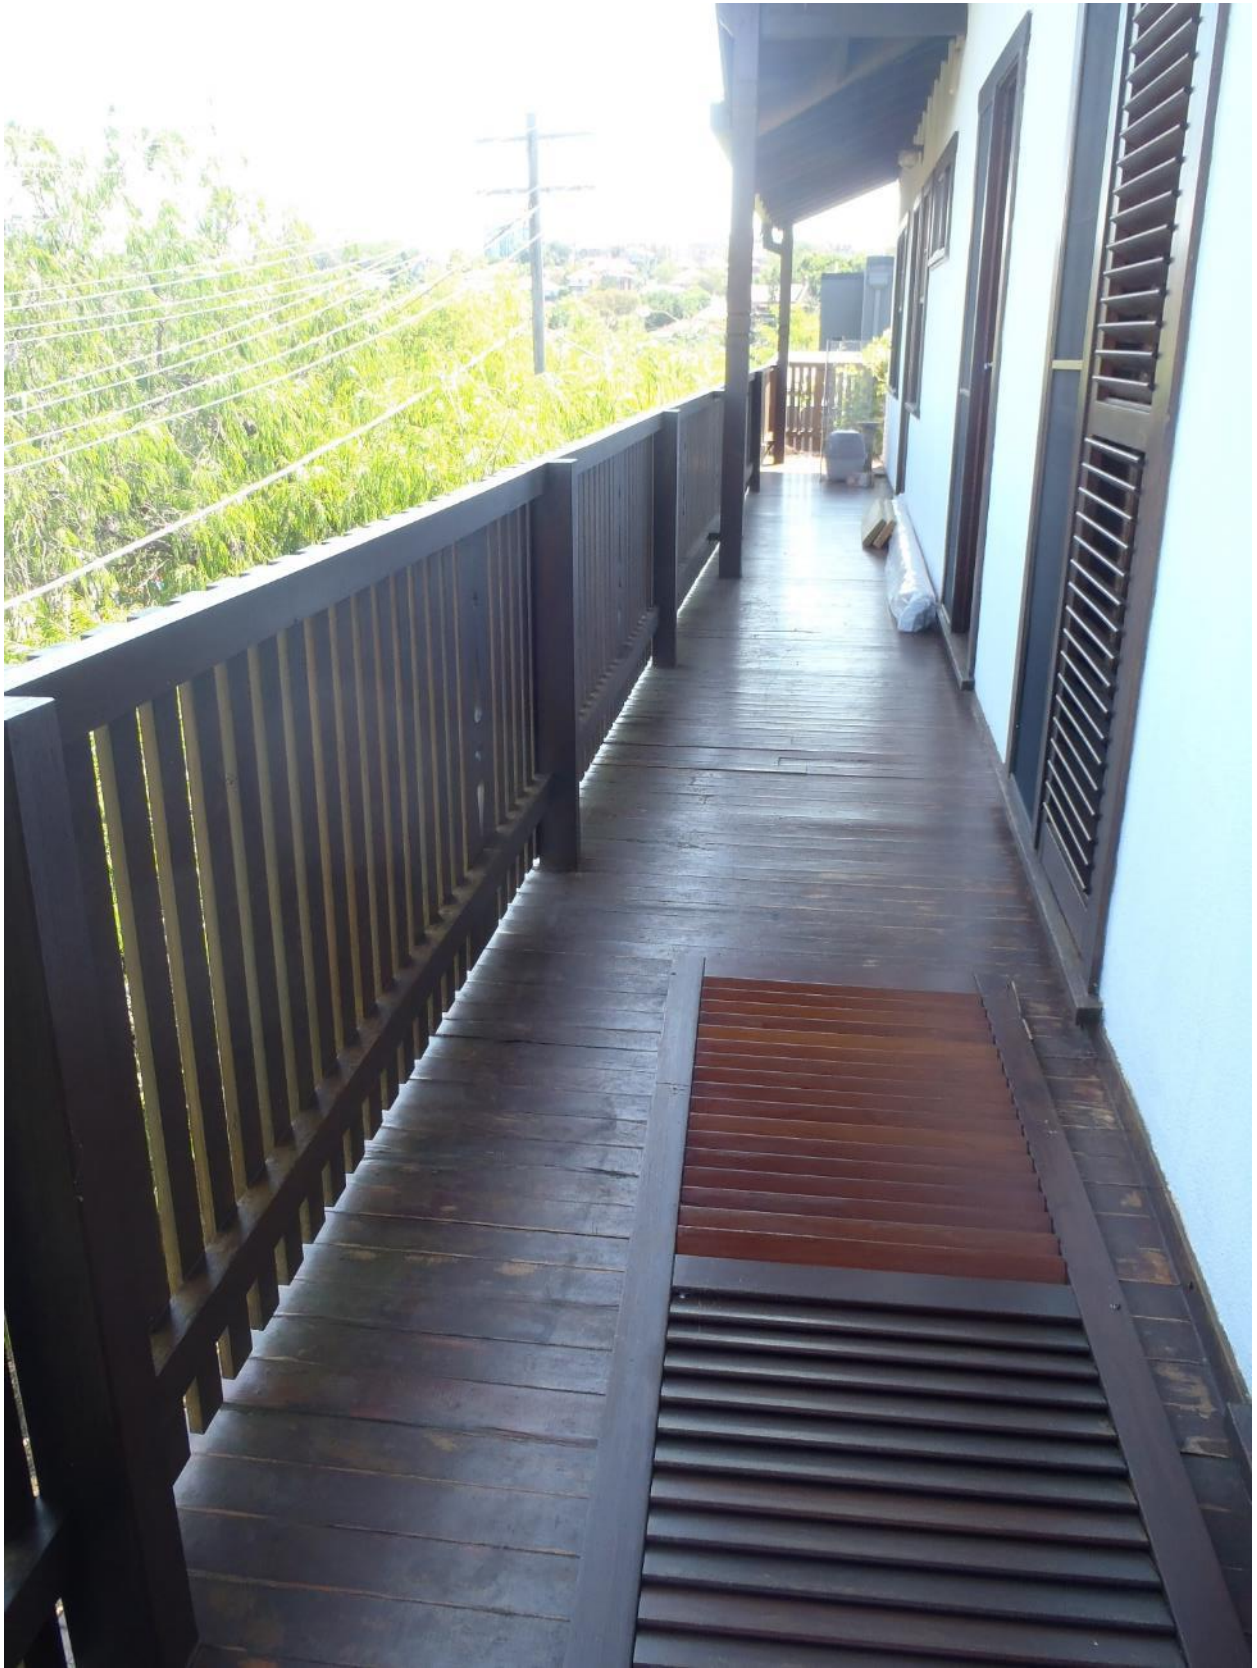
We noted a displaced louvre window cover from the door outside Bedroom 2. **[Photograph 14]**

We did not observe any recent cracking to the upper floor surface coated clay masonry brickwork. **[Photograph 14]**

Photograph 14 shows the general condition of the side balcony and the displaced louvre window cover from the door outside Bedroom 2.

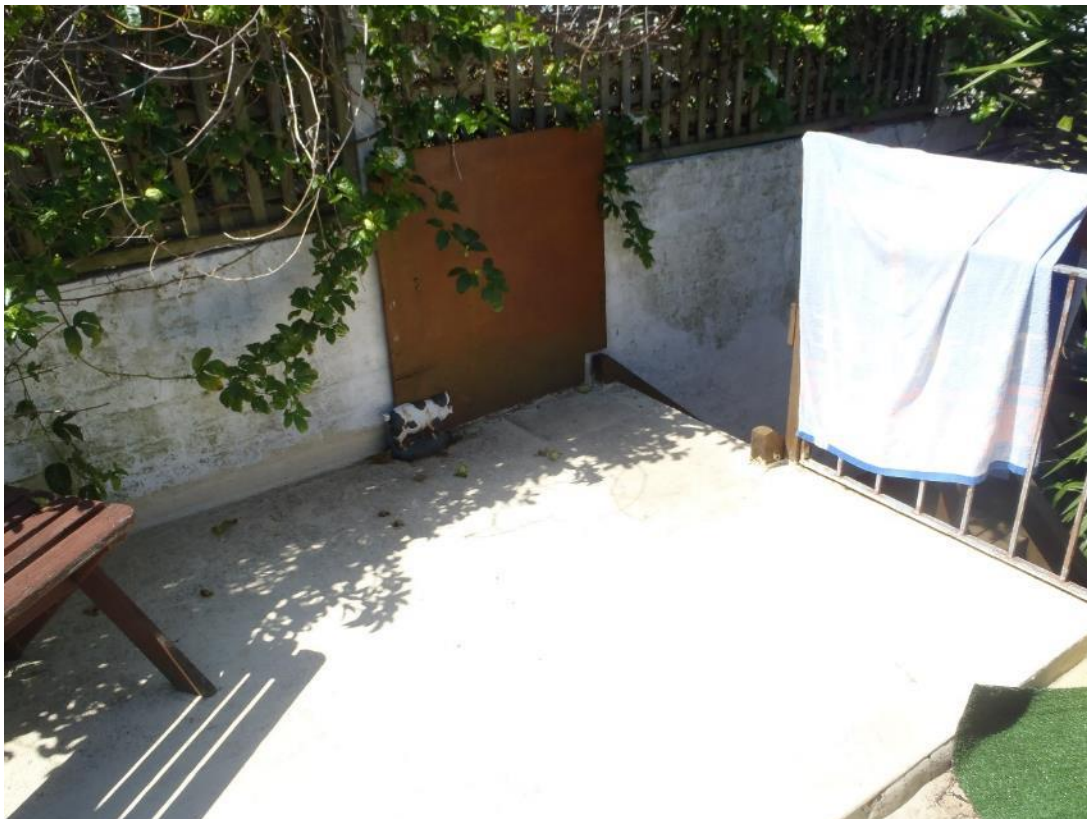
We noted the *common* boundary wall with the adjoining property, No. 4 Raleigh Street had lichen/moss and vegetation growth. **[Photograph 15]**

Photograph 15 shows the *common* boundary wall with the adjoining property, No. 4 Raleigh Street had lichen/moss and vegetation growth.

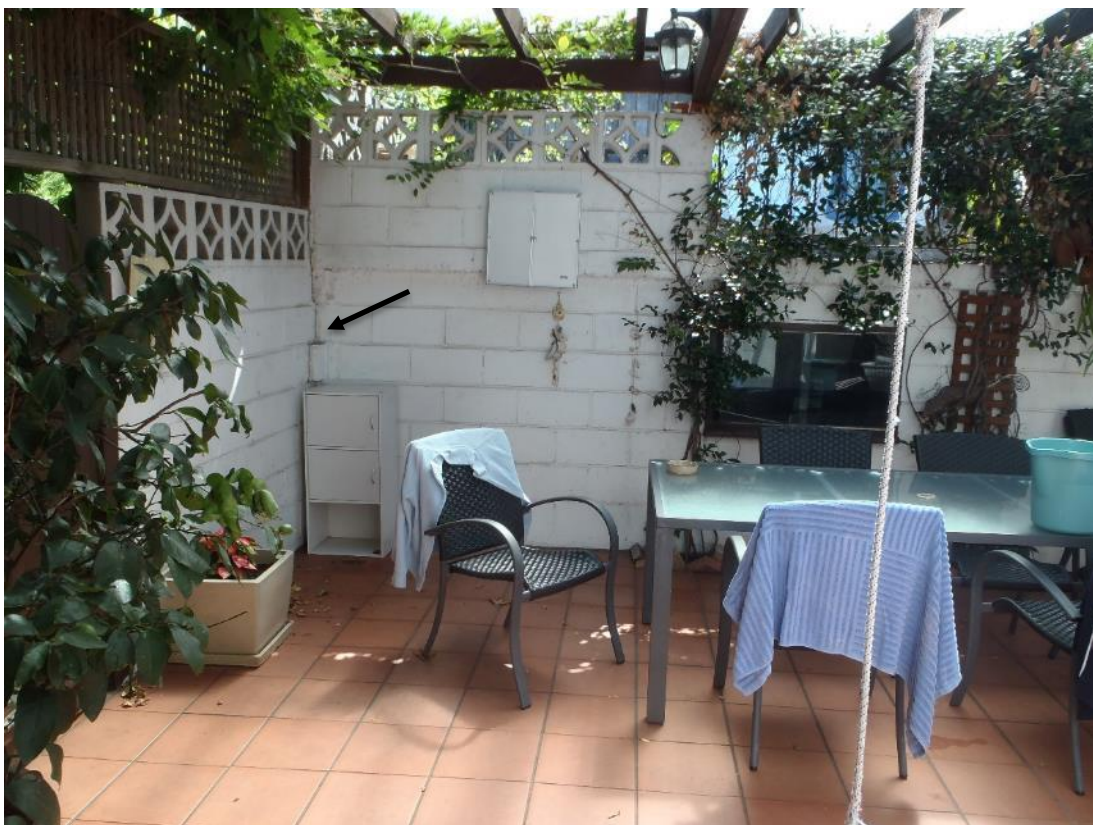
We noted a tiled timber pergola section to the rear elevation. We did not observe any recent cracking to the tiled floor surface under the pergola. **[Photograph 16]**

We noted separation cracking to the garage/boundary wall in the south-western corner. **[Photograph 16]**

Photograph 16 shows separation cracking to the garage/boundary wall in the south-western corner.

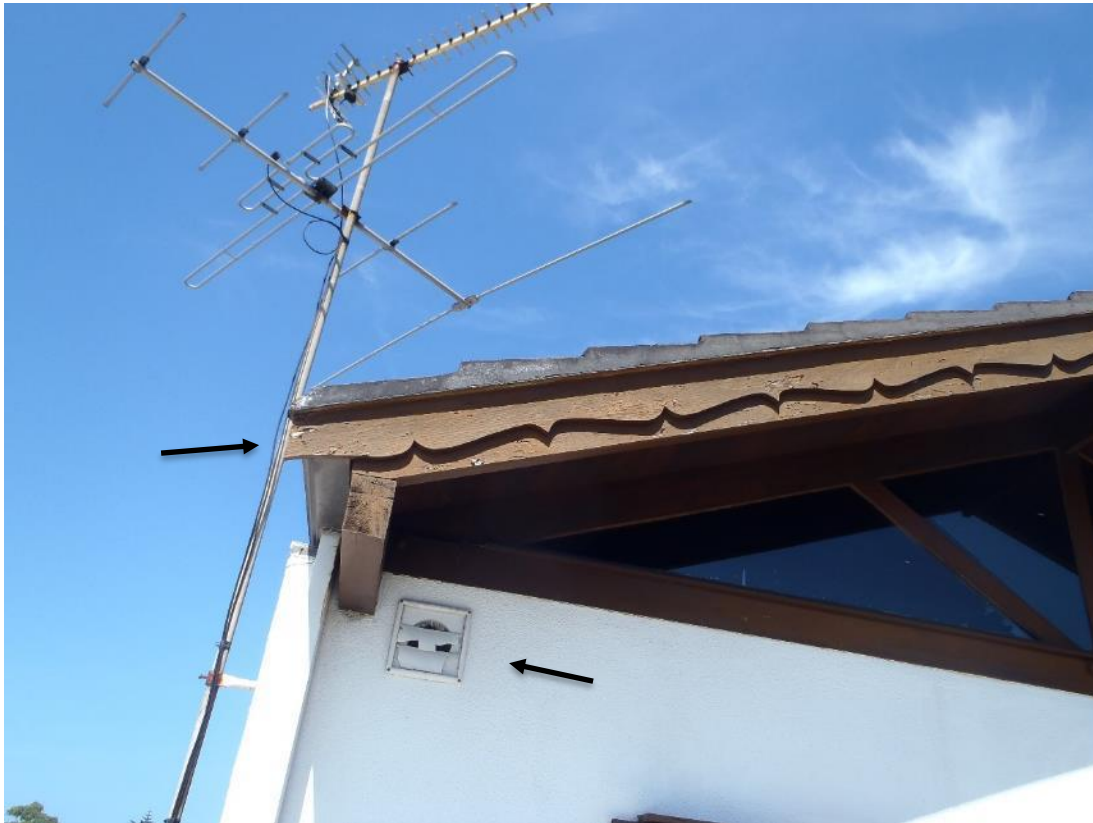
We noted that there is flaking paint to the gable barge boards and a broken vent to the external wall above the balcony. **[Photograph 17]**

Photograph 17 shows flaking paint to the gable barge boards and a broken vent to the external wall above the balcony.
