Dilapidation Assessment Report

Prepared for: Cape Cod Australia Pty. Limited
Job address: 2 Raleigh Street, Coogee.
Property Owner/s: Mr James Thompson.
Report reference: **RANDWICK CITY COUNCIL**
Development Application No: not available
Date of assessment: 15th February 2017

Re: Dilapidation Report – No. 2 Raleigh Street, Coogee.

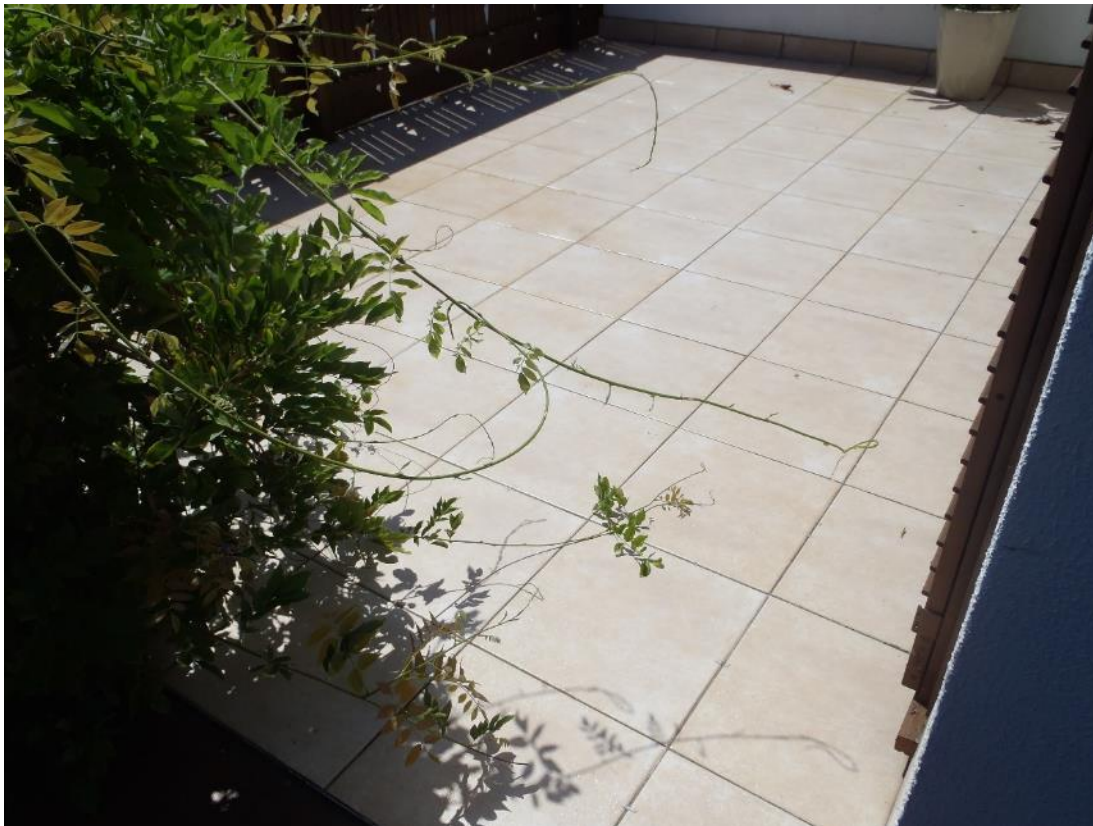
We noted that the rear section of the balcony was finished with tiles. We did not observe any recent cracking to the floor tiles. We noted that the grout to the floor tiles is complete and that the tiles when randomly “tap” tested appeared to be sound. **[Photograph 18]**

Photograph 18 shows the general condition of the rear balcony.

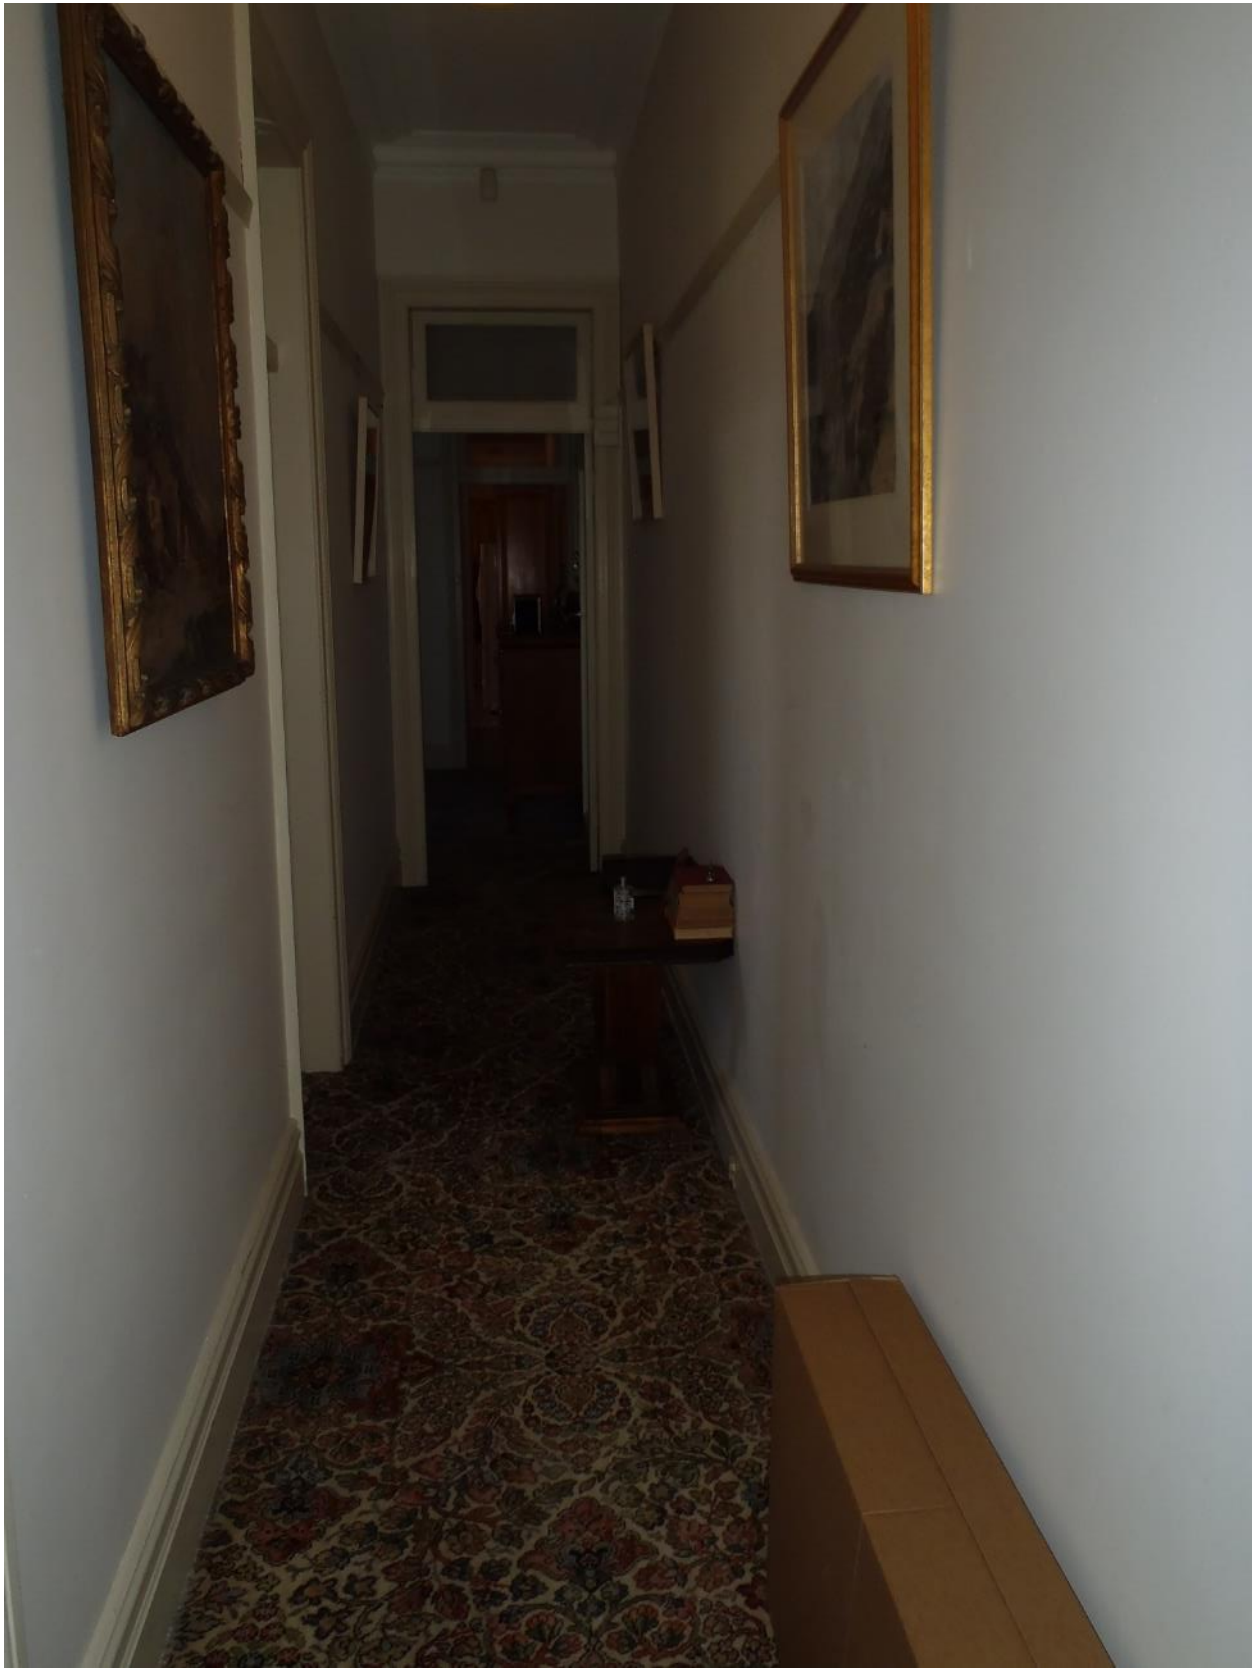
We observed that the hallway is a timber lined floor and the northern wall is the *common party / separation* wall with the adjoining property, No. 4 Raleigh Street. **[Photograph 19]**

Photograph 19 shows the general condition of the hallway.

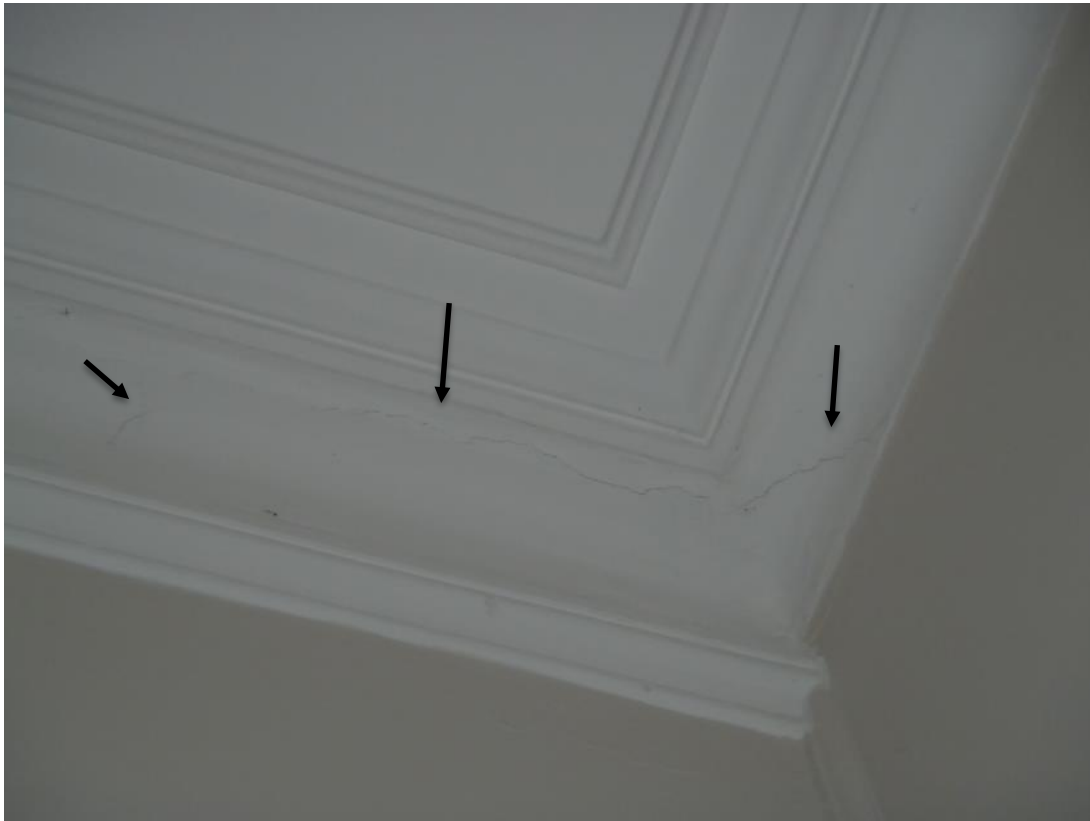
We observed hairline radial cracking [<1.0 mm] to the wide profiled plaster cornice in the north-eastern corner above the entry doorway, adjacent to the *common party / separation* wall with the adjoining property, No. 4 Raleigh Street. **[Photograph 20]**

Photograph 20 shows hairline radial cracking to the cornice in the north-eastern corner above the entry doorway.

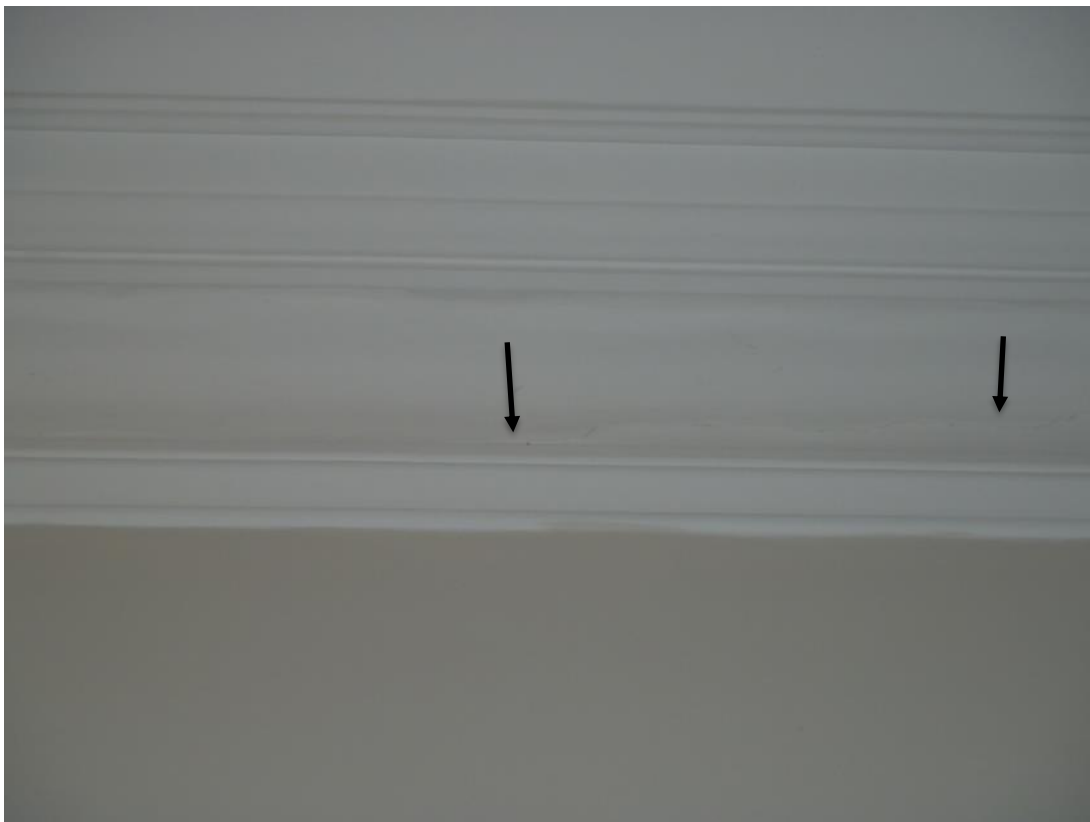
We observed hairline horizontal cracking [<1.0 mm] to the wide profiled plaster cornice along the northern wall, *common party / separation* wall with the adjoining property, No. 4 Raleigh Street. **[Photograph 21]**

Photograph 21 shows hairline horizontal cracking to the cornice along the northern wall in the Hallway.

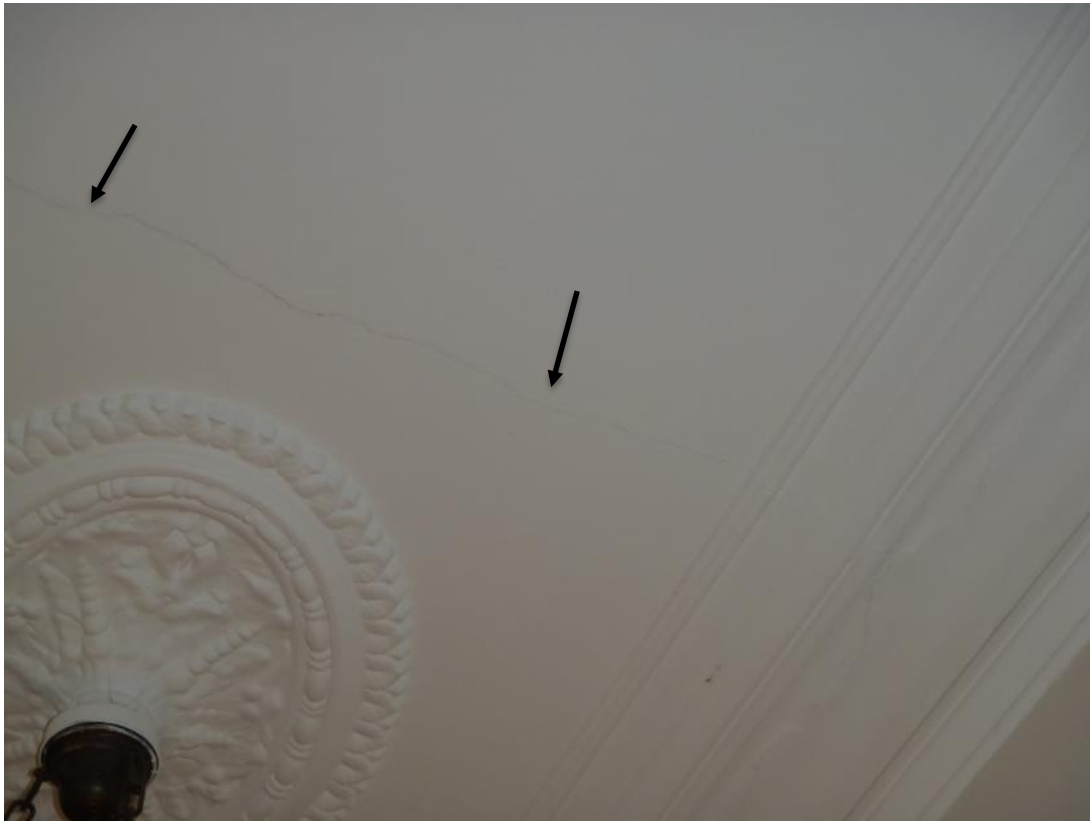
We observed hairline radial cracking [<1.0 mm] to the fibrous plaster ceiling on the eastern side of the decorative ceiling rose. **[Photograph 22]**

Photograph 22 shows hairline radial cracking to the fibrous plaster ceiling on the eastern side of the decorative ceiling rose in the Hallway.

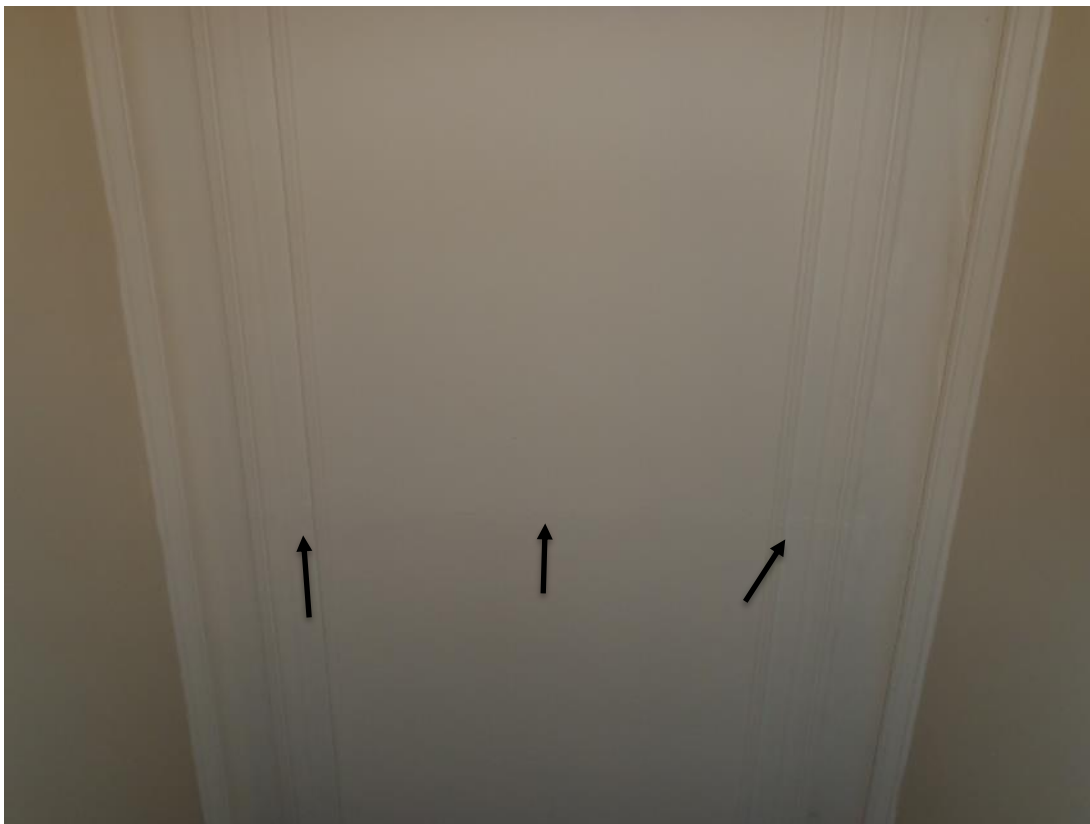
We observed hairline radial cracking [<1.0 mm] to the fibrous plaster ceiling on the western side of the decorative ceiling rose. **[Photograph 23]**

Photograph 23 shows hairline radial cracking to the fibrous plaster ceiling on the western side of the decorative ceiling rose in the Hallway.

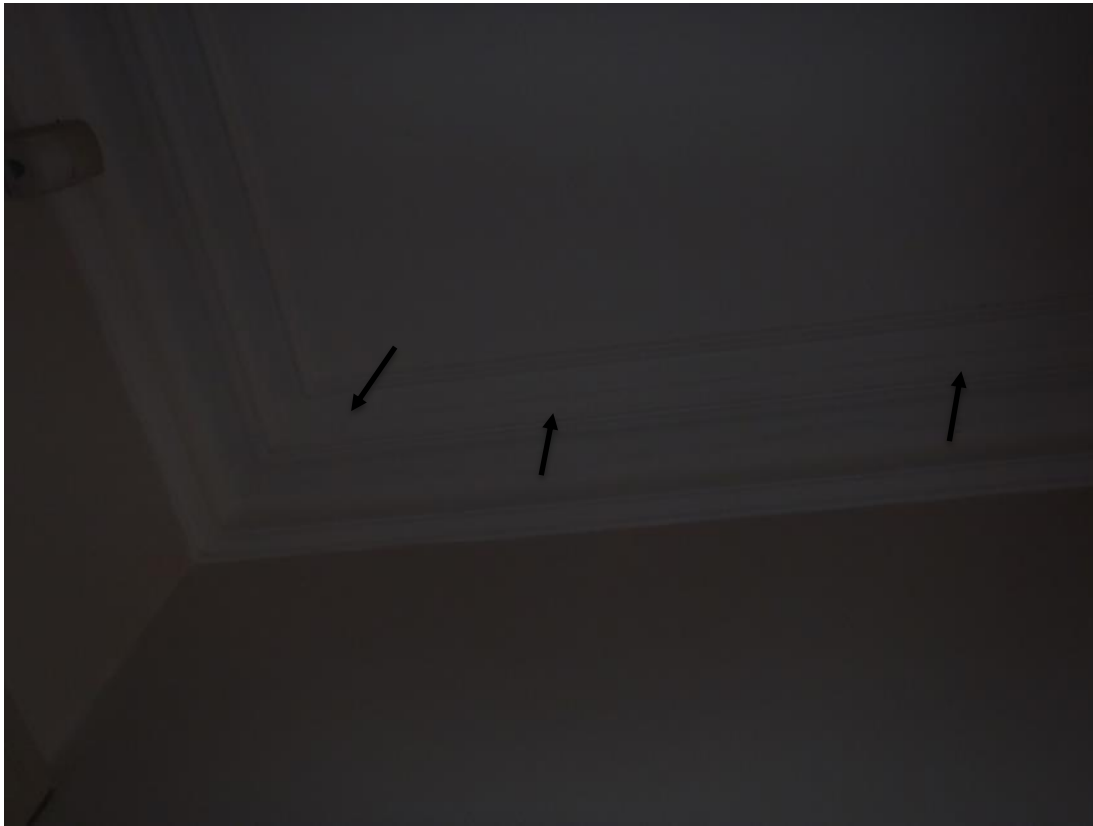
We observed hairline radial cracking [<1.0 mm] to the fibrous plaster ceiling and the wide profiled plaster cornice along the northern wall, *common party / separation* wall with the adjoining property, No. 4 Raleigh Street in the western end. **[Photograph 24]**

Photograph 24 shows hairline radial cracking to the fibrous plaster ceiling and the cornice along the northern wall in the western end in the Hallway.

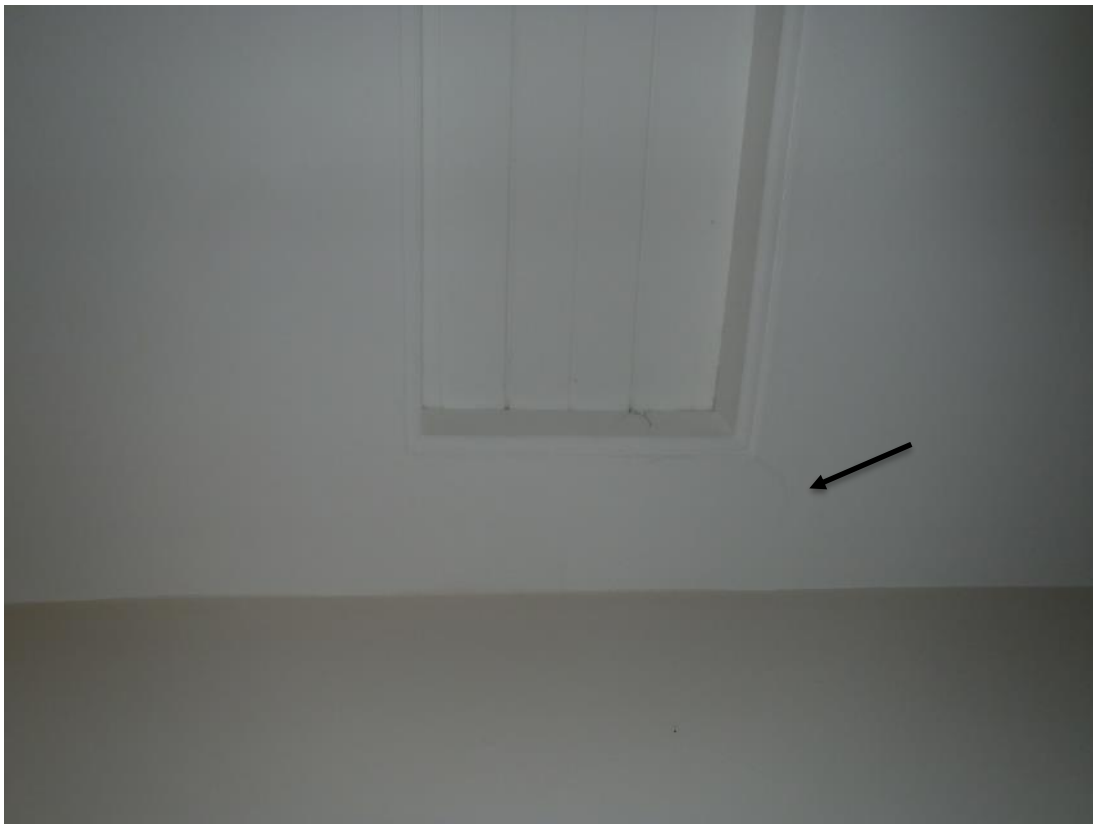
We observed hairline radial cracking [<1.0 mm] to the plaster ceiling lining extending from the corners of the roof access opening adjacent to the *common party / separation* wall with the adjoining property, No. 4 Raleigh Street in the western end. **[Photograph 25]**

Photograph 25 shows hairline radial cracking to the plaster ceiling lining extending from the corners of the roof access opening.

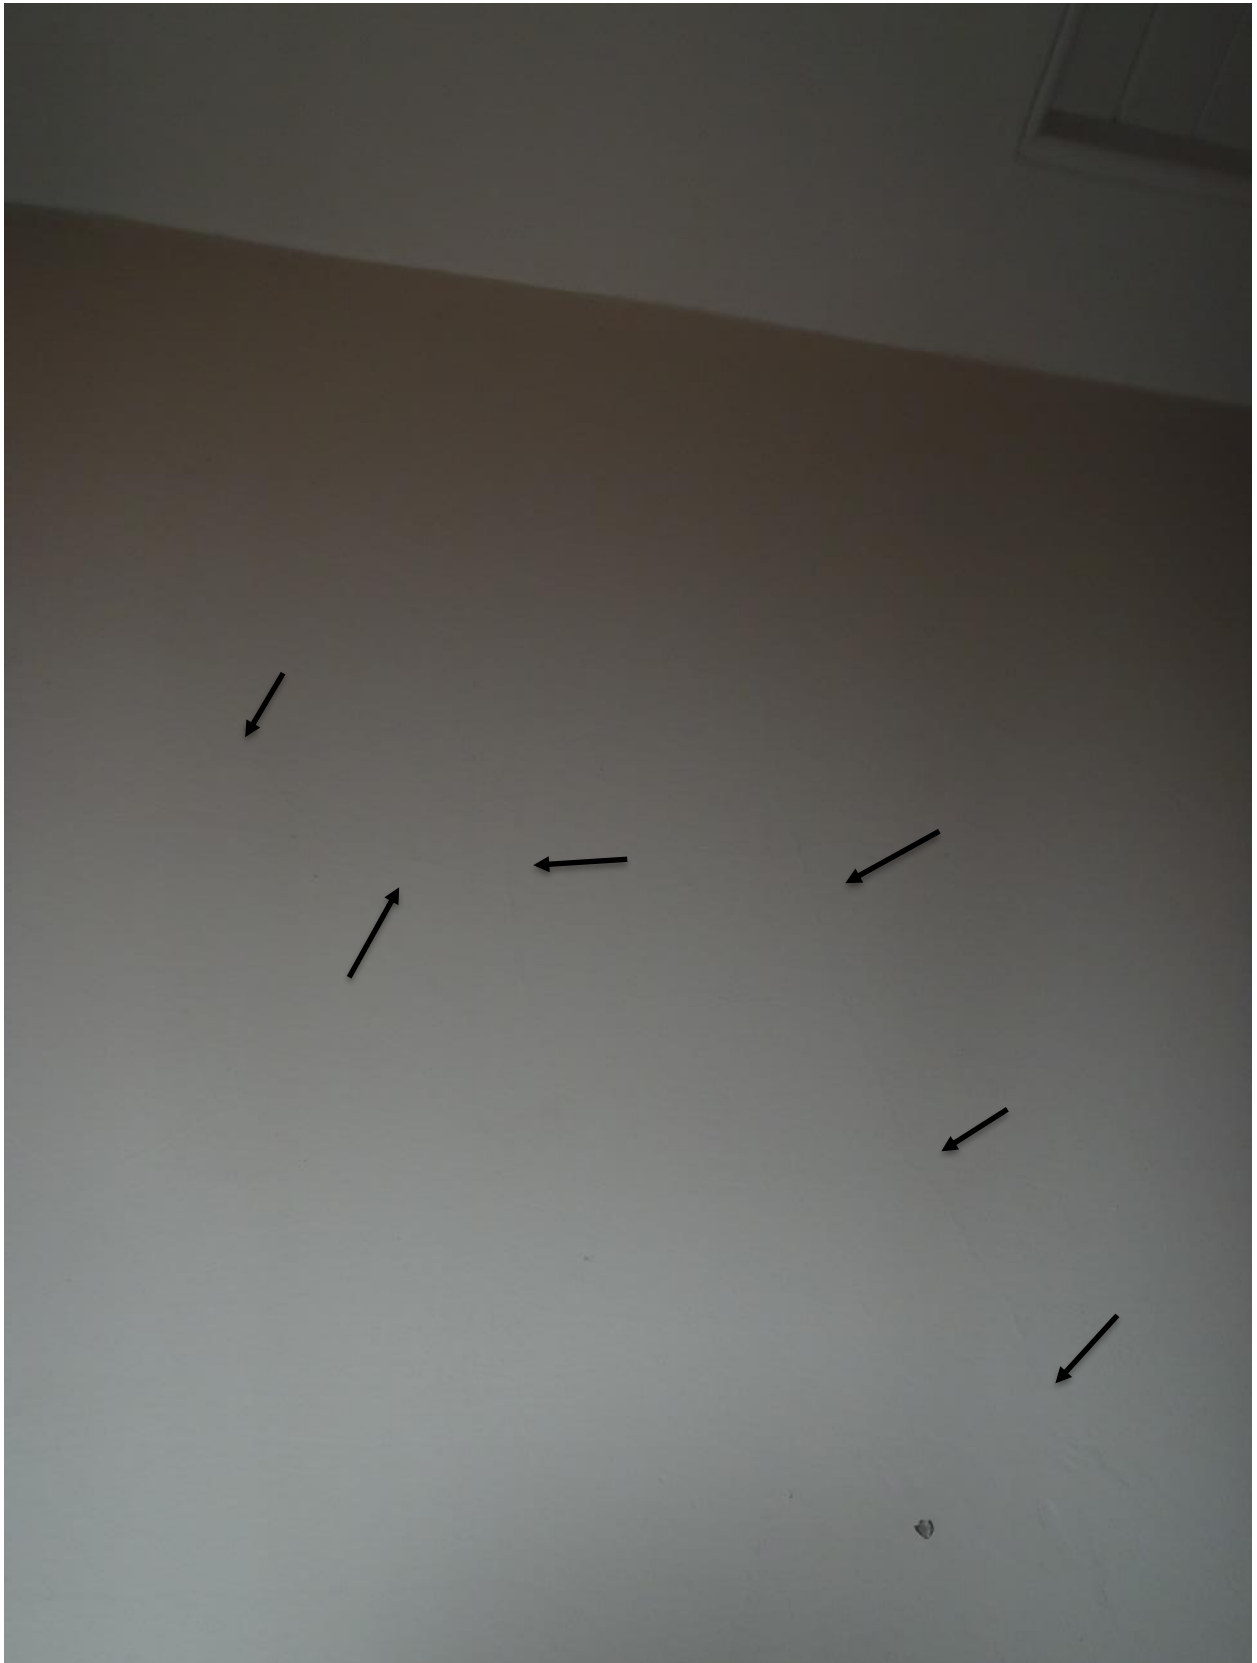
We noted hairline radial cracking [<1.0 mm] to the northern wall, *common party / separation* wall with the adjoining property, No. 4 Raleigh Street outside the Bathroom. **[Photograph 26]**

Photograph 26 shows hairline radial cracking to the northern wall, *common party / separation wall* with the adjoining property, No. 4 Raleigh Street outside the Bathroom.

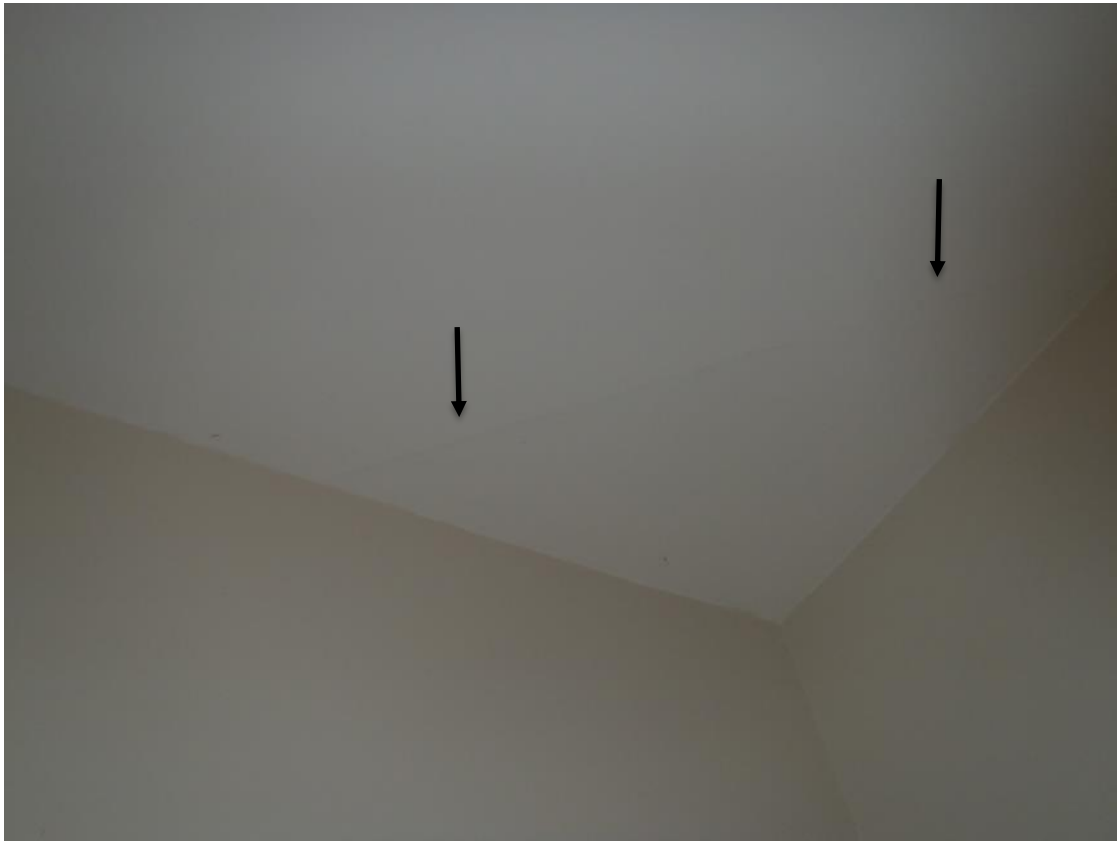
We noted hairline separation cracking [<1.0 mm] to the plaster ceiling in the south-eastern corner where the original fireplace was removed. **[Photograph 27]**

Photograph 27 shows hairline separation cracking to the plaster ceiling in the south-eastern corner.

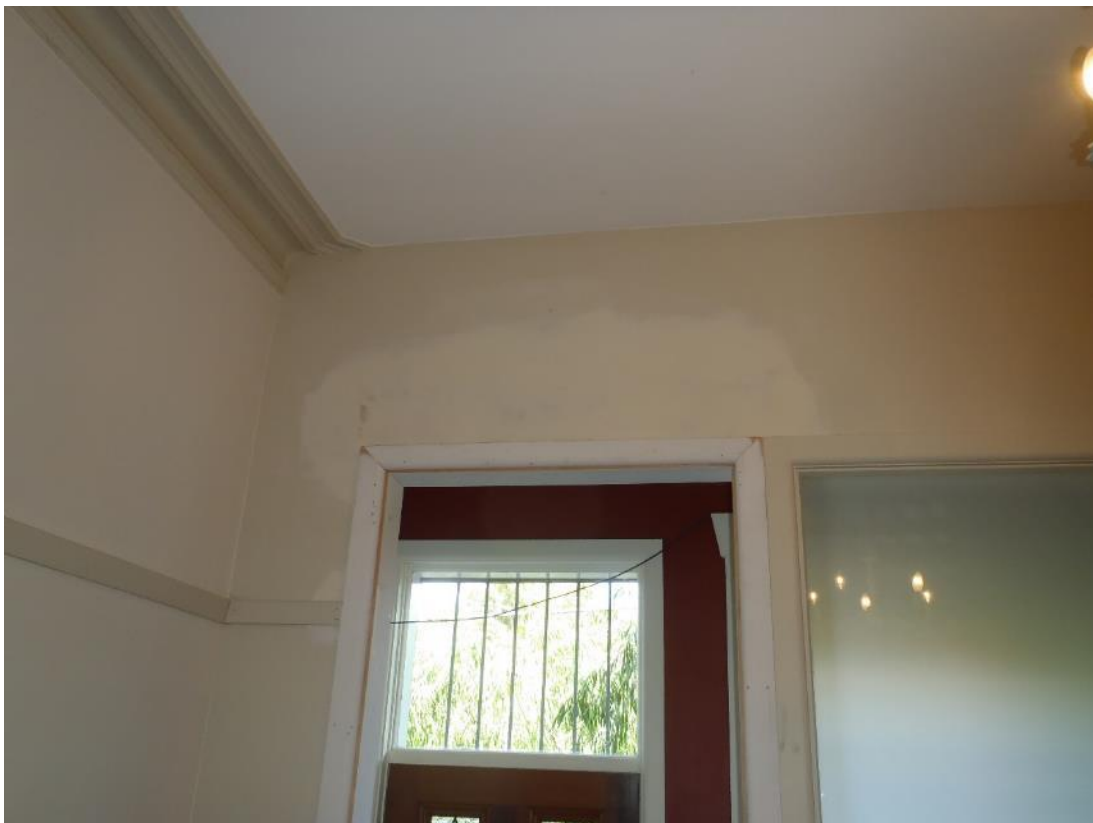
We noted an unfinished doorway opening to the stairwell access on the southern wall. **[Photograph 28]**

Photograph 28 shows the unfinished doorway opening to the stairwell access on the southern wall in the Lounge Room.

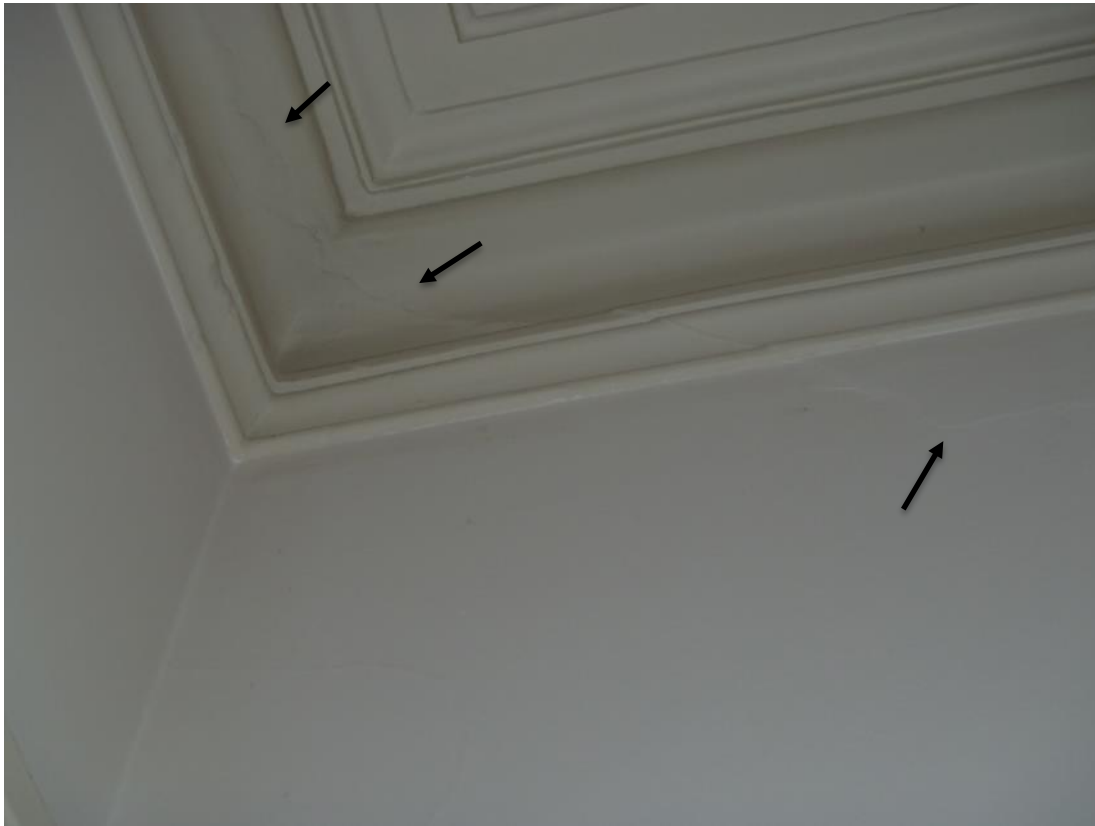
We observed hairline radial cracking [<1.0 mm] to the wide profiled plaster cornice which extends down the wall surface in the north-western corner adjacent to the *common party / separation* wall with the adjoining property, No. 4 Raleigh Street. **[Photograph 29]**

Photograph 29 shows hairline radial cracking to the plaster cornice which extends down the wall surface in the north-western corner of the Lounge Room.

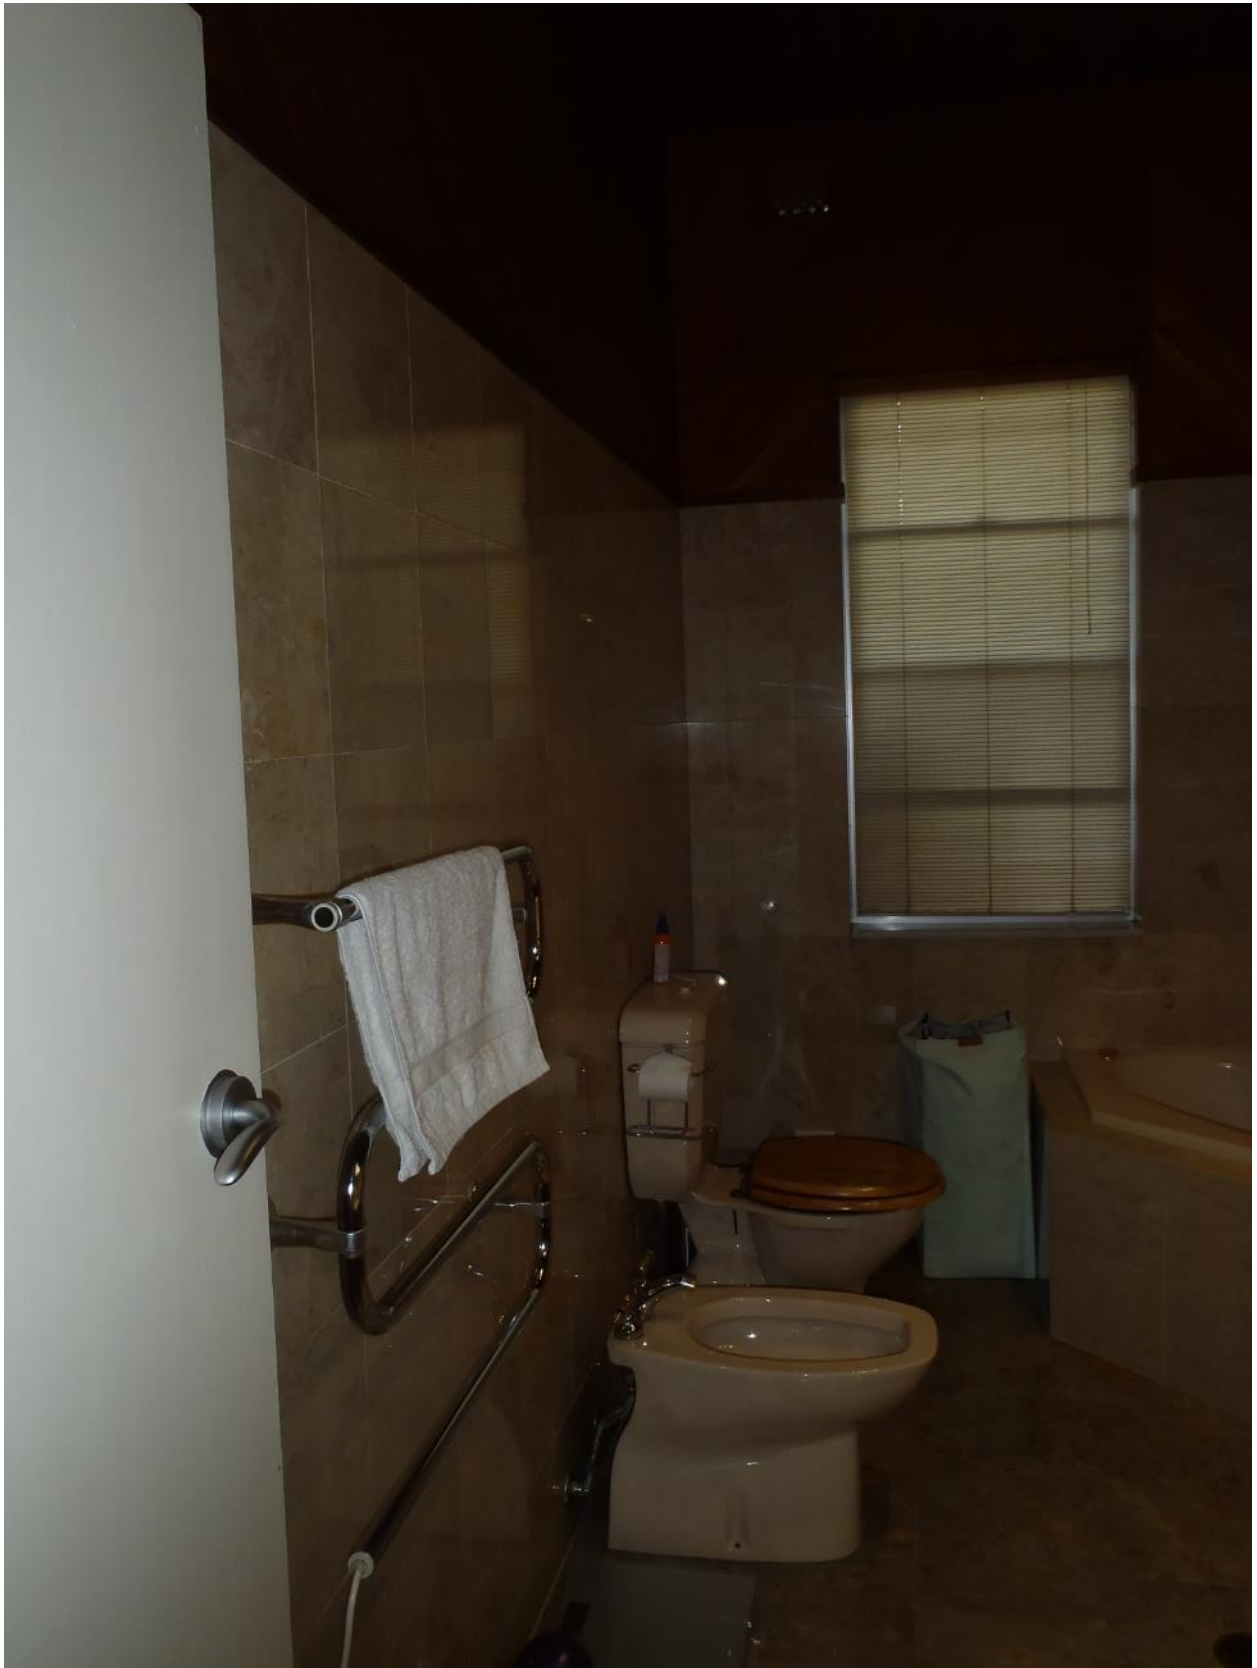
We noted that the grout to the wall and floor tiles is complete and that the wall and floor tiles when randomly “tap” tested appeared to be sound. We did not observe any recent cracking to the tile grout at the wall / wall, wall / floor junctions. **[Photograph 30]**

Photograph 30 shows the general condition of the ground floor Bathroom.

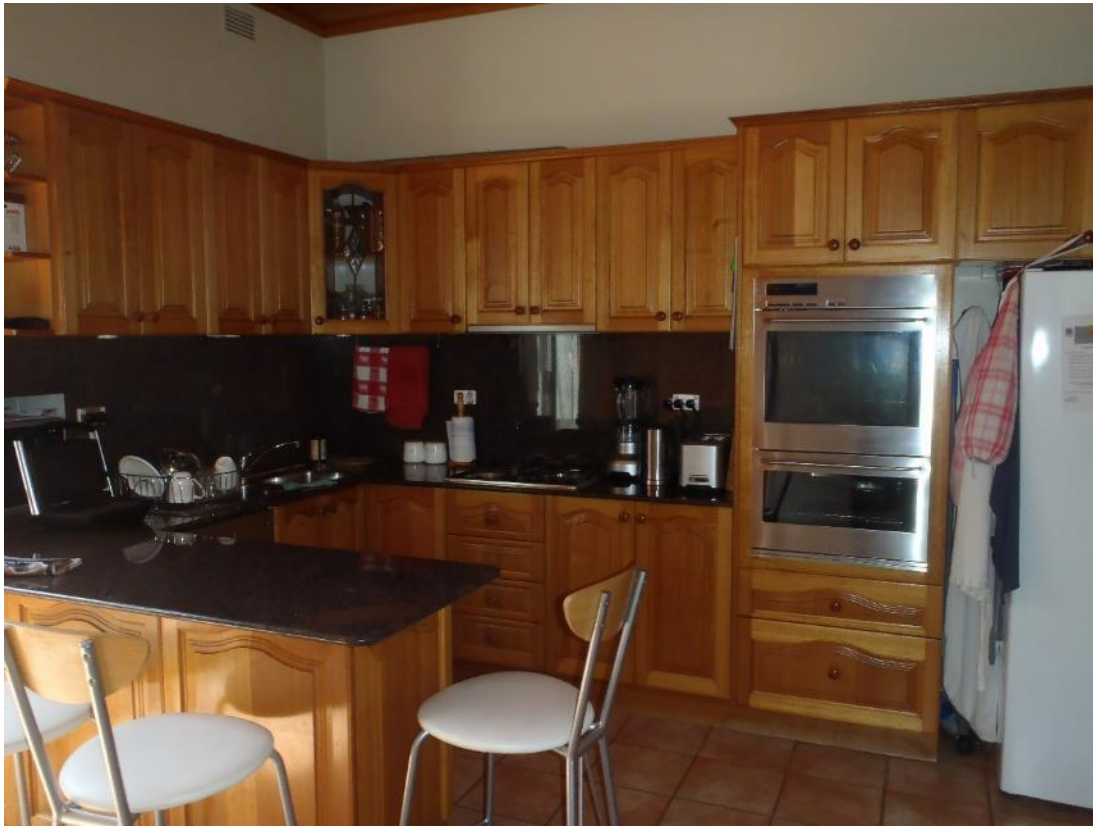
We observed that the floor is finished with ceramic tiles. We noted that the grout to the tiles is complete and that the tiles when randomly “tap” tested appeared to be sound. **[Photograph 31]**

Photograph 31 shows the general condition of the Kitchen.

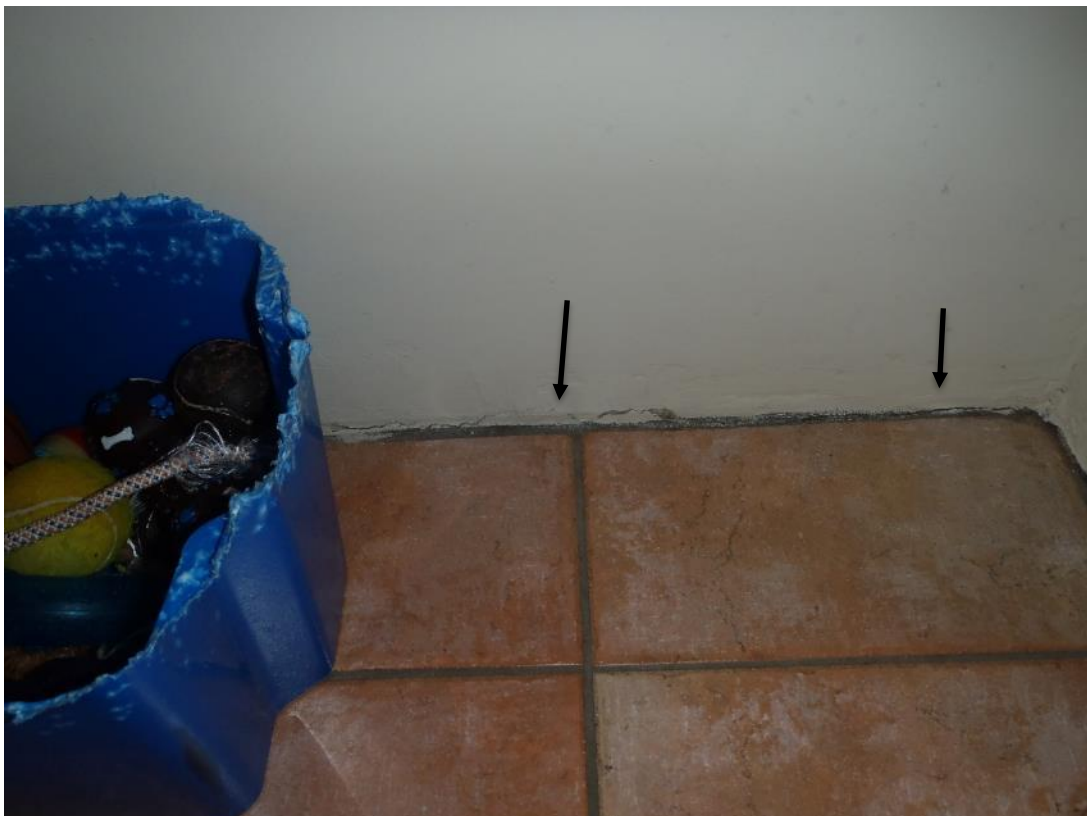
We observed separation cracking between the tiled floor and the *common party / separation* wall with the adjoining property, No. 4 Raleigh Street. **[Photograph 32]**

Photograph 32 shows separation cracking between the tiled floor and the *common party / separation* wall with the adjoining property, No. 4 Raleigh Street in the Dining Room.

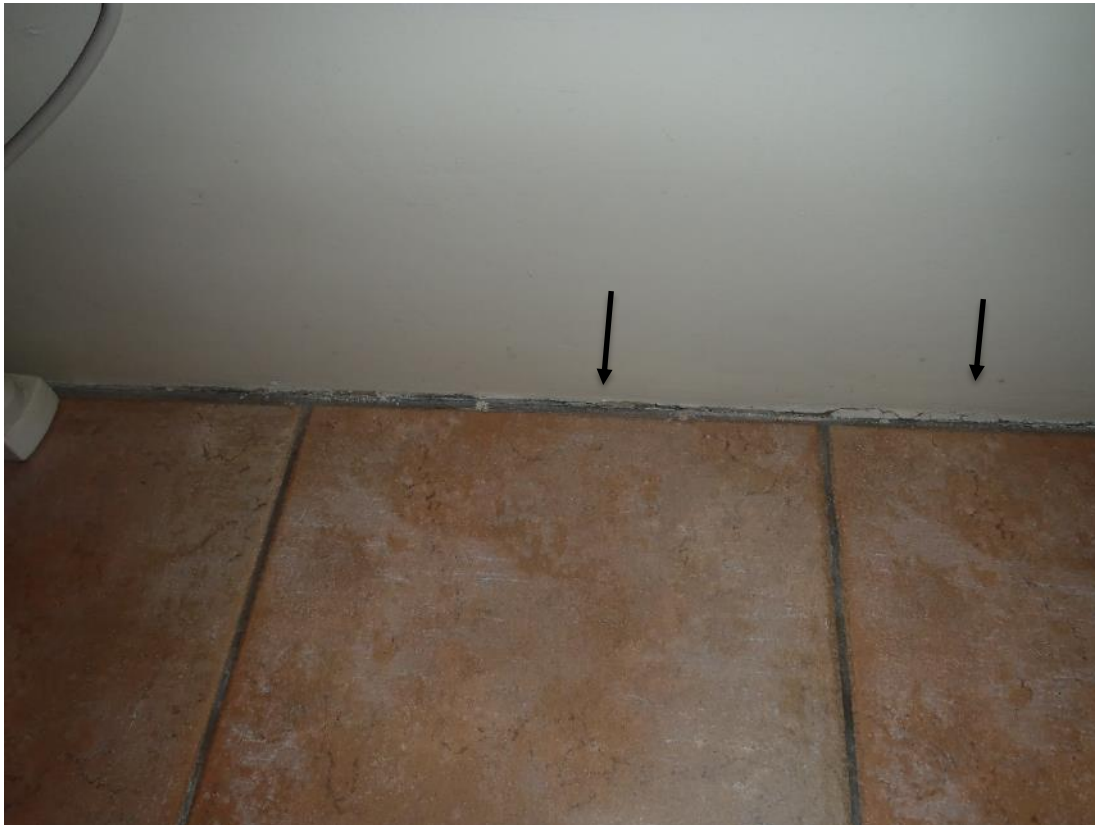
We observed separation cracking between the tiled floor and the external rendered wall under the window. **[Photograph 33]**

Photograph 33 shows separation cracking between the tiled floor and the external rendered wall under the window in the Dining Room.

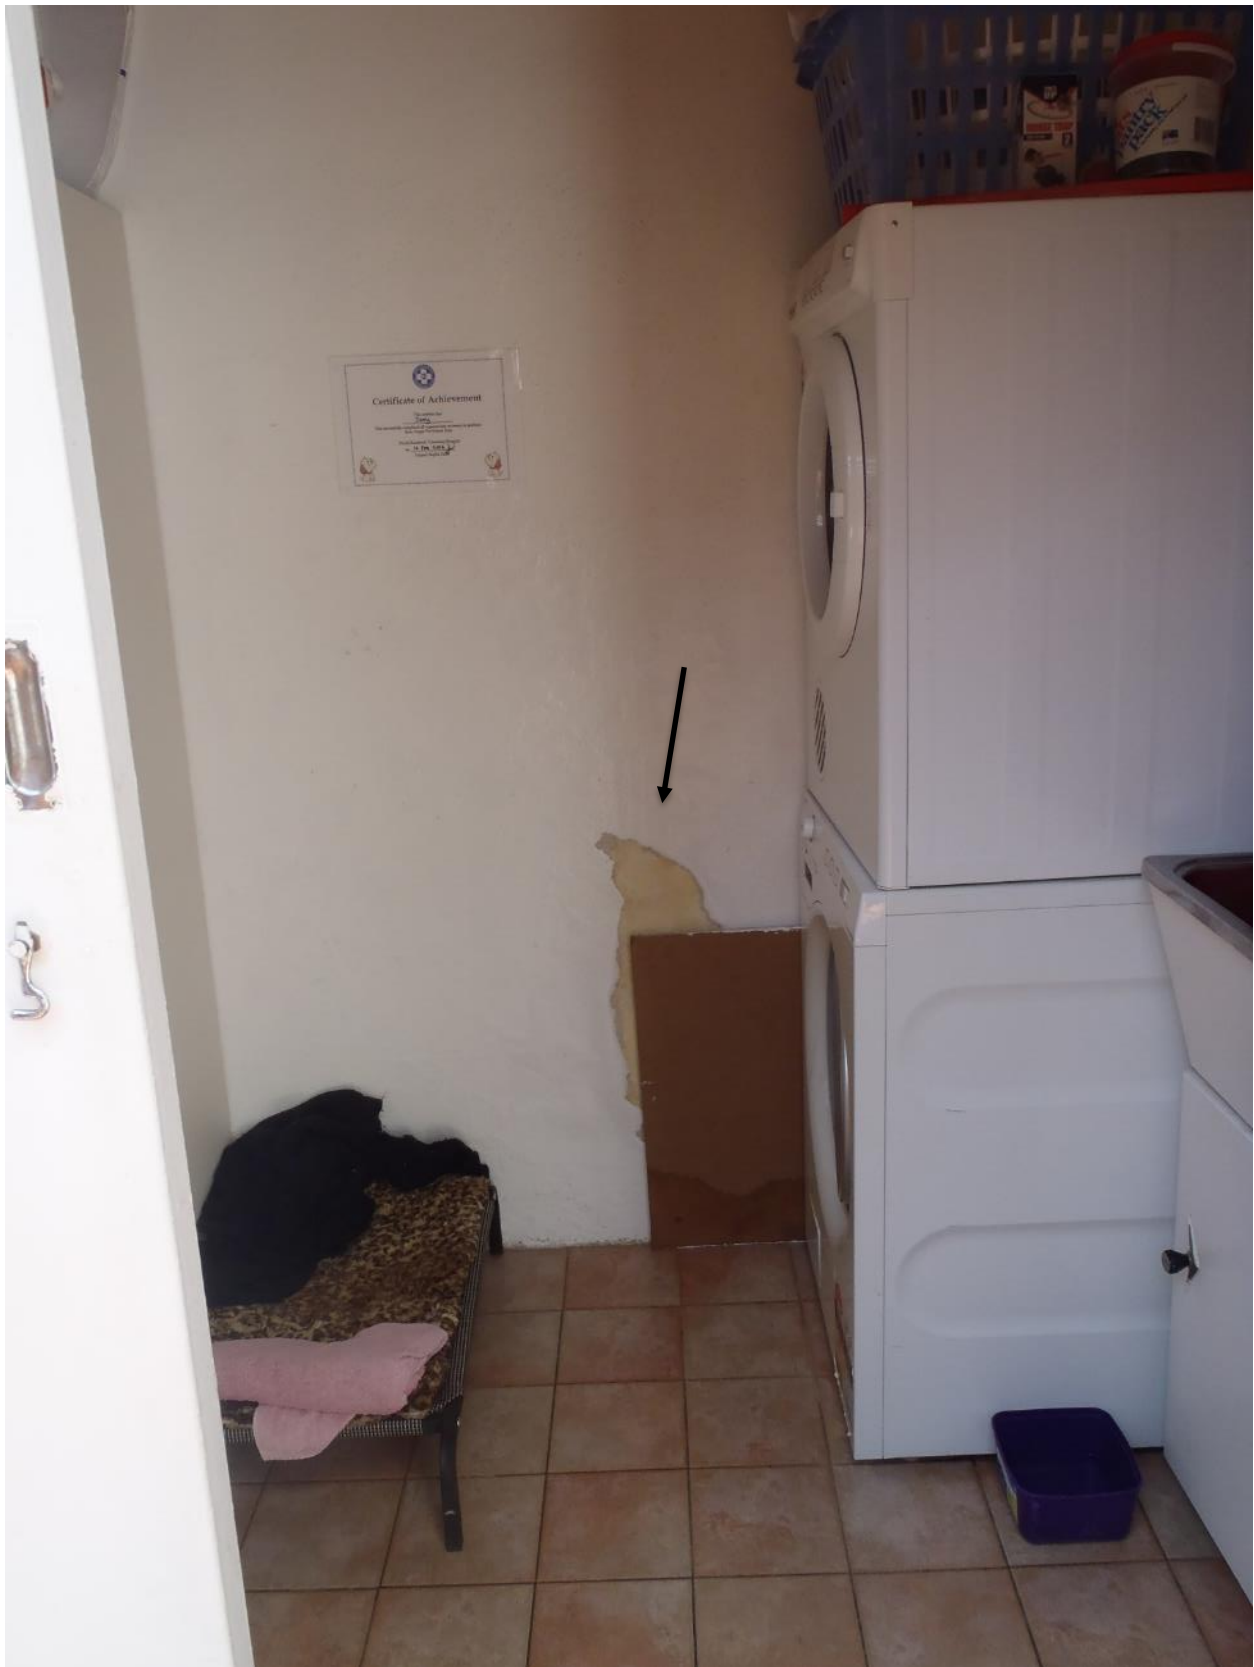
We noted flaking render to the *common party / separation* wall with the adjoining property, No. 4 Raleigh Street. **[Photograph 34]**

Photograph 34 shows flaking render to the *common party / separation* wall with the adjoining property, No. 4 Raleigh Street in the Laundry.
