Dilapidation Assessment Report

Prepared for: Cape Cod Australia Pty. Limited
Job address: 2 Raleigh Street, Coogee.
Property Owner/s: Mr James Thompson.
Report reference: **RANDWICK CITY COUNCIL**
Development Application No: not available
Date of assessment: 15th February 2017

Re: Dilapidation Report – No. 2 Raleigh Street, Coogee.

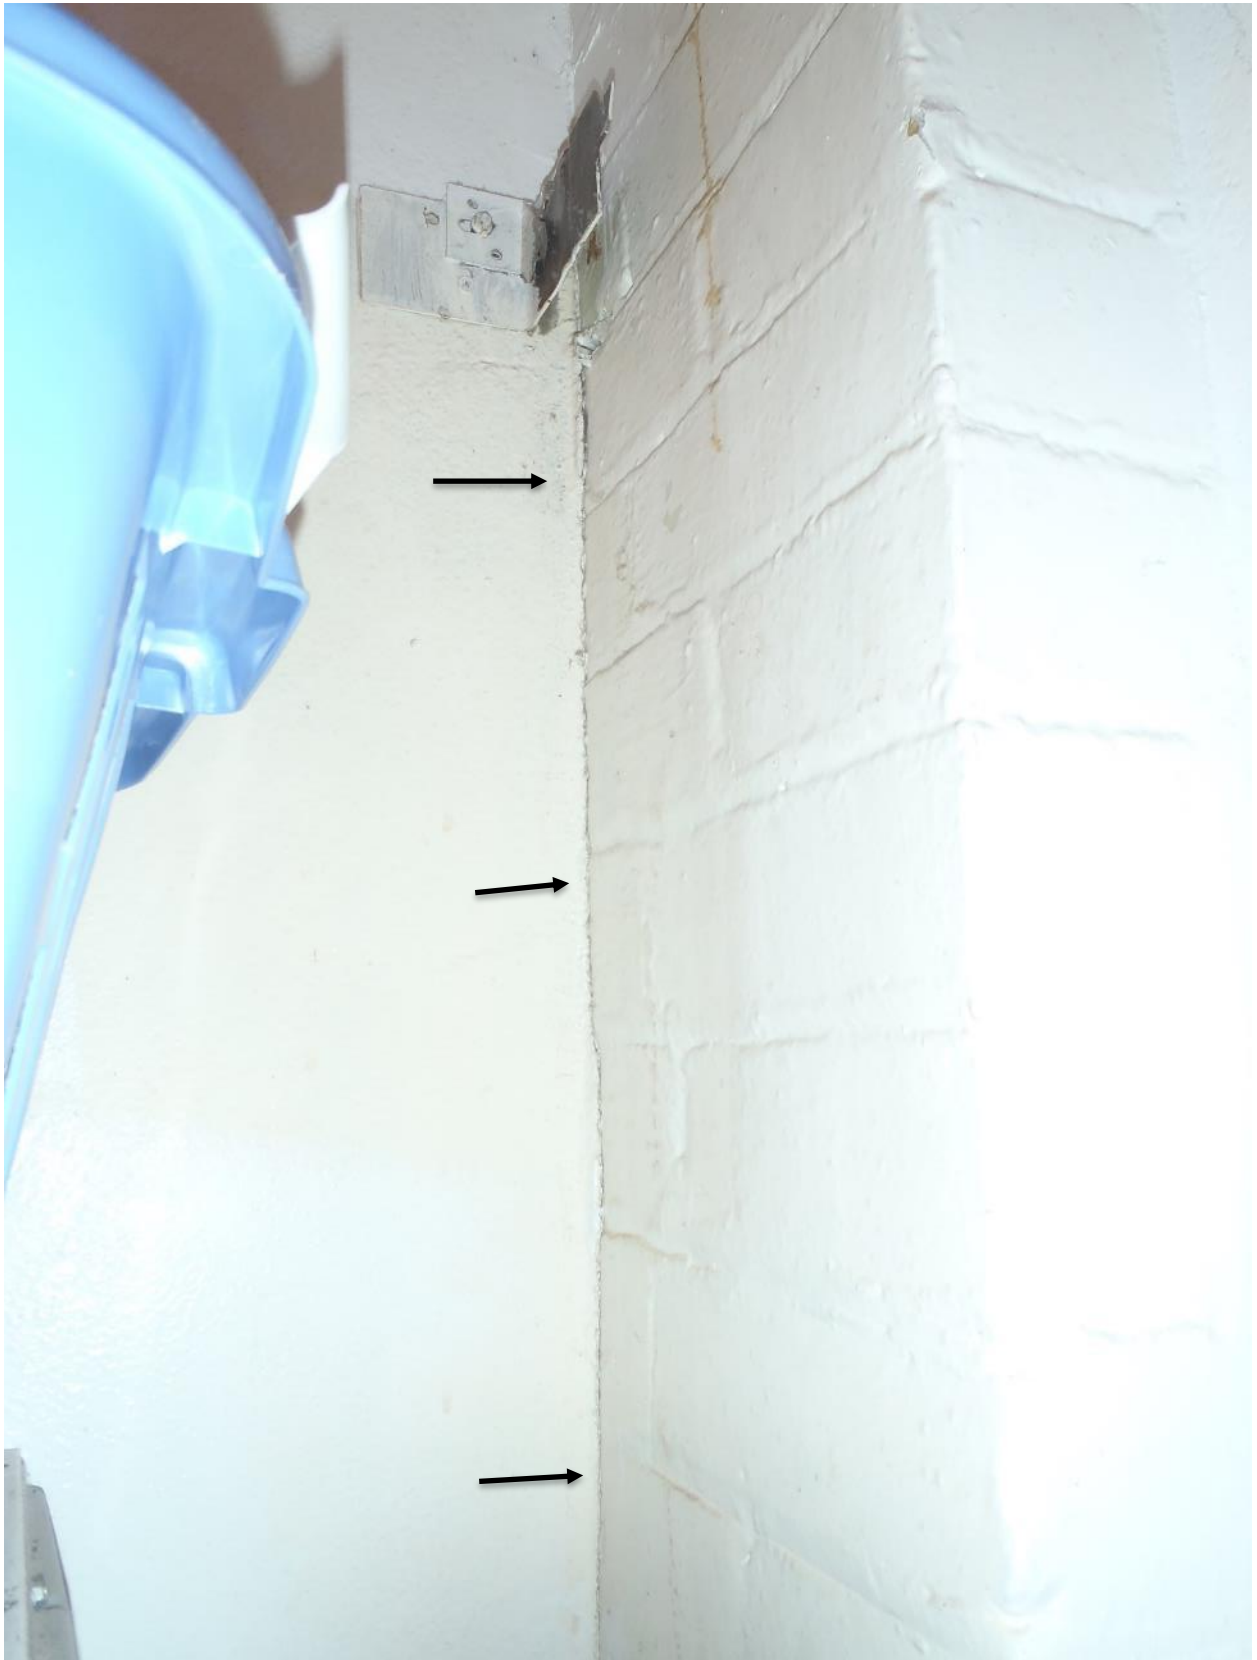
We noted separation cracking of the wall junction in the north-eastern corner. **[Photograph 35]**

Photograph 35 shows separation cracking of the wall junction in the north-eastern corner of the Laundry.

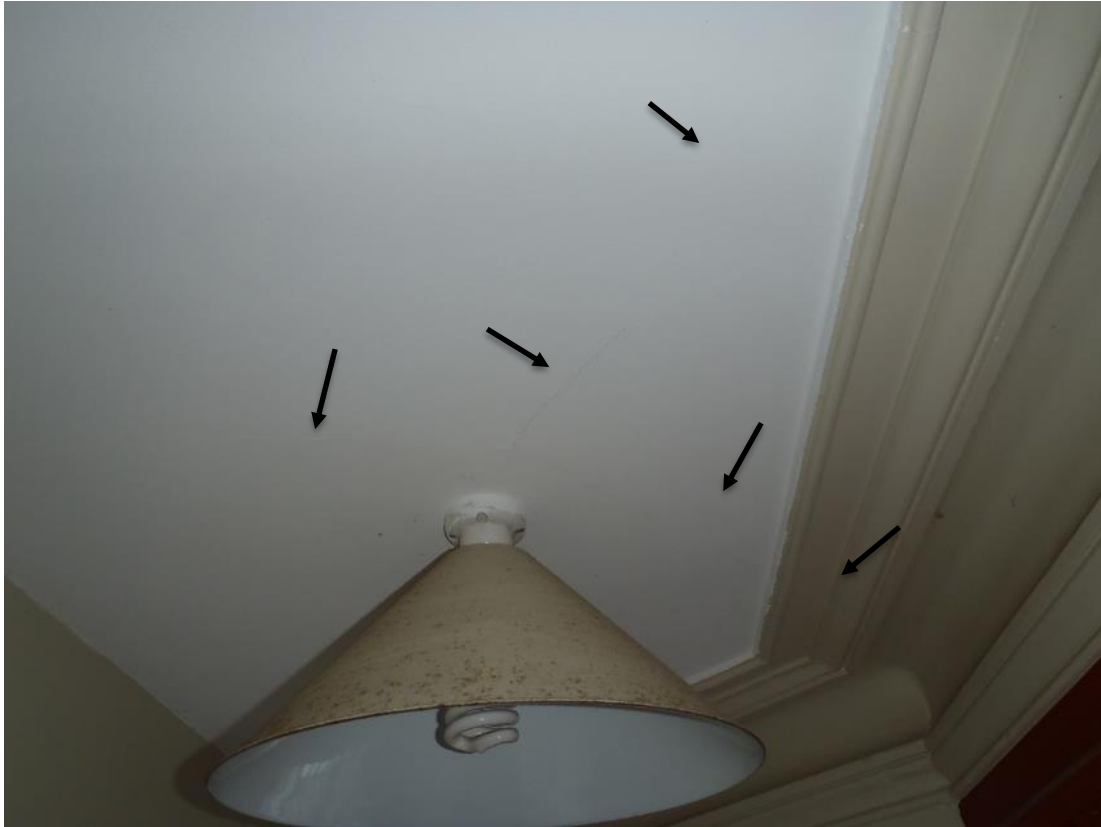
We noted hairline radial cracking [<1.0 mm] to the plaster ceiling extending from around the light fitting and to the wide profiled plaster cornice. **[Photograph 36]**

Photograph 36 shows hairline radial cracking to the plaster ceiling extending from around the light fitting and to the plaster cornice.

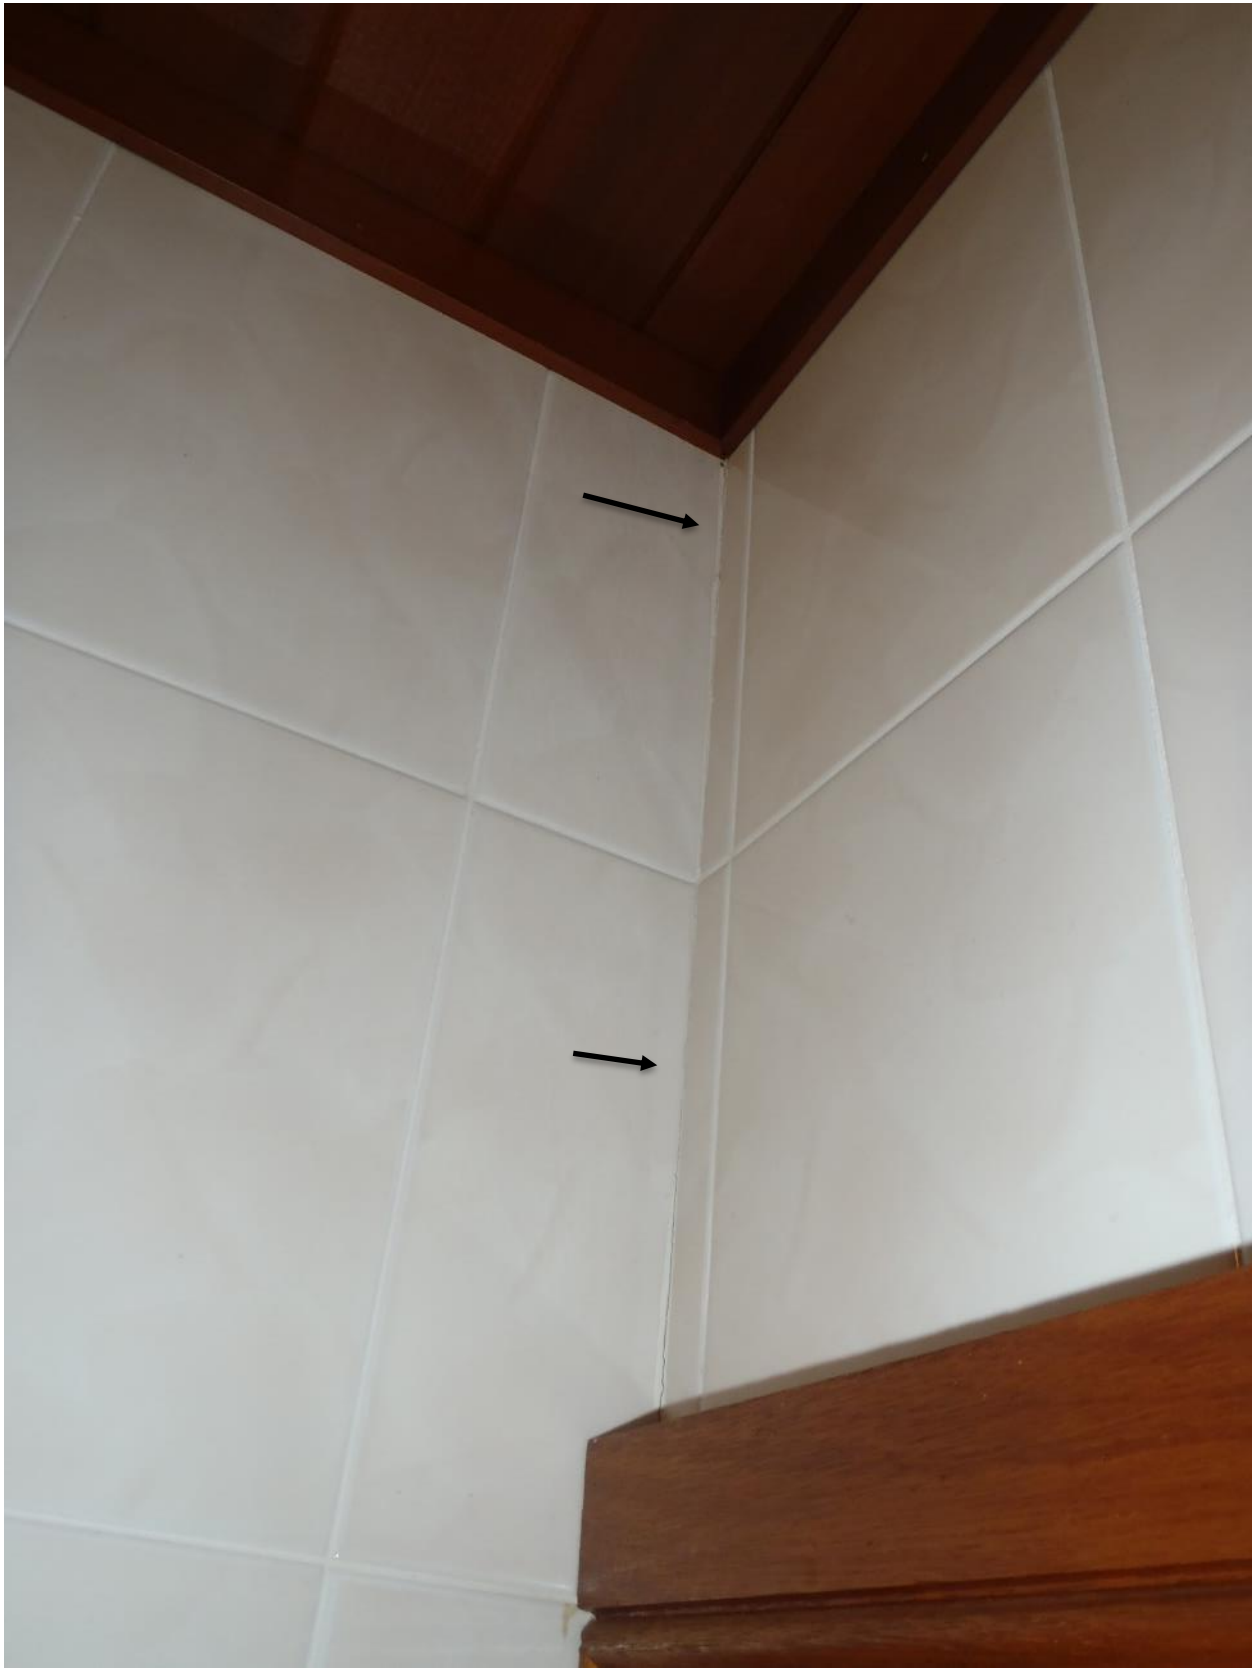
We noted vertical separation cracking [<1.0 mm] to the wall to wall junction above the door. **[Photograph 37]**

Photograph 37 shows vertical separation cracking to the wall to wall junction above the door in the first floor Bathroom.

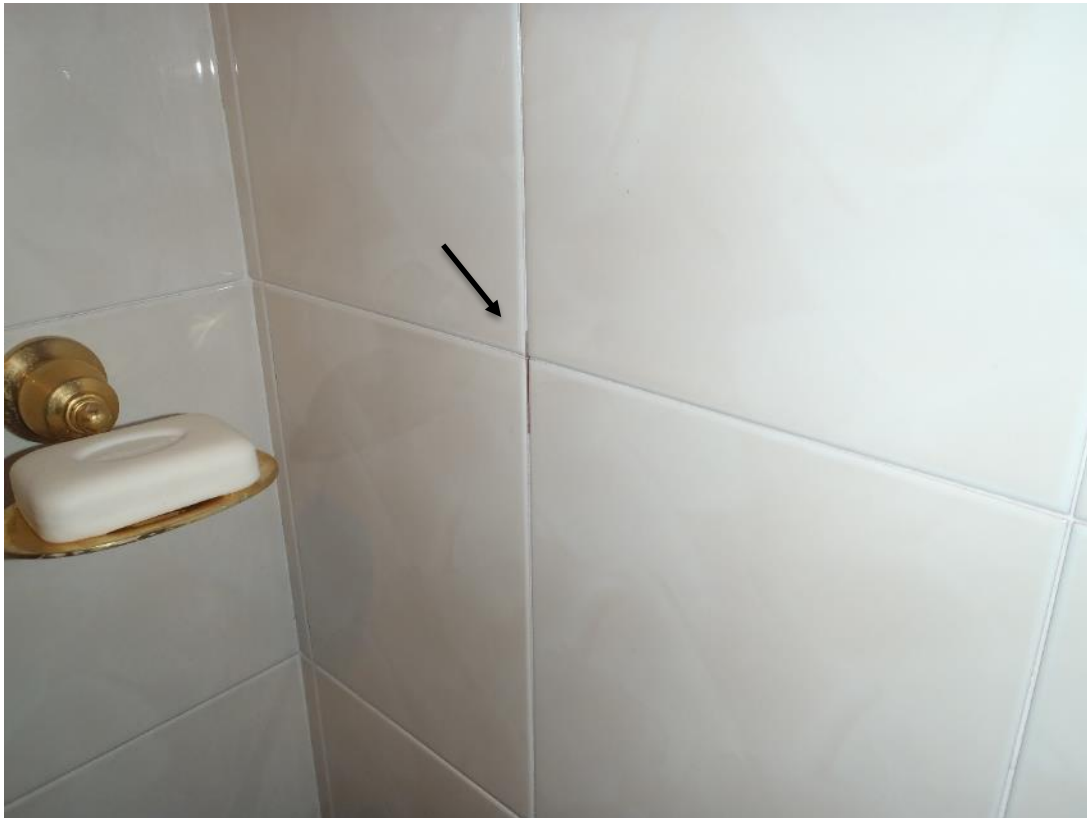
We noted displaced grout in the shower on the external wall. **[Photograph 38]**

Photograph 38 shows displaced grout in the shower on the external wall in the first floor Bathroom.

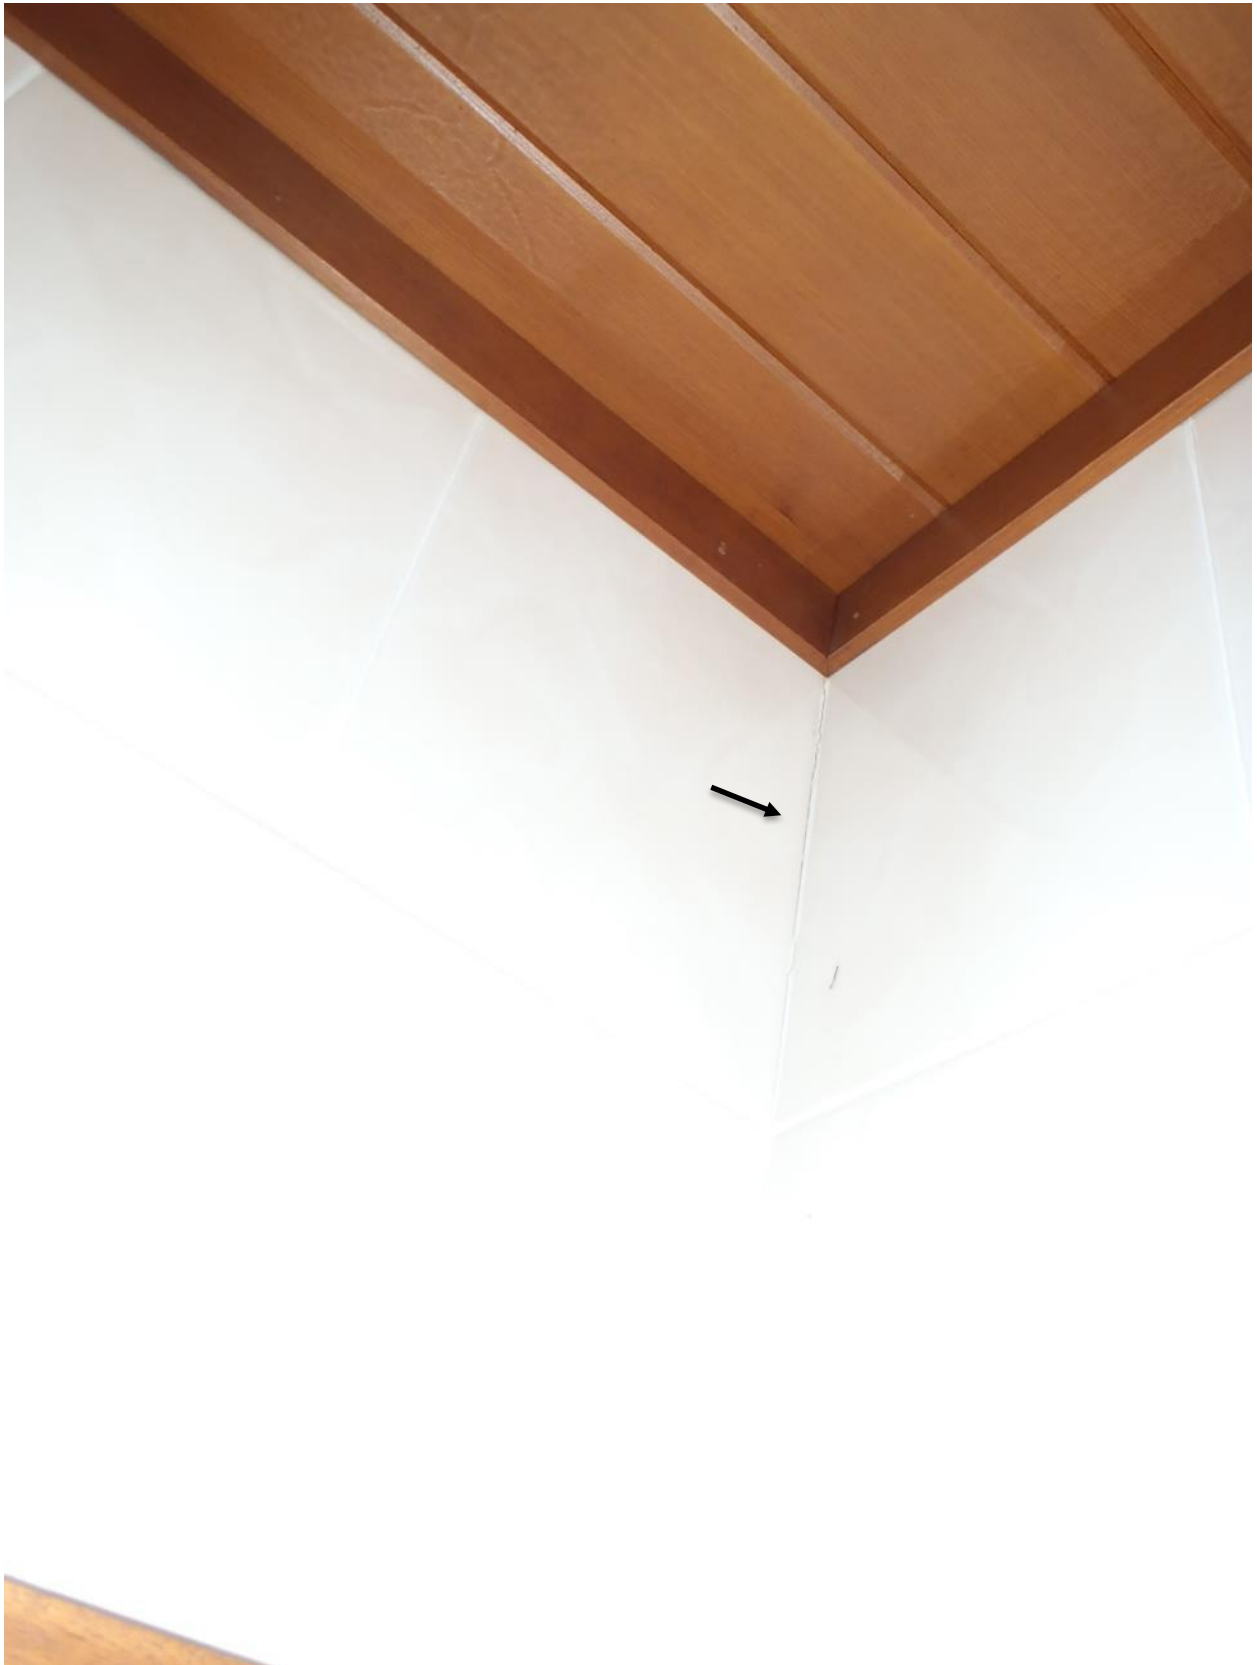
We noted vertical separation cracking [<1.0 mm] to the wall to wall junction in the south-western corner above the shower. **[Photograph 39]**

Photograph 39 shows vertical separation cracking to the wall to wall junction in the south-western corner above the shower in the first-floor Bathroom.

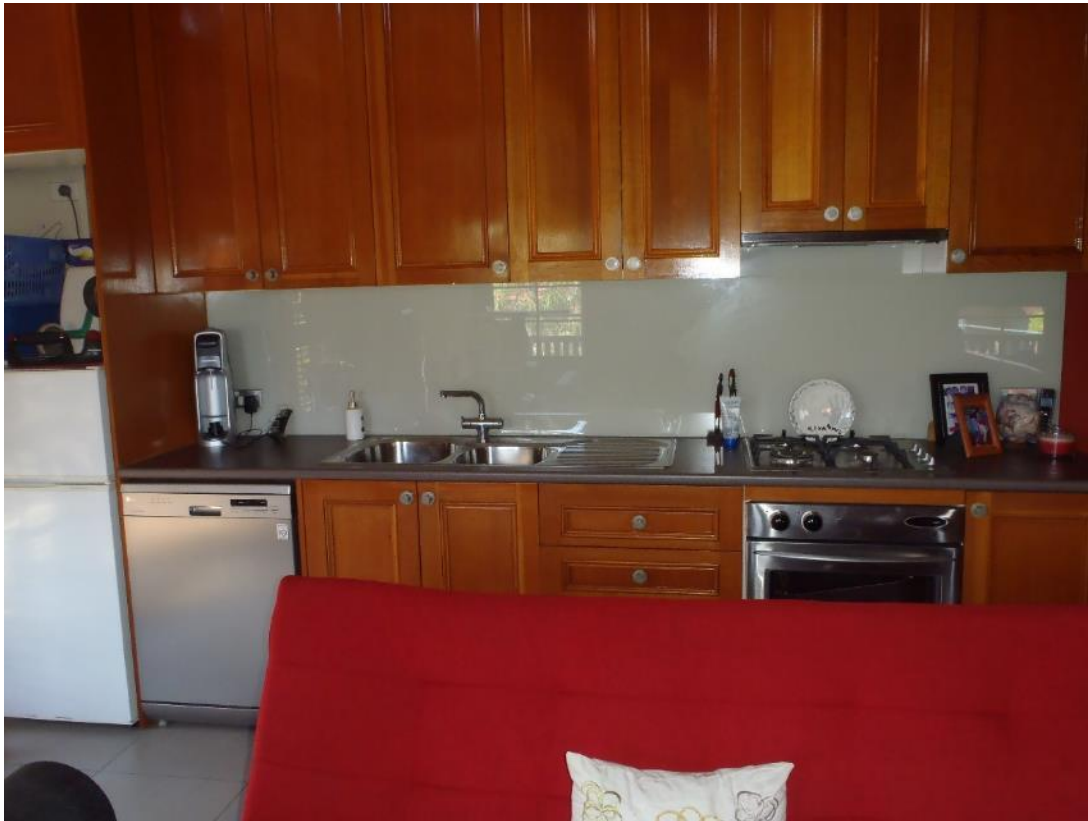
We noted that a kitchenette was built along the *common party / separation* wall with the adjoining property, No. 4 Raleigh Street. We did not observe any cracking to the glass splashback above the kitchen bench. **[Photograph 40]**

Photograph 40 shows the general condition of the Kitchenette.

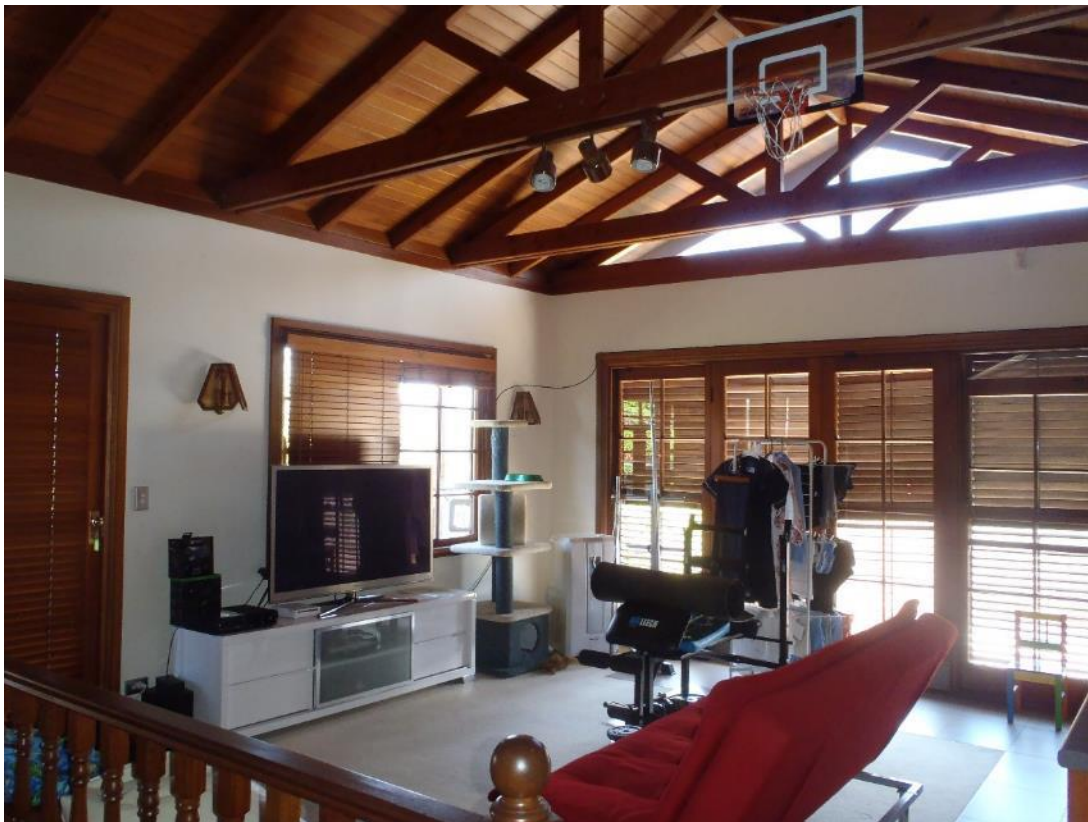
We did not observe any cracking to the plasterboard wall lining. **[Photograph 41]**

Photograph 41 shows the general condition of the Family Room.
