HAZARDOUS MATERIALS ASSESSMENT REPORT

Client: Cape Cod Australia Pty. Limited

Job details: Owner: Mr. P. & Mrs. L. Lam.
Location: 10 Wirraway Place, Doonside.

Our reference: HM05480117

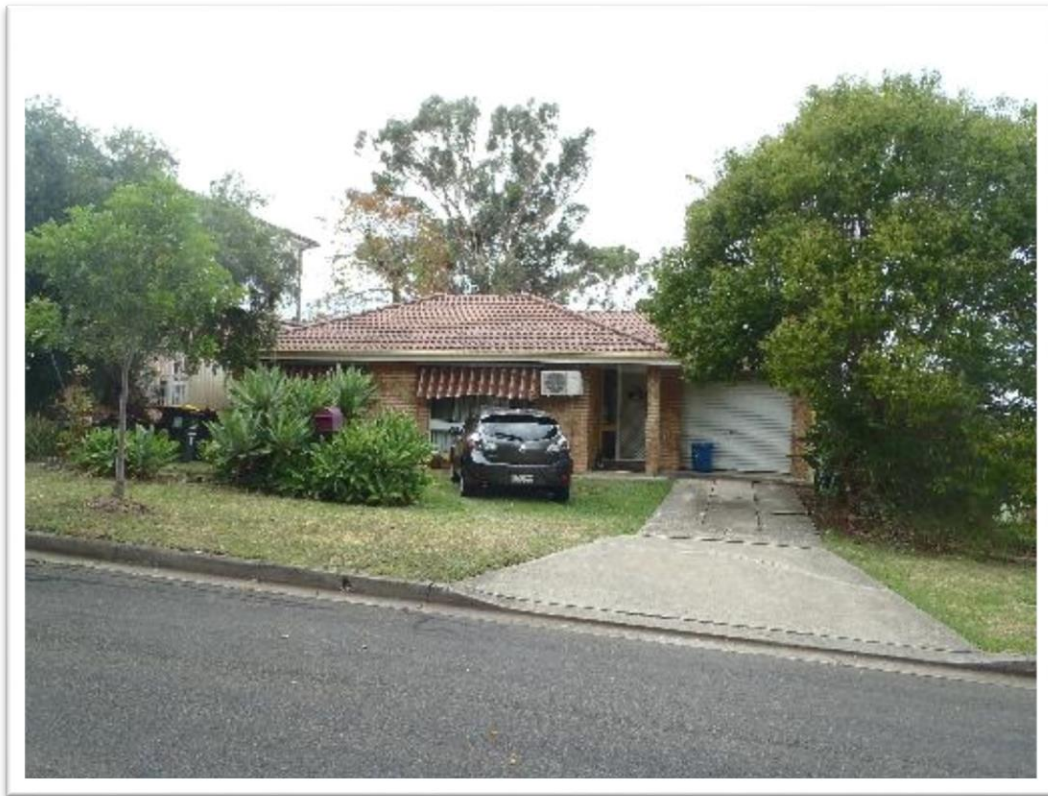
Front northern elevation of the residence
