HAZARDOUS MATERIALS ASSESSMENT REPORT

Job details: Owner: Mr. C. & Mrs. A. Burt.
Location: 25 Carrington Street, North Strathfield

Date of assessment: 28th April 2017

Our reference: HM05690517

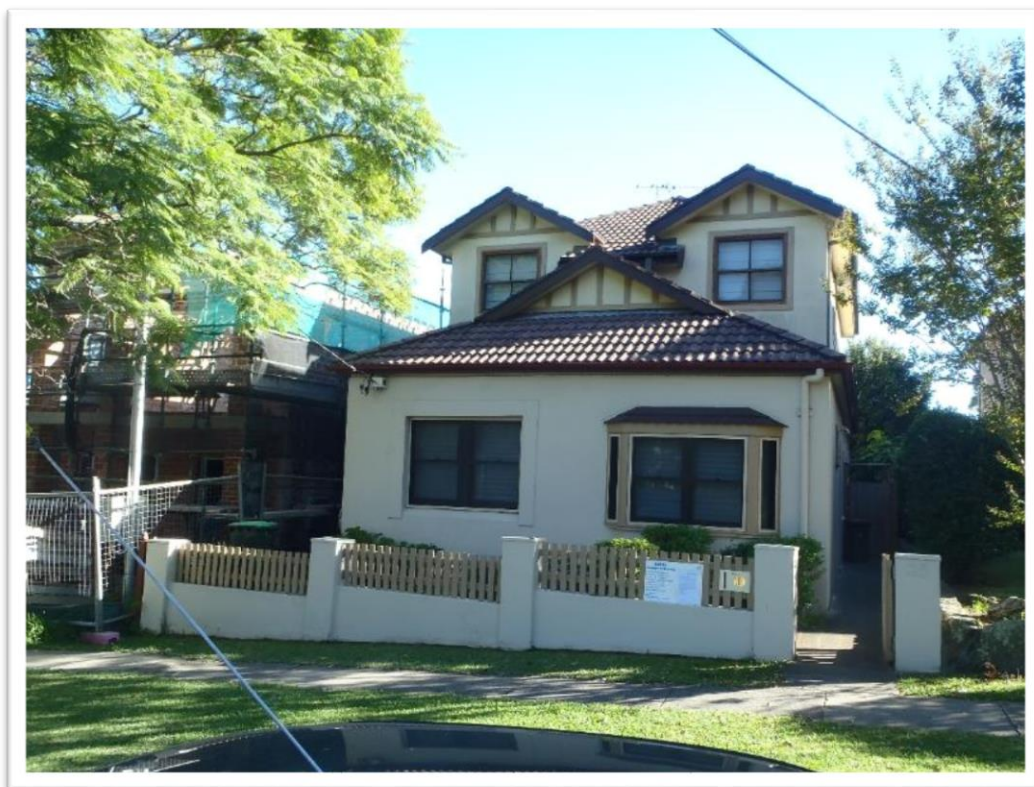
Front southern elevation of the residence
