HAZARDOUS MATERIALS ASSESSMENT REPORT

Job details: Owner: Mrs. V. Jackett
Location: 1 Gatehouse Circuit, Werrington Downs

Plans for Job No: 7642/15 Revision No: D Dated: 09-04-15

Our reference: HM03900415

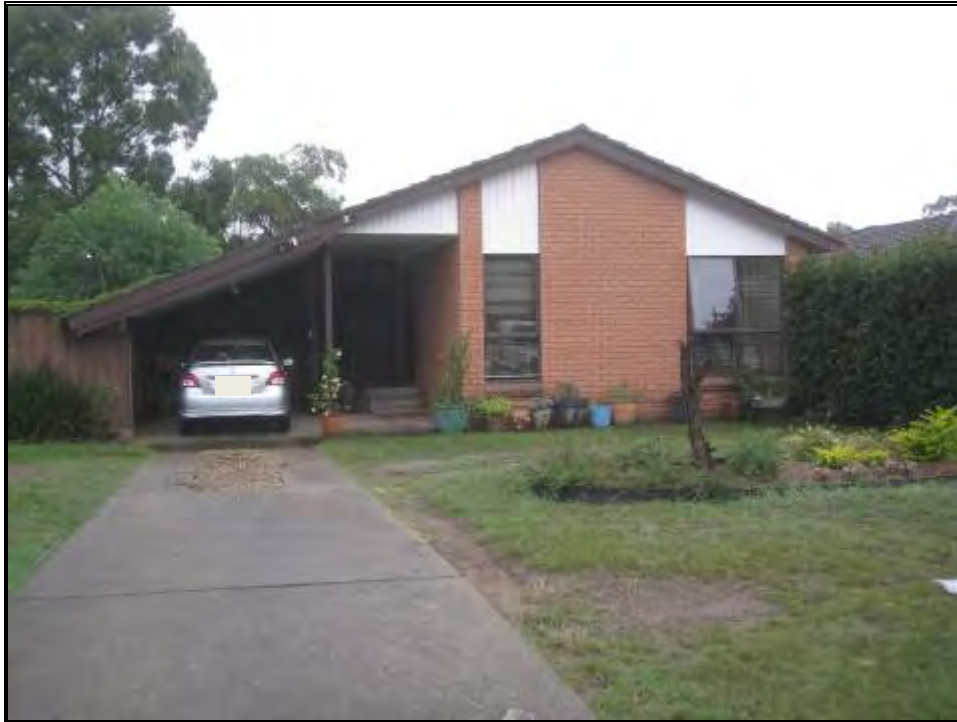
Front southern elevation of the residence
