Dilapidation Assessment Report

Prepared for: Cape Cod Australia Pty. Limited
Job address: 30 Alt Street, Queens Park
Property Owner/s: Mr. Doug Murchison
Report reference: **WAVERLEY COUNCIL**
Development Application No: not available
Date of assessment: 23rd November 2016

Re: Dilapidation Report – No. 30 Alt Street, Queens Park. NSW.

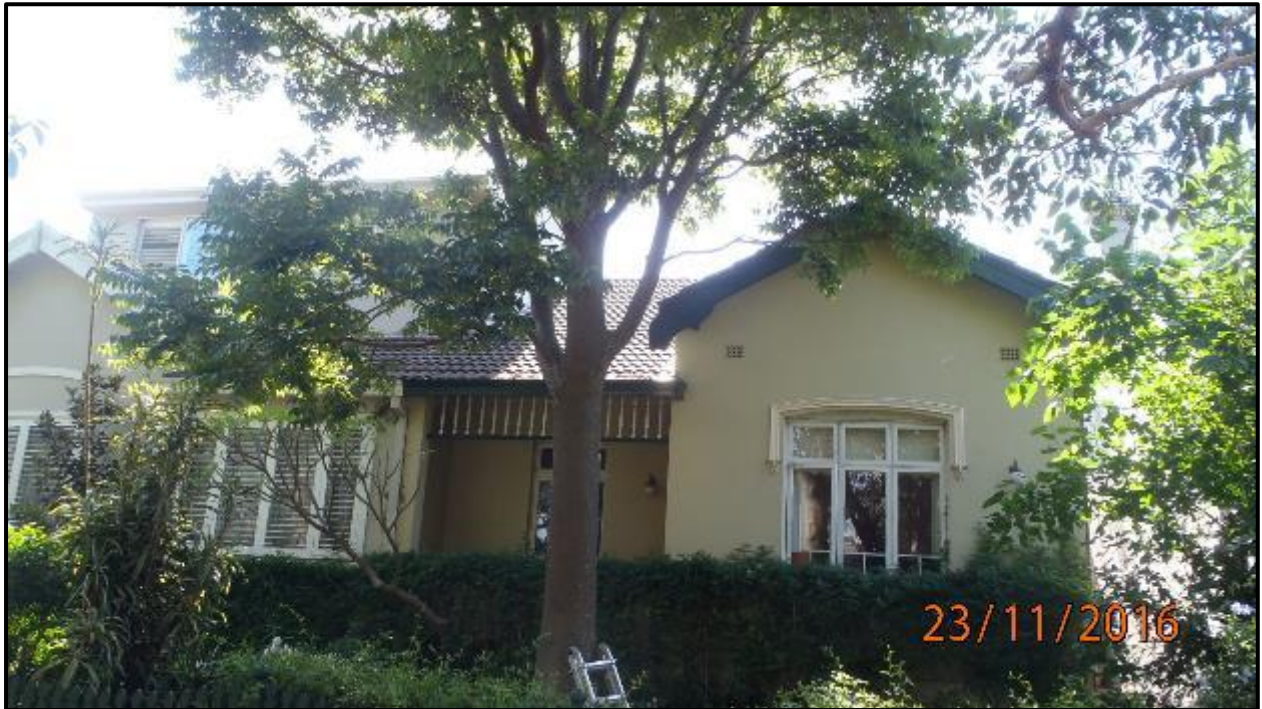
Shows the front western elevation of the adjoining properties:
No.28 and No.30 Alt Street, Queens Park

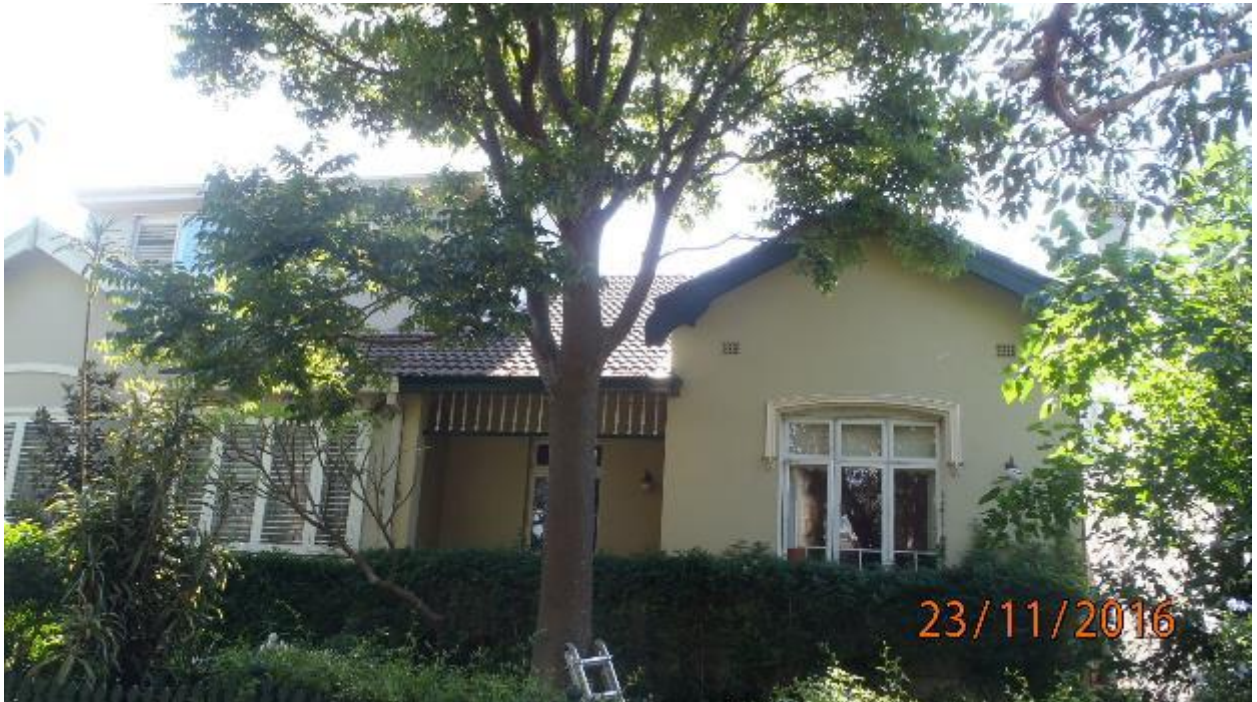
We observed that the concrete roof tiles to the original roof surfaces are generally interlinked and securely bedded, in our opinion forming a weather resistant cover to the residence. **[Photograph 1]**

Photograph 1 shows the front elevation of the residence.

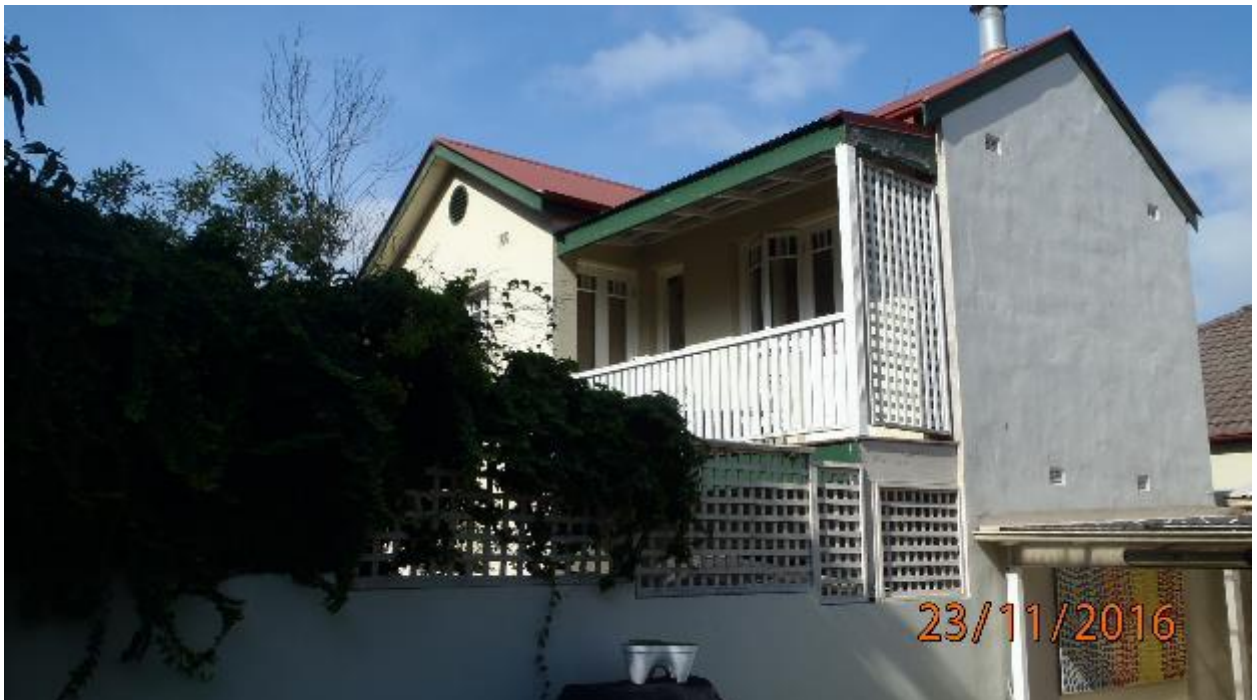
We noted that the pre-finished corrugated profile sheet metal roofing to the rear addition roof surfaces is in good condition and is securely fixed, in our opinion forming a weather resistant cover to the rear addition. **[Photograph 2]**

Photograph 2 shows the rear elevation of the residence.

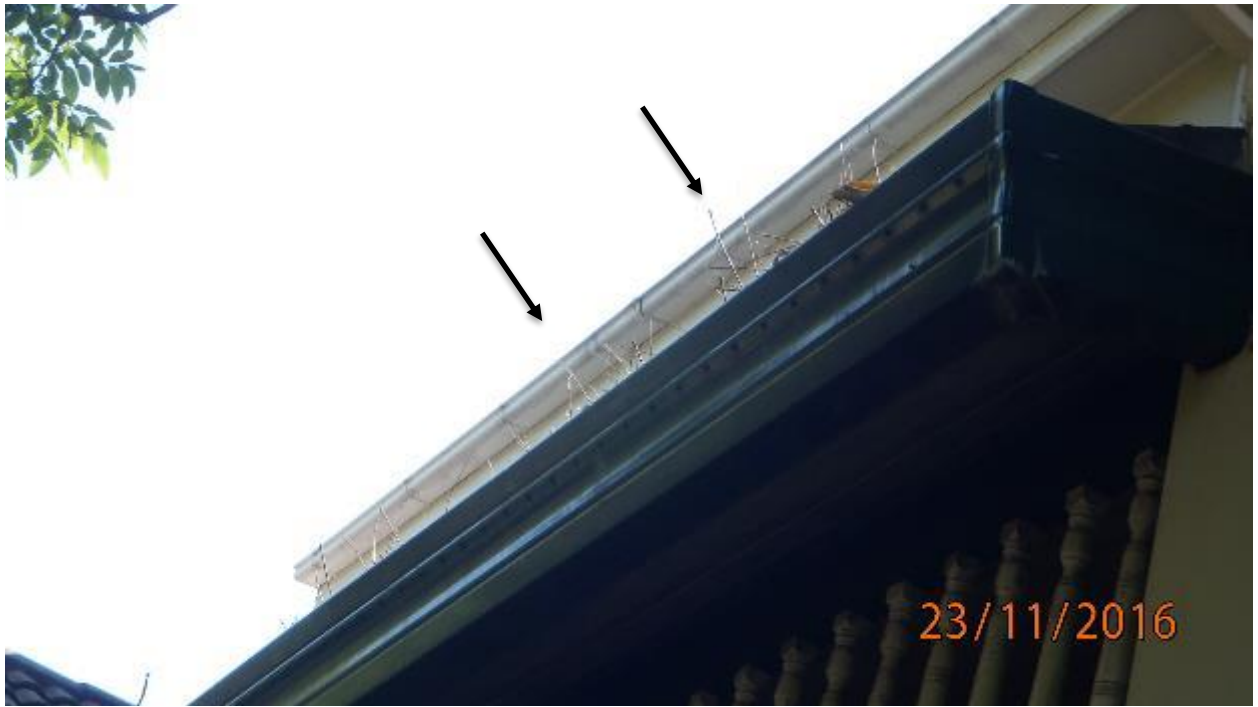
We noted vegetation and debris settling in the front gutter system. **[Photograph 3]**

Photograph 3 shows vegetation and debris settling in the front gutter system.

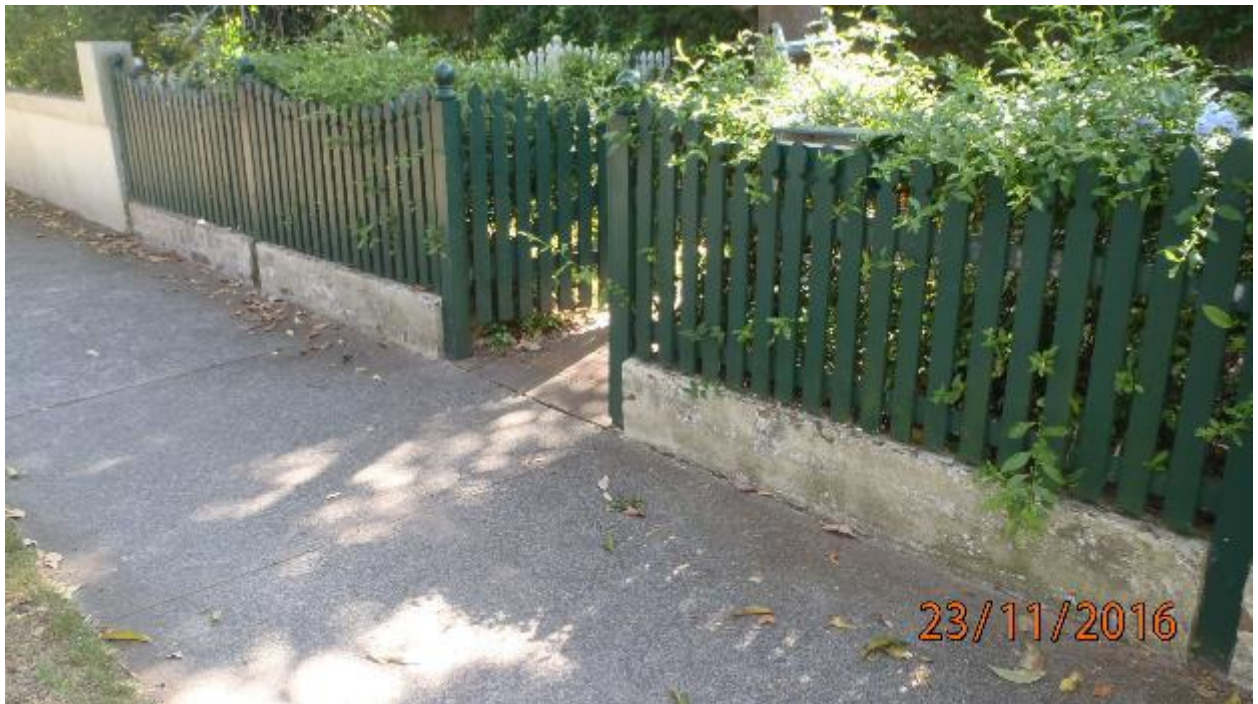
We noted the front boundary fence was of timber post and rail (picket style) construction with a cement rendered brickwork plinth. **[Photograph 4]**

Photograph 4 shows the front boundary fence.

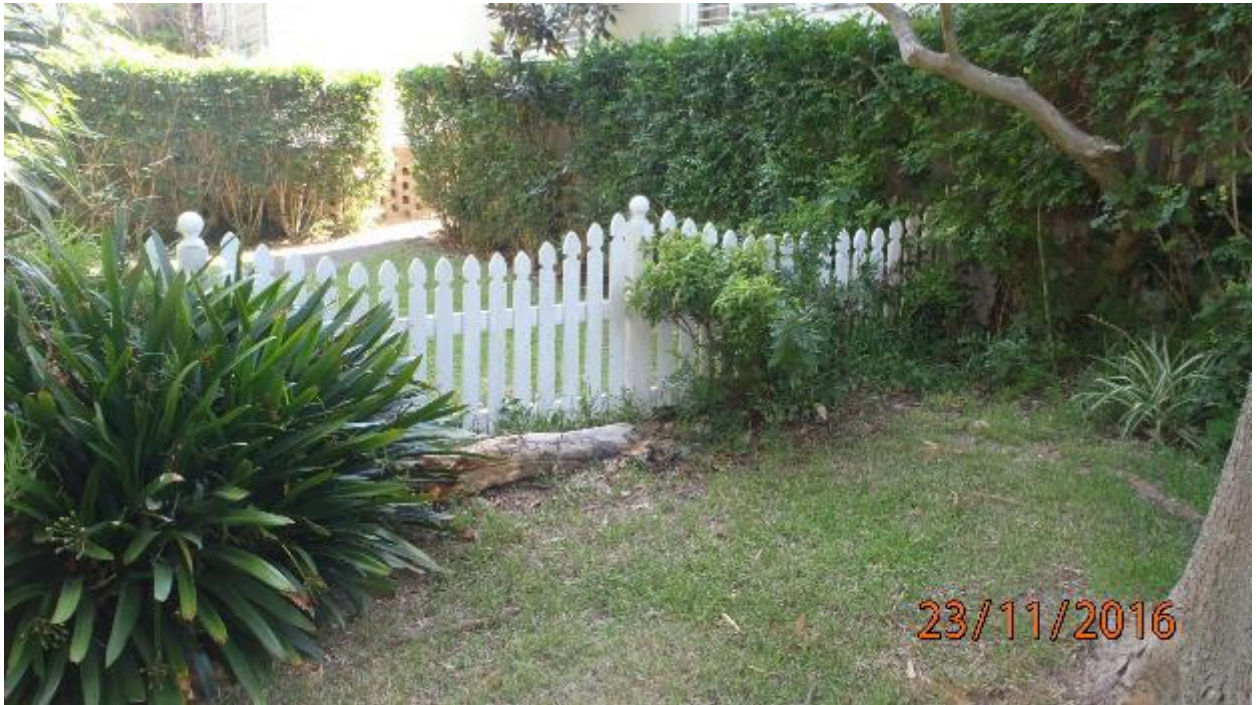
We noted that the common boundary fence with No. 28 Alt Street, Queens Park is of timber post and rail (picket style) construction. **[Photograph 5]**

Photograph 5 shows the front common boundary fence with No. 28 Alt Street.

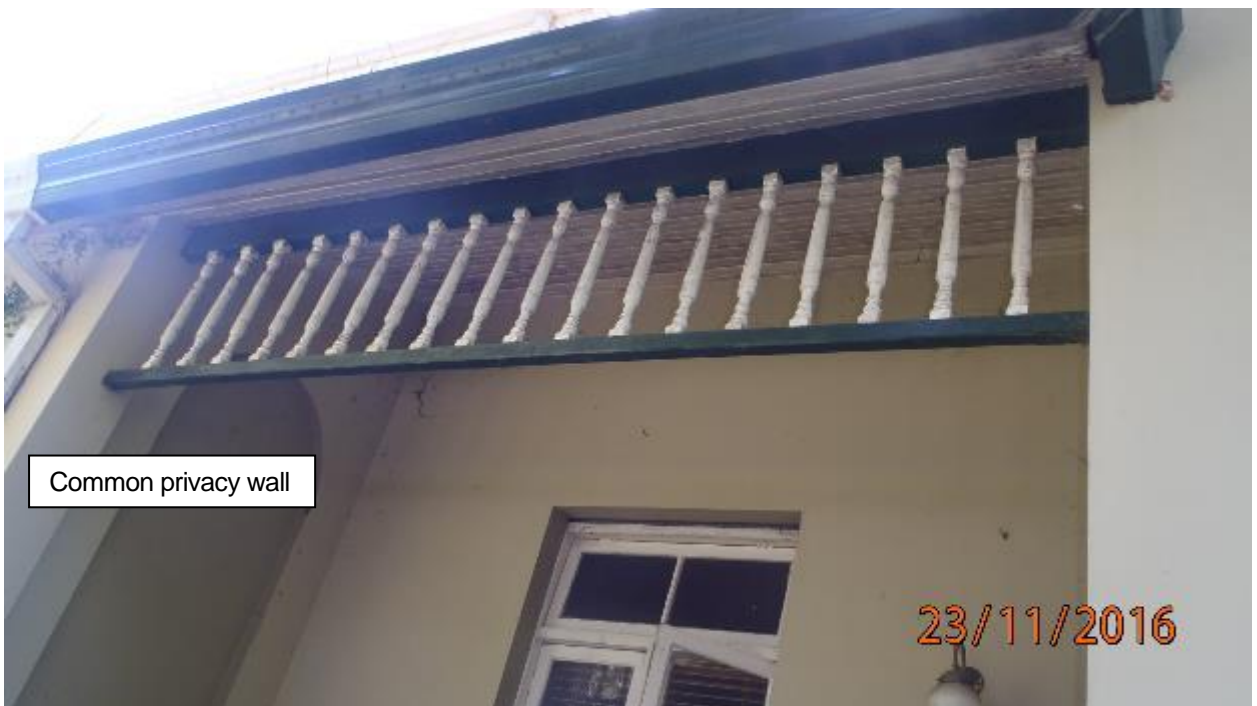
We noted that the northern wall of the porch was the *common* privacy wall with No. 28 Alt Street, Queens Park. **[Photograph 6]**

We noted that the front verandah soffit was lined with timber boards. **[Photograph 6]**

Photograph 6 shows the front verandah of the residence.

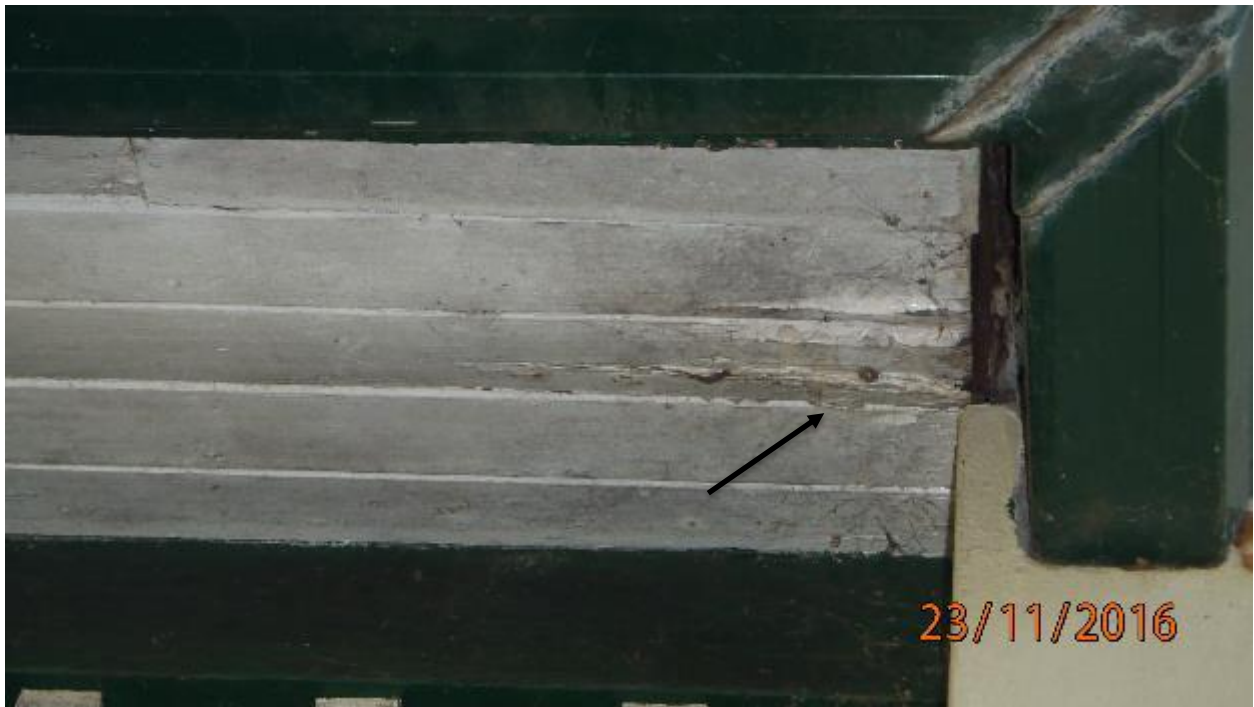
We noted general deterioration to the surface coating of the timber lining boards and rotting adjacent to the southern guttering system. **[Photograph 7]**

Photograph 7 shows deterioration to the surface coating and rotting of the timber lining boards on the front verandah.

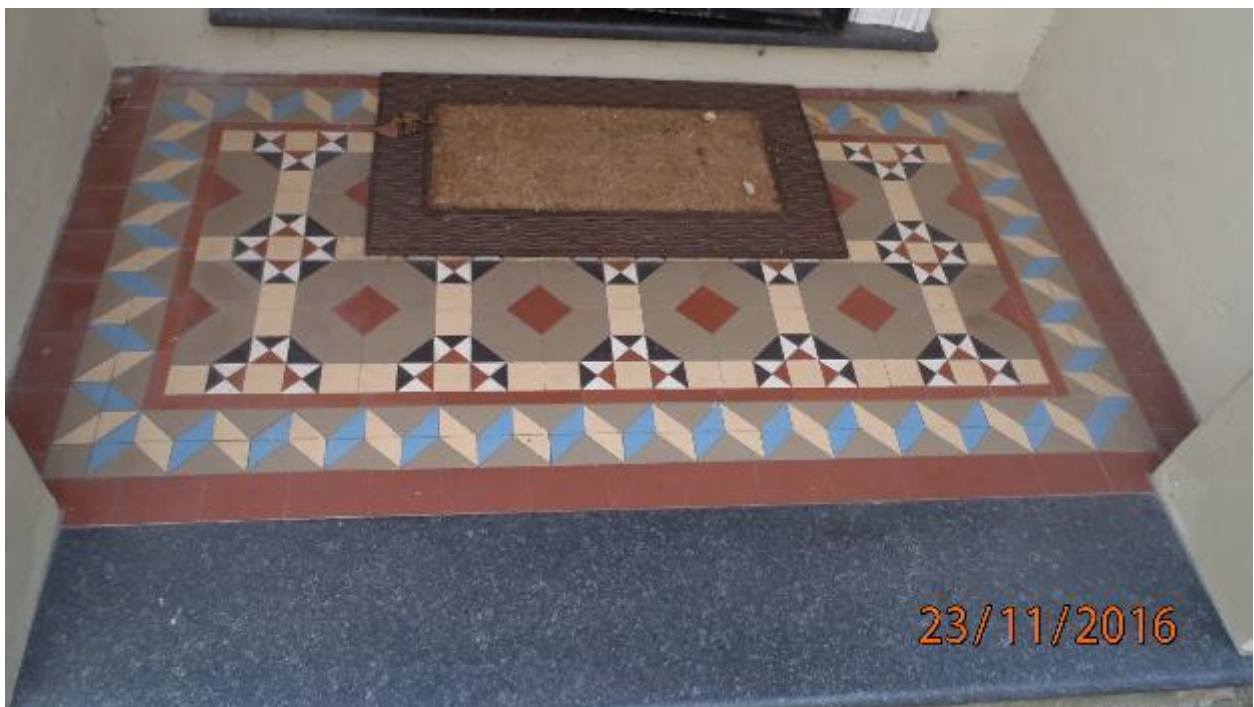
We noted that the patterned vitrified clay tiles to the front porch were generally sound with the grout complete. **[Photograph 8]**

Photograph 8 shows the general condition of the front entry porch.

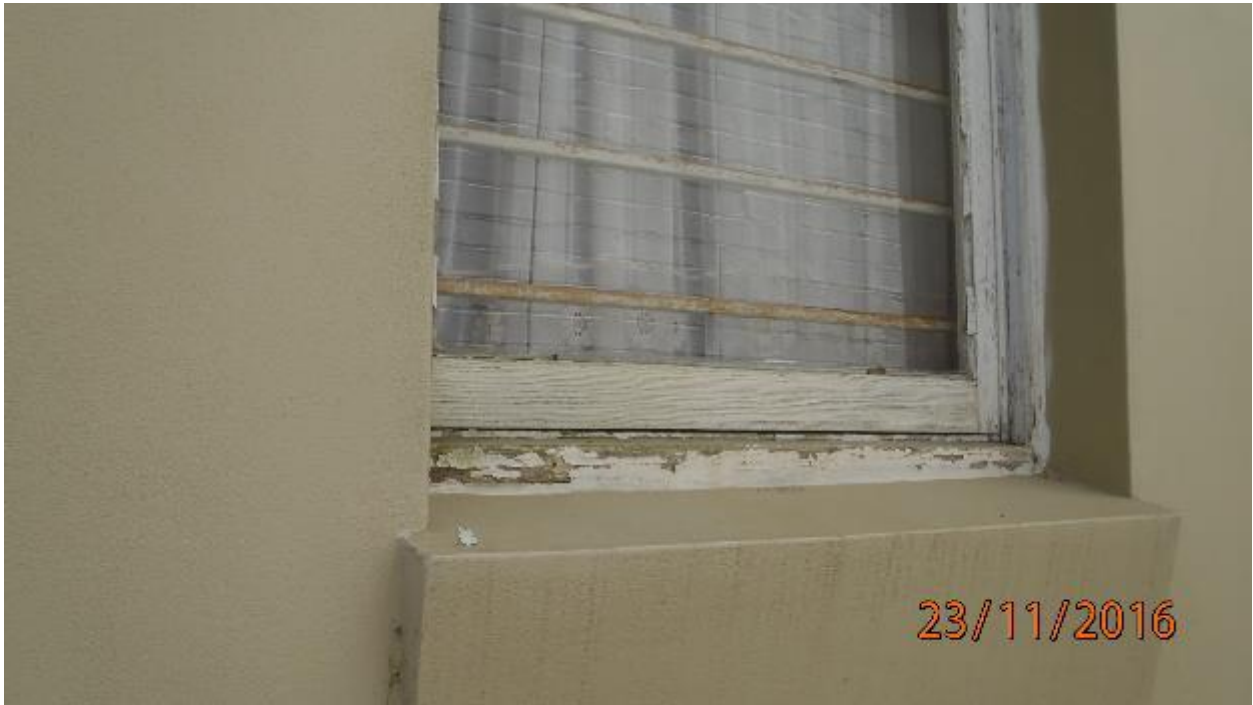
We noted general deterioration to the surface coating on the timber window frame outside the Bedroom 1. **[Photograph 9]**

Photograph 9 shows general deterioration to the surface coating on the timber window frame outside the Bedroom 1.

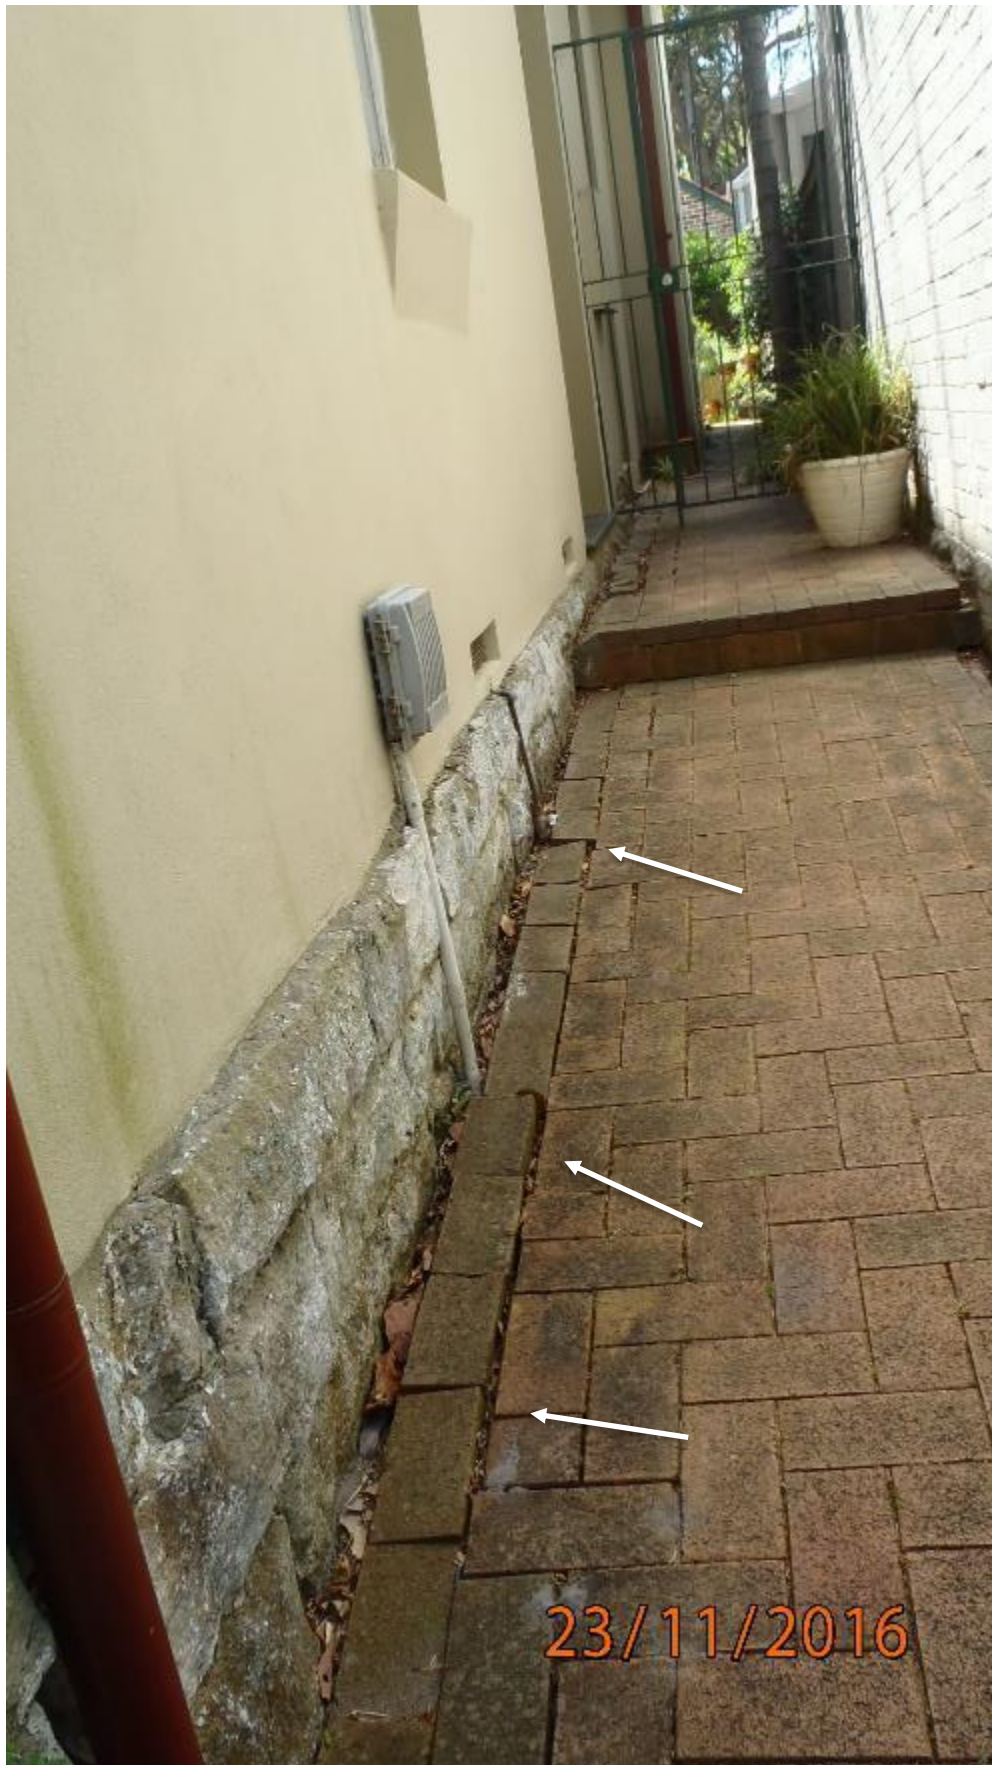
We noted displacement of the pavers to side pathway adjacent to the sandstone block foundation wall. **[Photograph 10]**

Photograph 10 shows the displacement of the pavers to side pathway.

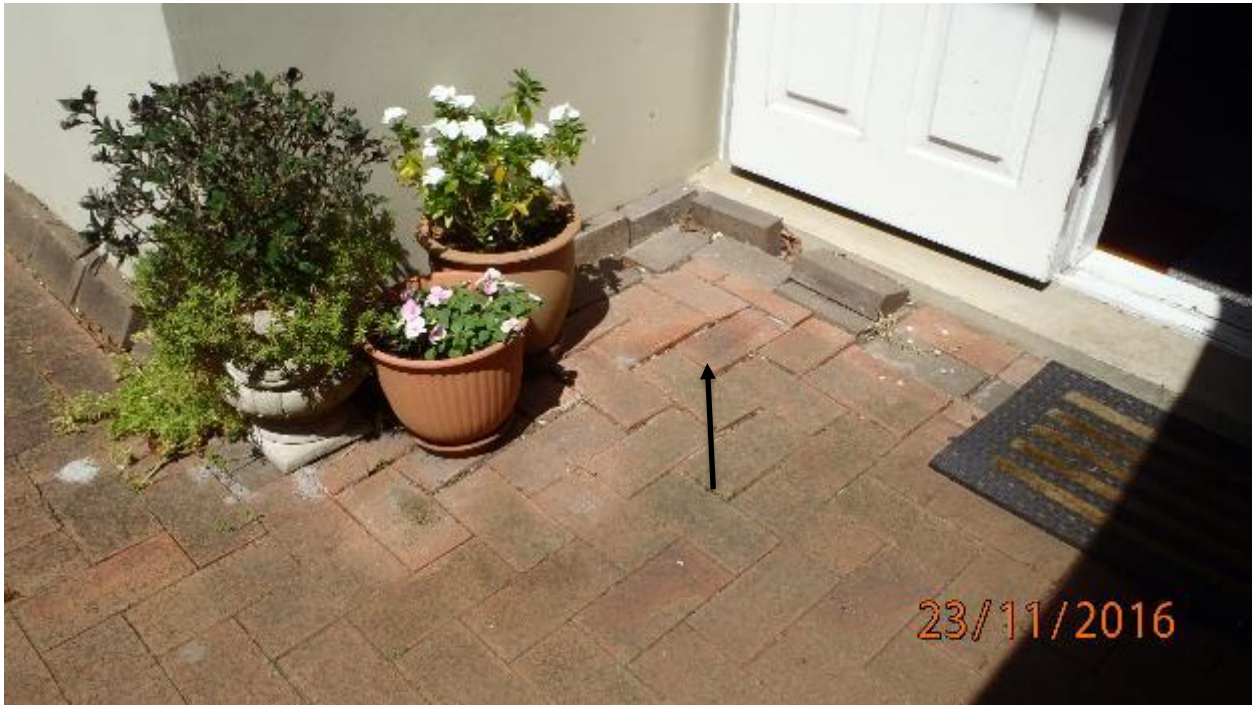
We noted displacement of the pavers to side pathway adjacent to the rear entry doorway. **[Photograph 11]**

Photograph 11 shows the displacement of the pavers adjacent to the rear entry door.

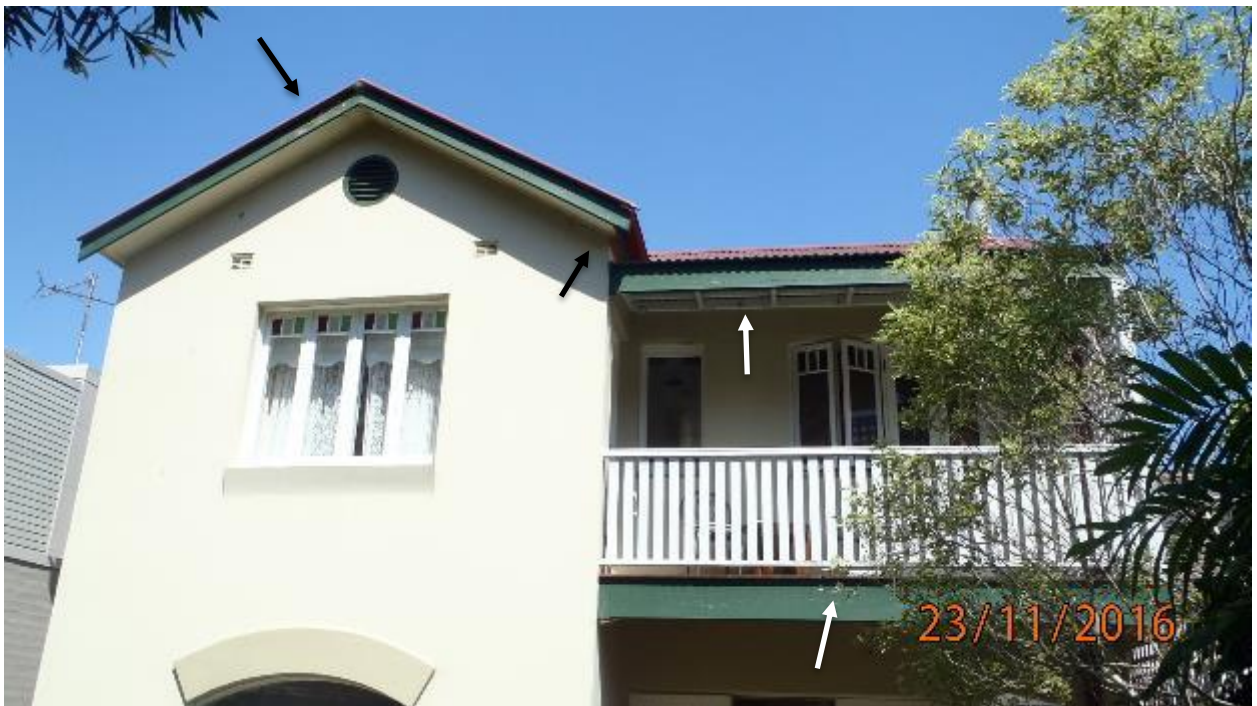
We noted general deterioration to the surface coating on the timber barge and fascia boards. **[Photograph 12]**

Photograph 12 shows general deterioration to the surface coating on the timber barge and fascia boards to the rear eastern elevation.

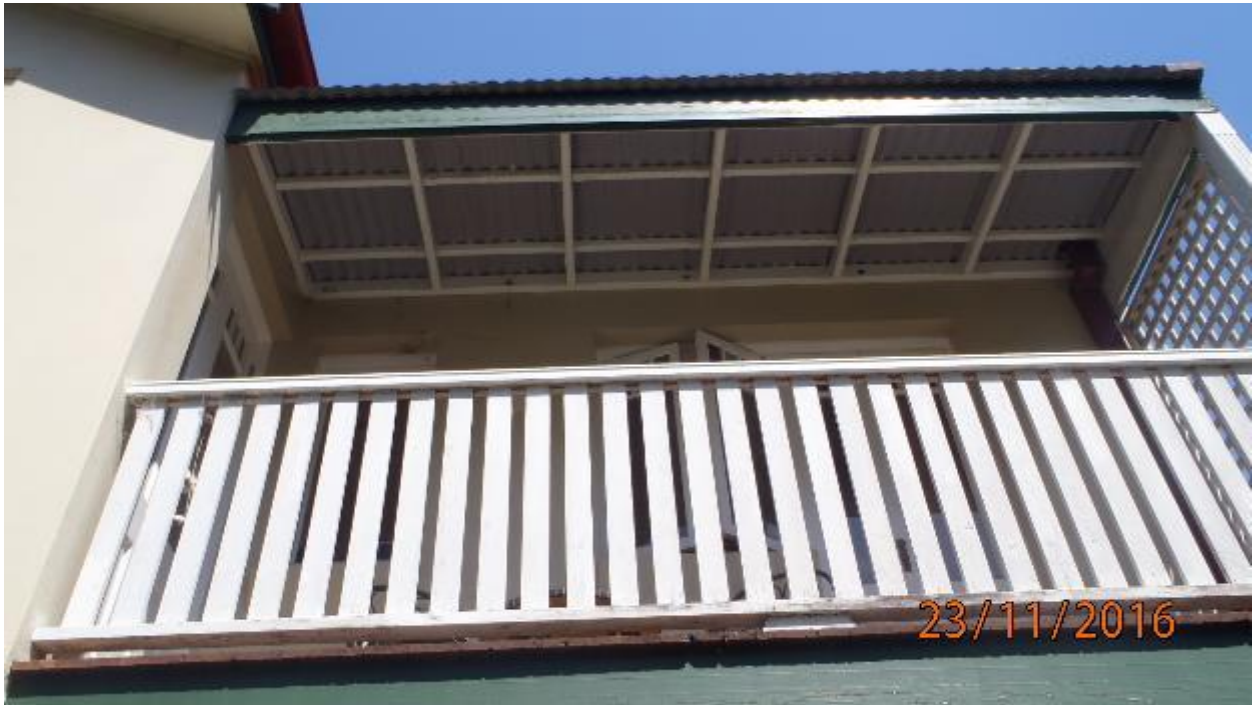
We noted general deterioration to the surface coating to the timber balustrade on the rear verandah. **[Photograph 13]**

Photograph 13 shows general deterioration to the surface coating to the timber balustrade on the rear verandah.

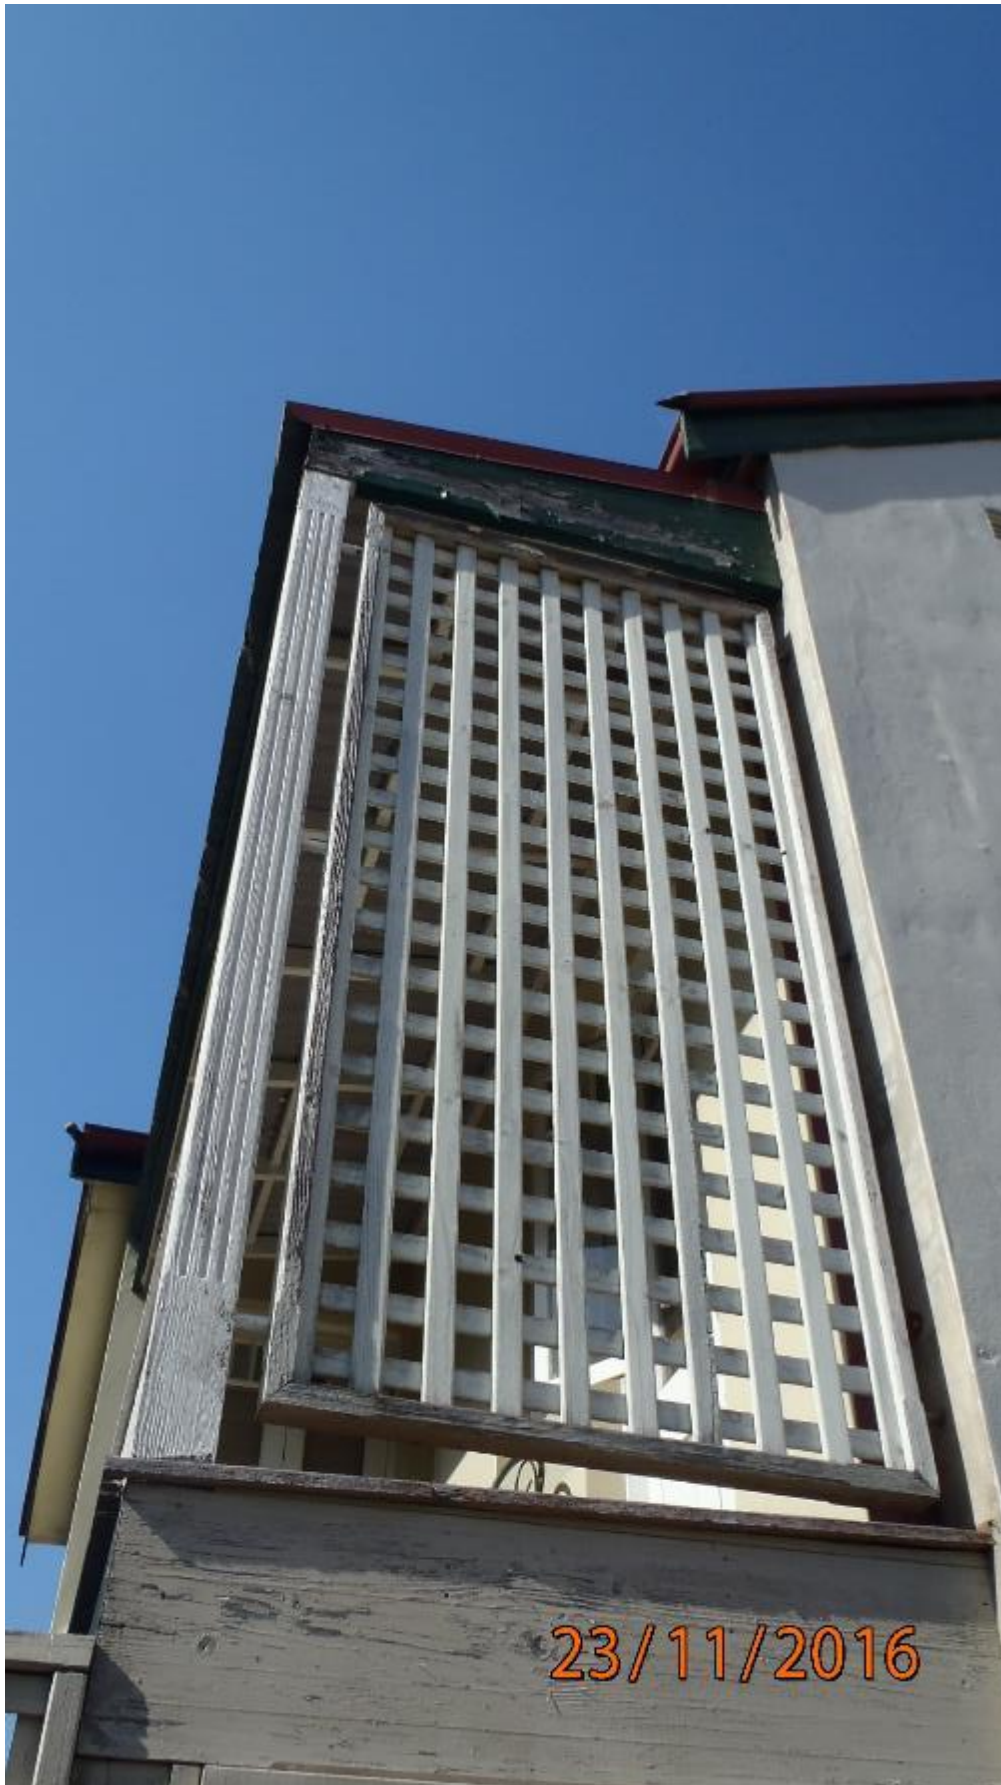
We further noted general deterioration to the surface coating to the timber lattice work, floor plate and roof beam outside the rear verandah. **[Photograph 14]**

Photograph 14 shows deterioration to the surface coating to the timber lattice work, floor plate and roof beam outside the rear verandah.

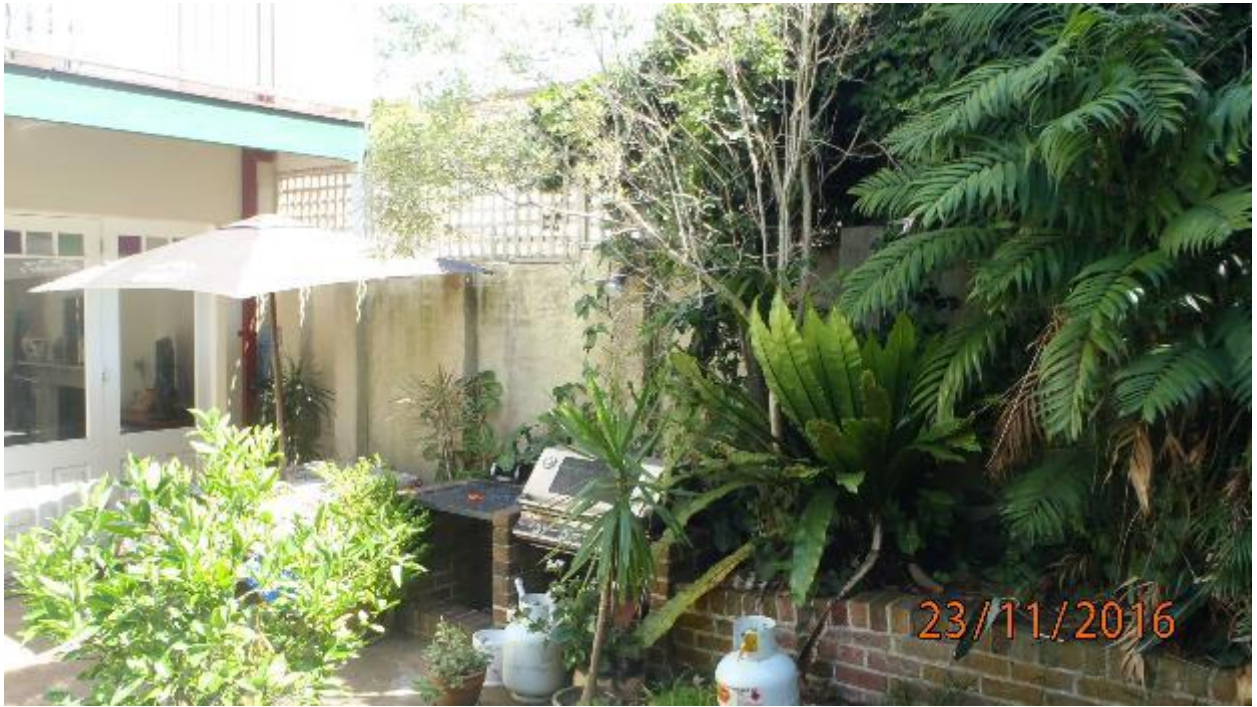
We noted that the rear *common* boundary fence with No. 28 Alt Street, Queens Park was of surface coated brickwork construction. **[Photograph 15]**

Photograph 15 shows the general condition of the rear common boundary fence.

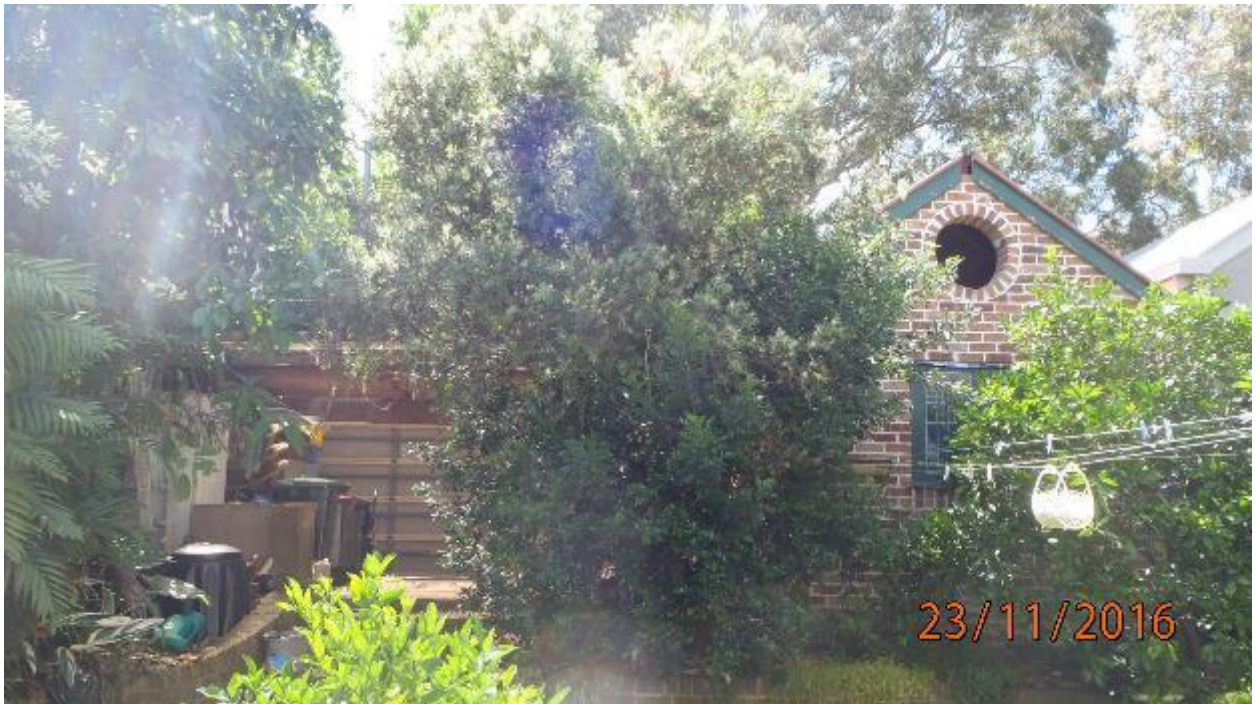
We noted that there was a brick external garage built at the rear of the residence. **[Photograph 16]**

Photograph 16 shows the external brick garage to the rear with entry off Alt Lane.

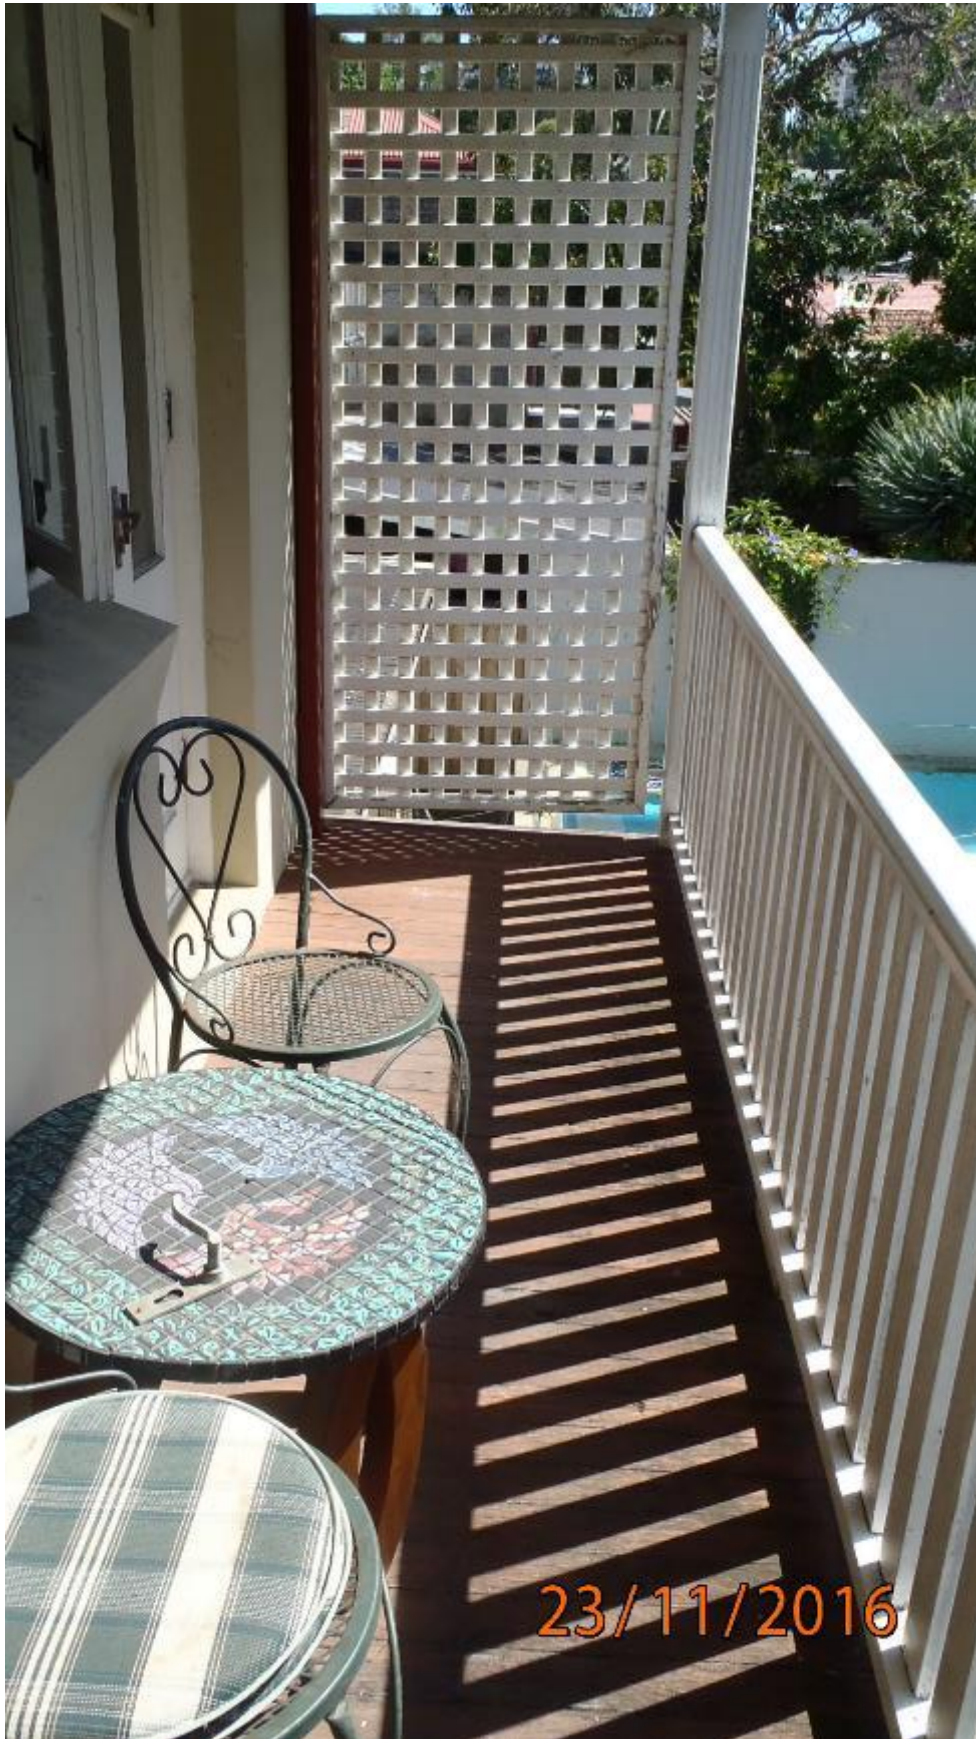
We observed that there is a rear timber verandah structure with timber lattice privacy screen and timber balustrade. **[Photograph 17]**

Photograph 17 shows the general condition of the rear verandah structure.

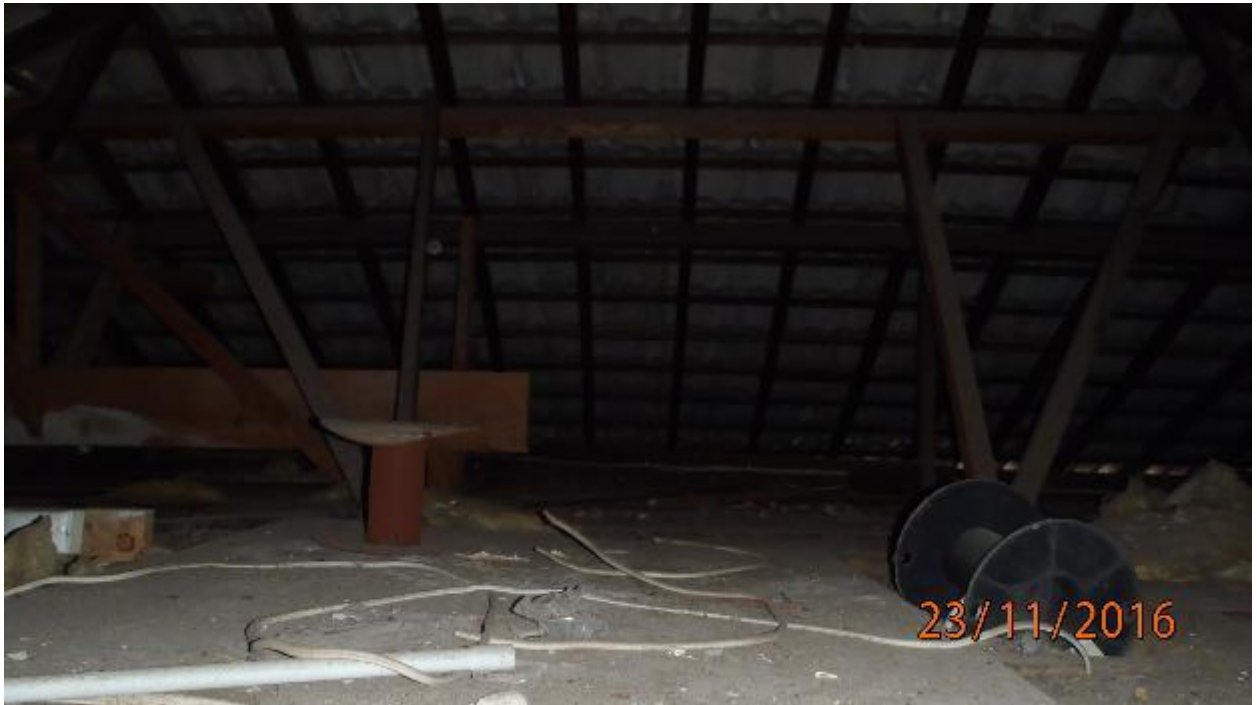
We noted that there is no sarking provided to the underside of the roofing tiles. **[Photograph 18]**

We observed that the roof and ceiling timbers that are accessible are generally in good condition. **[Photograph 18]**

Photograph 18 shows the roof space of the residence. **Note:** no sarking to the underside of the roofing tiles.

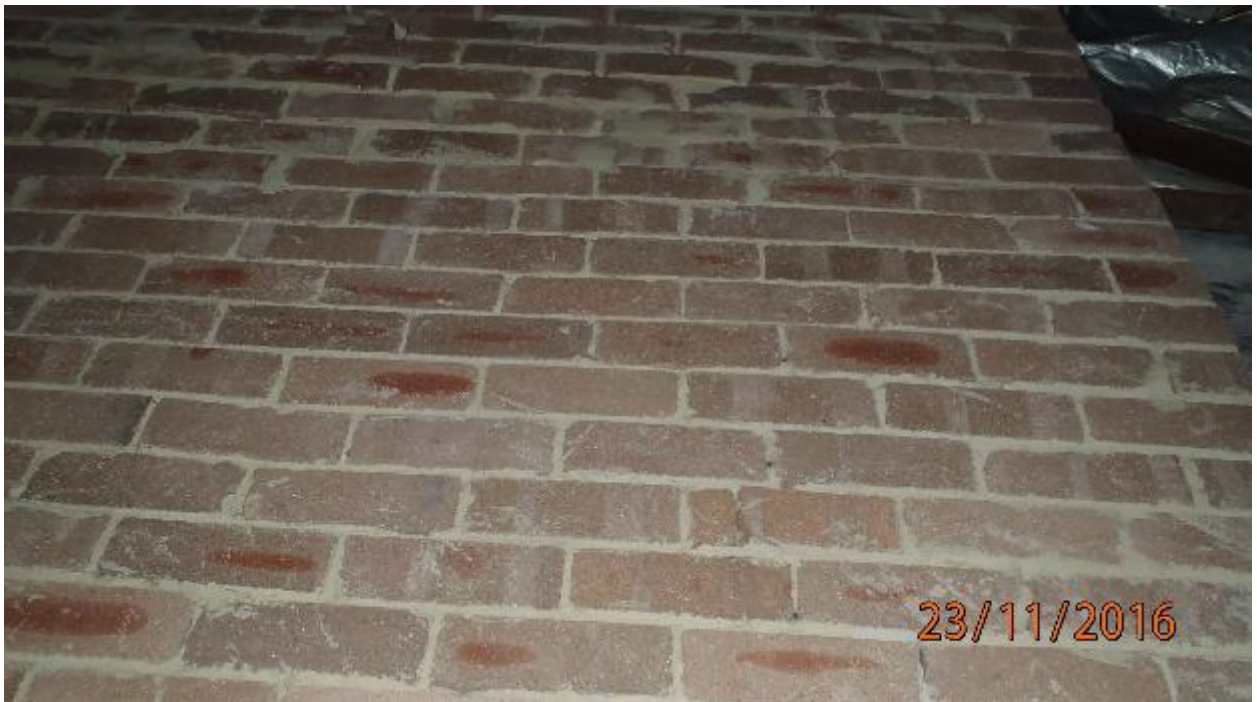
We also noted that the clay brick *common party* wall extends to the underside of the rafters but is incomplete. **[Photograph 19]**

Photograph 19 shows the brick *common party / separation* wall in the roof space. **Note:** the brick wall does not span the entire common roof space.

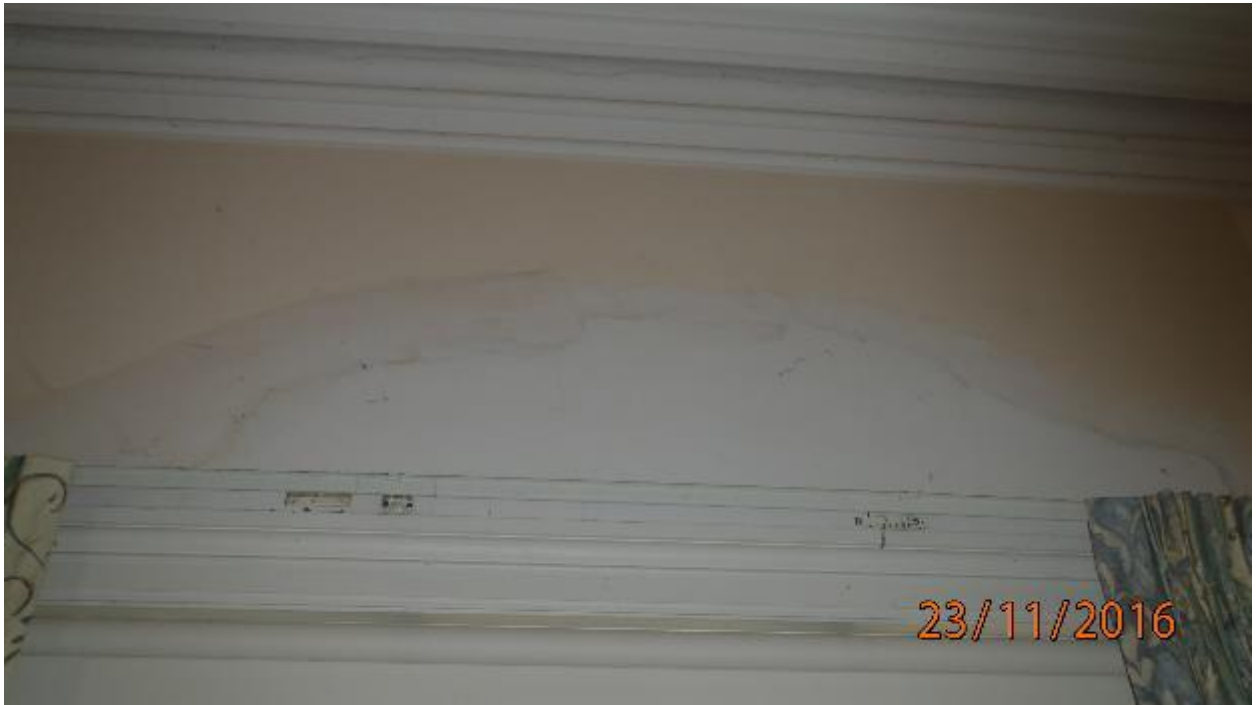
We noted evidence of a previous repair to the painted cement rendered wall above the window. **[Photograph 20]**

Photograph 20 shows evidence of a previous repair to the painted cement rendered wall above the window in Bedroom 1.
