Dilapidation Assessment Report

Prepared for: Cape Cod Australia Pty. Limited
Job address: 30 Alt Street, Queens Park
Property Owner/s: Mr. Doug Murchison
Report reference: **WAVERLEY COUNCIL**
Development Application No: not available
Date of assessment: 23rd November 2016

Re: Dilapidation Report – No. 30 Alt Street, Queens Park. NSW.

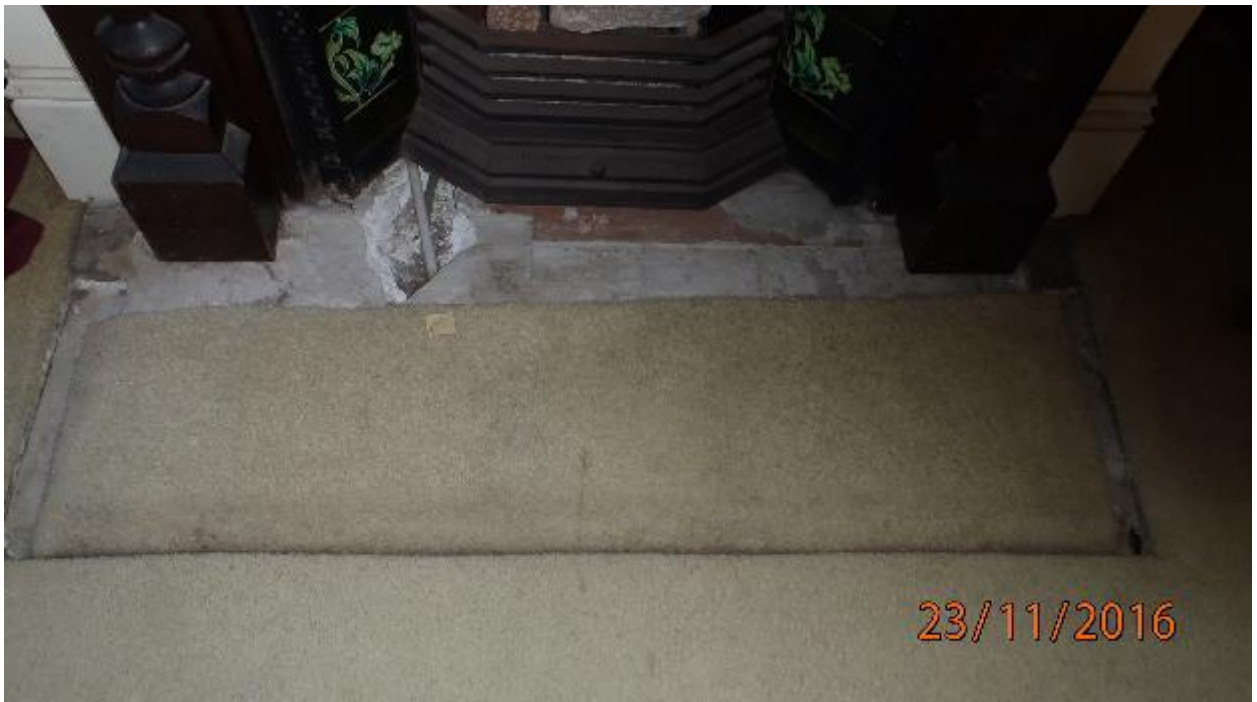
We noted that there are no tiles provided to the hearth of the fireplace. **[Photograph 21]**

Photograph 21 shows no tiles provided to the hearth of the fireplace in Bedroom 1.

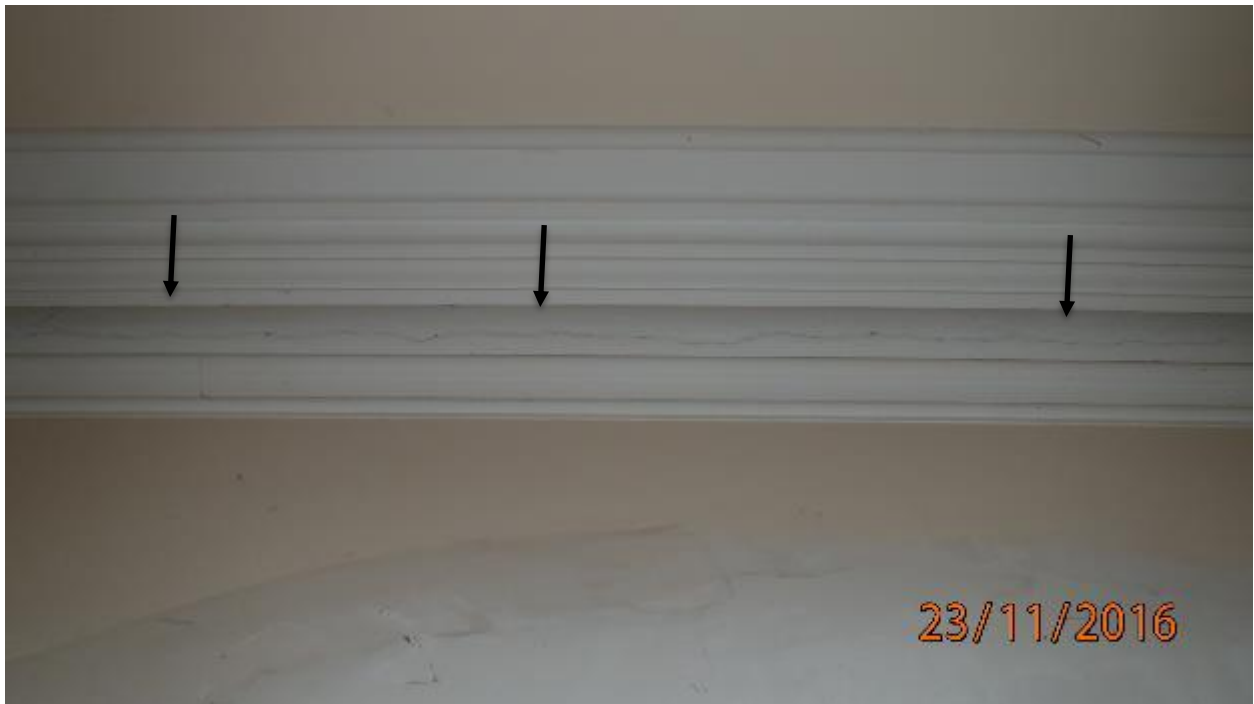
We noted horizontal hairline cracking [$<1.0\text{mm}$] to the wide ornate plaster cornice above the window. **[Photograph 22]**

Photograph 22 shows horizontal cracking to the plaster cornice above the window in Bedroom 1.

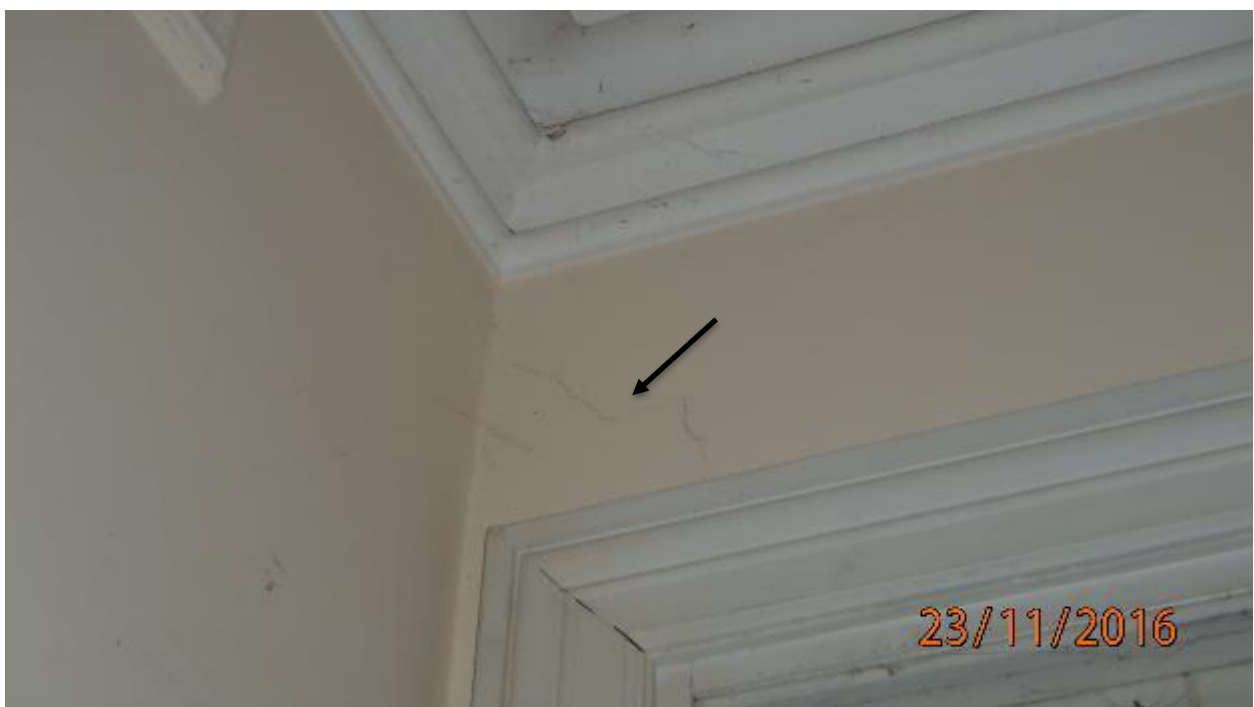
We noted radial hairline cracking [$<1.0\text{mm}$] above the window in the north-western corner. **[Photograph 23]**

Photograph 23 shows radial cracking above the window in the north-western corner of Bedroom 1.

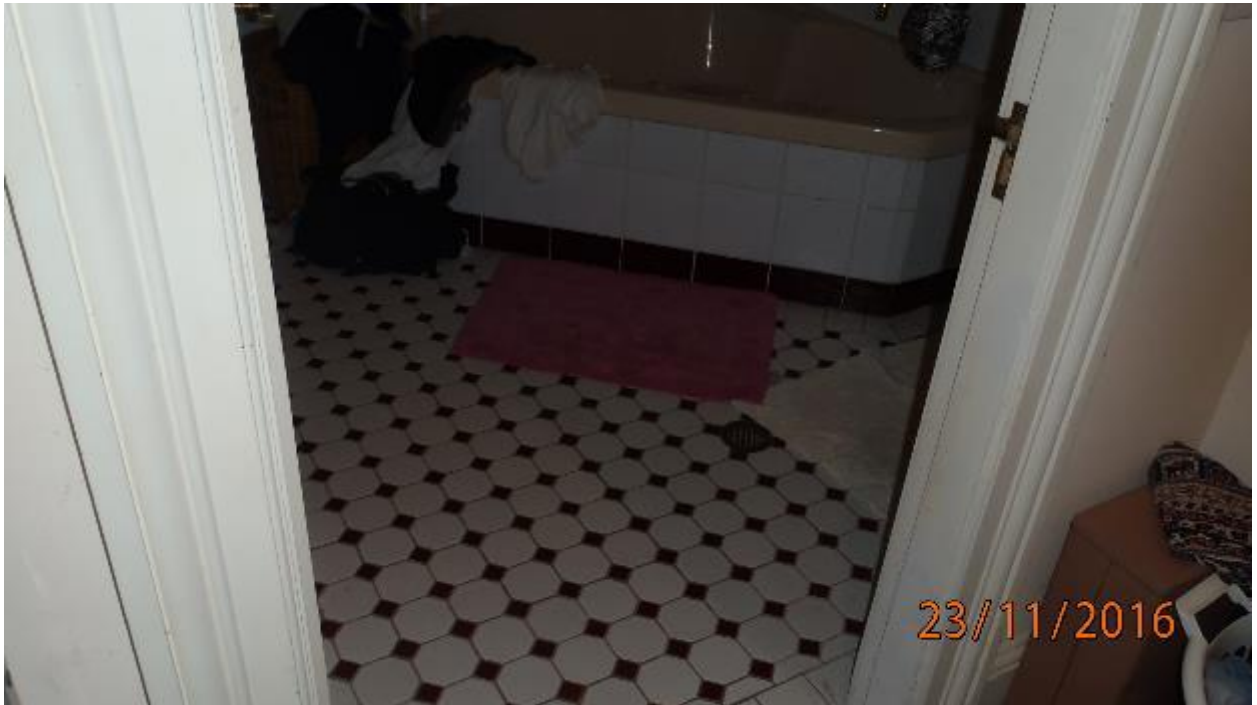
We noted that the grout to the wall and floor tiles is complete and that the wall and floor tiles when randomly “tap” tested appeared to be sound. We did not observe any recent cracking to the tile grout at the wall / wall, wall / floor junctions. **[Photograph 24]**

Photograph 24 shows the general layout of the Bathroom.

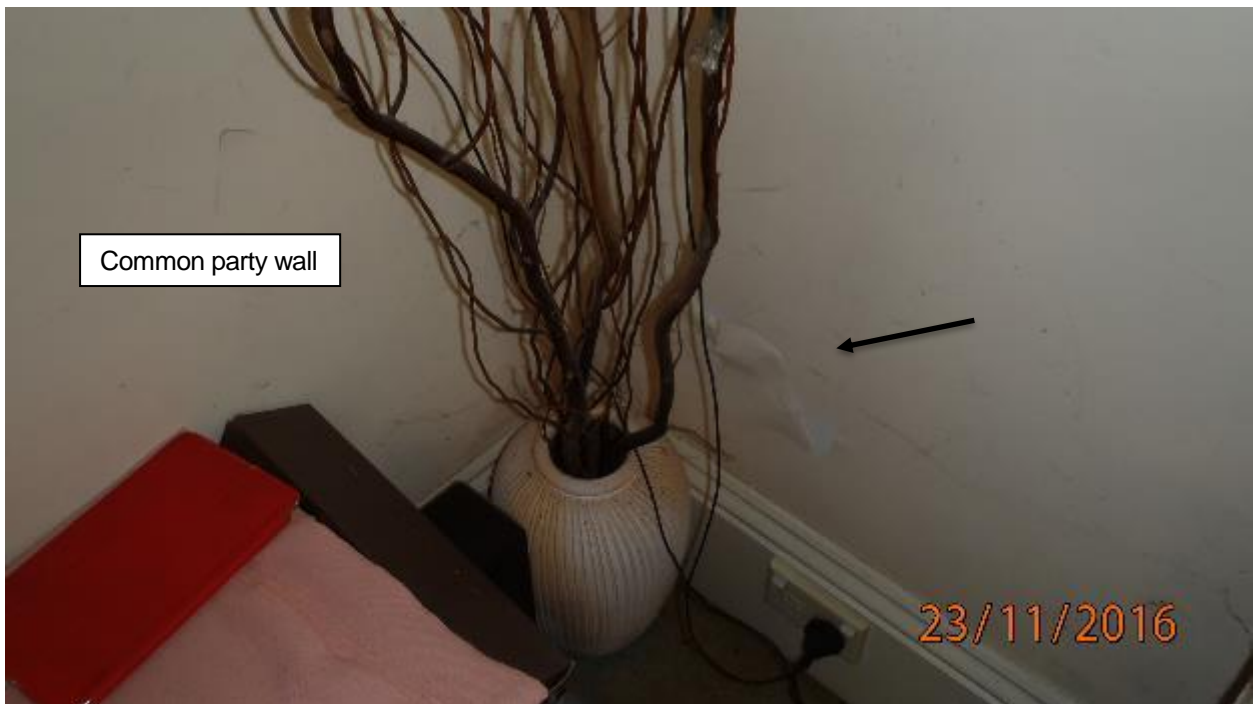
We noted flaking paint to the cement rendered wall in the north-western corner of the room and abutting the common party / separation wall with the adjoining property No. 28 Alt Street, Queens Park. **[Photograph 25]**

Photograph 25 shows flaking paint to the cement rendered wall in the north-western corner of the Dining Room and abutting the common party / separation wall with the adjoining property No. 28 Alt Street, Queens Park.

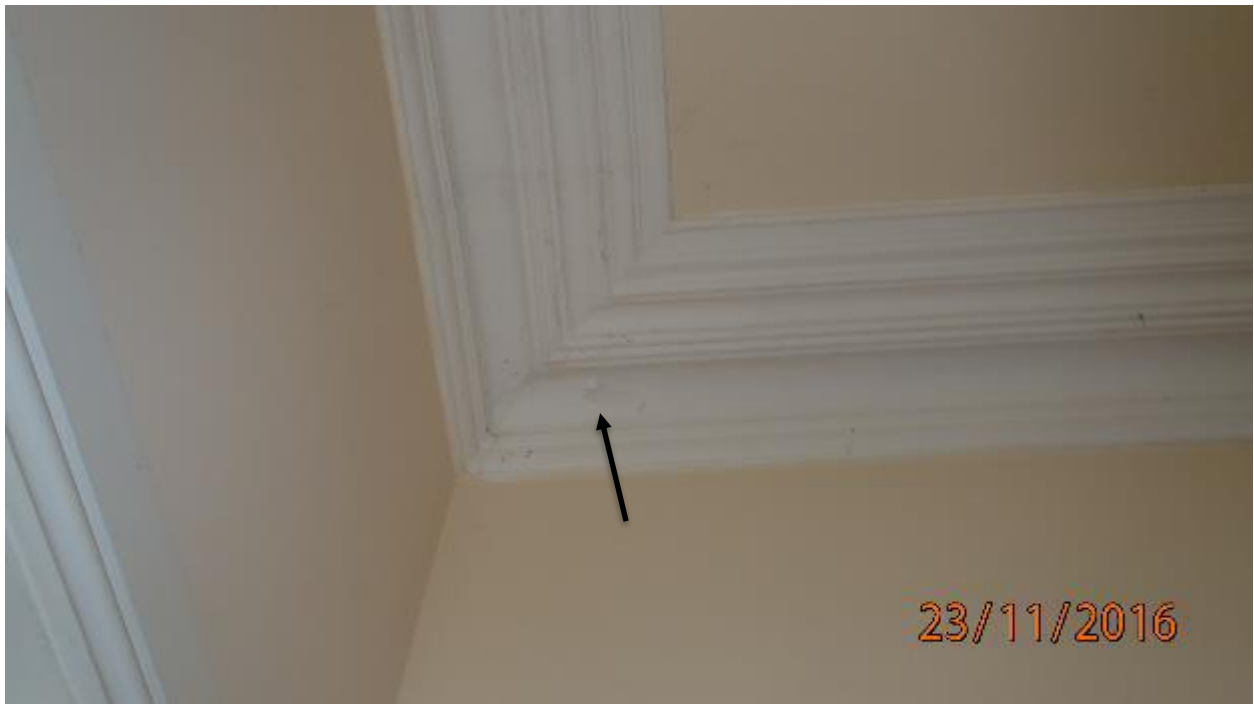
We noted flaking paint to the decorative plaster cornice in the north-western corner of the room. **[Photograph 26]**

Photograph 26 shows flaking paint to the plaster cornice in the north-western corner of the Dining Room.

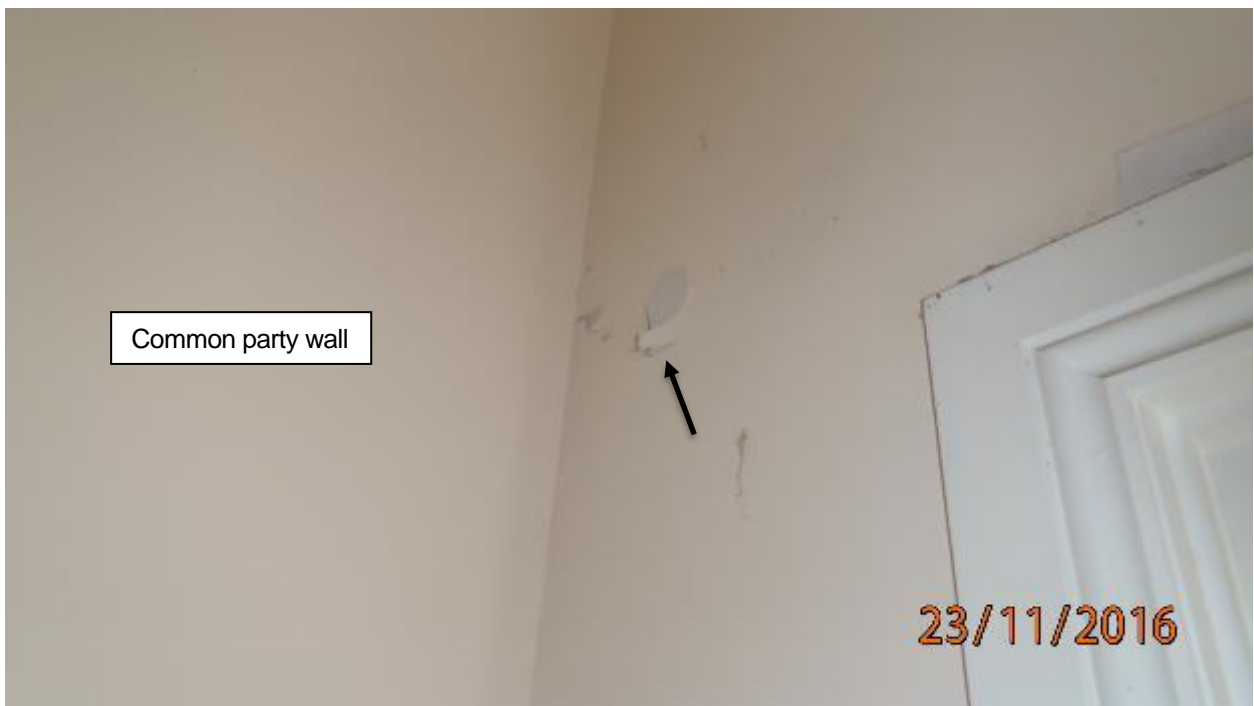
We noted flaking paint to the cement rendered wall in the north-eastern corner of the room and abutting the common party / separation wall with the adjoining property No. 28 Alt Street, Queens Park. **[Photograph 27]**

Photograph 27 shows flaking paint to the cement rendered wall in the north-eastern corner of the Dining Room and abutting the common party / separation wall with the adjoining property No. 28 Alt Street, Queens Park.

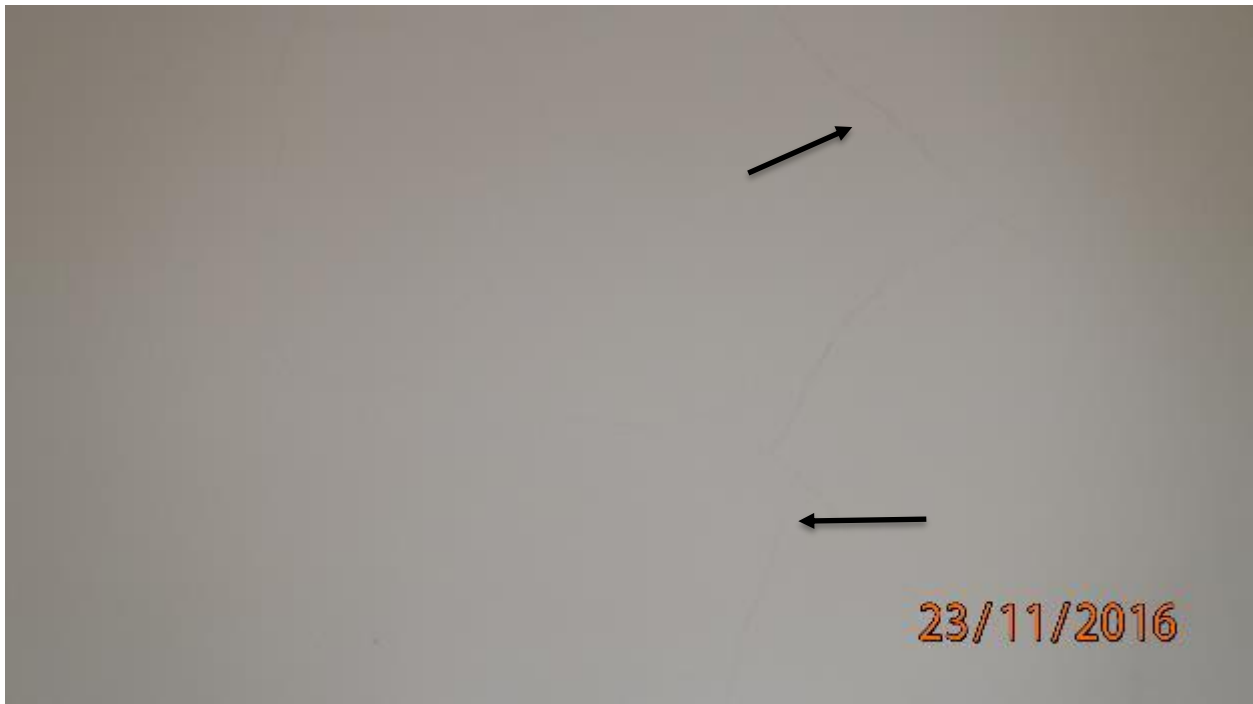
We noted radial hairline cracking [$<1.0\text{mm}$] to the *common party / separation* wall with the adjoining property No. 28 Alt Street, Queens Park. **[Photograph 28]**

Photograph 28 shows radial hairline cracking to the common party / separation wall with the adjoining property No. 28 Alt Street, Queens Park.

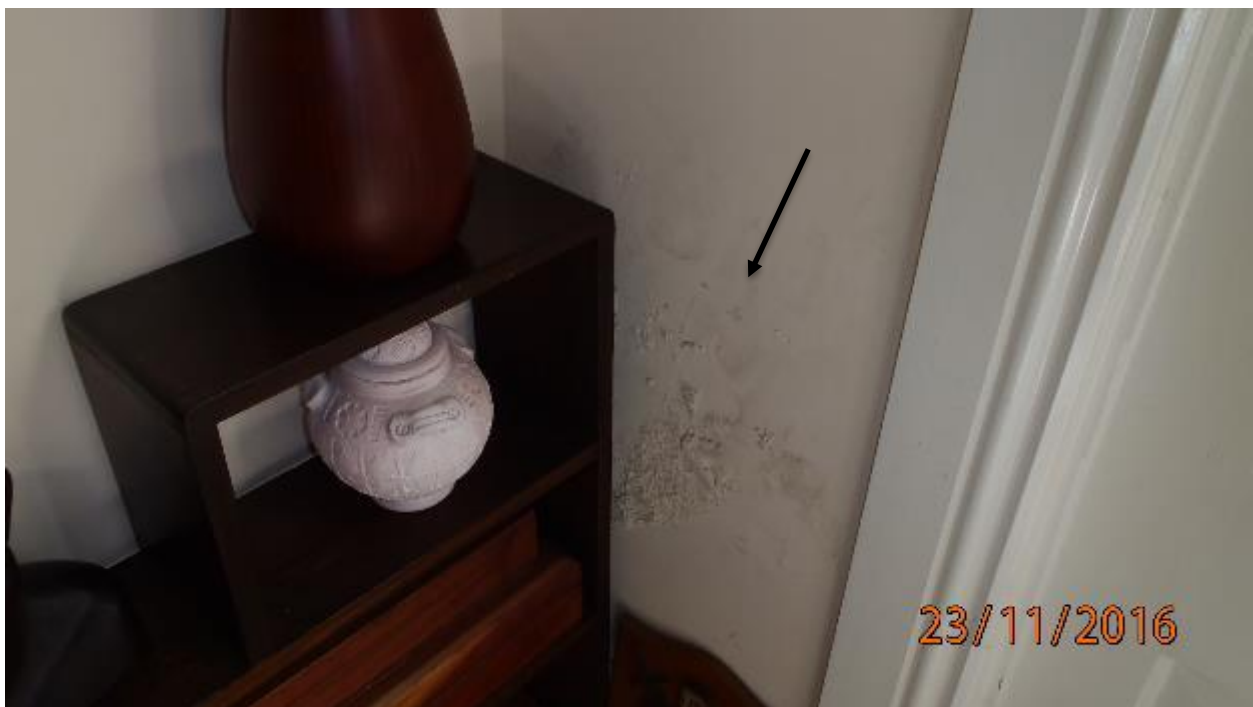
We noted areas of flaking / lifting paint to the north-eastern wall adjacent to the *common party / separation* wall with the adjoining property No. 28 Alt Street, Queens Park. This, in our experience, is consistent with rising damp. **[Photograph 29]**

Photograph 29 shows flaking / lifting paint to the north-eastern wall adjacent to the common party / separation wall with the adjoining property No. 28 Alt Street, Queens Park

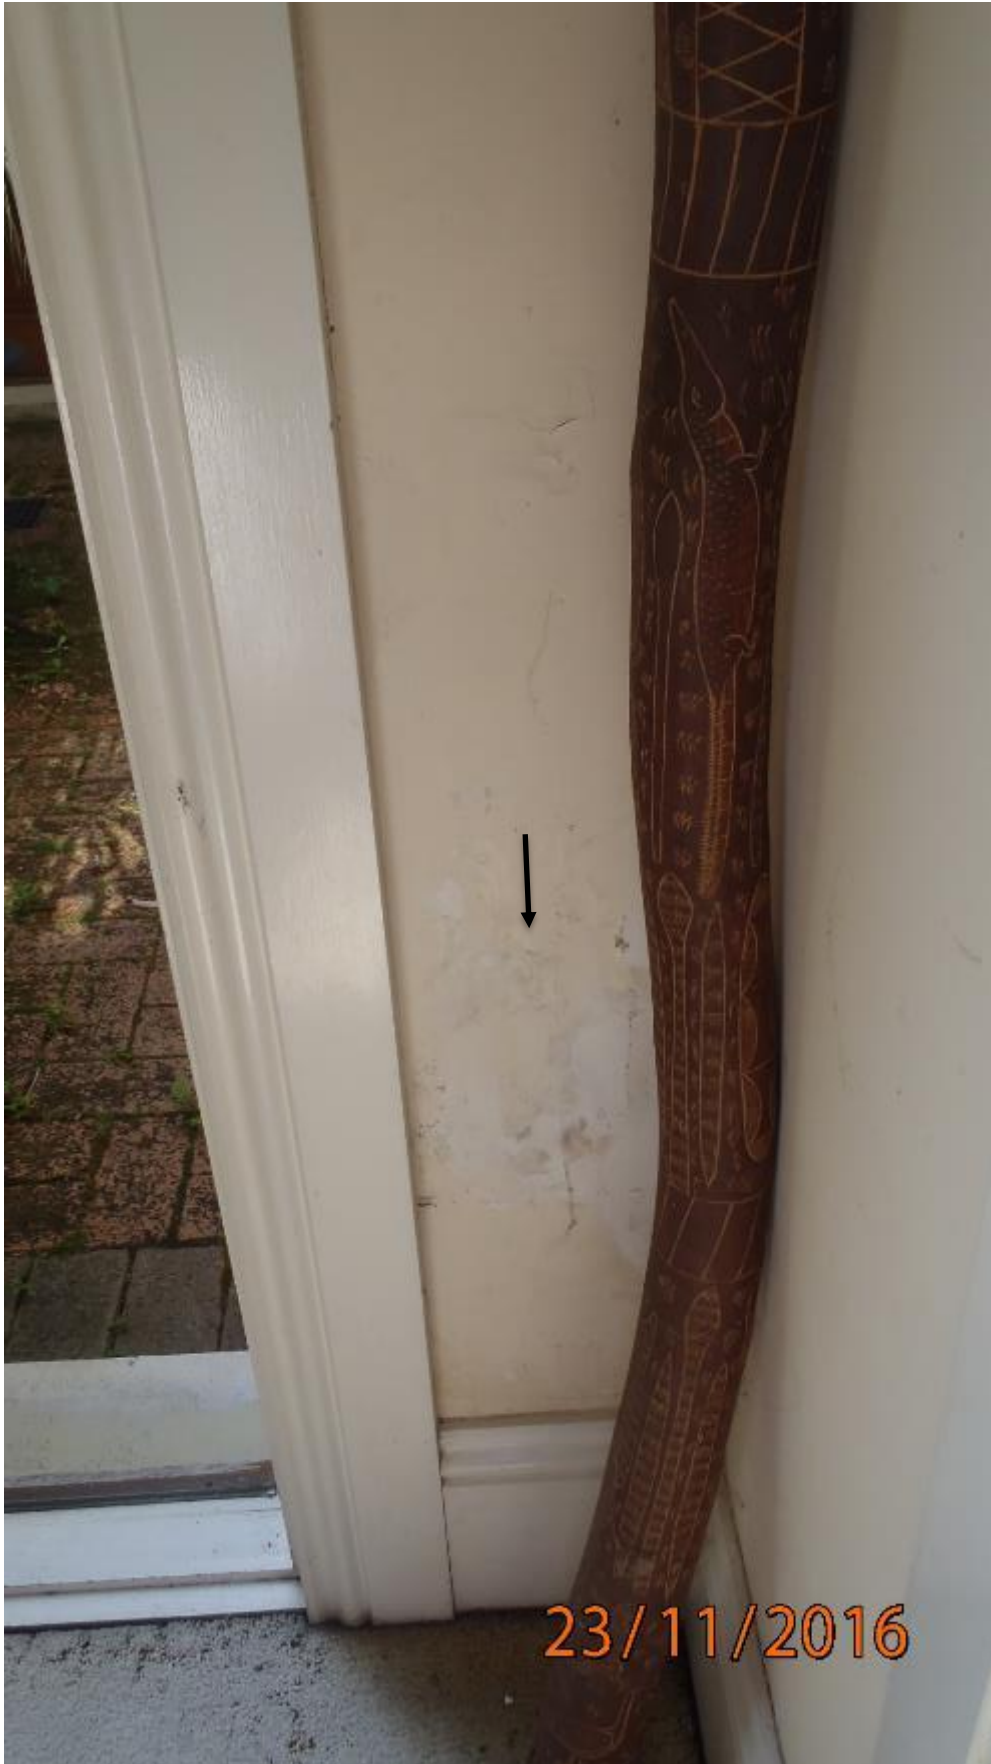
We noted flaking paint to the cement rendered external wall adjacent to the door. **[Photograph 30]**

Photograph 30 shows flaking paint to the cement rendered external wall adjacent to the door in the Dining Room.

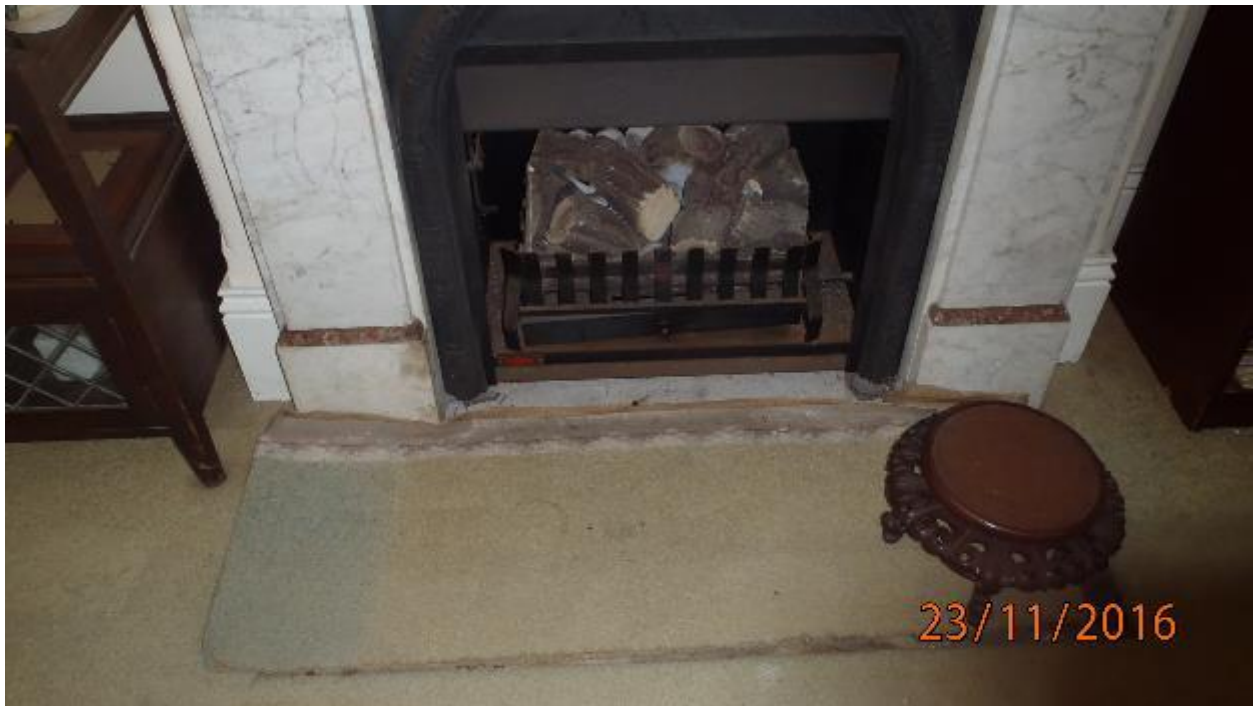
We noted that there are no tiles provided to the hearth of the fireplace. **[Photograph 31]**

Photograph 31 shows no tiles provided to the hearth of the fireplace in the Lounge Room.

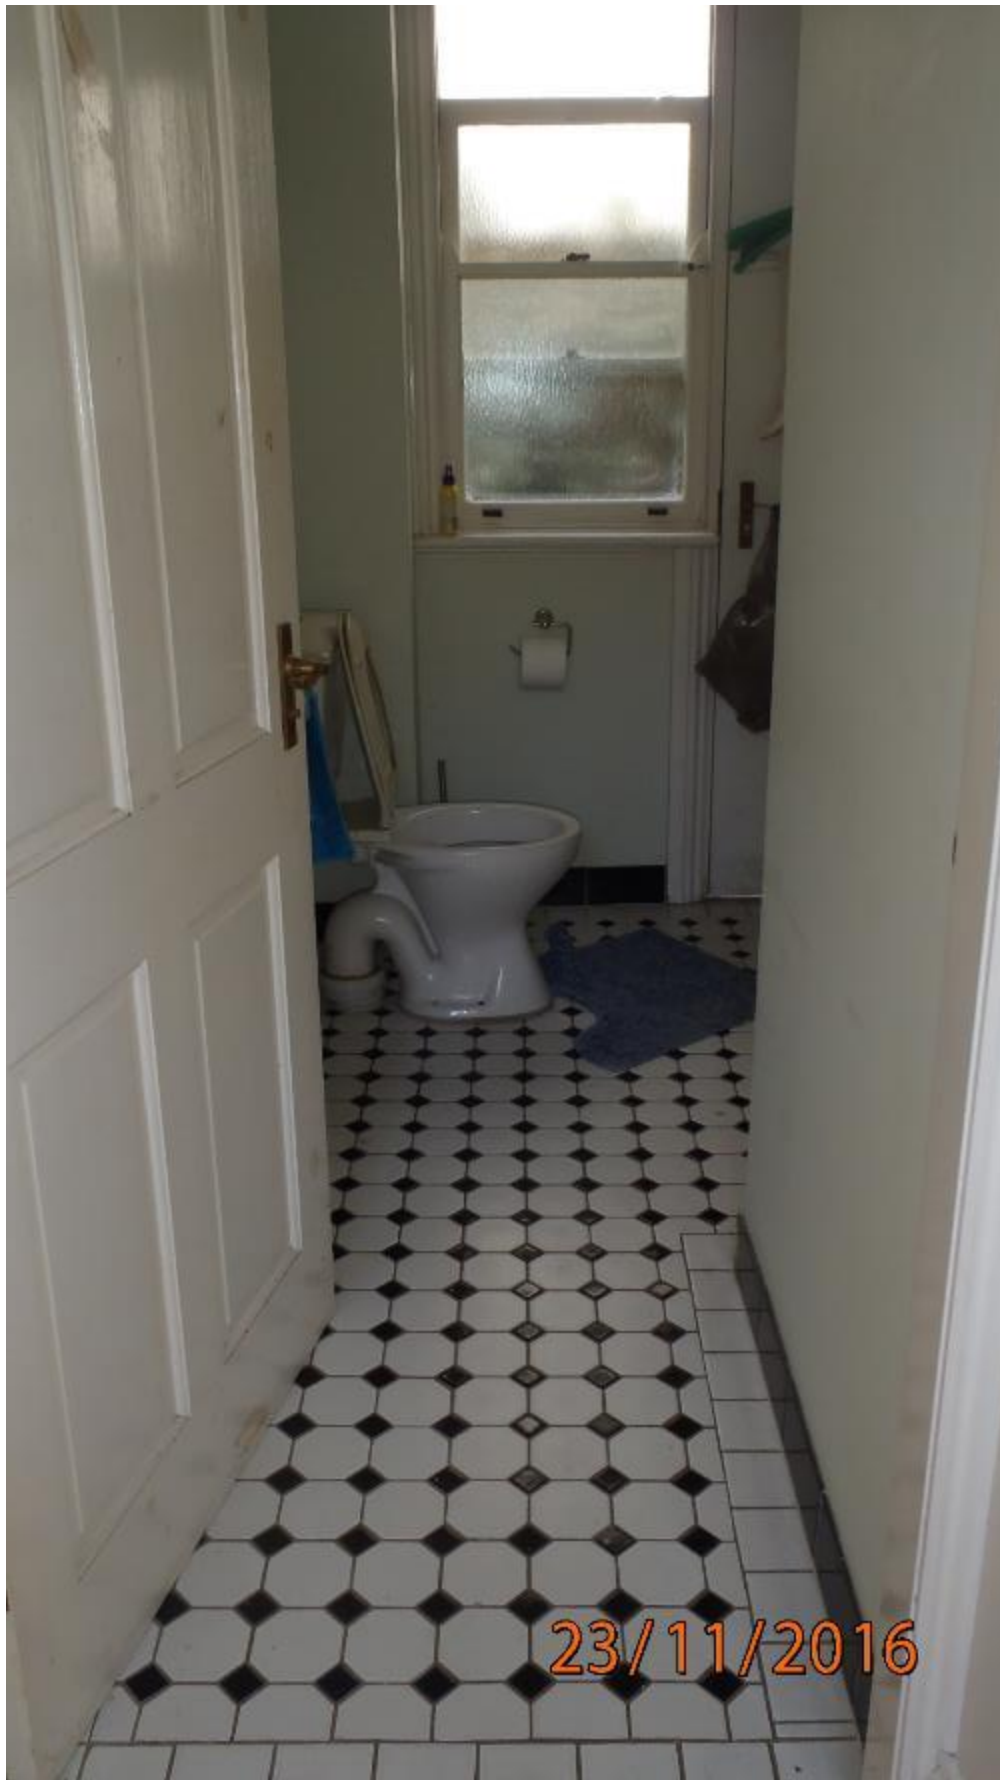
We noted that the grout to the floor tiles is complete and that the tiles when randomly “tap” tested appeared to be sound. **[Photograph 32]**

Photograph 32 shows the general condition of the Laundry floor tiles.

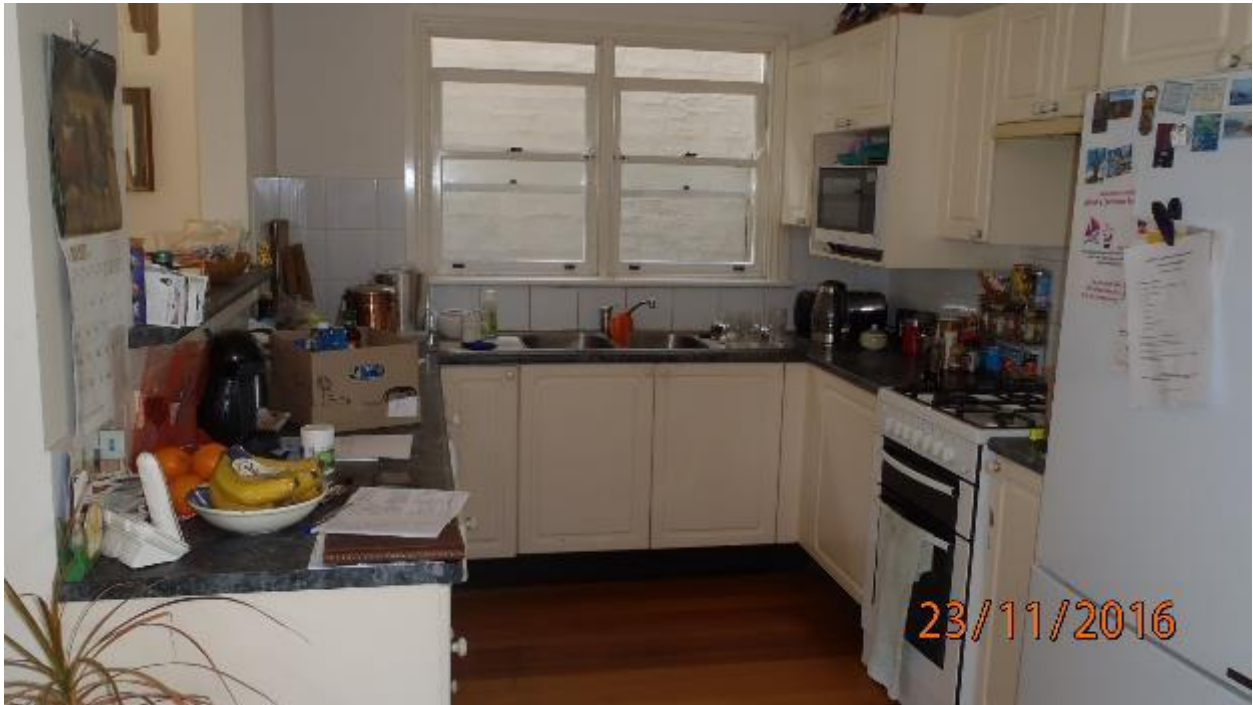
We noted that the floor is finished with polished timber boards. **[Photograph 33]**

Photograph 33 shows the general layout of the Kitchen.

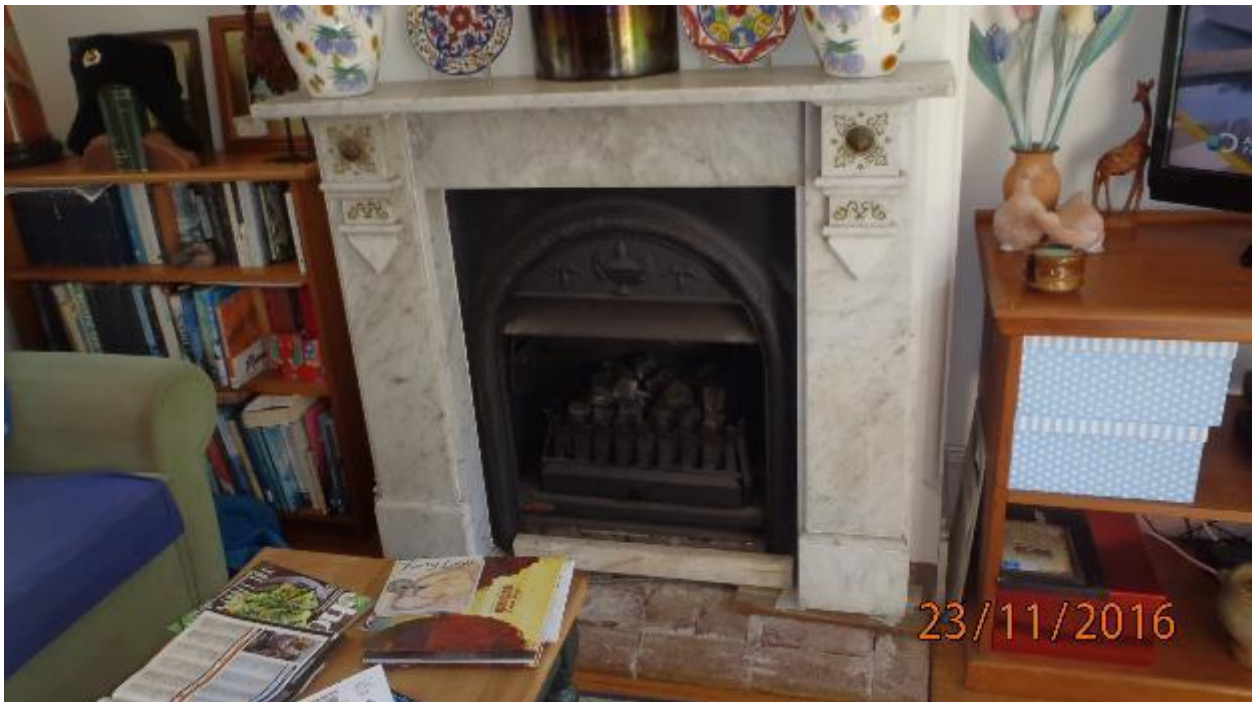
We noted a fireplace built in to the *common party / separation* wall with the adjoining property, No. 28 Alt Street, Queens Park. **[Photograph 34]**

Photograph 34 shows the fireplace built into the common party / separation wall with the adjoining property, No. 28 Alt Street, Queens Park in the Family Room.

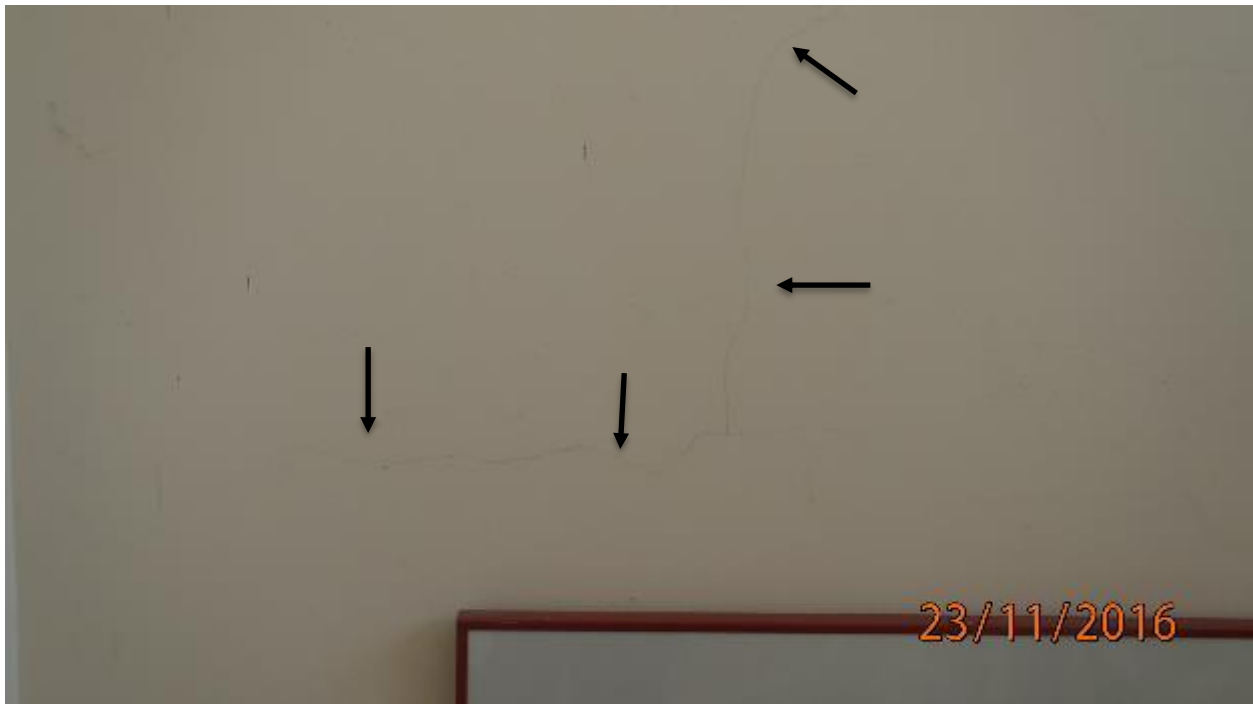
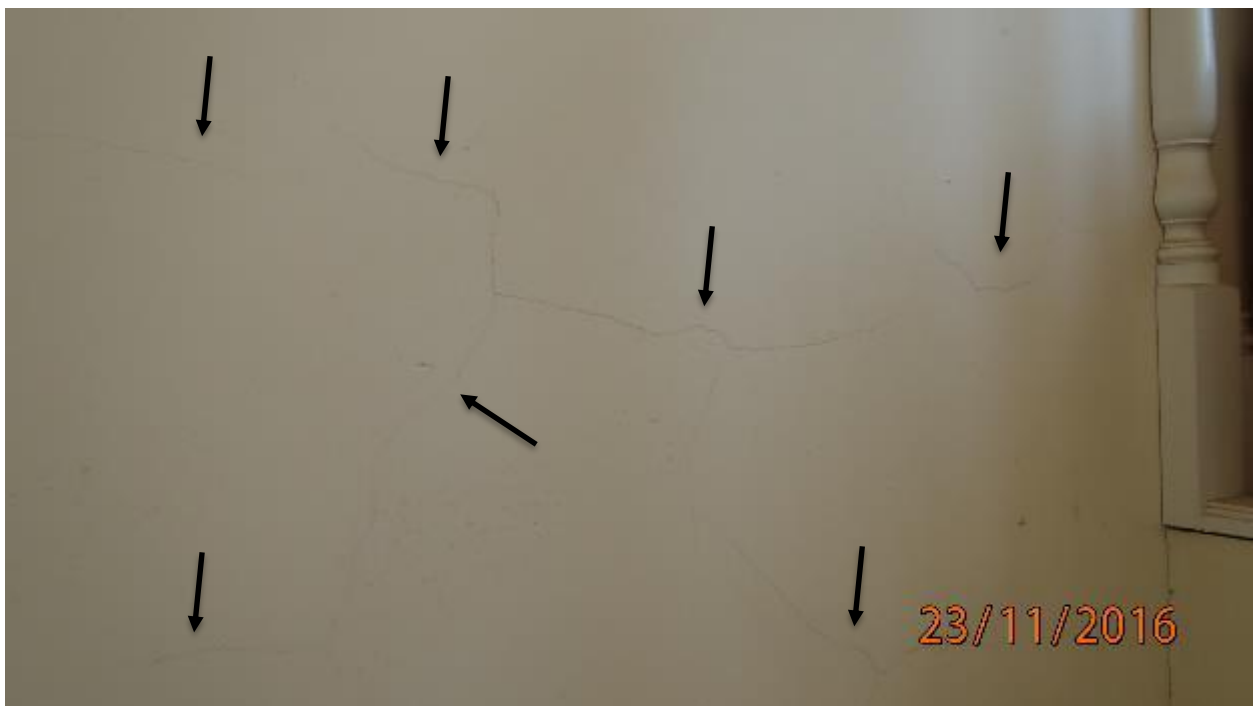
We noted step cracking [$<1.0\text{mm}$] to the painted cement rendered wall on the western wall. **[Photographs 35 & 36]**

Photograph 35 shows step cracking to the painted cement rendered wall on the western wall of the stairwell.

Photograph 36 shows step cracking to the painted cement rendered wall on the western wall of the stairwell.

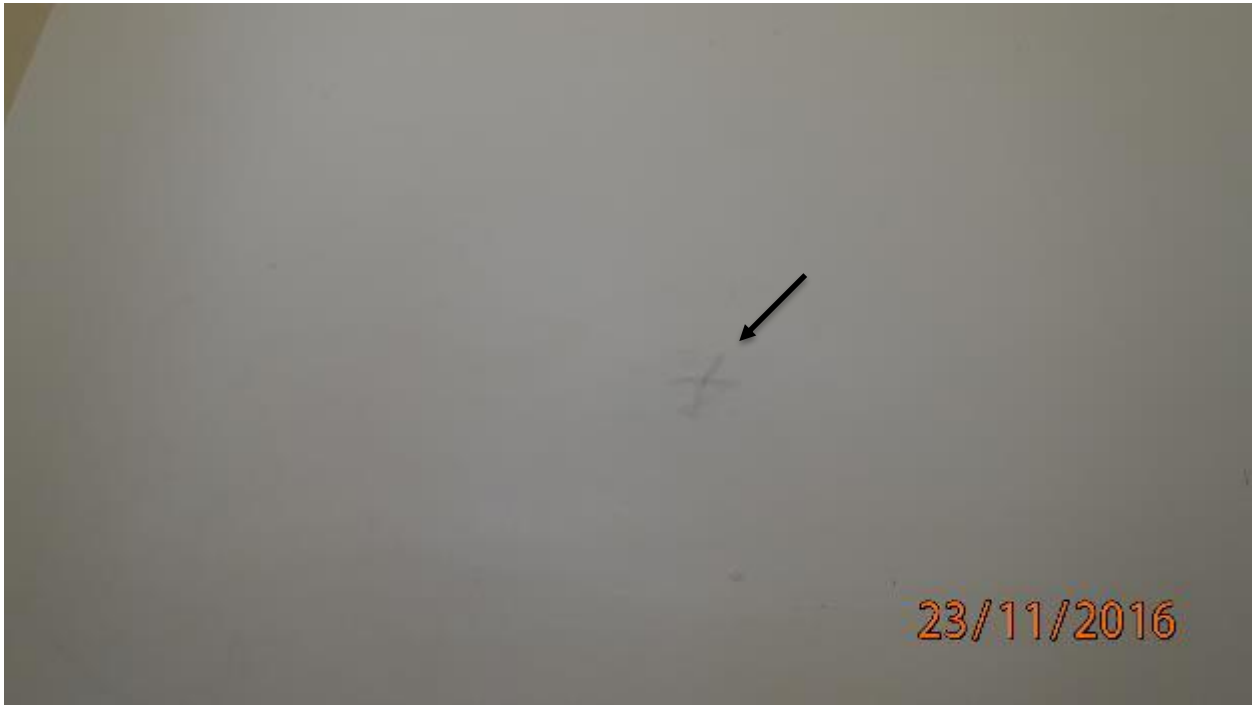
We noted flaking paint to the southern wall surface. **[Photograph 37]**

Photograph 37 shows flaking paint to the southern wall surface of the stairwell.

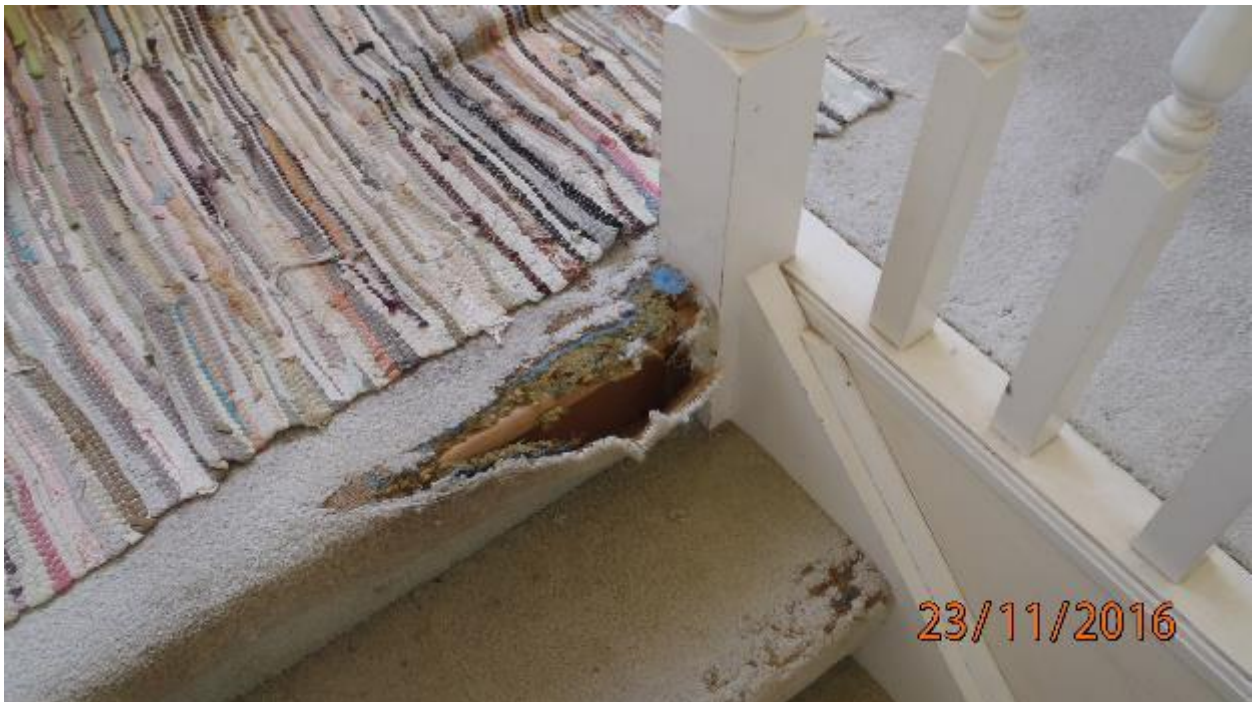
We noted damage to the carpet at the top of the stairwell. **[Photograph 38]**

Photograph 38 shows the condition of the carpet at the top of the staircase.

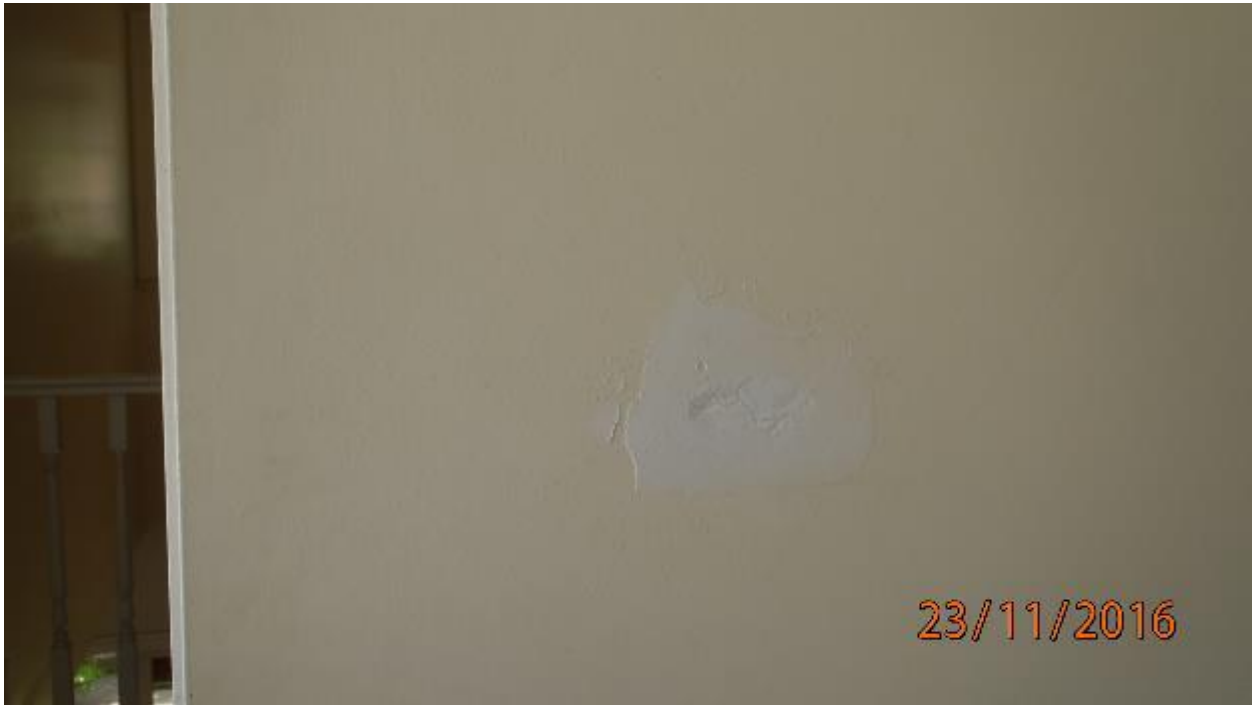
We noted damage to the plasterboard wall surface and evidence of a previous repair to the eastern wall common with Bedroom 2. **[Photograph 39]**

Photograph 39 shows damage to the plasterboard wall surface and evidence of a previous repair to the eastern wall outside Bedroom 2.

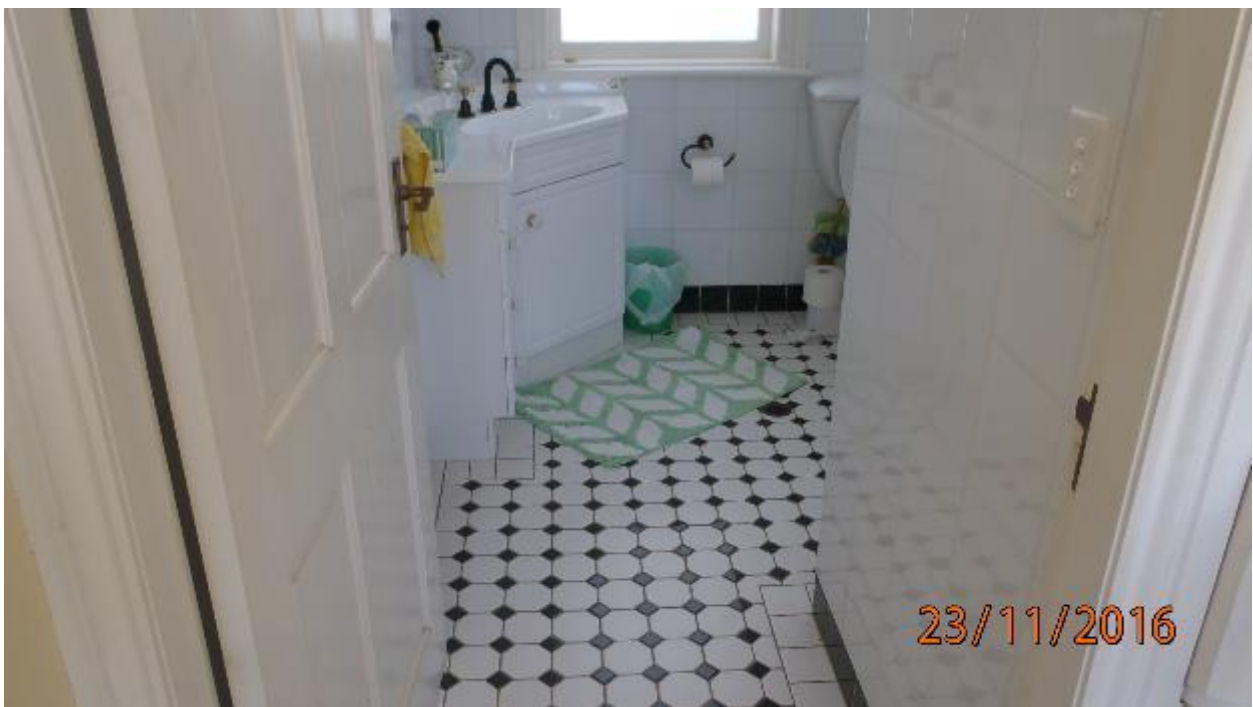
We noted that the grout to the wall and floor tiles is complete and that the wall and floor tiles when randomly "tap" tested appeared to be sound. We did not observe any recent cracking to the tile grout at the wall / wall, wall / floor junctions. **[Photograph 40]**

Photograph 40 shows the general condition of the first floor Bathroom.

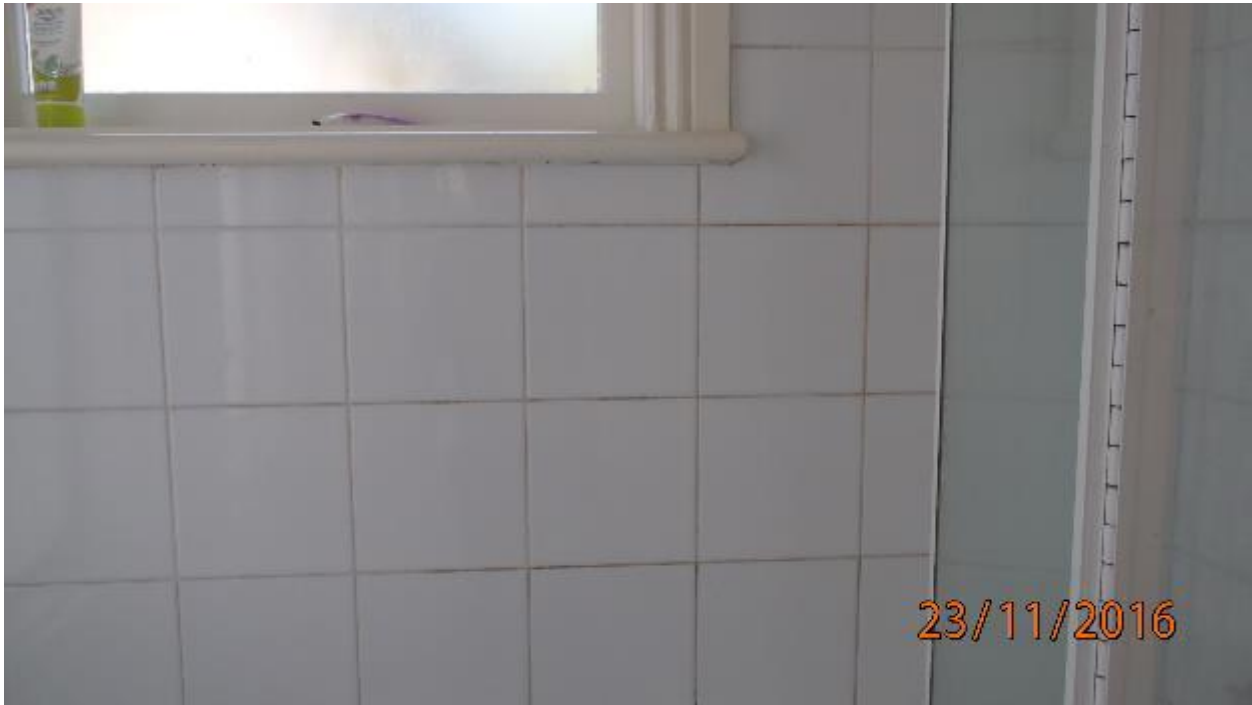
We noted hairline radial cracking to the ceramic tiled surface extending outward from the window sill. **[Photograph 41]**

We noted mildew / mould growth to the tile grout under the window. **[Photograph 41]**

Photograph 41 shows hairline radial cracking to the ceramic tiled surface and mildew / mould growth to the tile grout under the window in the first floor Bathroom.

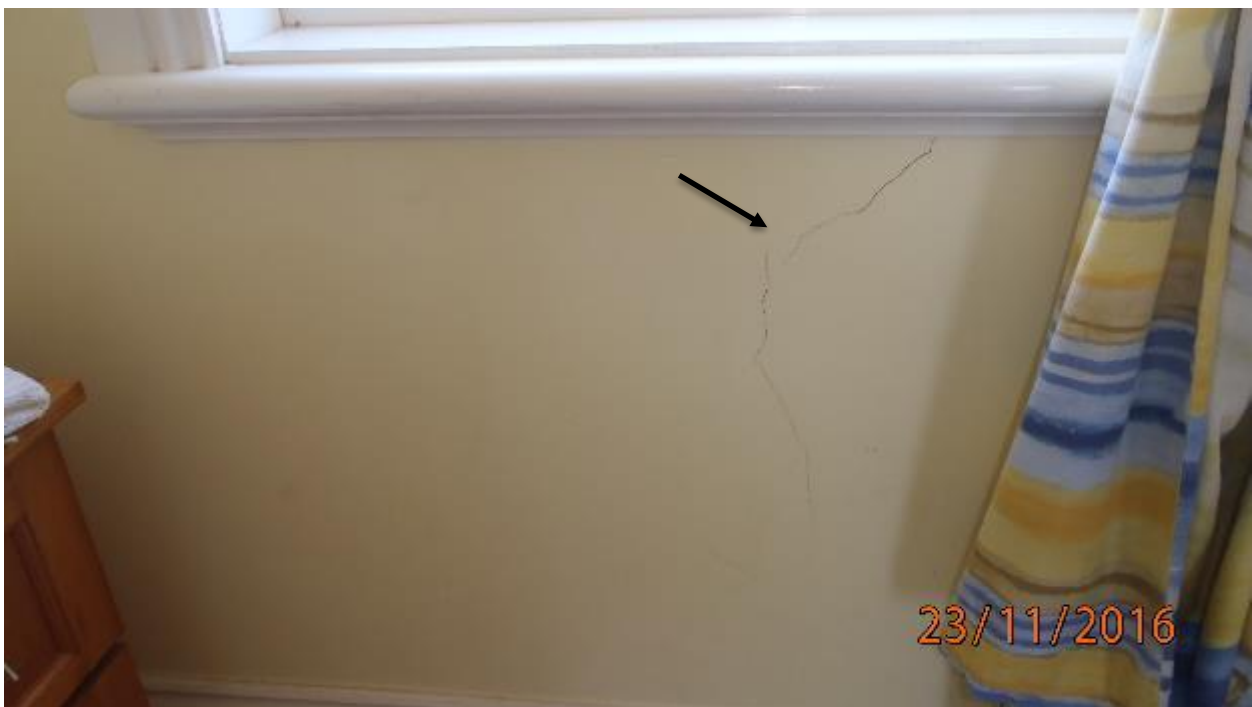
We noted radial cracking [$<1.0\text{mm}$] to the plasterboard wall extending from below the timber window sill. **[Photograph 42]**

Photograph 42 shows radial cracking to the plasterboard wall extending from below the timber window sill in Bedroom 2.
