Dilapidation Assessment Report

Prepared for: Cape Cod Australia Pty. Limited
Job address: 30 Alt Street, Queens Park
Property Owner/s: Mr. Doug Murchison
Report reference: **WAVERLEY COUNCIL**
Development Application No: not available
Date of assessment: 23rd November 2016

Re: Dilapidation Report – No. 30 Alt Street, Queens Park. NSW.

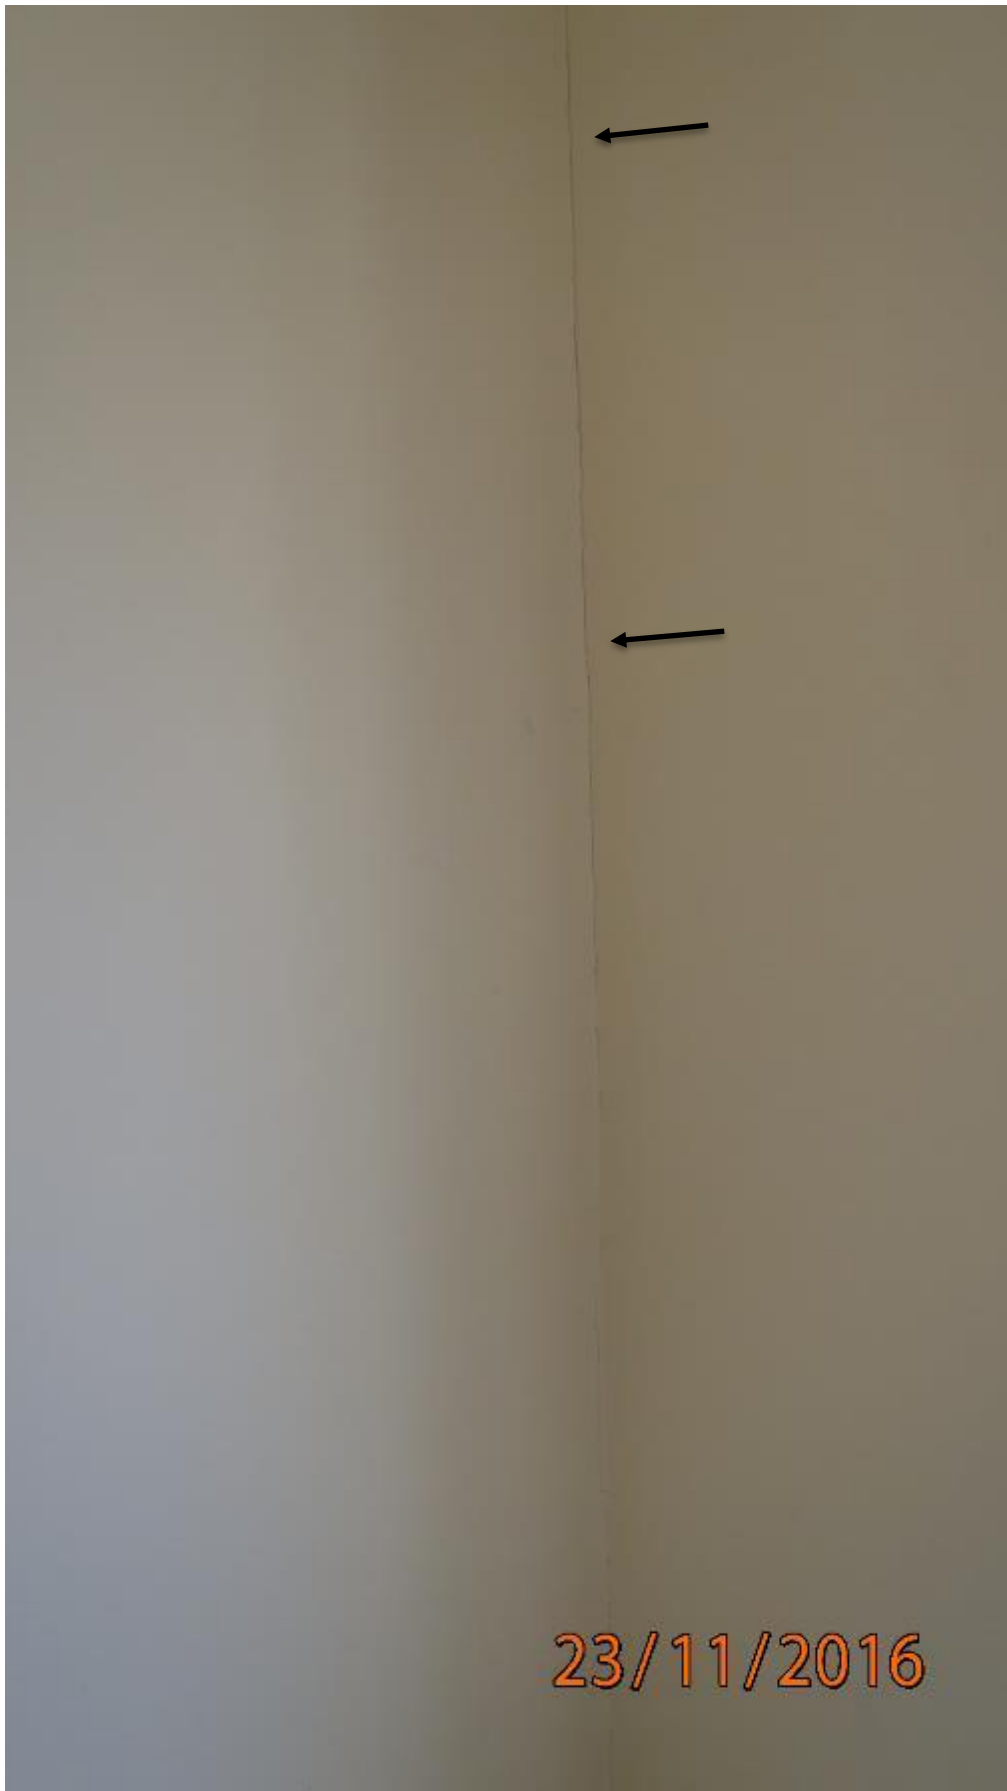
We noted vertical cracking [$<1.0\text{mm}$] to the wall to wall junction of the plasterboard walls in the south-eastern corner. **[Photograph 43]**

Photograph 43 shows cracking to the wall to wall junction of the plasterboard walls in the south-eastern corner in Bedroom 2.

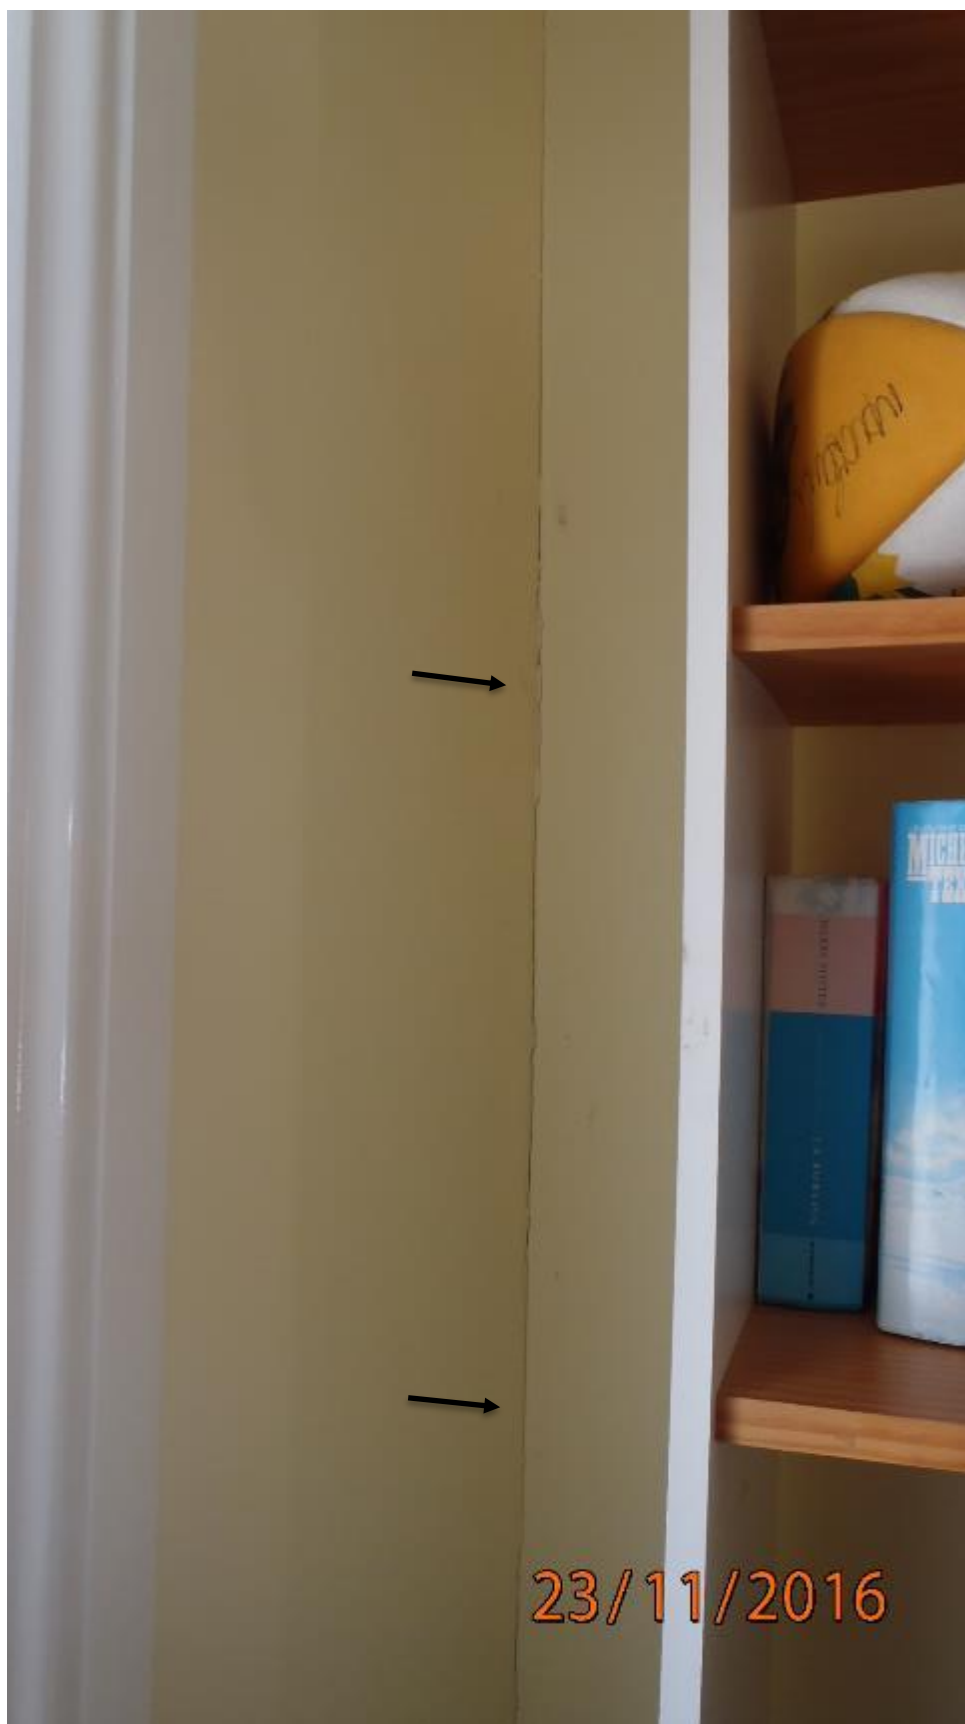
We noted vertical cracking [$<1.0\text{mm}$] to the wall to wall junction of the plasterboard walls in the south-western corner. **[Photograph 44]**

Photograph 44 shows cracking to the wall to wall junction of the plasterboard walls in the south-western corner in Bedroom 2.

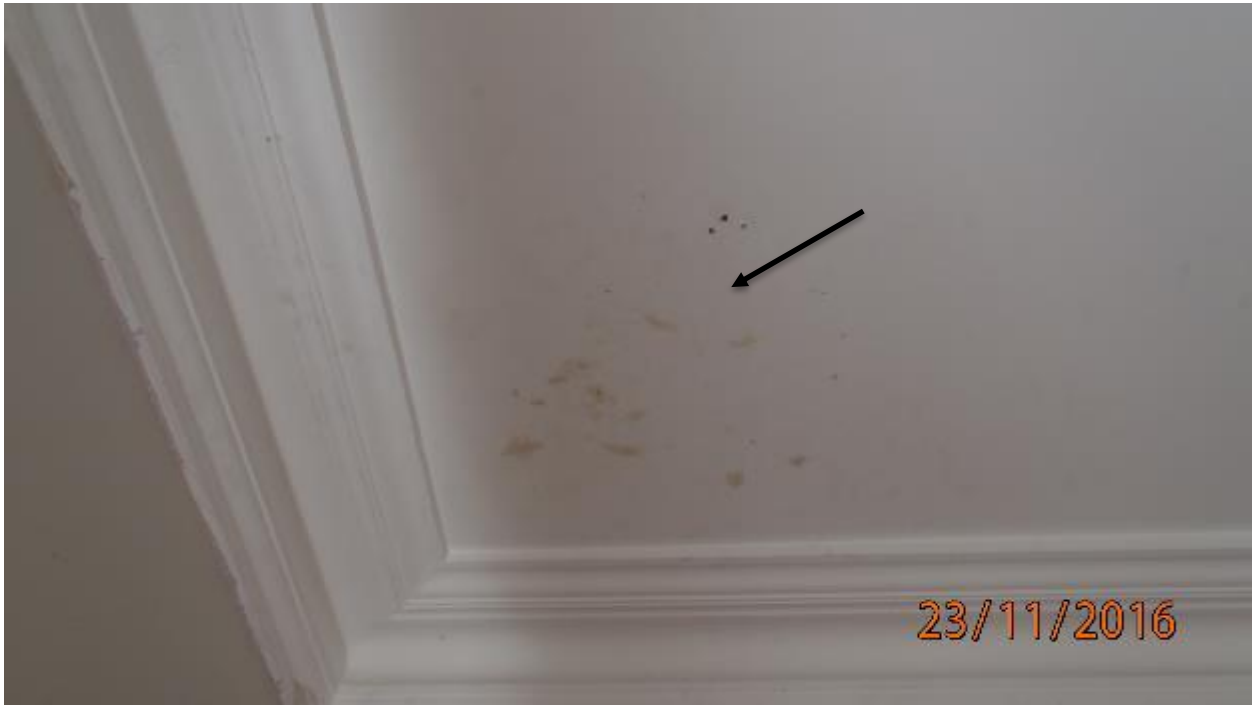
We noted staining to the plaster ceiling lining in the south-eastern corner. **[Photograph 45]**

Photograph 45 shows staining to the plaster ceiling lining in the south-eastern corner in Bedroom 3.
