HAZARDOUS MATERIALS ASSESSMENT REPORT

Job details: Owner: Mr. D Di Francesco & Ms. A. Hemmings
Location: 51 Eastern Avenue, Kingsford.

Our reference: HM05160916

Date of Issue: 5th September 2016

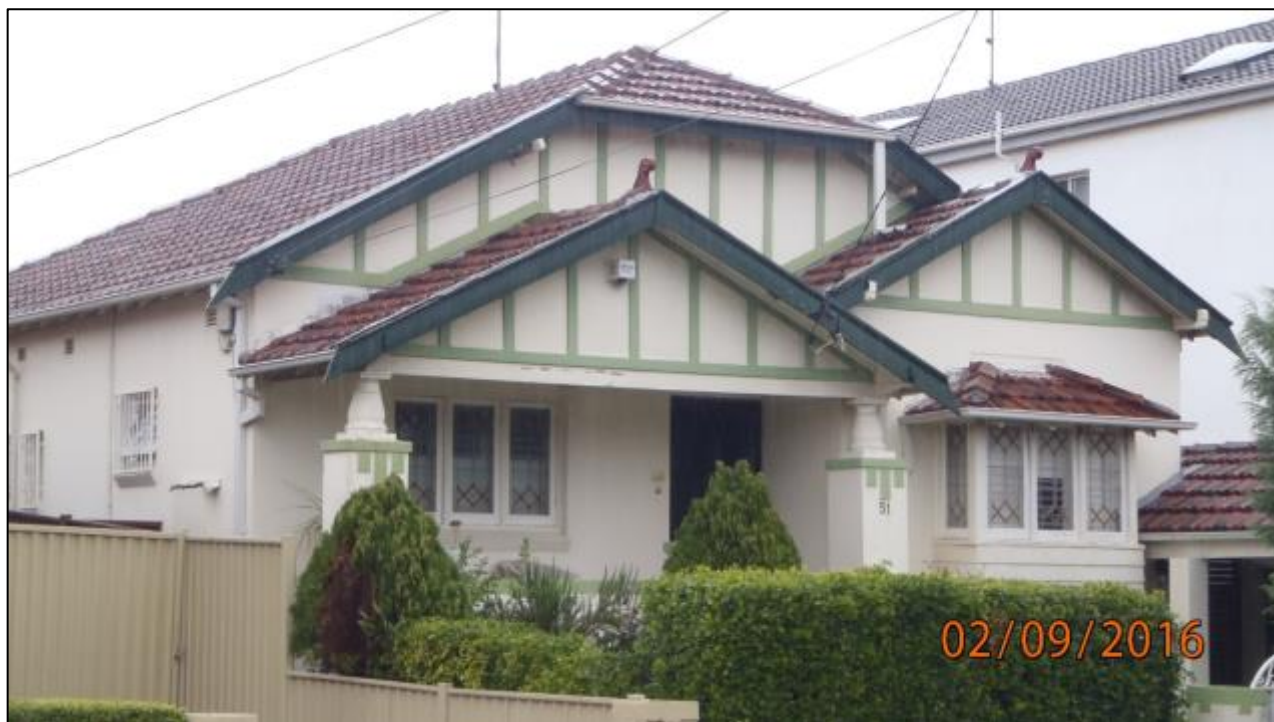
Front western elevation of the residence
