## **HAZARDOUS MATERIALS ASSESSMENT REPORT**

**Job details:** Owner/s: Mr. P. & Mrs. E. Keogh  
Location: 68 King Street, Eastlakes NSW

**Date of assessment:** 20<sup>th</sup> November 2014

**Our reference:** HM03531114

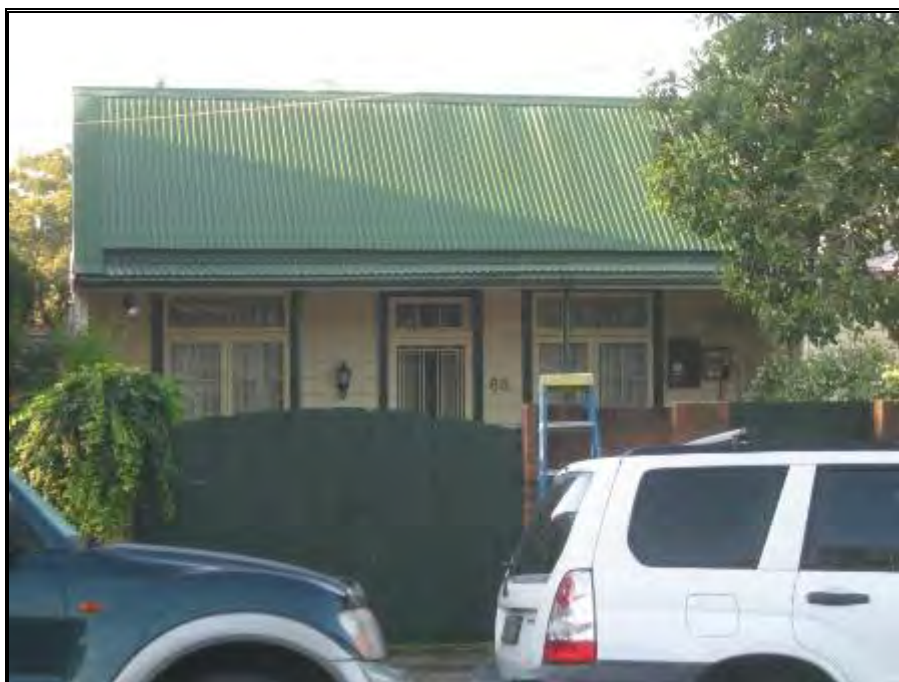
**Front northern elevation of the residence**
