HAZARDOUS MATERIALS ASSESSMENT REPORT

Client: Cape Cod Australia Pty. Limited

Job details: Owner: Mr. W. & Mrs. C. Radley.
Location: 10 Gwandalan Crescent, Berowra.

Our reference: HM06211017

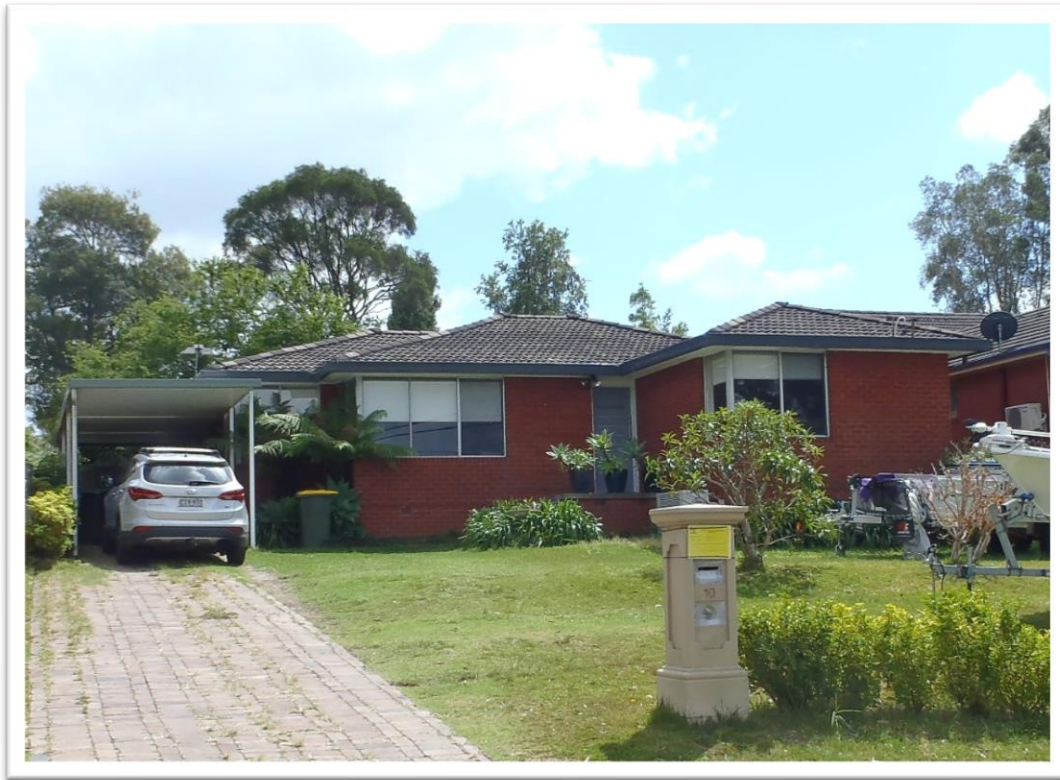
Front southern elevation of the residence
