HAZARDOUS MATERIALS ASSESSMENT REPORT

Job details: Owner: Mrs. E. Needs
Location: 6 Jodie Place, Quakers Hill NSW

Date of assessment: 9th March 2015

Our reference: HM03760315

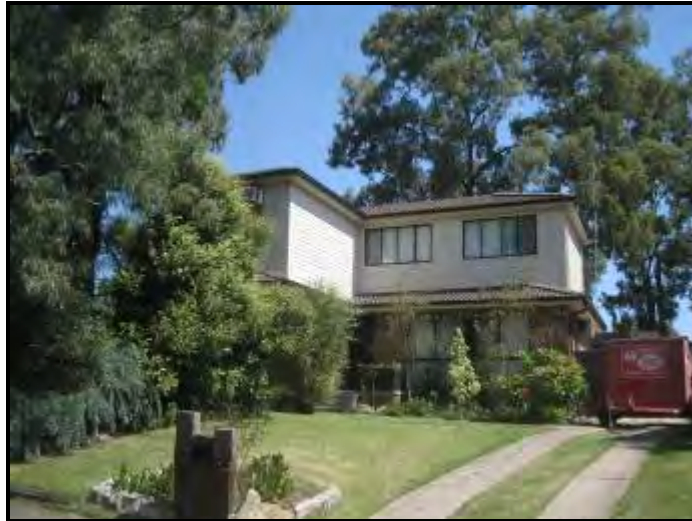
Front north eastern elevation of the residence
