## **HAZARDOUS MATERIALS ASSESSMENT REPORT**

**Job details:** Owner/s: Mr. J. & Mrs. L. Ravulo  
Location: 35 Garrong Road, Lakemba NSW

**Date of assessment:** 4<sup>th</sup> March 2016

**Our reference:** HM04670216

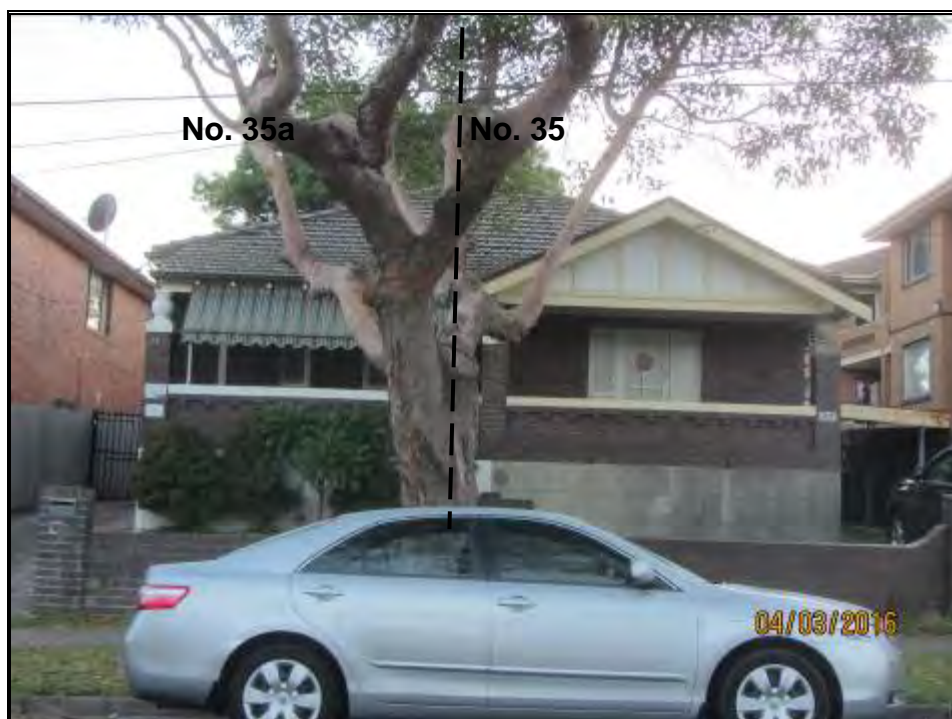
Front south western elevation of the adjoining properties:  
No. 35 & No. 35A Garrong Road, Lakemba
