HAZARDOUS MATERIALS ASSESSMENT REPORT

Client: Cape Cod Australia Pty. Limited

Job details: Owner/s: Mr. M. Carter & Ms. D. Zhai
Location: 15 Fraser Road, Normanhurst

Our reference: HM03320914

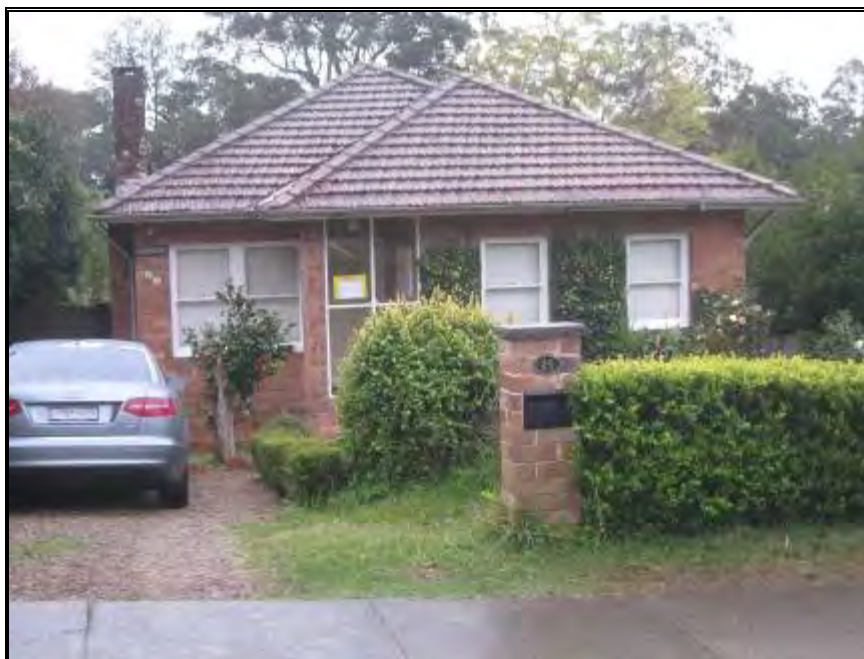
Front southern elevation of the residence
