Dilapidation Assessment Report

Prepared for: Cape Cod Australia Pty. Limited
Job address: 362 Avoca Street, Kingsford.
Property Owner/s: Mrs. Gordana Poljak.
Report reference: **RANDWICK CITY COUNCIL**
Development Application No: not available
Date of assessment: 18th August 2016.

Re: Dilapidation Report

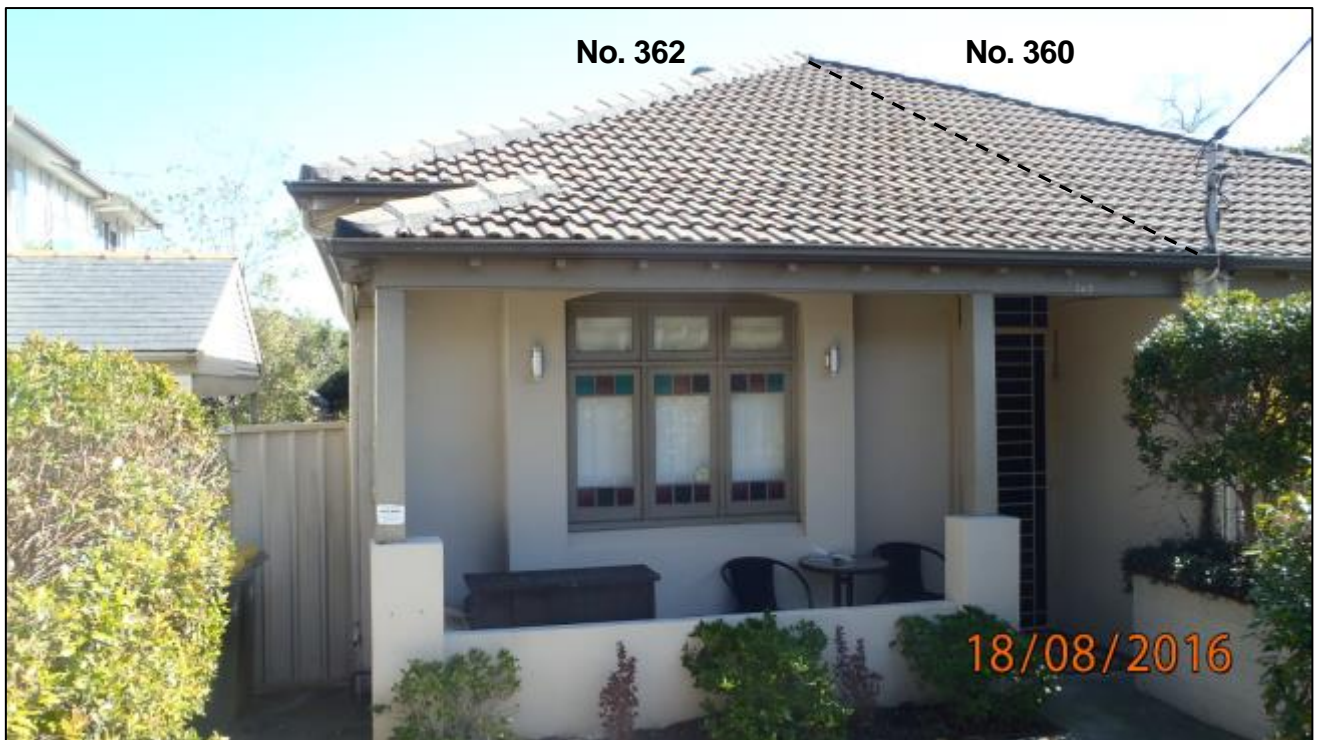
Shows the front eastern elevation of the adjoining properties:
No.362 and No.360 Avoca Street, Kingsford.

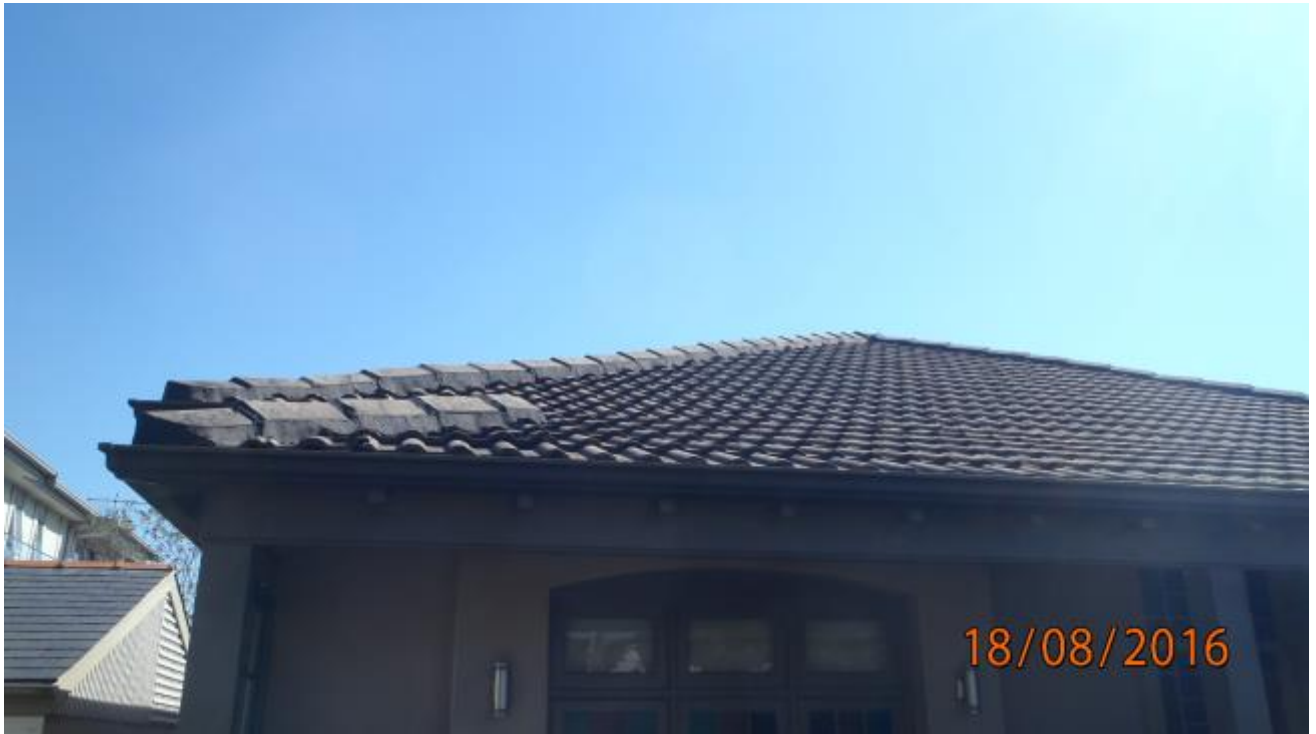
We observed that the concrete roof tiles to the roof surface are generally interlinked and securely bedded, in our opinion forming a weather resistant cover to the residence. **[Photograph 1]**

Photograph 1 shows the condition of the concrete roof tiles to the common roof.

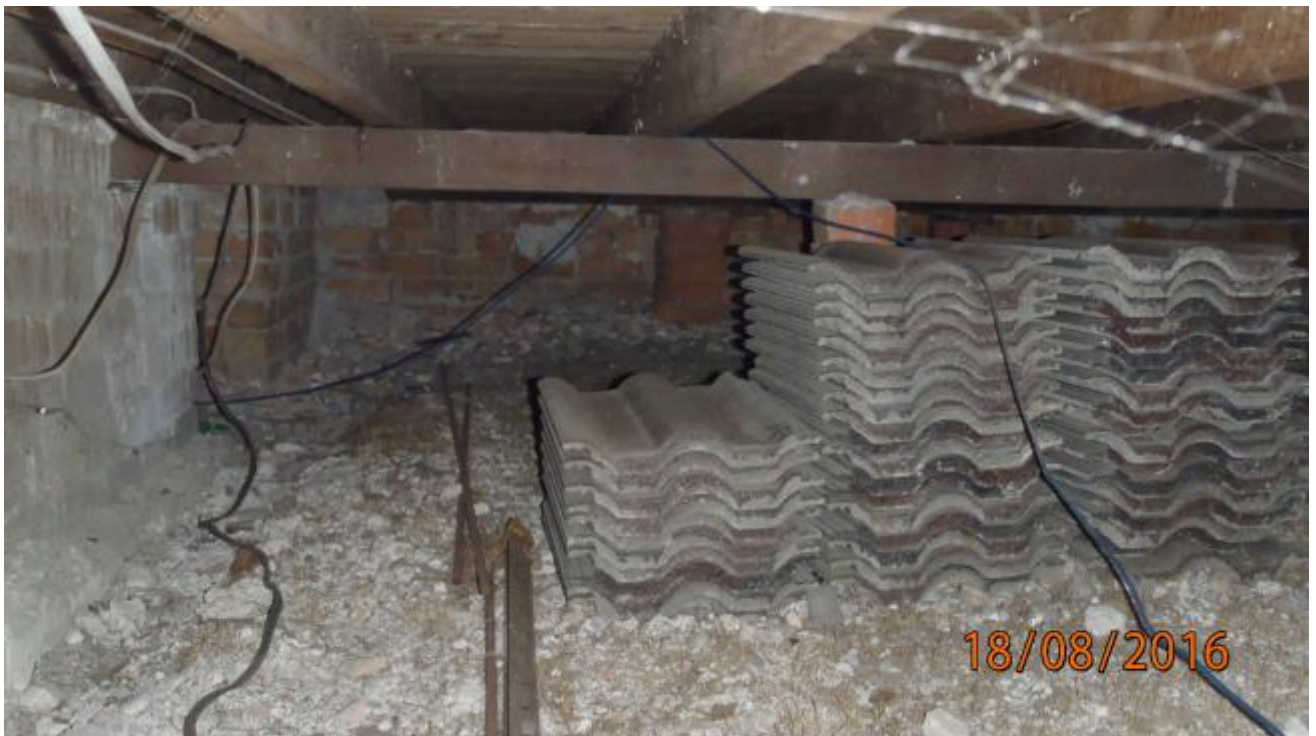
We noted that the original floor system is hardwood timber bearers and joists that are supported on clay masonry brick footings. **[Photograph 2]**

Photograph 2 shows the common party / separation wall under the floor space and the construction method used.

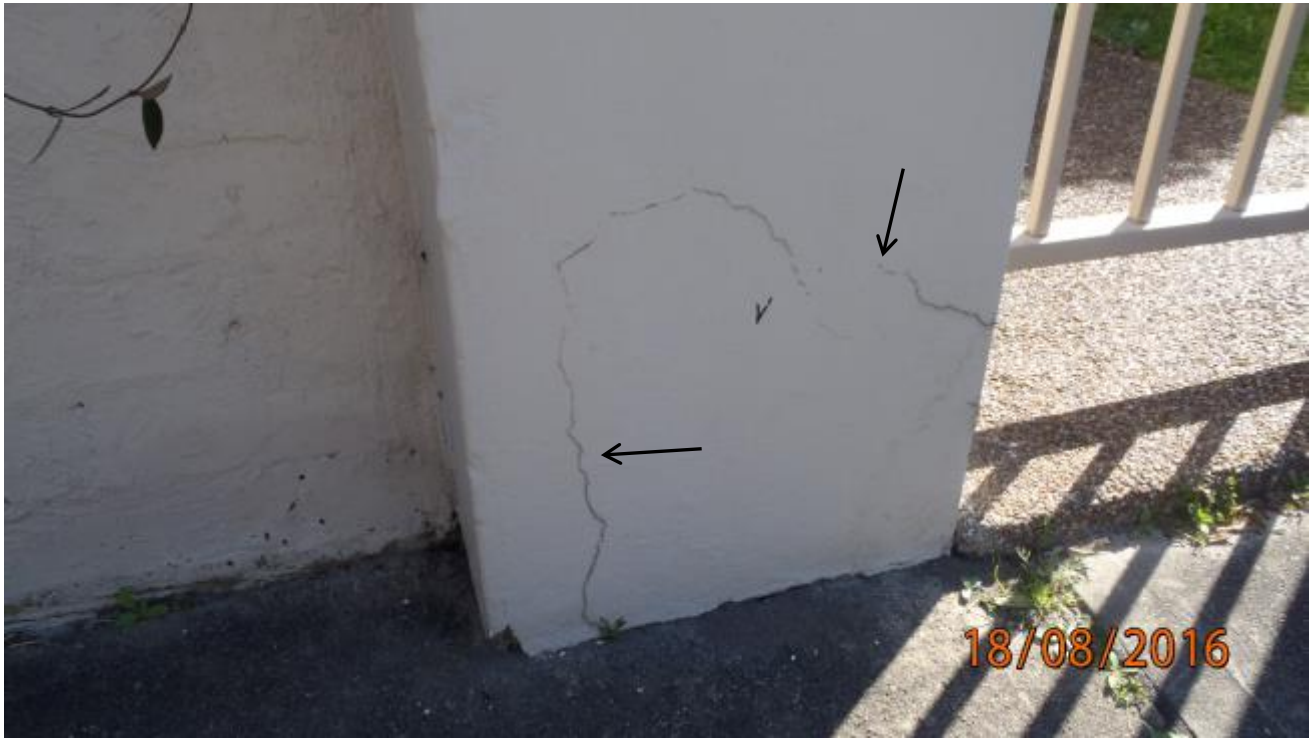
We noted radial cracking to the front common boundary wall as seen from the footpath **[Photograph 3]**

Photograph 3 shows cracking to the front boundary wall.

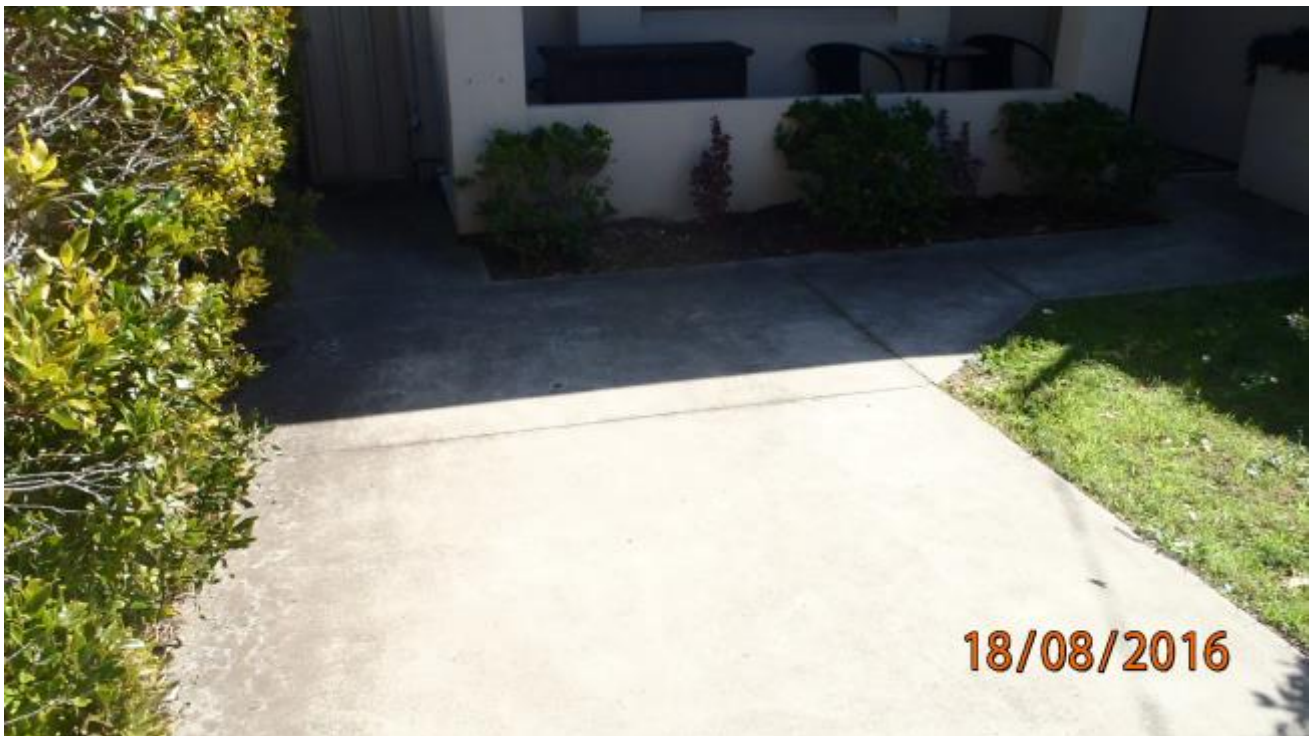
We noted that the front northern aspect has a concreted driveway/car space and front path. We did not observe any cracking to the driveway surface **[Photograph 4]**

Photograph 4 shows the front driveway and path.

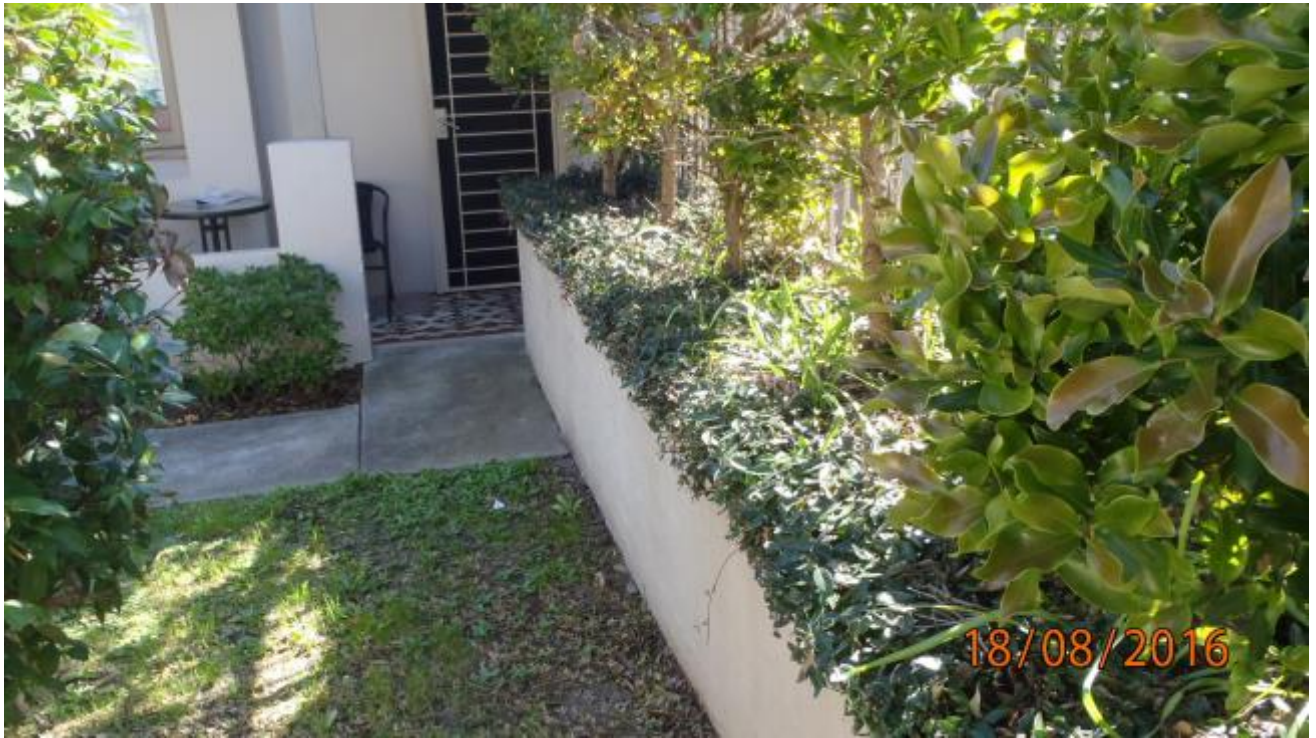
We noted that the common boundary fence line has a cement rendered brick garden bed built along its entirety with a pre-finished metal fence on the boundary **[Photograph 5]**

Photograph 5 shows the common boundary fence and garden bed.

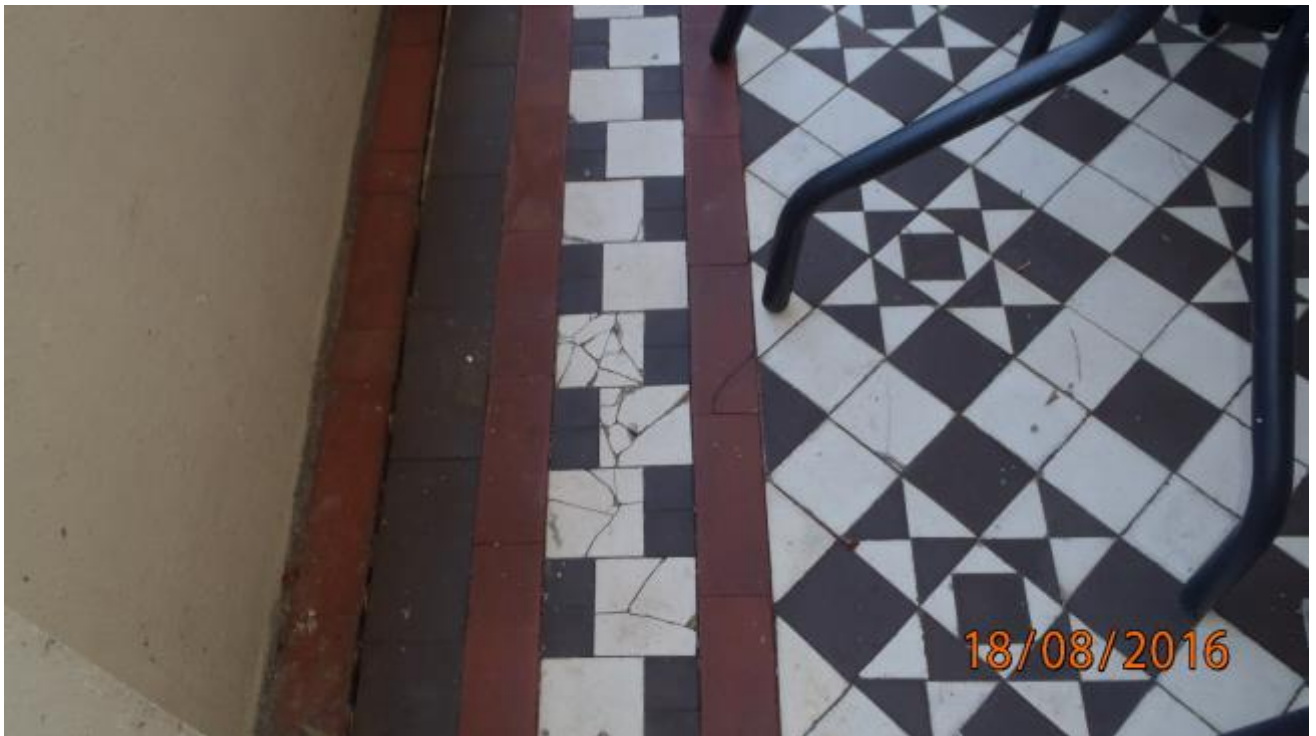
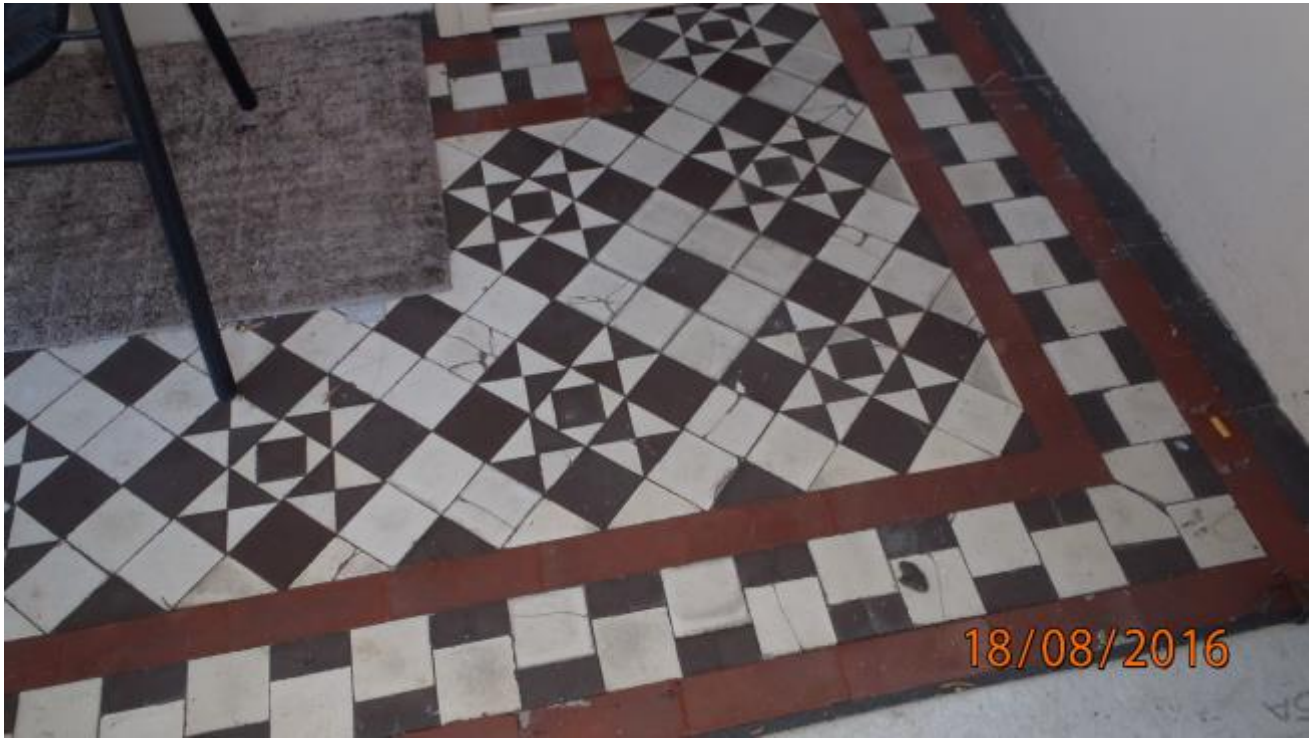
We observed that the front porch is of concrete slab construction and that the tessellated tiled surface has differential movement cracking **[Photographs 6 and 7]**

Photograph 6 shows the cracking to the tessellated front porch tiles.

Photograph 7 shows another view of the cracking to the tessellated front porch tiles.

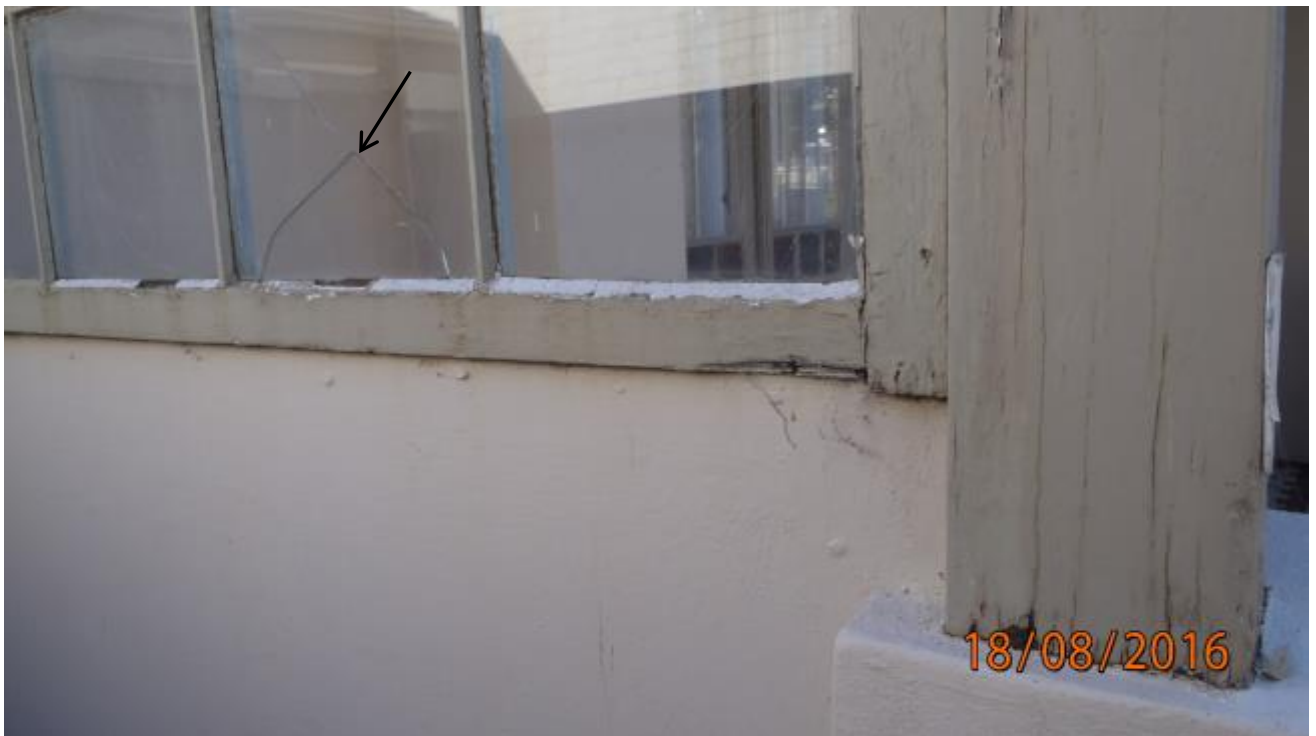
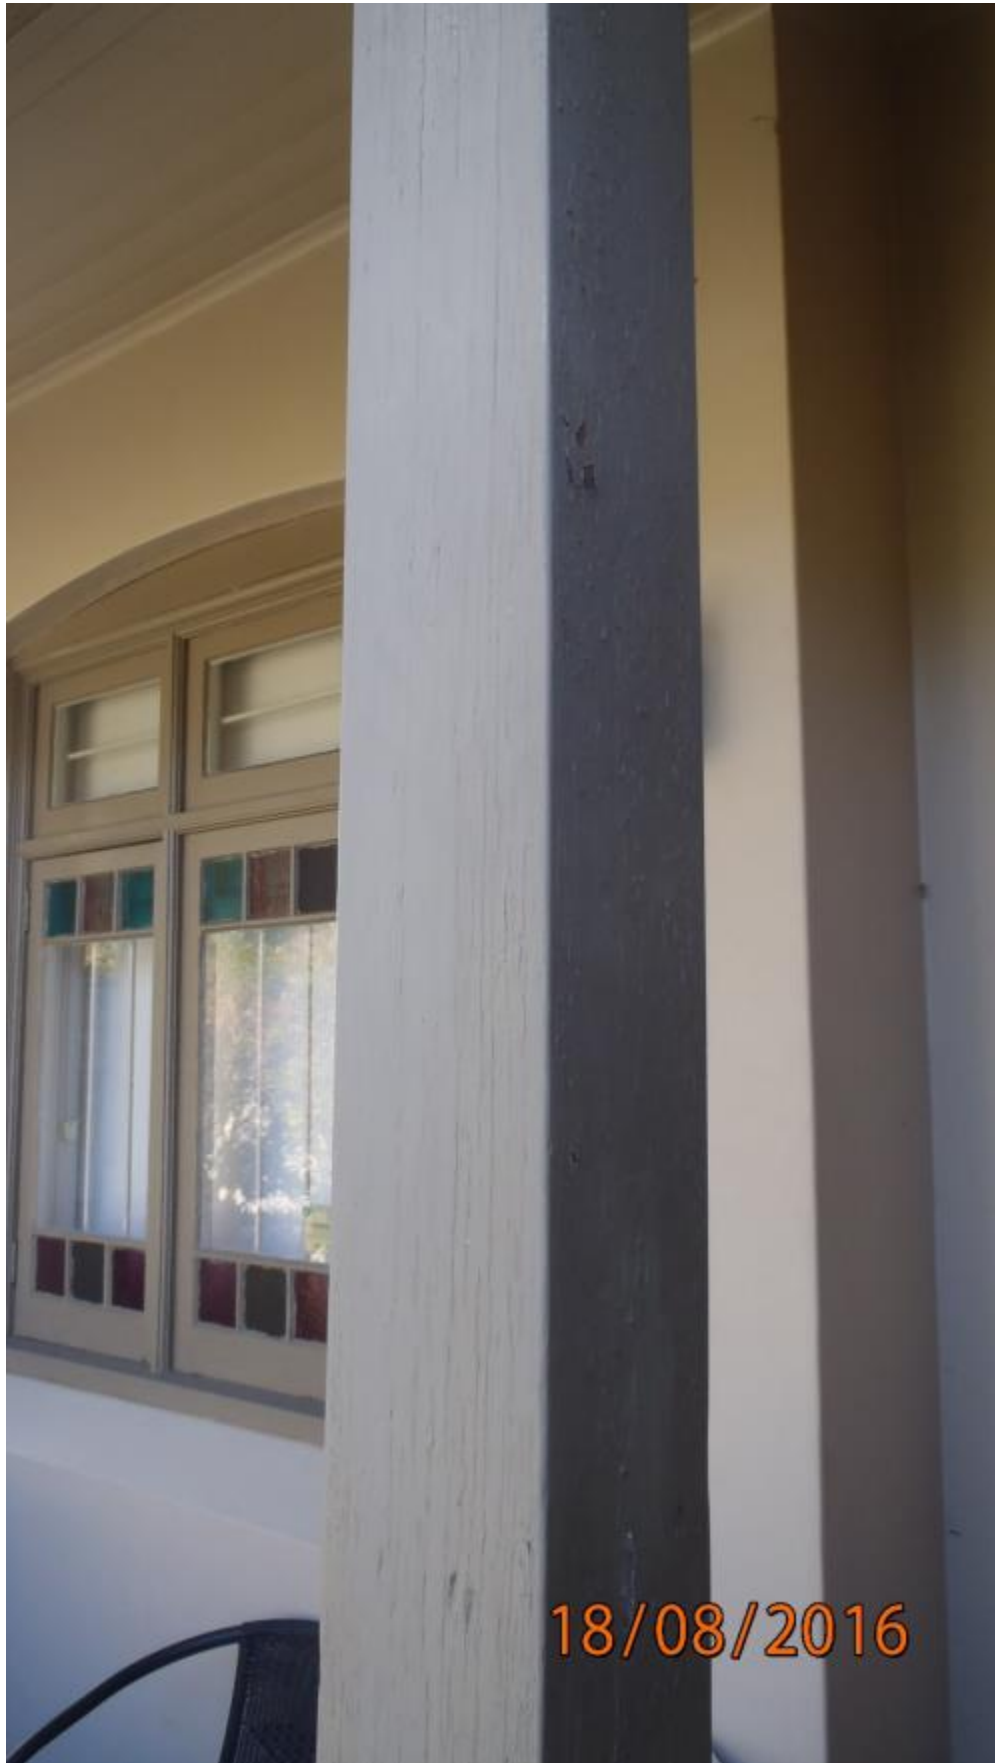
We noted a crack to the window glass at the far end of the front porch, We also noted a general deterioration of the surface coating to the timber trims, posts and windows. **[Photographs 8 and 9]**

Photograph 8 shows the cracked window glass and the condition of the painted surfaces.

Photograph 9 shows the condition of the painted surface to the front porch support post.

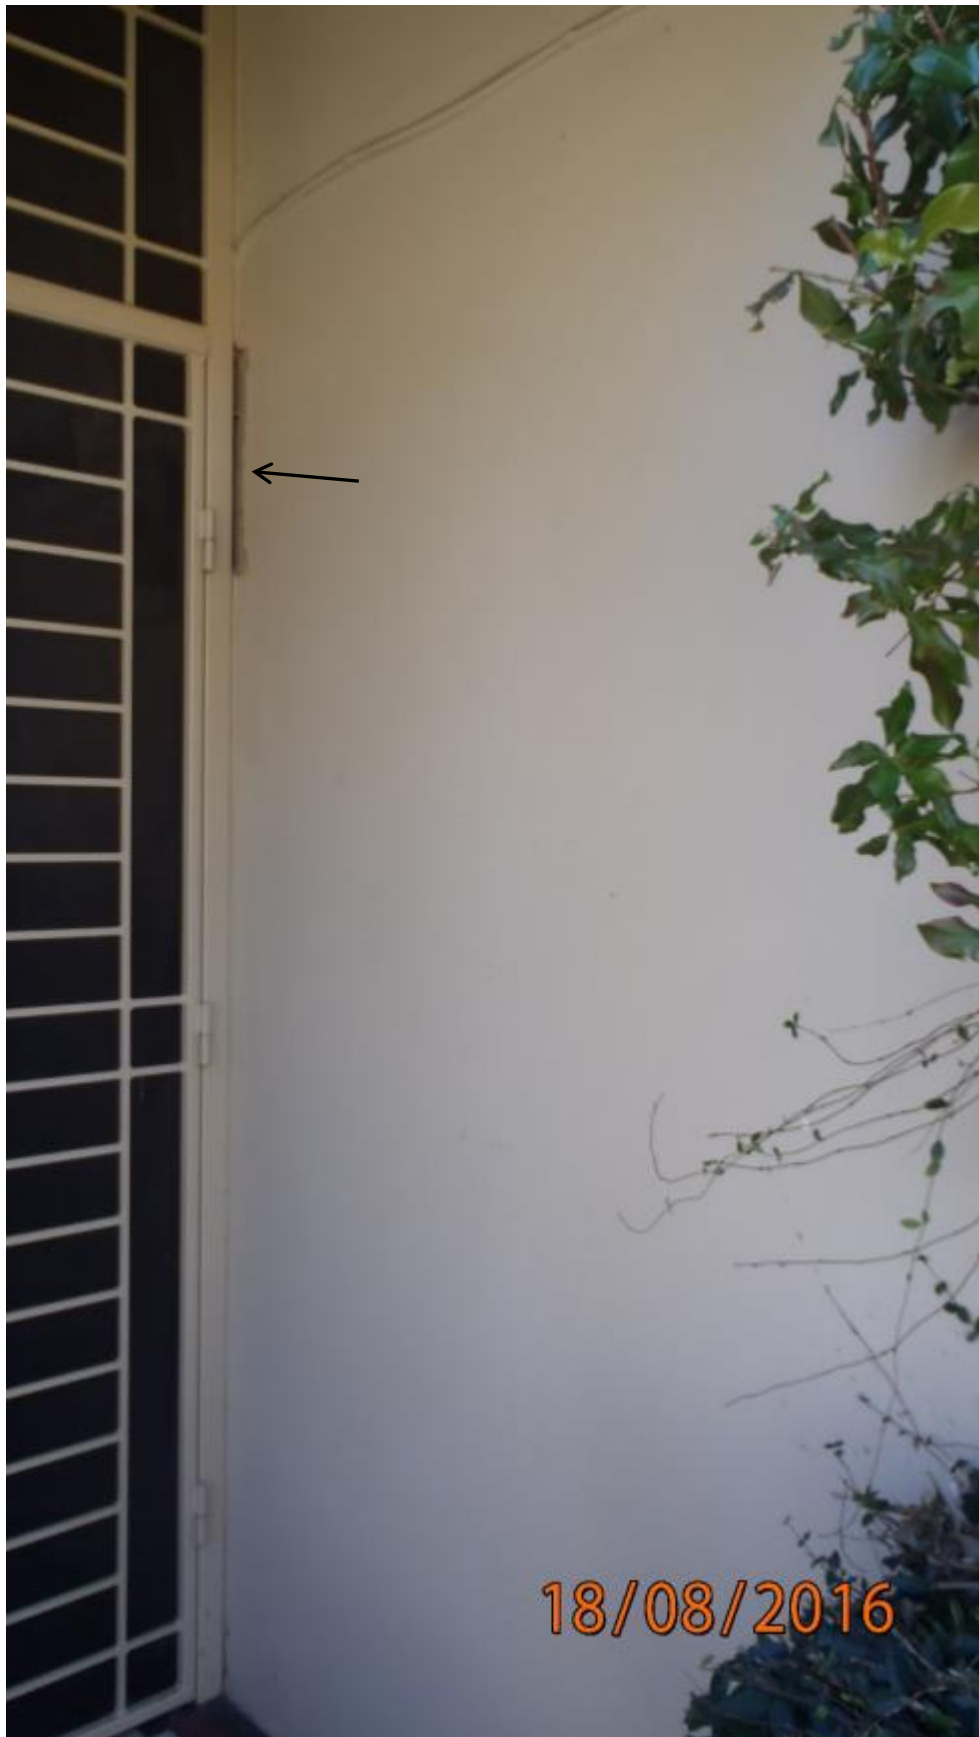
We noted a gap between the security door jamb and the common privacy wall. **[Photograph 10]**

Photograph 10 shows the gap adjacent to the front security door.

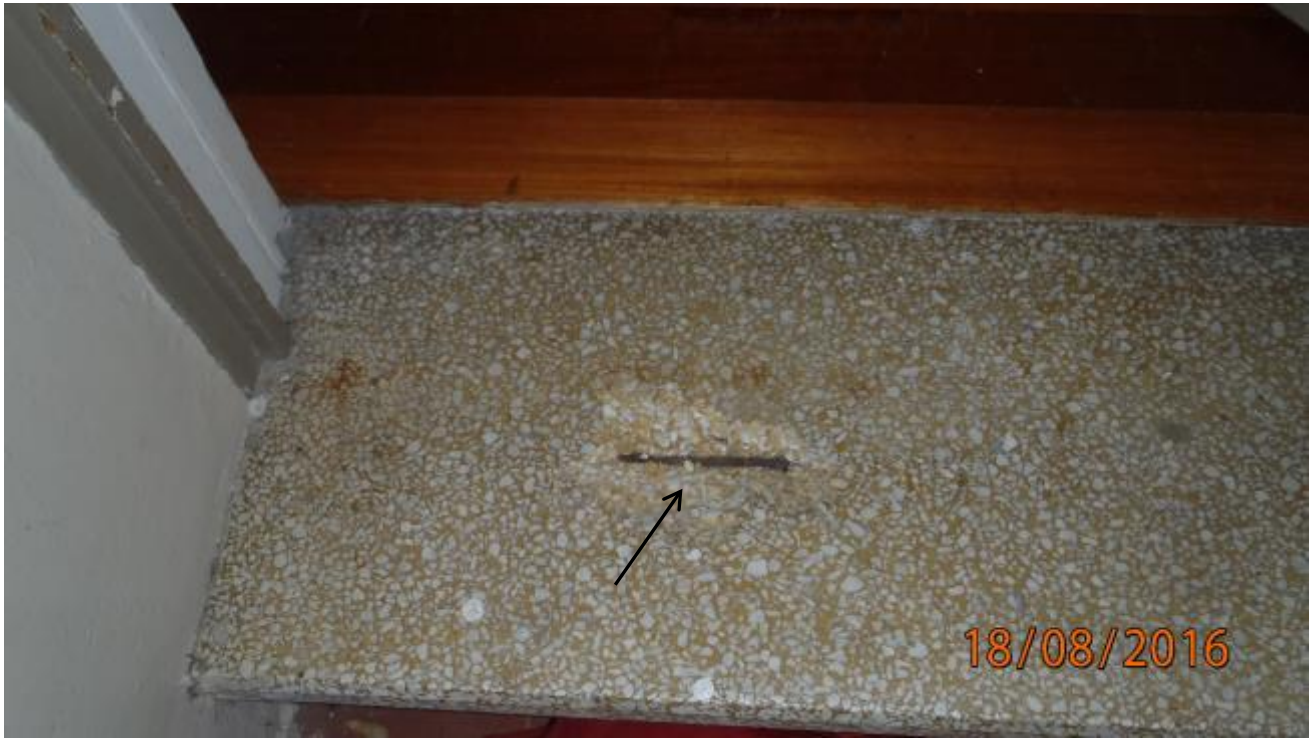
We noted damage to the front door threshold step. **[Photograph 11]**

Photograph 11 shows damage to the front threshold step.

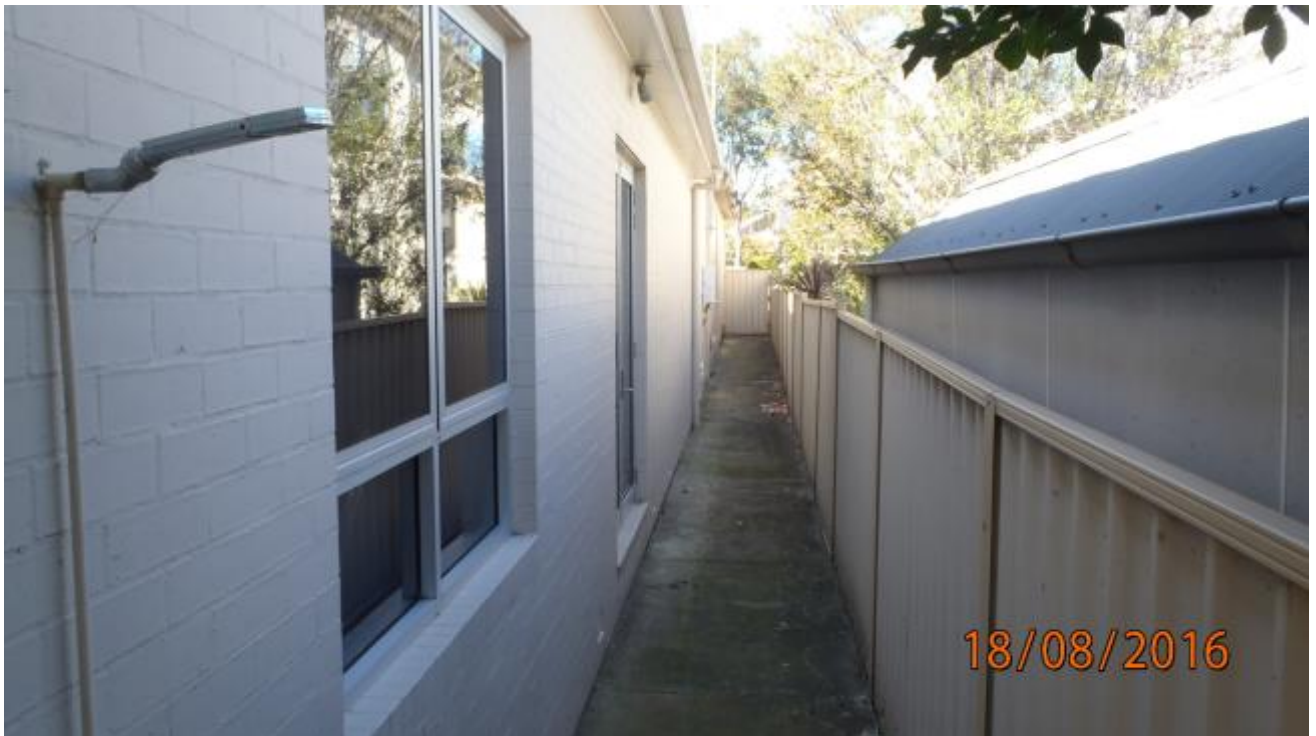
We noted that the side southern elevation external wall is surface coated clay masonry brickwork, we did not note any recent cracking to the external brickwork **[Photograph 12]**

Photograph 12 shows the general condition of the southern elevation.

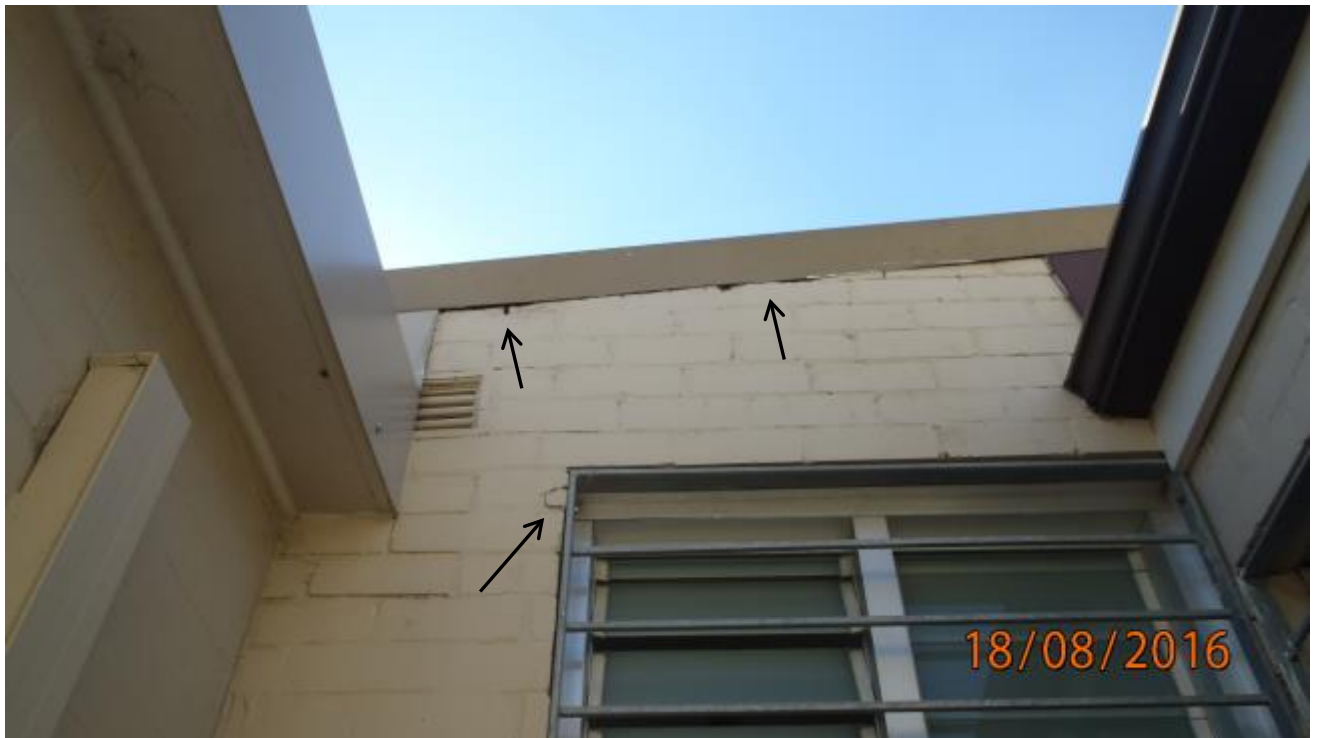
We noted a chip to the brickwork where the security grill is attached to the Bathroom window. **[Photograph 13]**

We noted gaps between the side roofing flashing and the external surface coated brick wall. **[Photograph 13]**

Photograph 13 shows the gap between the roof flashing and external wall and chip/broken brickwork.

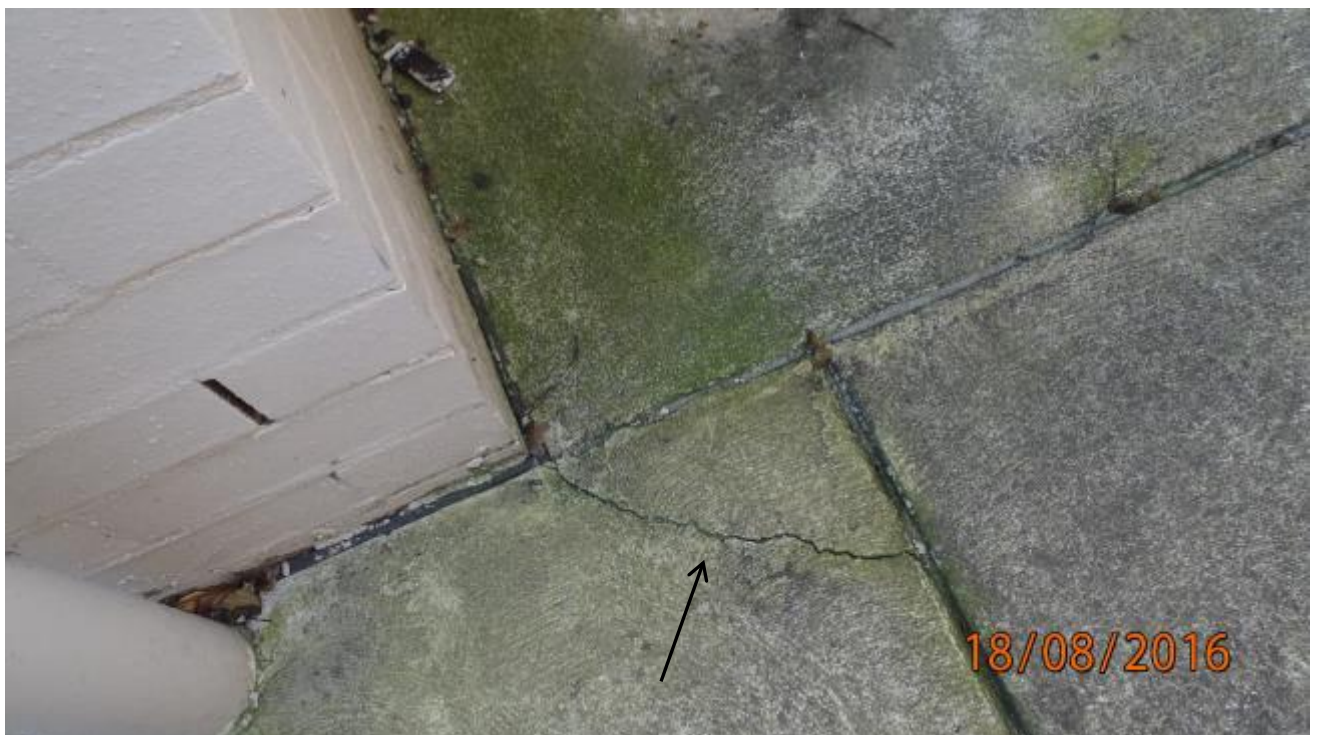
We observed settlement cracking to the side concrete path and mildew growth on the path outside the Bathroom. **[Photograph 14]**

Photograph 14 shows a crack to the concrete pathway at the southern side and mildew growth.

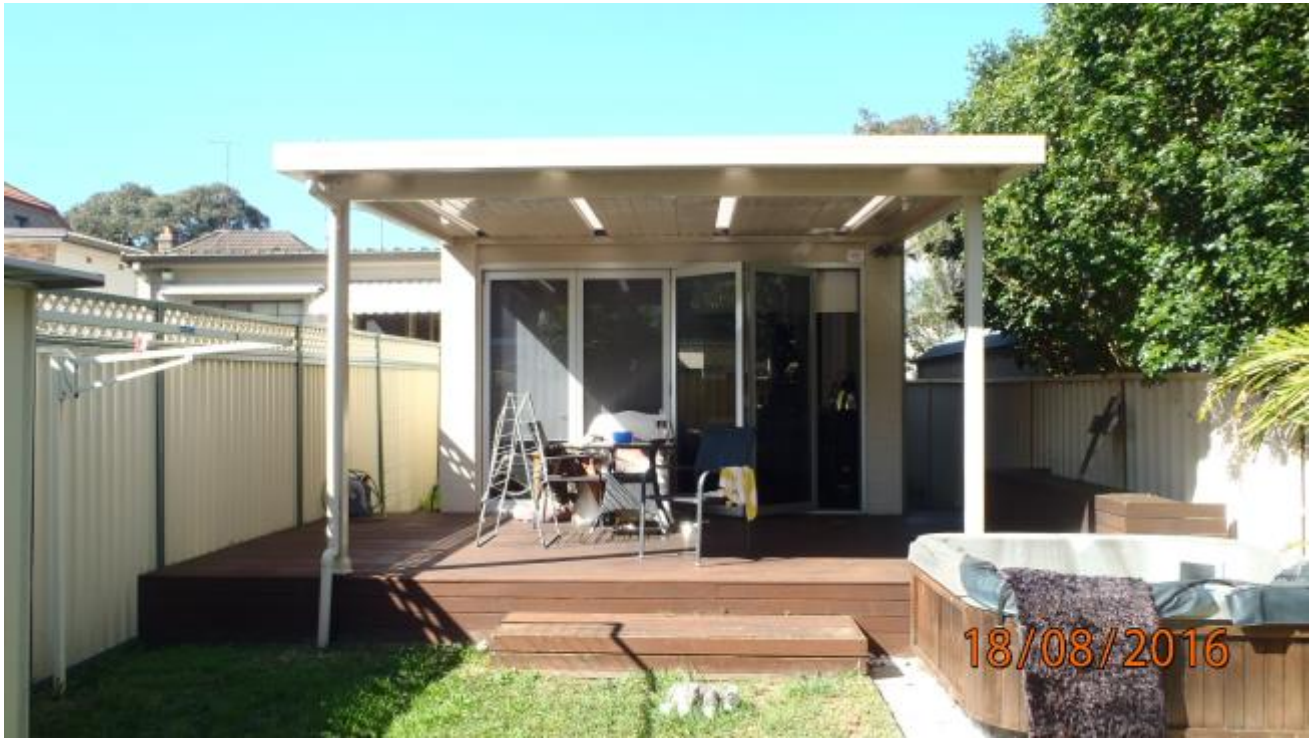
We observed that the rear of the premises has a timber deck structure with a pre-finished metal pergola that is covered with a combination of acrylic and pre-finished pan profiled sheet metal roofing. **[Photograph 15]**

Photograph 15 shows the general condition of the rear western elevation.

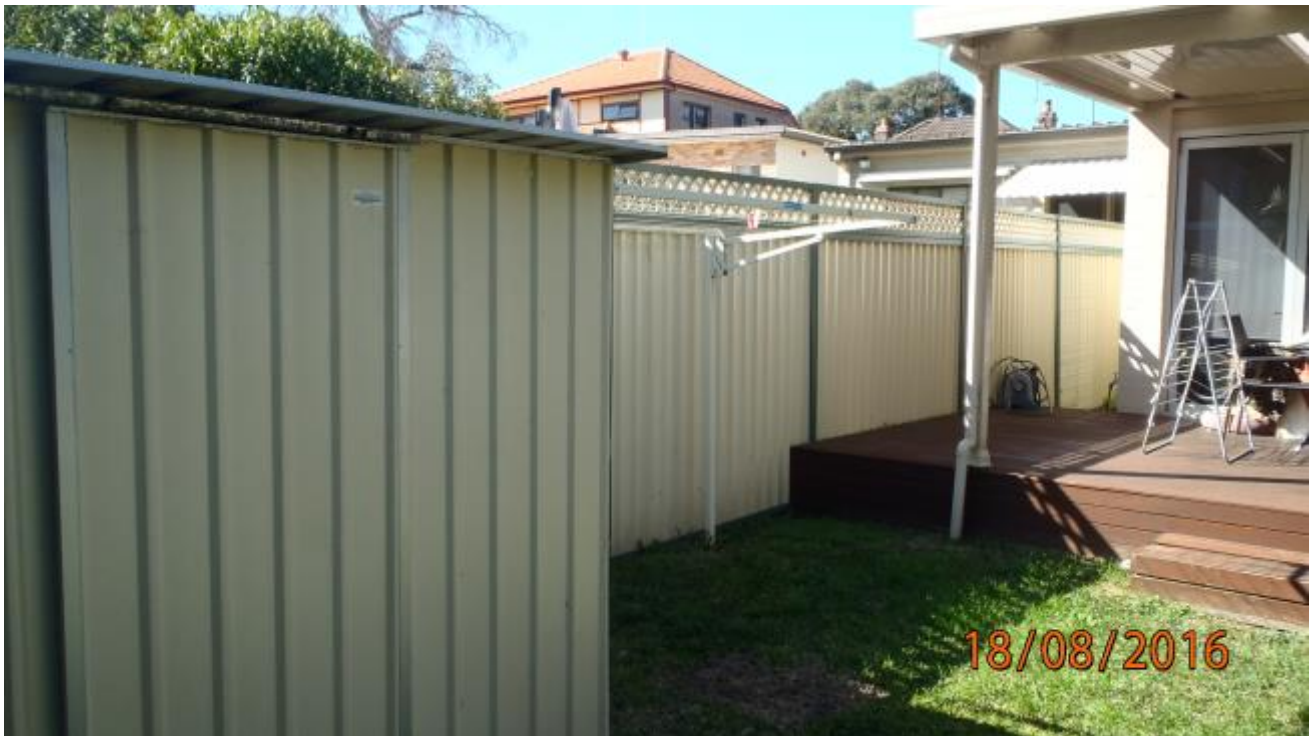
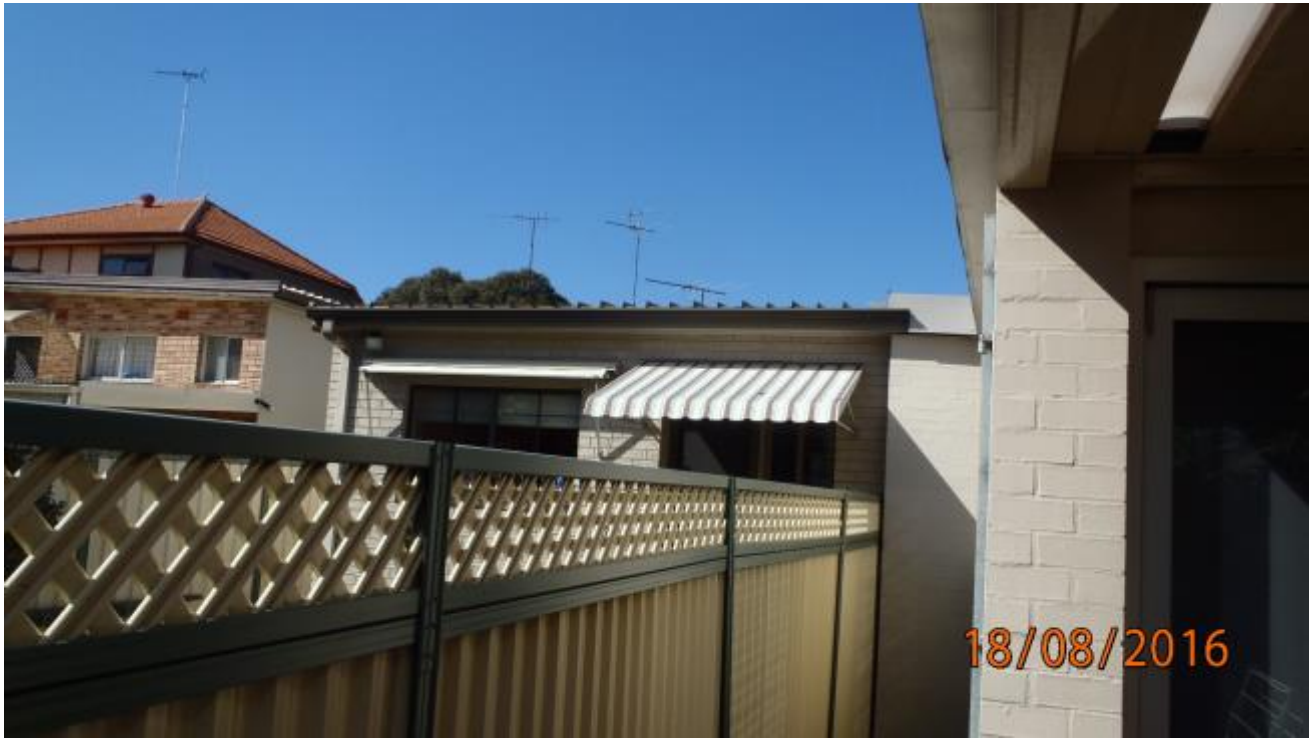
We noted that the rear common boundary fence is of pre-finished metal post and rail construction with a lattice insert at the top. **[Photographs 16 and 17]**

Photograph 16 shows the condition of the common boundary fence with the adjoining property 360 Avoca Street, Kingsford.

Photograph 17 shows another view of the common boundary fence with the adjoining property 360 Avoca Street, Kingsford.

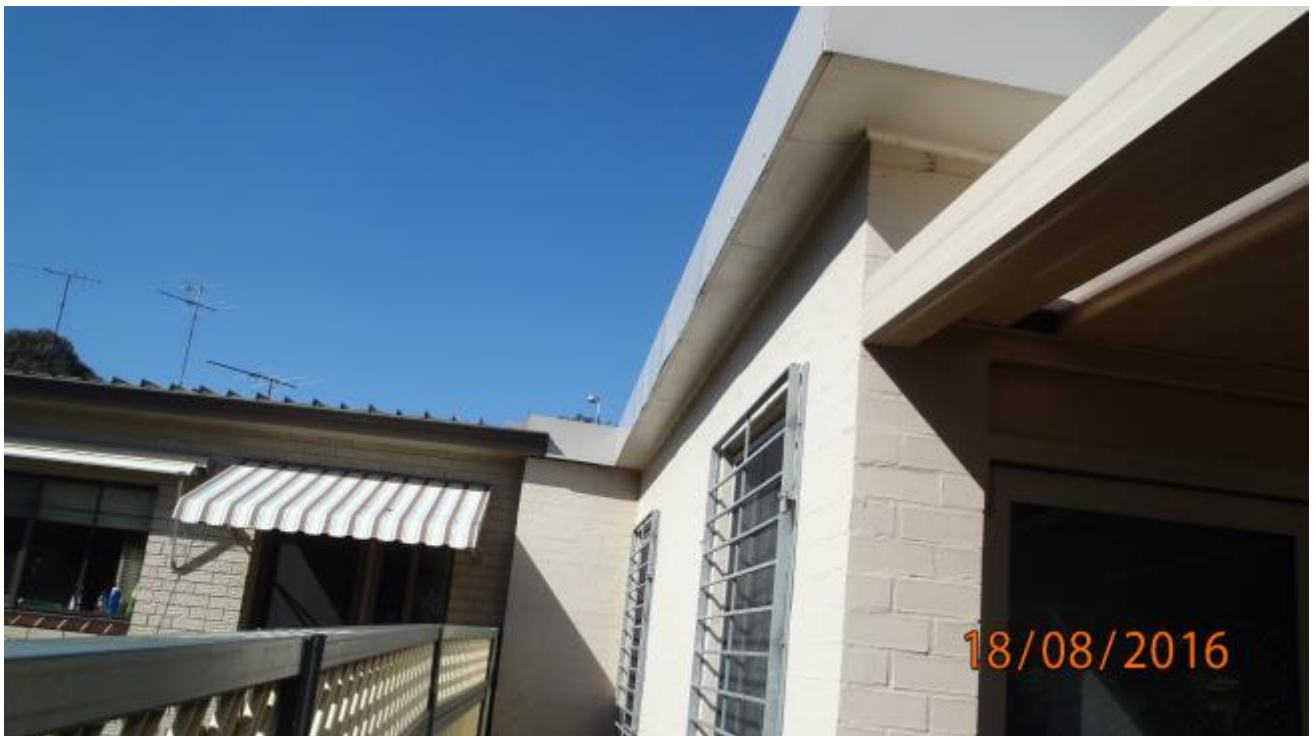
We noted that the side northern elevation (adjacent to adjoining property No. 360 Avoca Street, Kingsford), external wall is surface coated clay masonry brickwork, we did not note any recent cracking to the external brickwork **[Photograph 18]**

Photograph 18 shows the general condition of the northern elevation external wall.

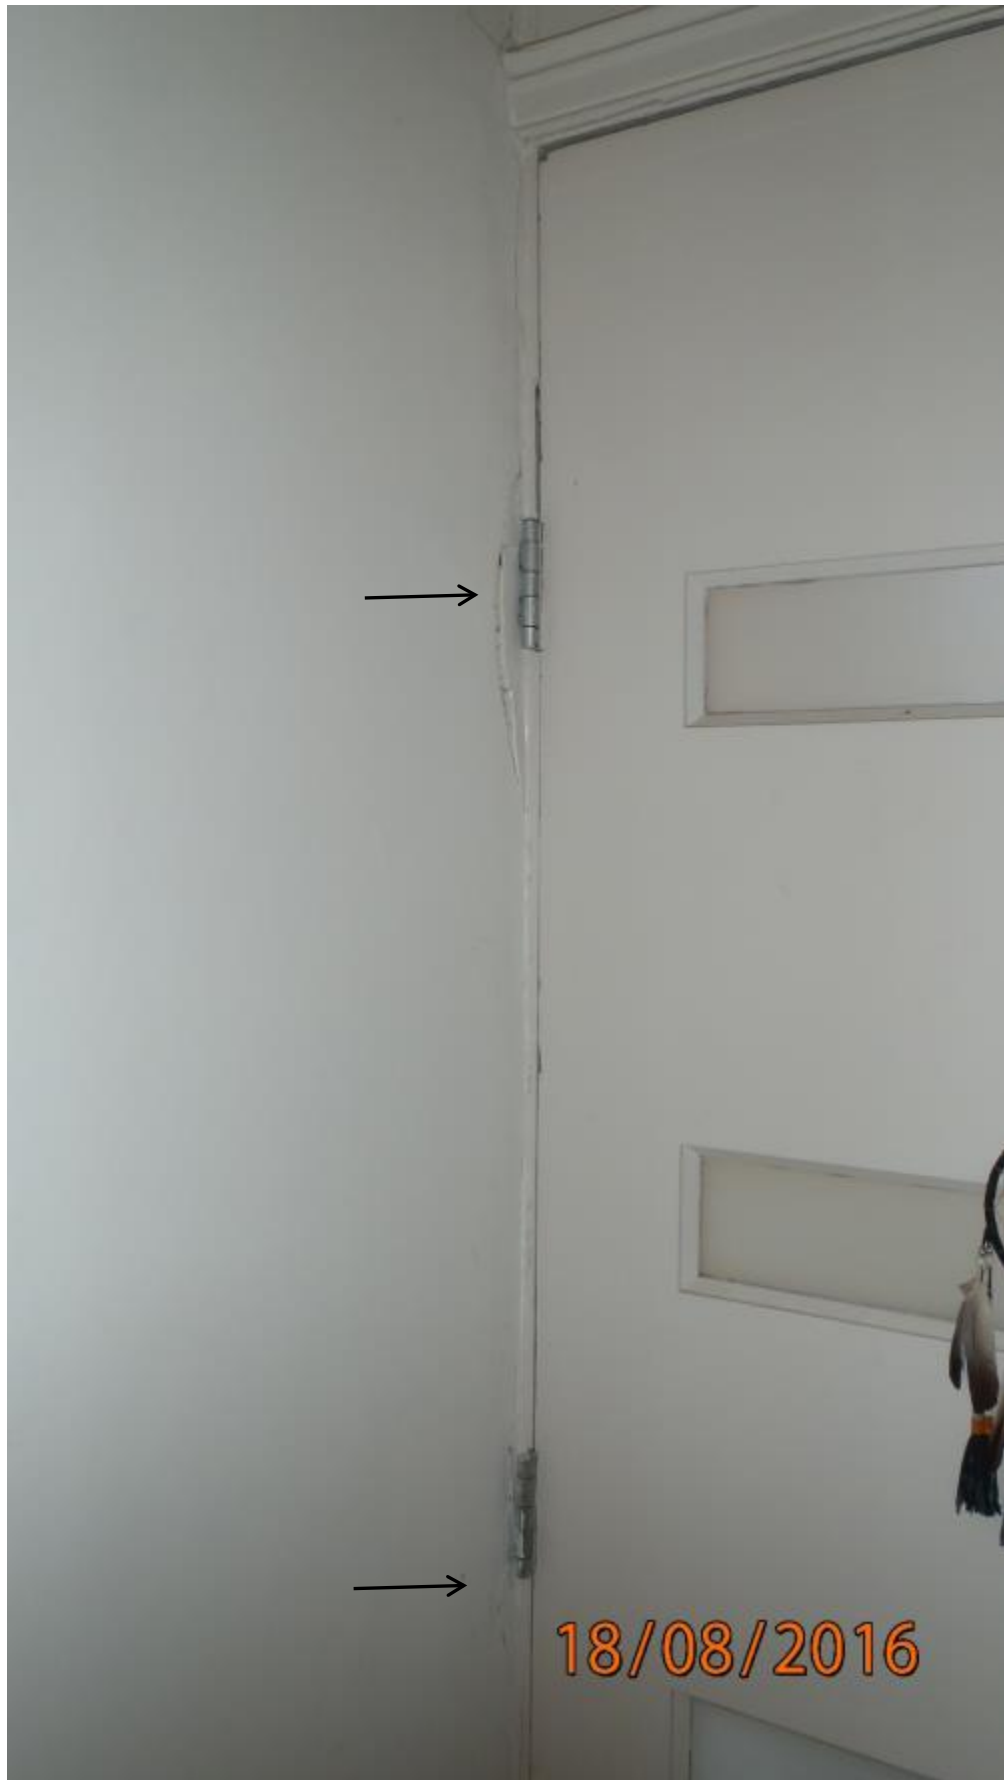
We noted cracking to the door around the hinges of the front door [**Photograph 19**]

Photograph 19 shows cracking to the wall around the door hinges of the front door.
