Dilapidation Assessment Report

Prepared for: Cape Cod Australia Pty. Limited
Job address: 362 Avoca Street, Kingsford.
Property Owner/s: Mrs. Gordana Poljak.
Report reference: **RANDWICK CITY COUNCIL**
Development Application No: not available
Date of assessment: 18th August 2016.

Re: Dilapidation Report

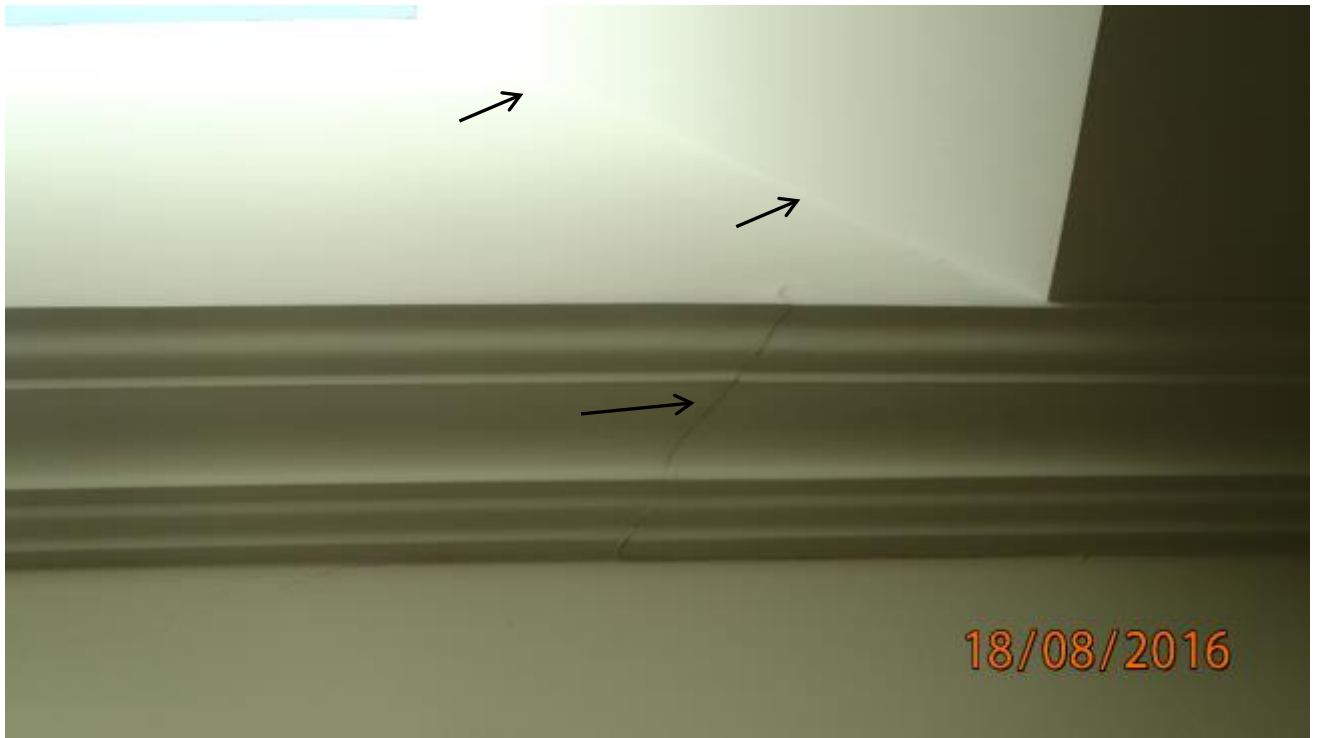
We noted that there was a skylight built into the roof surface. We also noted hairline separation cracking [$<1.0\text{mm}$] to the cornice mitre joint and the square set joints inside the skylight. [**Photograph 20**]

Photograph 20 shows cracking to the cornice joint and inside skylight.

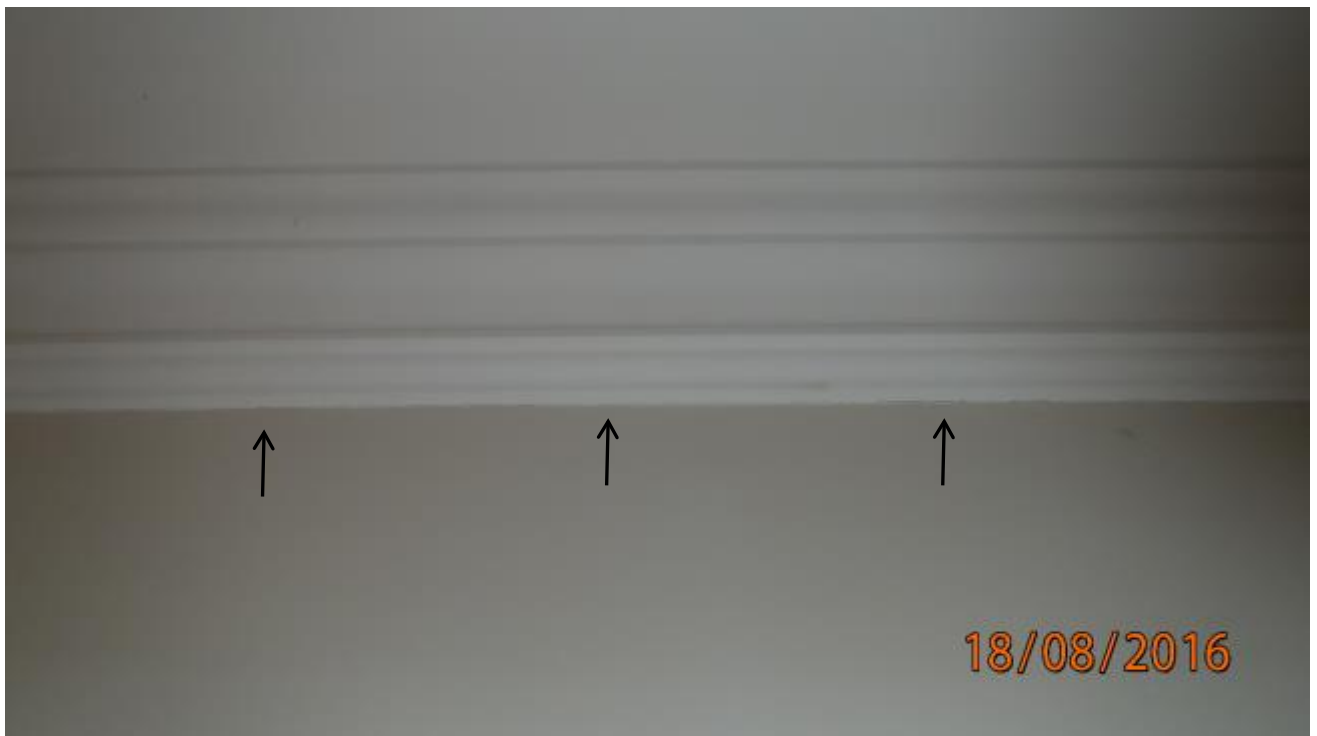
We noted hairline separation cracking [$<1.0\text{mm}$] at the wall/cornice junction along *the common party / separation* wall with the adjoining property No. 360 Avoca Street, Kingsford. [**Photograph 21**]

Photograph 21 shows cracking to the wall / cornice junction in the Hallway

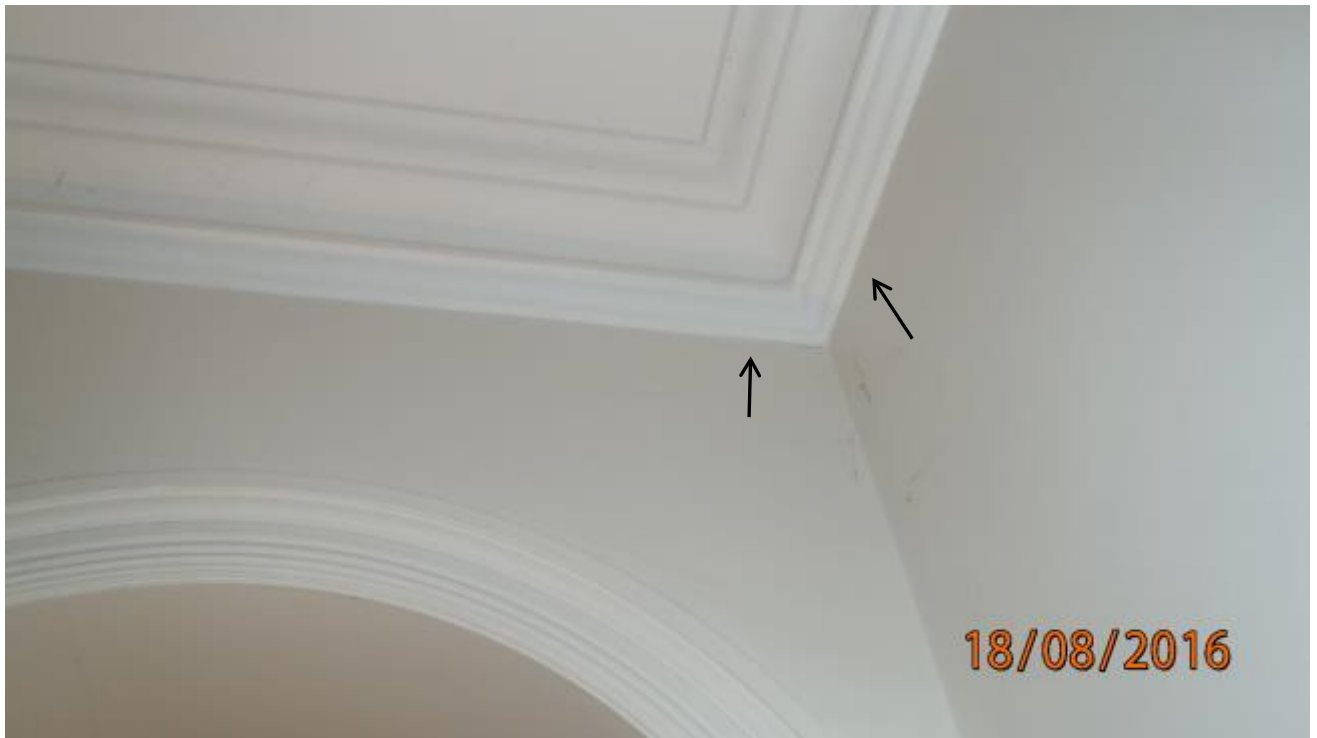
We noted hairline separation cracking [$<1.0\text{mm}$] at the wall/cornice junction along *the common party / separation* wall with the adjoining property, adjacent to the hallway arch. [**Photograph 22**]

Photograph 22 shows cracking to the wall / cornice junction adjacent to the hallway arch.

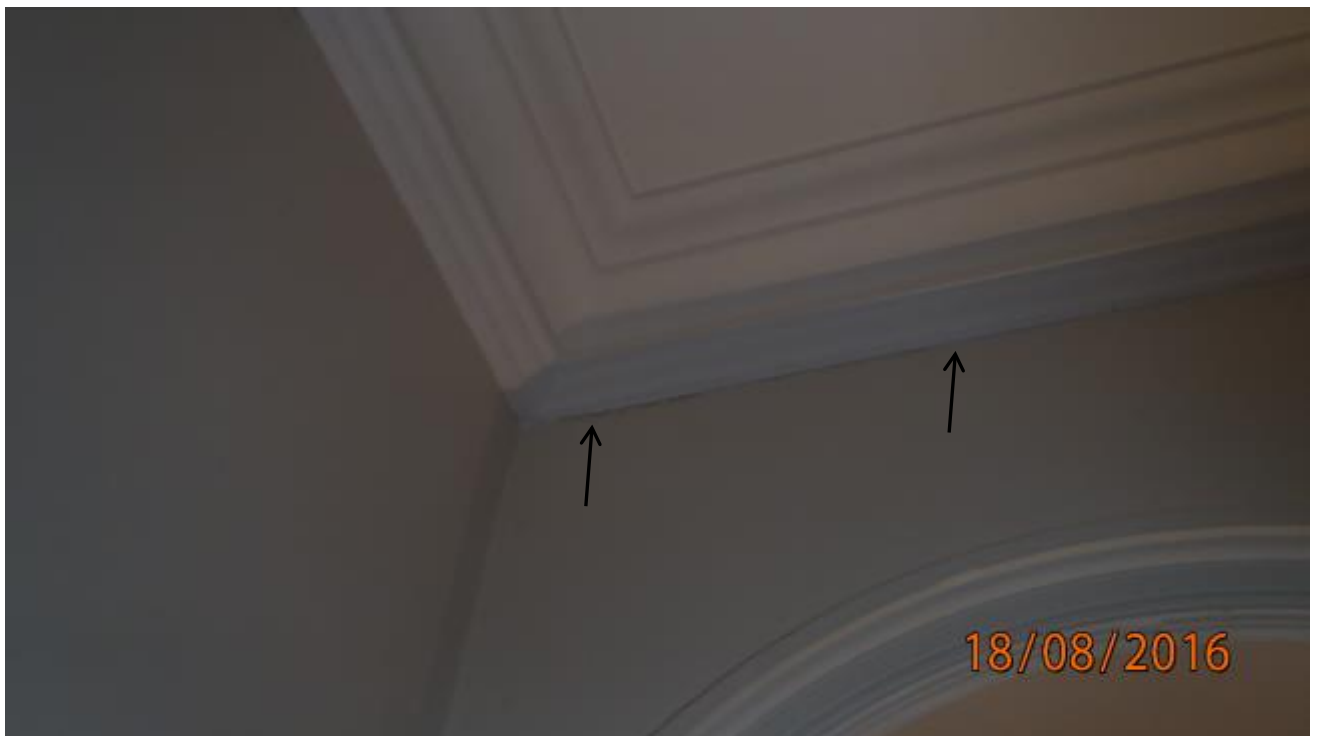
We noted hairline separation cracking [$<1.0\text{mm}$] at the wall/cornice junction along *the common party / separation* wall with the adjoining property, adjacent to the hallway arch. Opposite side to Photograph 22. [**Photograph 23**]

Photograph 23 shows cracking to the wall / cornice junction adjacent to the hallway arch (other side of the arch to Photograph 22).

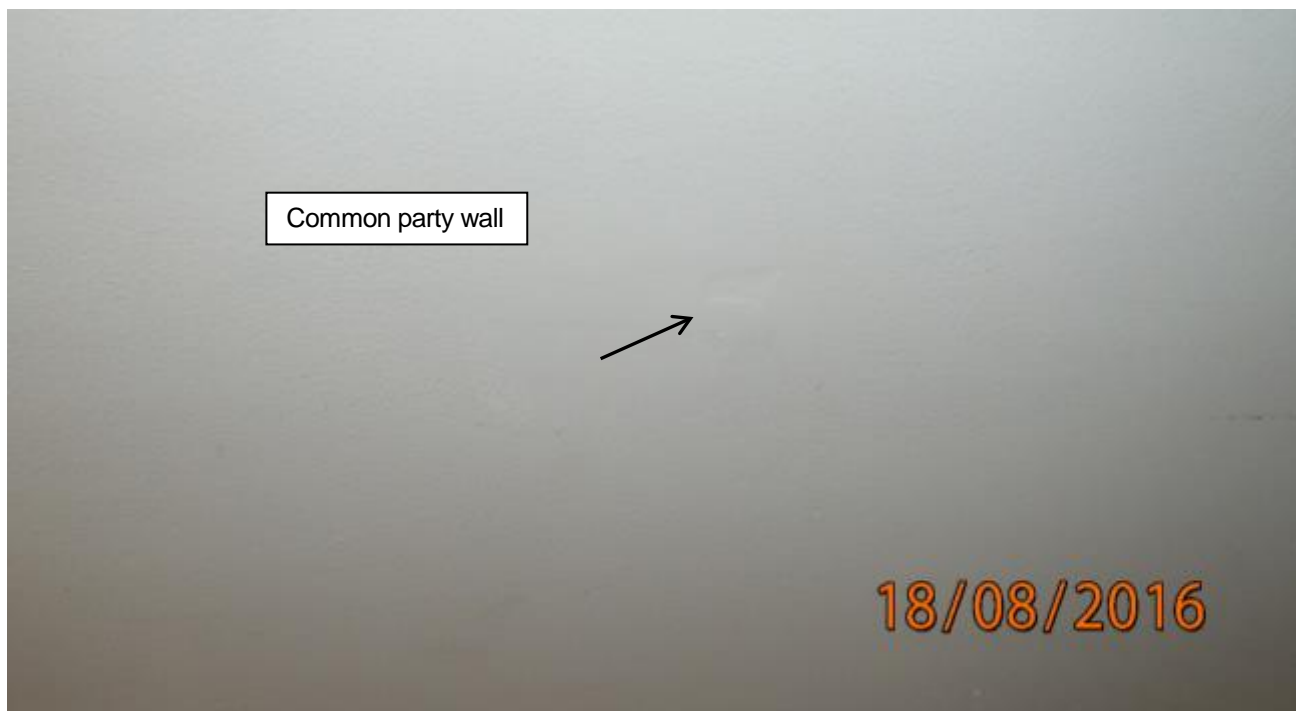
We noted evidence of a previous repair to the *common party / separation* wall outside Bedroom 2 [**Photograph 24**]

Photograph 24 shows evidence of a previous repair to the common party / separation wall outside Bedroom 2.

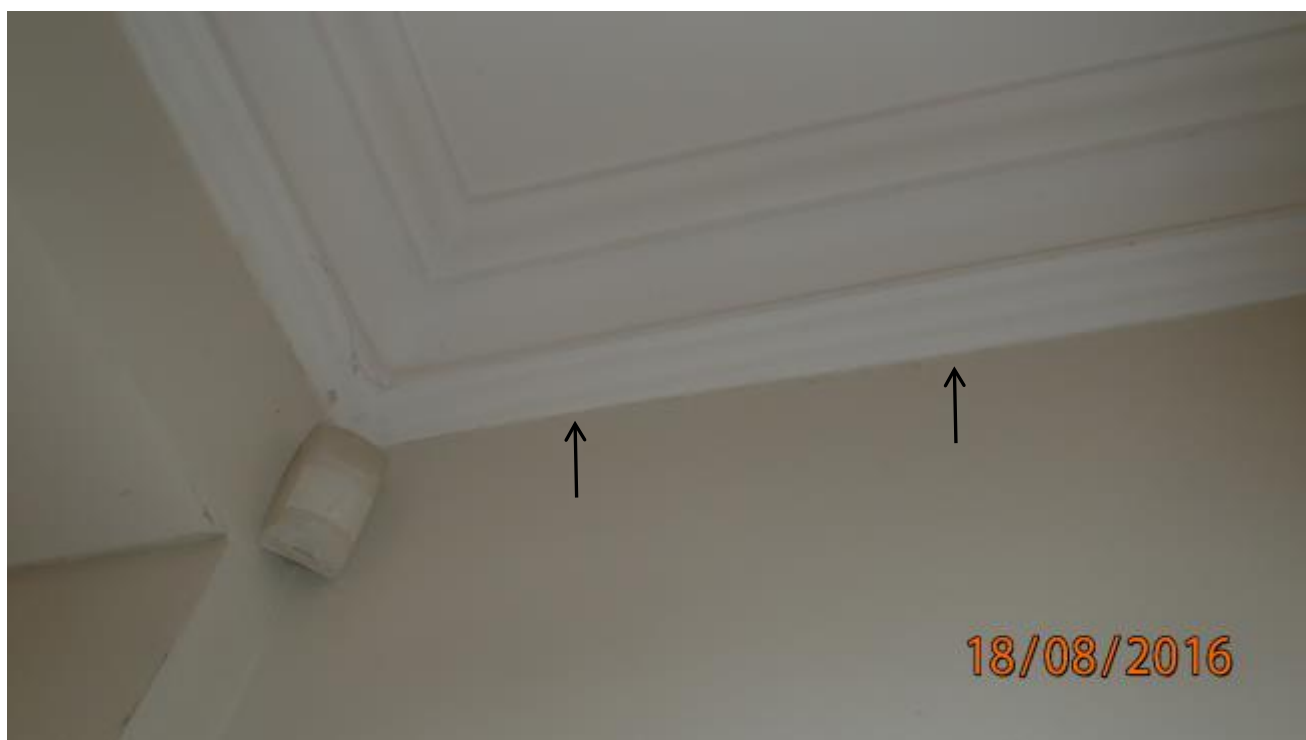
We noted hairline separation cracking [$<1.0\text{mm}$] at the wall/cornice junction along *the common party / separation* wall with the adjoining property, opposite the Laundry. [**Photograph 25**]

Photograph 25 shows cracking to the wall / cornice junction outside the Laundry.

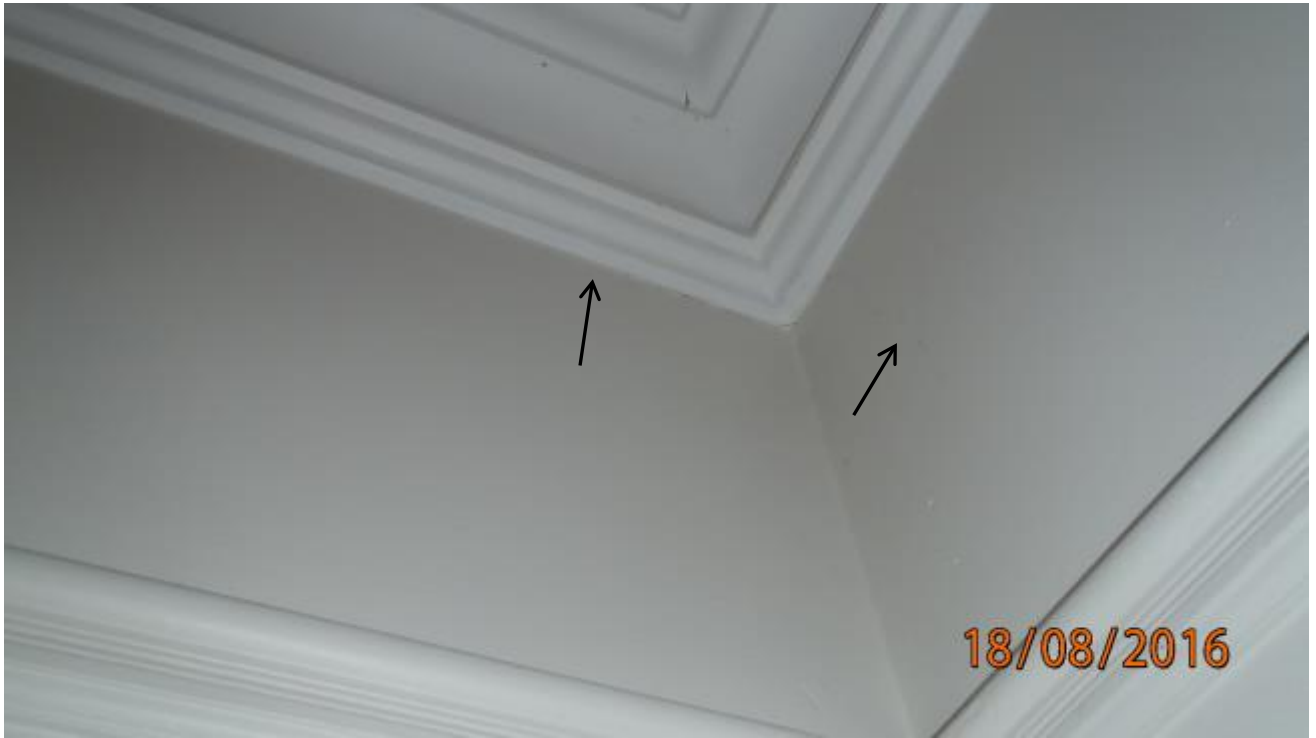
We noted hairline separation cracking [$<1.0\text{mm}$] at the wall/cornice junction in the north western corner adjacent to the door. We also noted radial cracking [$<1.0\text{mm}$] extending down towards the door head. [**Photograph 26**]

Photograph 26 shows cracking to the wall / cornice junction extending down toward the door in Bedroom 1.

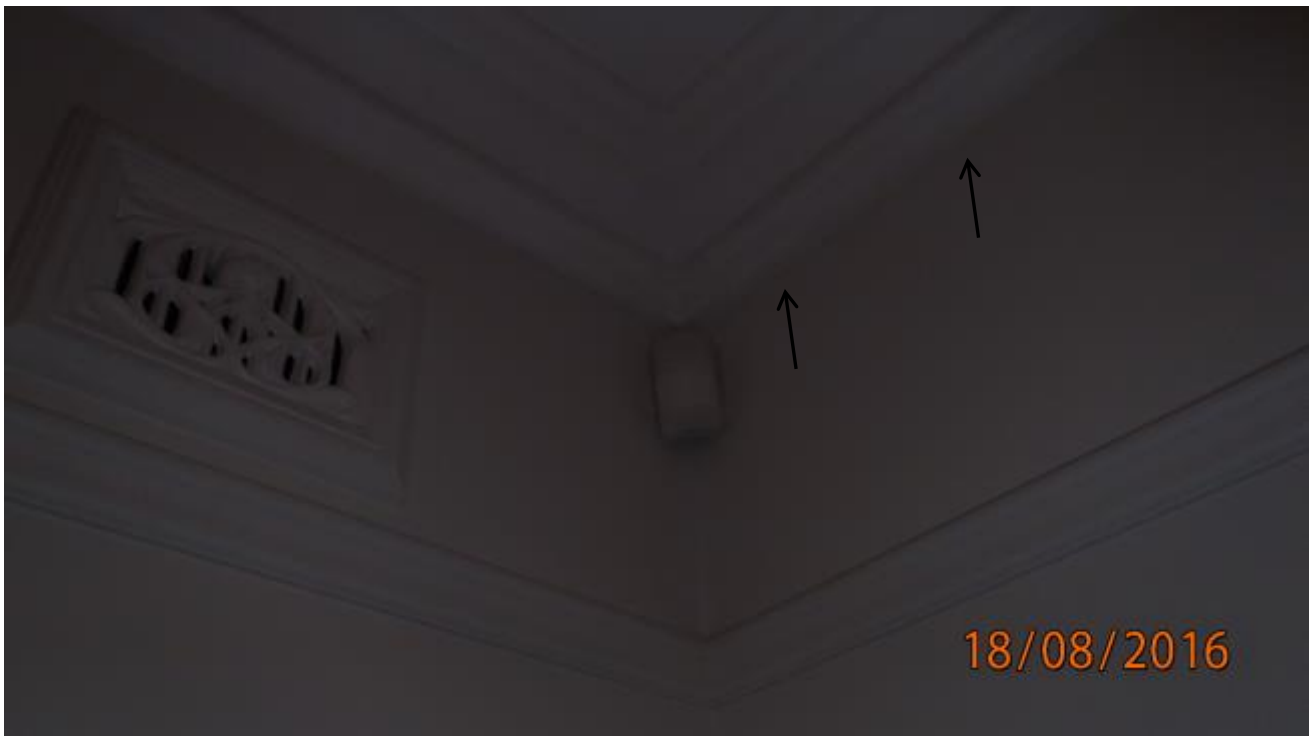
We noted hairline separation cracking [$<1.0\text{mm}$] at the wall/cornice junction in the south eastern corner extending along the wall. [**Photograph 27**]

Photograph 27 shows cracking at the wall/cornice junction in the south eastern corner extending along the wall in Bedroom 1.

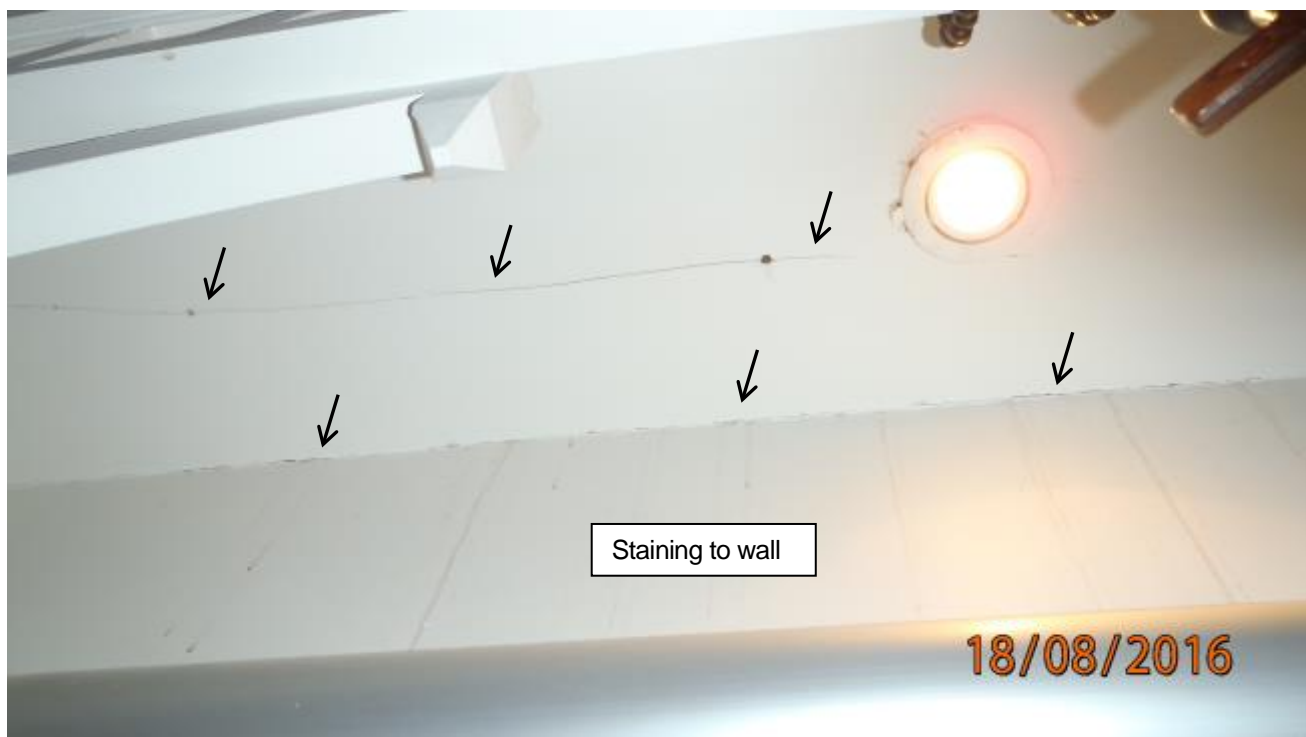
We noted cracking to the soffit lining, hairline separation cracking [$<1.0\text{mm}$] at the wall/cornice junction and staining to the wall above the window. [**Photograph 28**]

Photograph 28 shows cracking to the soffit lining, separation cracking at the wall/cornice junction and staining to the wall above the window in Bedroom 1.

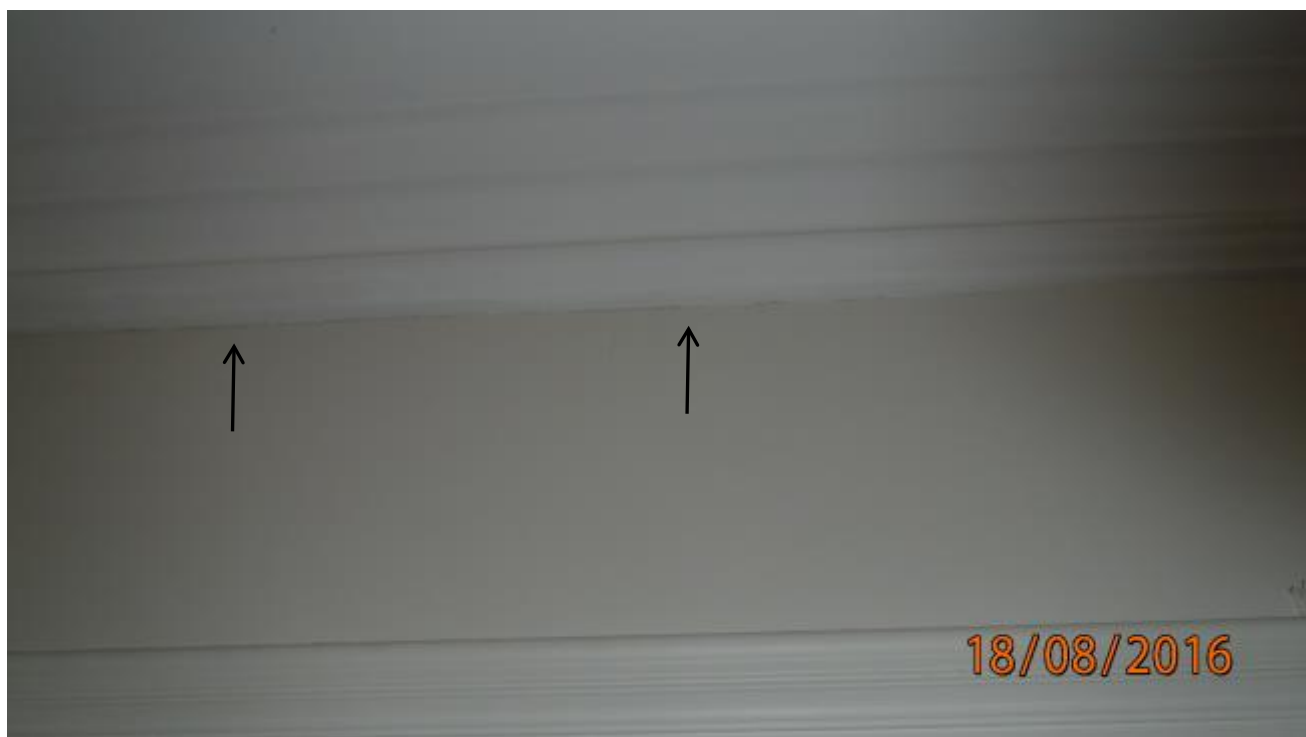
We noted hairline separation cracking [$<1.0\text{mm}$] at the wall/cornice junction on the northern wall. [**Photograph 29**]

Photograph 29 shows cracking to the wall / cornice junction in Bedroom 2.

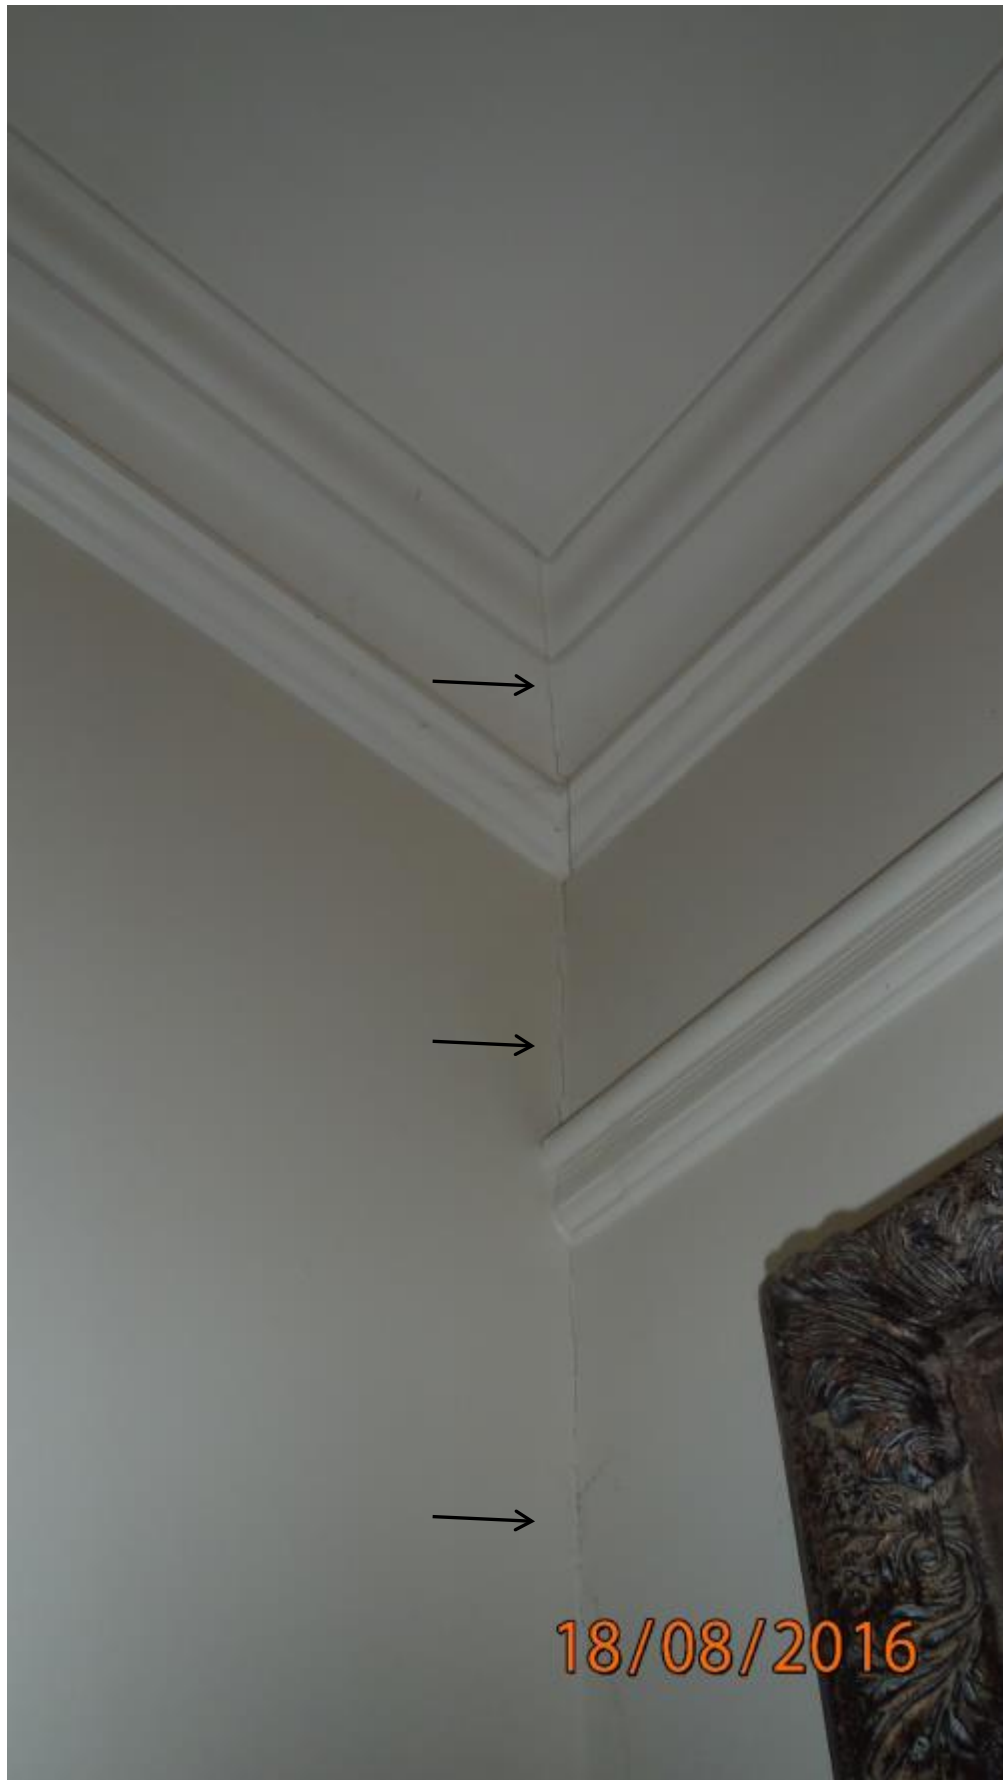
We noted hairline separation cracking [$<1.0\text{mm}$] to the mitre joint in the decorative profiled cornice. We also noted separation cracking [$<1.0\text{mm}$] between the painted cement rendered wall and the plasterboard lined wall in the north eastern corner. **[Photograph 30]**

Photograph 30 shows cracking to the mitre joint in the cornice and vertical cracking at the wall / wall junction in Bedroom 3.

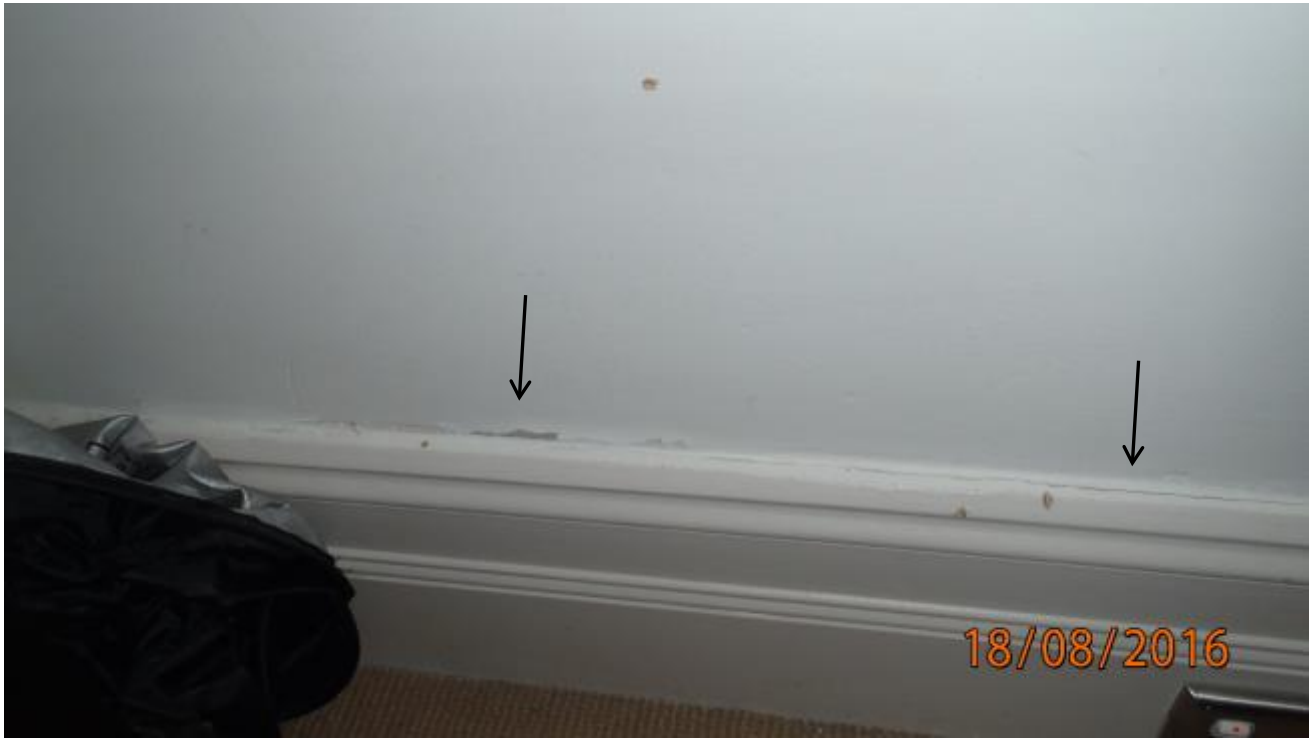
We noted separation cracking [$<1.0\text{mm}$] to the wall/skirting junction and flaking paint to the southern external wall. **[Photograph 31]**

Photograph 31 shows cracking to the wall/skirting junction and flaking paint to the southern external wall in Bedroom 3.

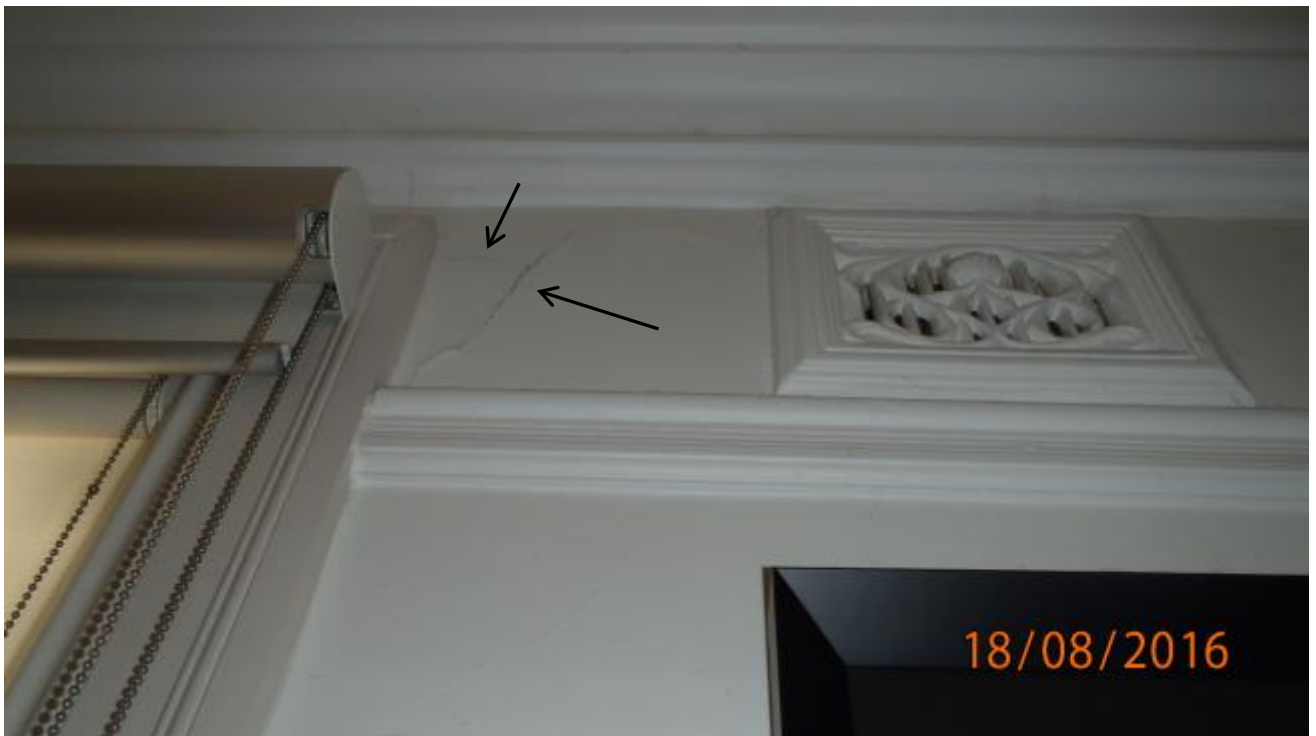
We noted radial cracking [$<1.0\text{mm}$] extending from the window head to the wall vent. **[Photograph 32]**

Photograph 32 shows radial cracking extending from the window head to the wall vent in Bedroom 3

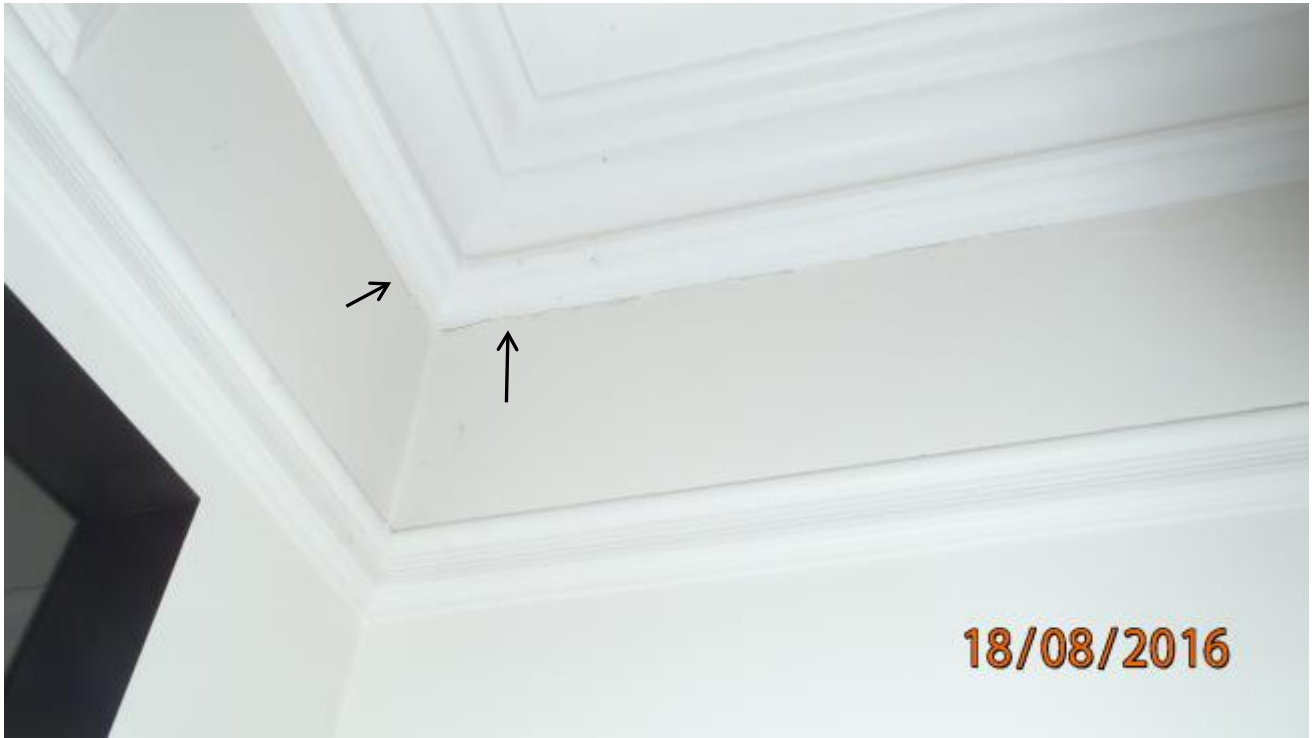
We noted hairline separation cracking [$<1.0\text{mm}$] at the wall/cornice junction in the south western corner. **[Photograph 33]**

Photograph 33 shows cracking at the wall/cornice junction in the south western corner in Bedroom 3.

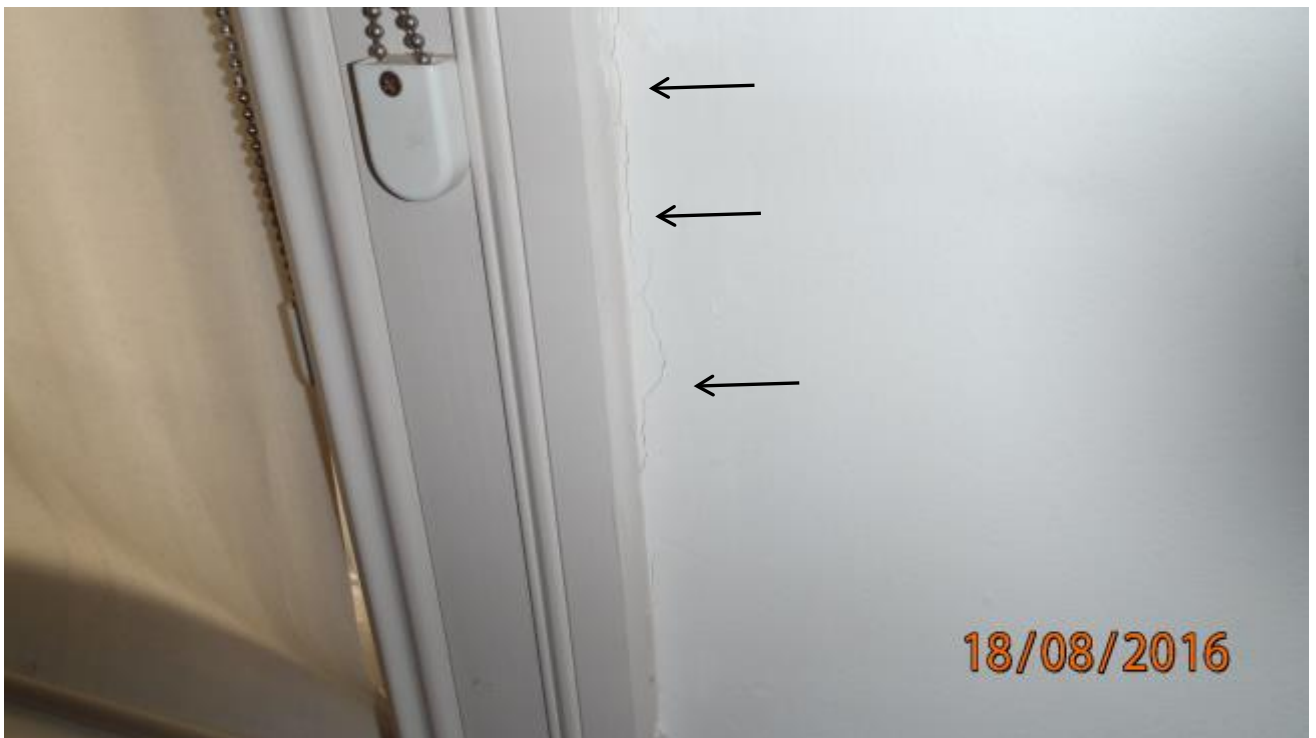
We noted hairline separation cracking [$<1.0\text{mm}$] to the right hand side of the window. **[Photograph 34]**

Photograph 34 shows separation cracking to the right hand side of the window in Bedroom 3.

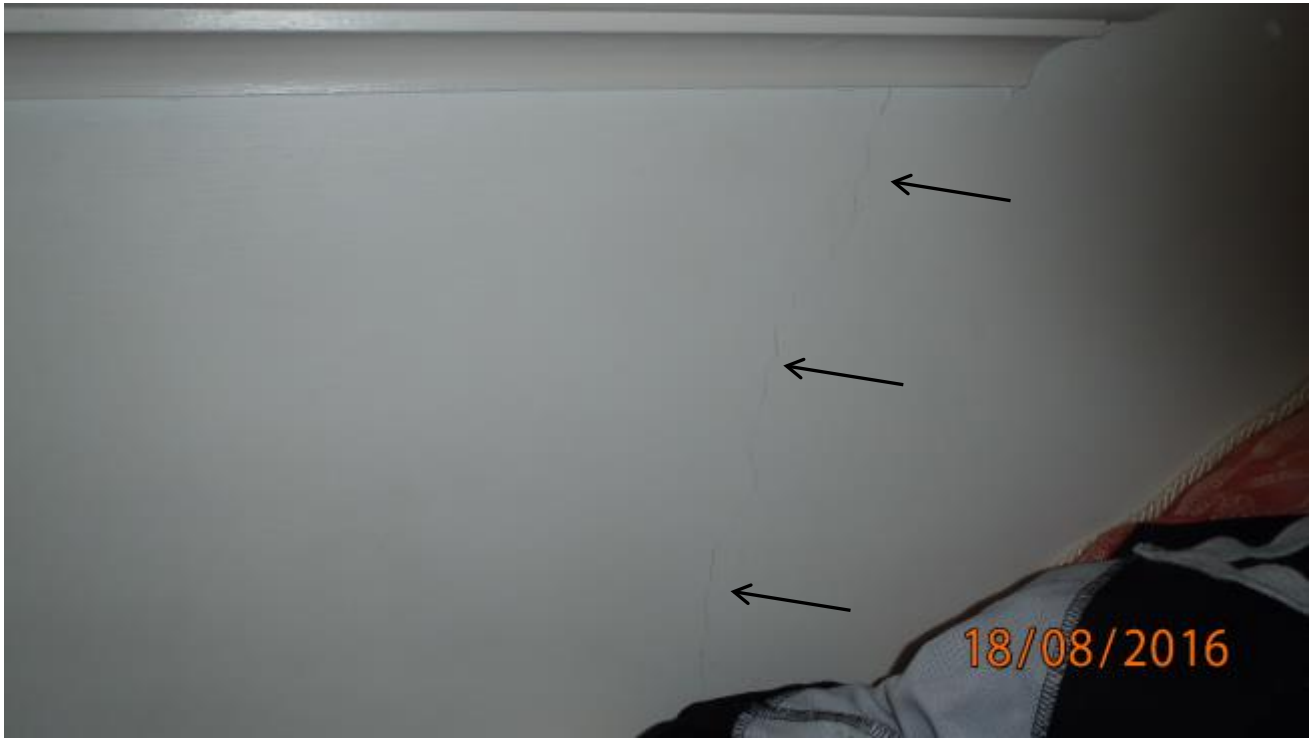
We noted radial cracking [$<1.0\text{mm}$] extending from the right hand side window sill toward the floor. **[Photograph 35]**

Photograph 35 shows a radial crack extending from the right hand side window sill toward the floor in Bedroom 3.

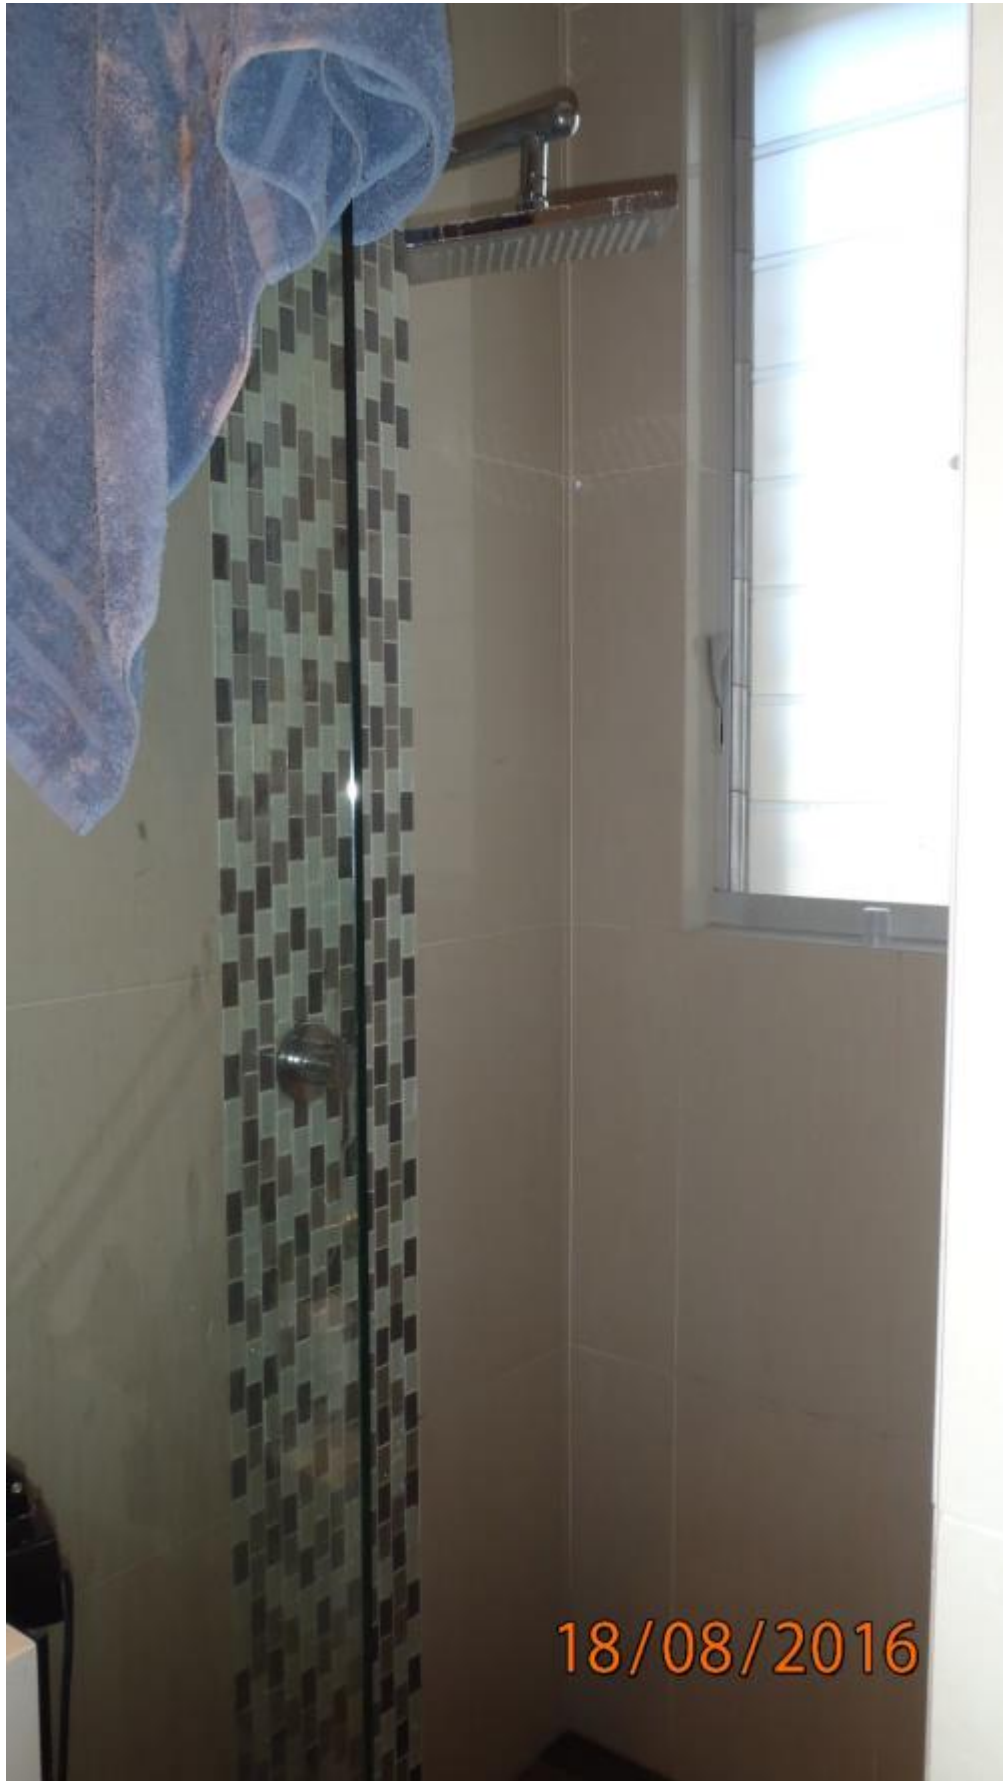
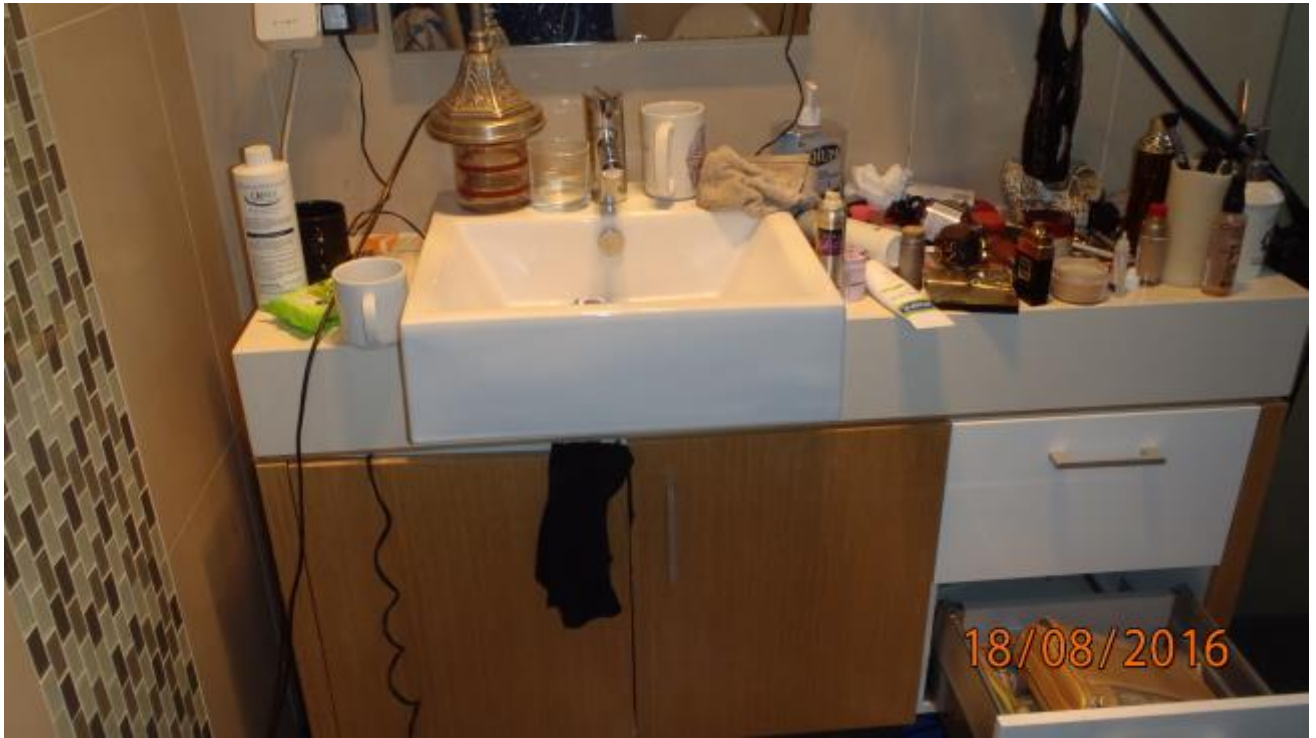
We noted that the grout to the wall and floor tiles is complete and that the wall and floor tiles when randomly “tap” tested appeared to be sound. We did not observe any recent cracking to the tile grout at the wall / wall, wall / floor junctions. **[Photographs 36 and 37]**

Photograph 36 shows the general condition of the ensuite shower.

Photograph 37 shows the general condition of the ensuite cabinet.

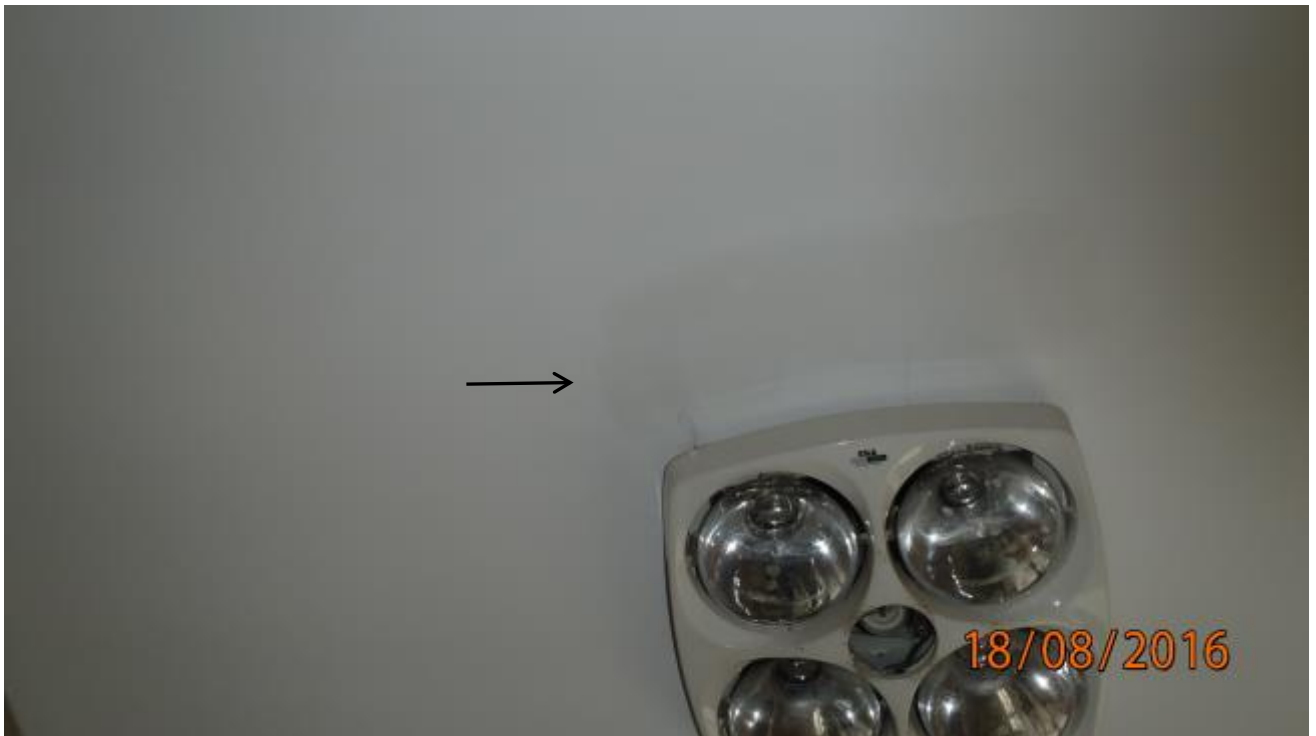
We noted a previous repair to the ceiling adjacent to the light fitting **[Photograph 38]**

Photograph 38 shows a previous repair to the ceiling adjacent to the light fitting in the Bathroom.
