Dilapidation Assessment Report

Prepared for: Cape Cod Australia Pty. Limited
Job address: 362 Avoca Street, Kingsford.
Property Owner/s: Mrs. Gordana Poljak.
Report reference: **RANDWICK CITY COUNCIL**
Development Application No: not available
Date of assessment: 18th August 2016.

Re: Dilapidation Report

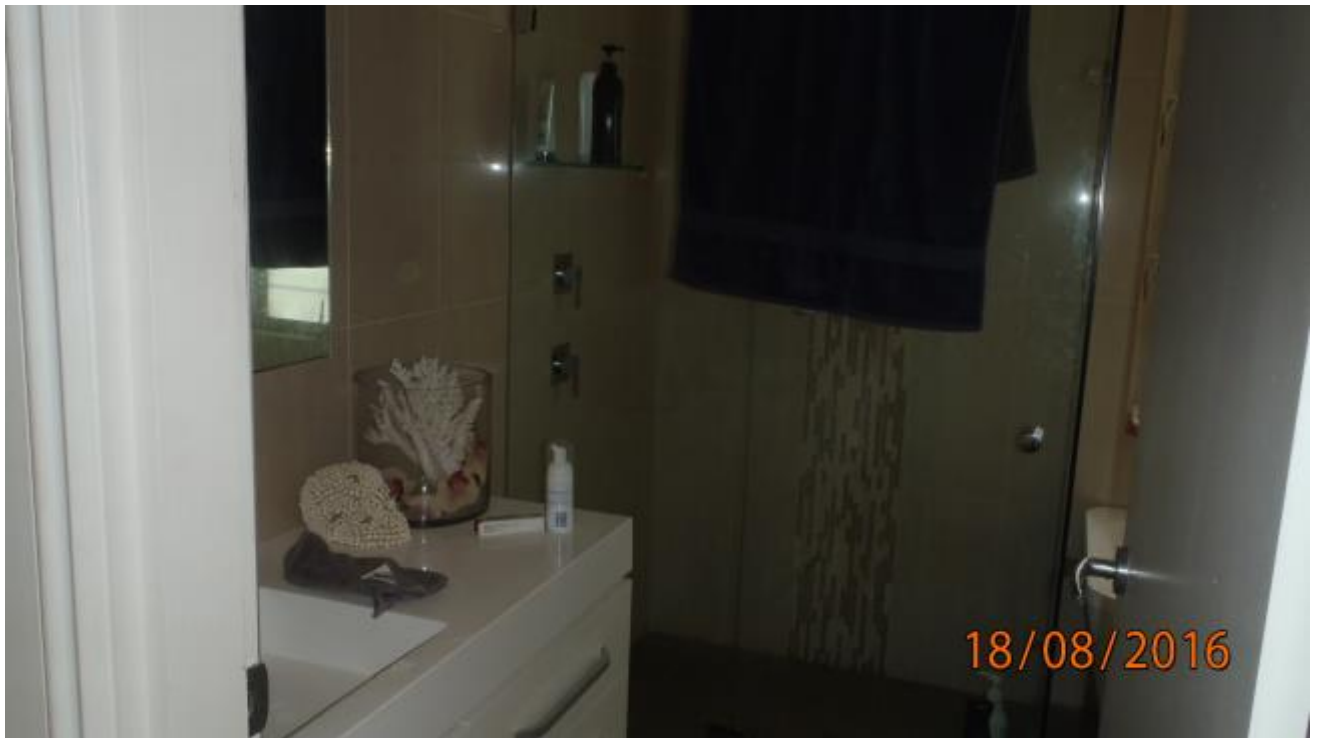
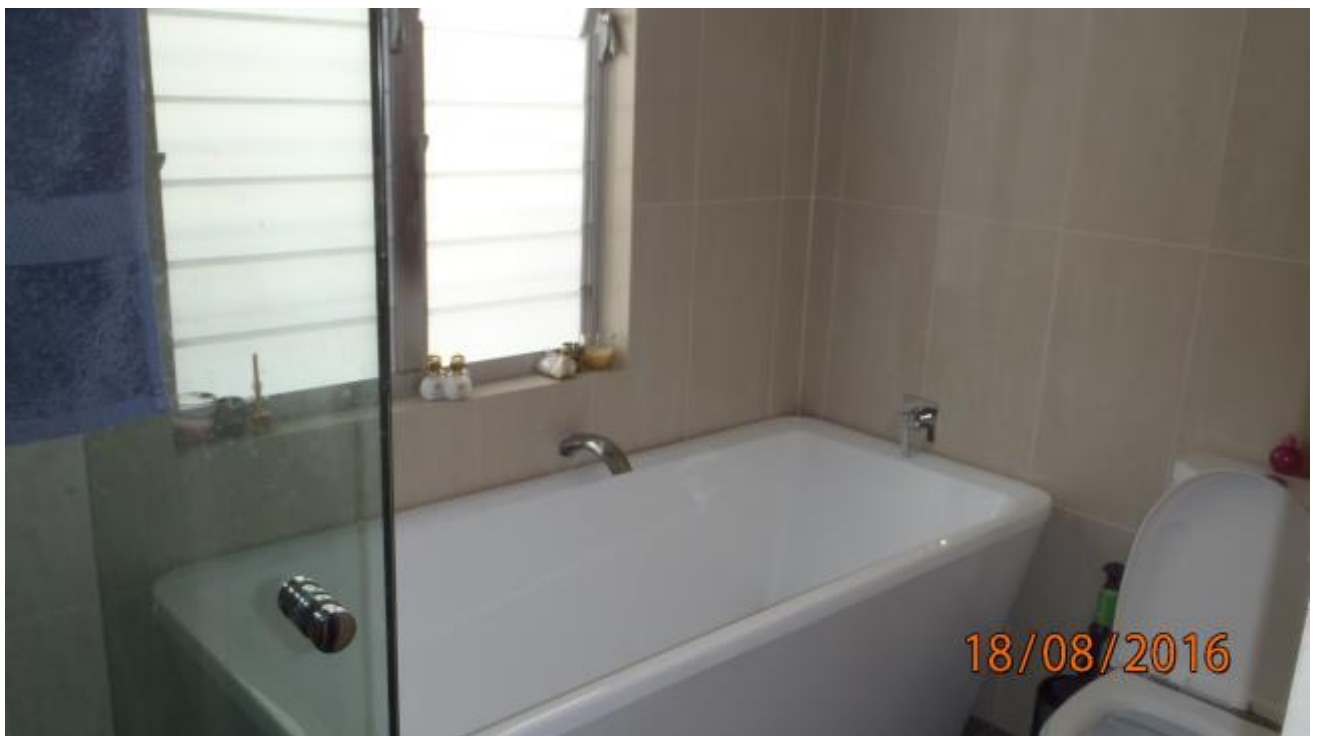
We noted that the grout to the wall and floor tiles is complete and that the wall and floor tiles when randomly “tap” tested appeared to be sound. We did not observe any recent cracking to the tile grout at the wall / wall, wall / floor junctions. **[Photographs 39 and 40]**

Photograph 39 shows the general condition of the Bathroom shower.

Photograph 40 shows the general condition of the Bath.

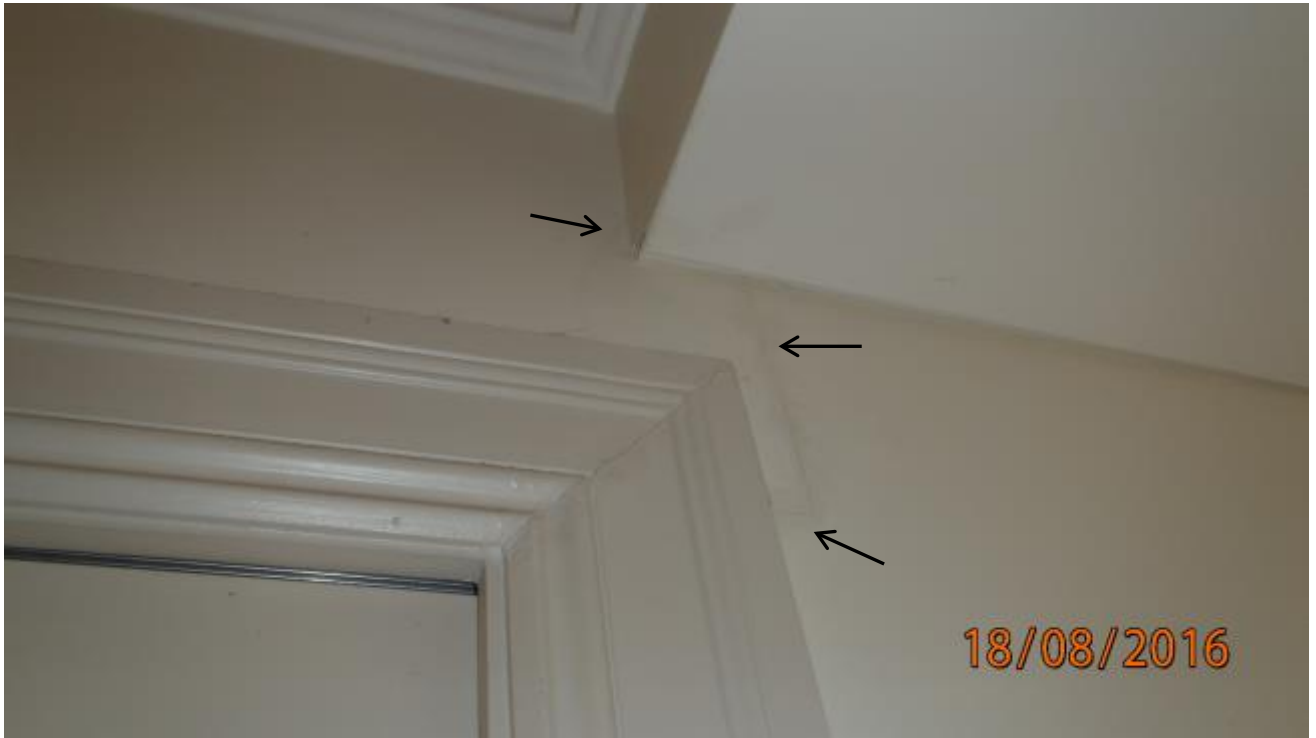
We noted evidence of a previous repair and separation cracking [$<1.0\text{mm}$] outside the Kitchen in the hallway **[Photograph 41]**

Photograph 41 shows evidence of a previous repair and separation cracking outside the Kitchen in the hallway.

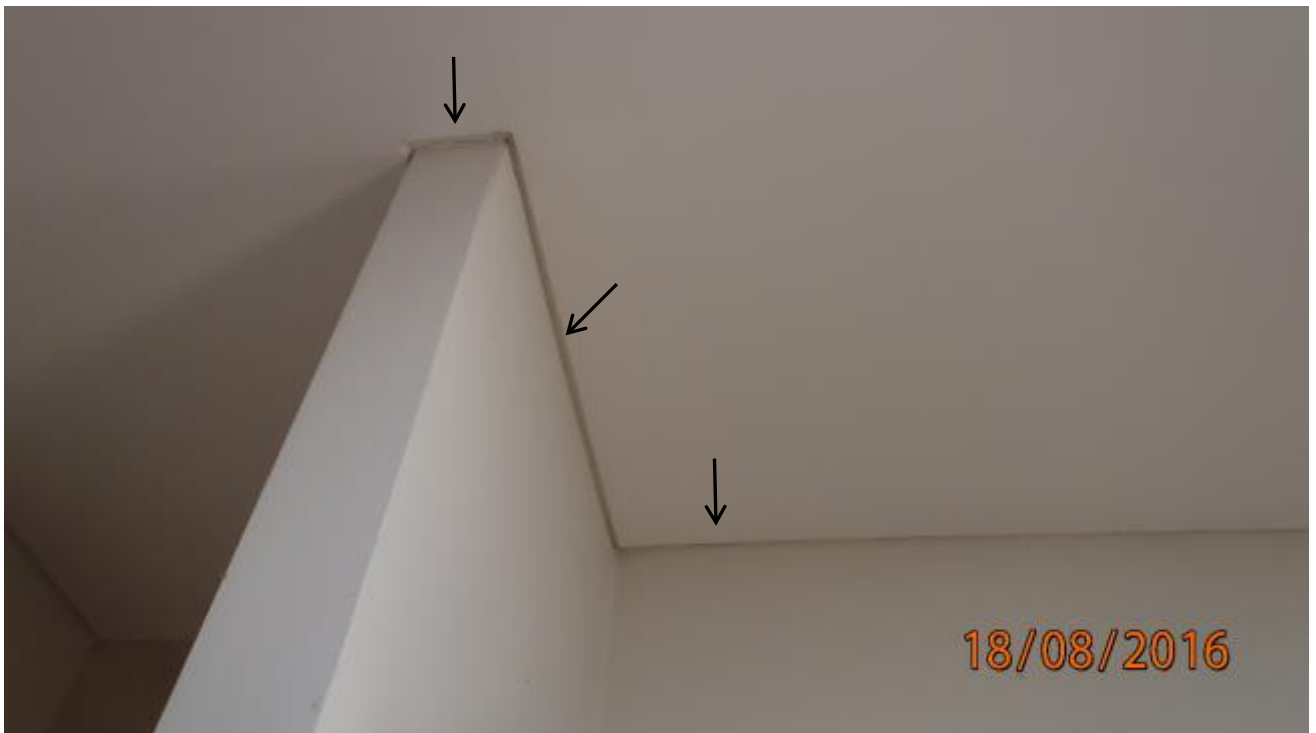
We noted separation cracking to the shadow cornice junction in the north eastern corner **[Photograph 42]**

Photograph 42 shows separation cracking to the shadow cornice junction in the north eastern corner of the Kitchen.

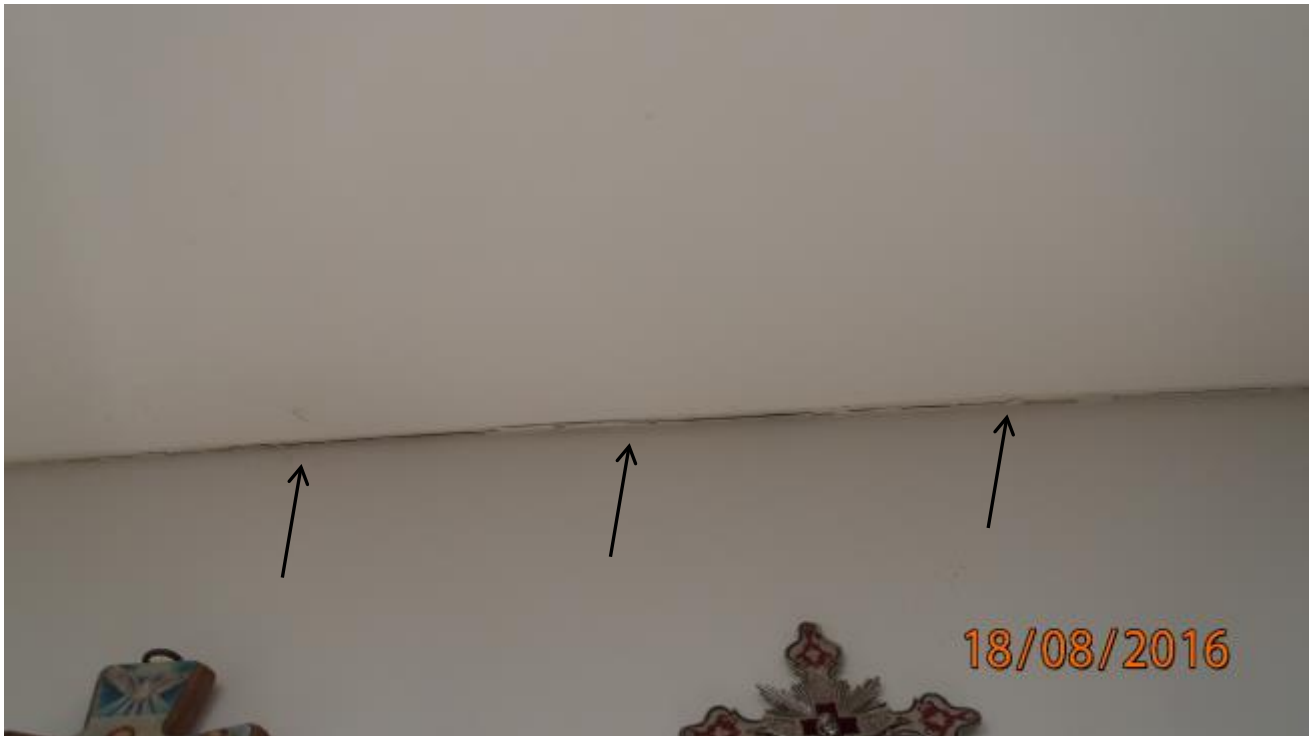
We noted general separation cracking to the shadow cornice between the ceiling and wall junctions
[Photograph 43]

Photograph 43 shows an example of general separation cracking to the shadow cornice junction in the Lounge Room.

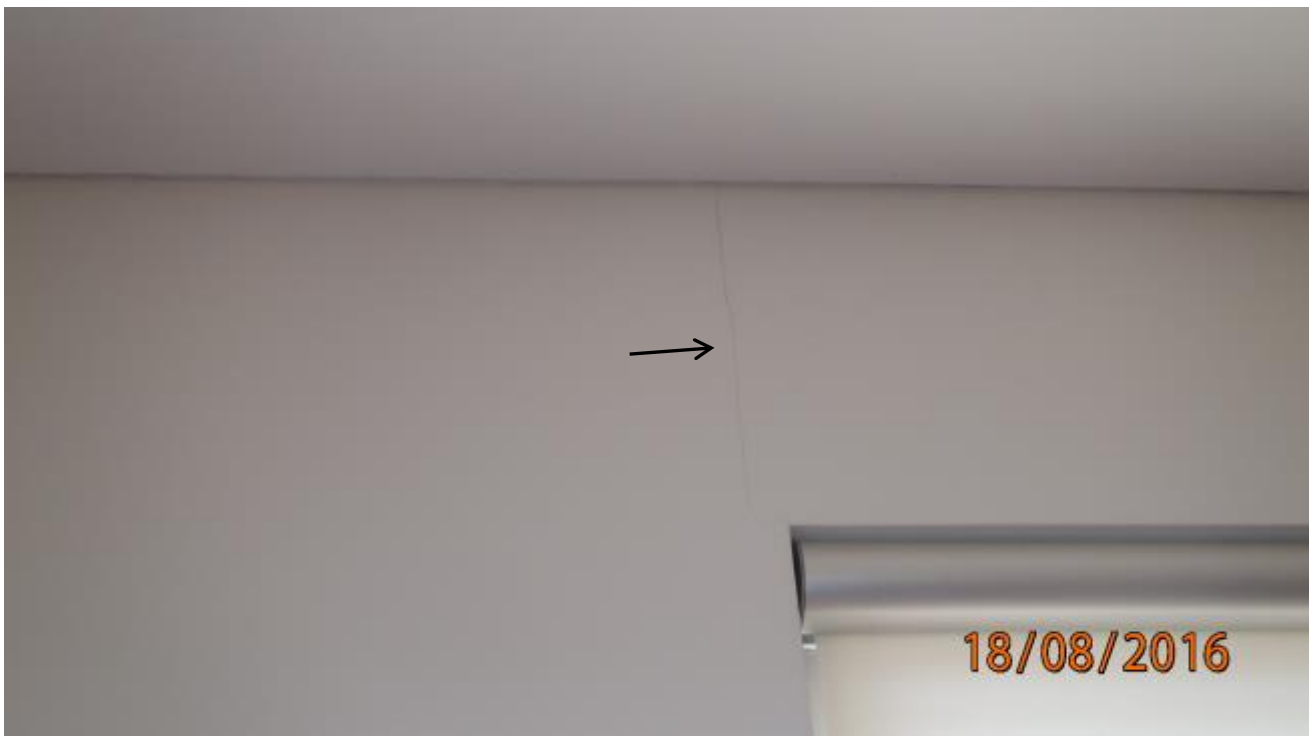
We noted hairline vertical cracking [$<1.0\text{mm}$] to the plasterboard lined wall extending from the window head to the ceiling at the eastern window **[Photograph 44]**

Photograph 44 shows vertical cracking to the plasterboard lined wall extending from the window head to the ceiling at the eastern window in the Lounge room.

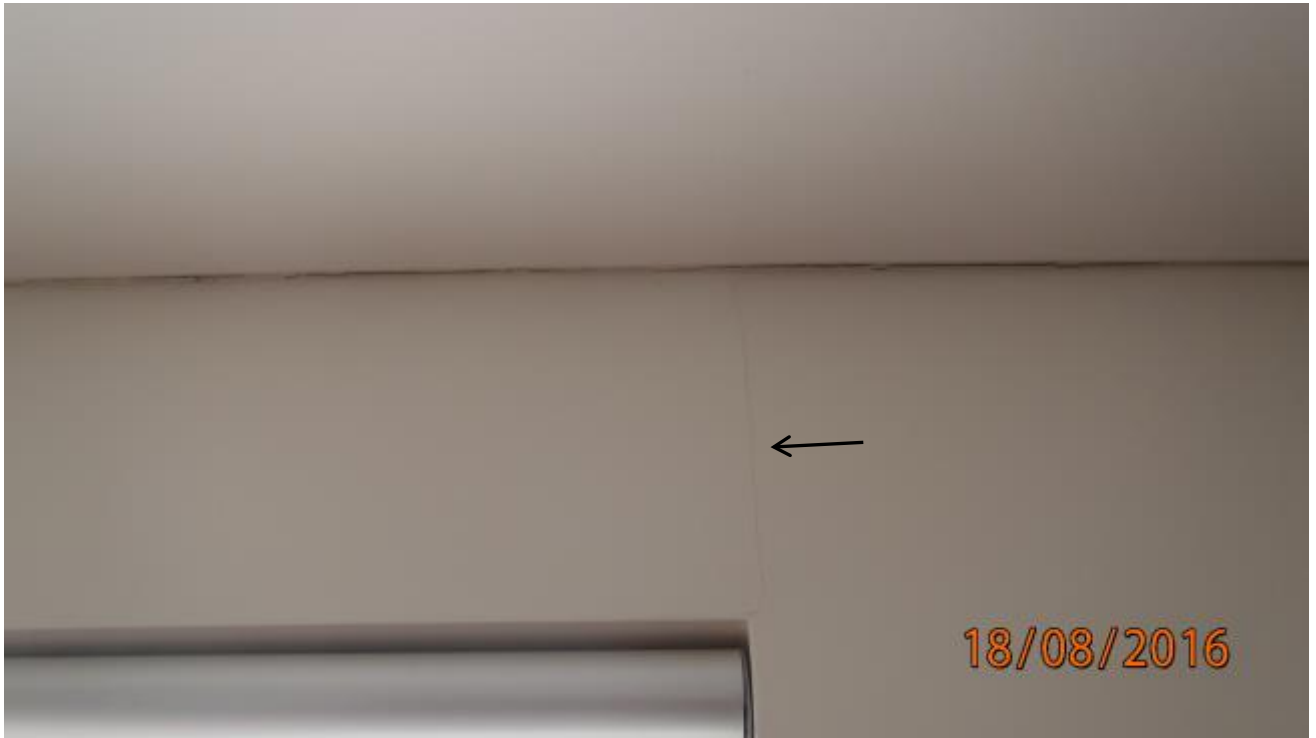
We noted hairline vertical cracking [$<1.0\text{mm}$] to the plasterboard lined wall extending from the window head to the ceiling at the western window **[Photograph 45]**

Photograph 45 shows vertical cracking to the plasterboard lined wall extending from the window head to the ceiling at the western window in the Lounge room.
