HAZARDOUS MATERIALS ASSESSMENT REPORT

Job details: Owner: Mr. K. & Mrs. S. Langan.
Location: 10 Garden Street, Maroubra.

Our reference: HM05960917

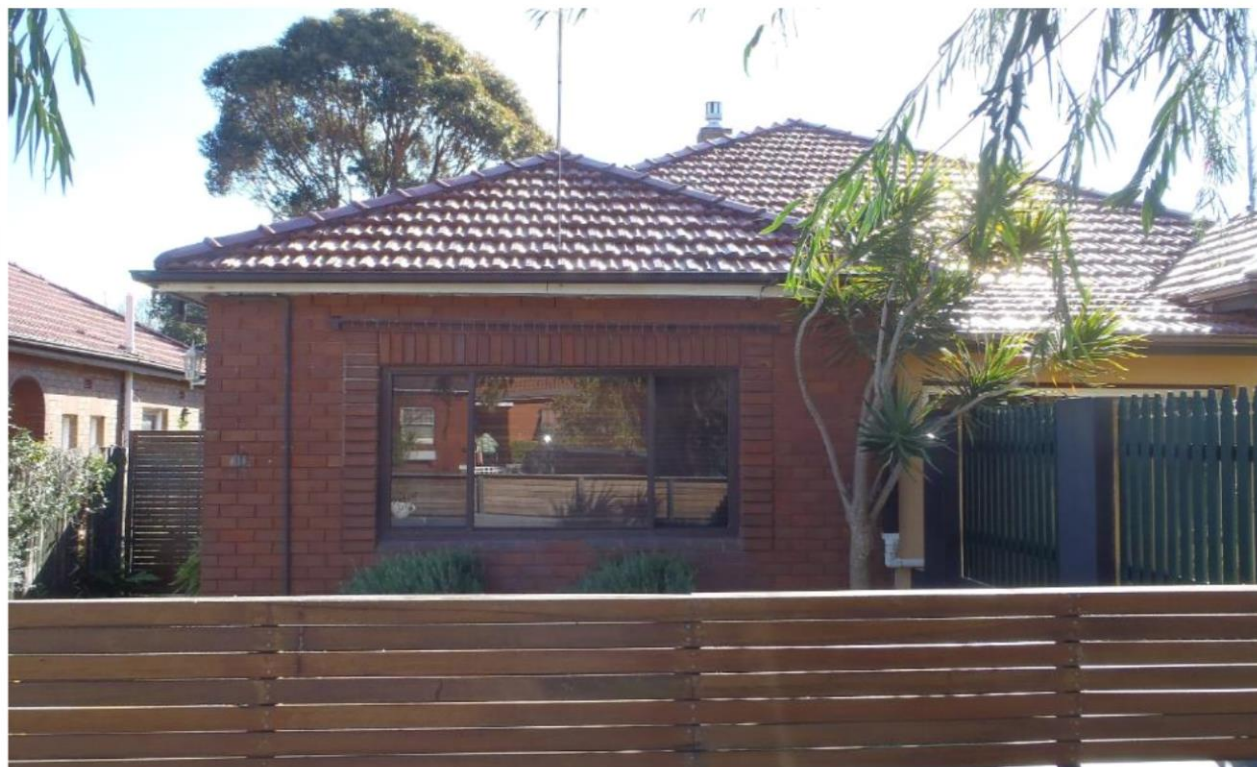
Front eastern elevation of the residence
