HAZARDOUS MATERIALS ASSESSMENT REPORT

Client: Cape Cod Australia Pty. Limited

Job details: Owner: Mr. R. McLintock
Location: 3 Wistaria Place, Blacktown NSW

Our reference: HM04190815

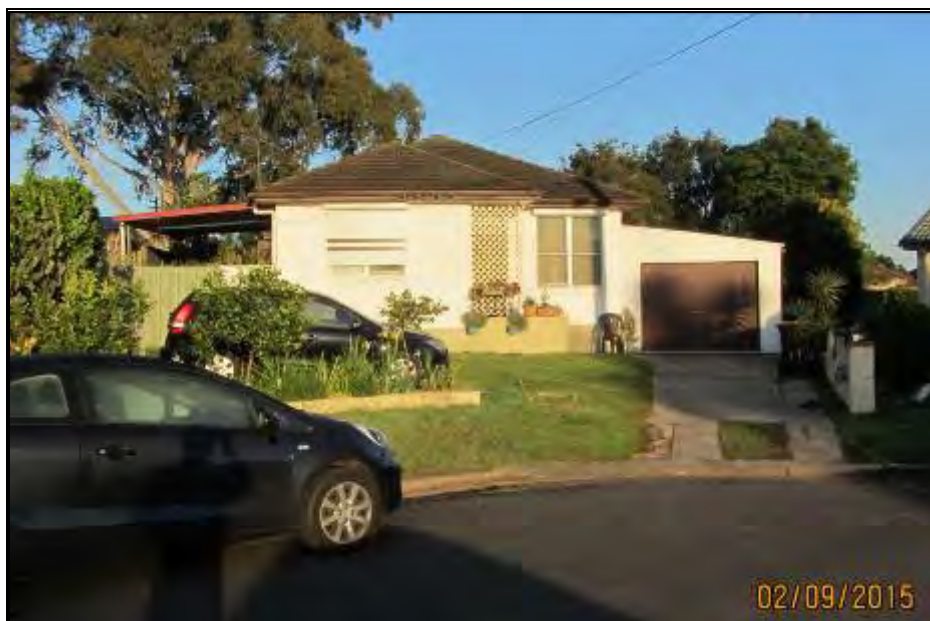
Front eastern elevation of the residence
