HAZARDOUS MATERIALS ASSESSMENT REPORT

Job details: Owner/s: Mr. N. Prendeville & Ms. C. Campbell
Location: 30 Gilderthorpe Avenue, Randwick

Our reference: HM04810416

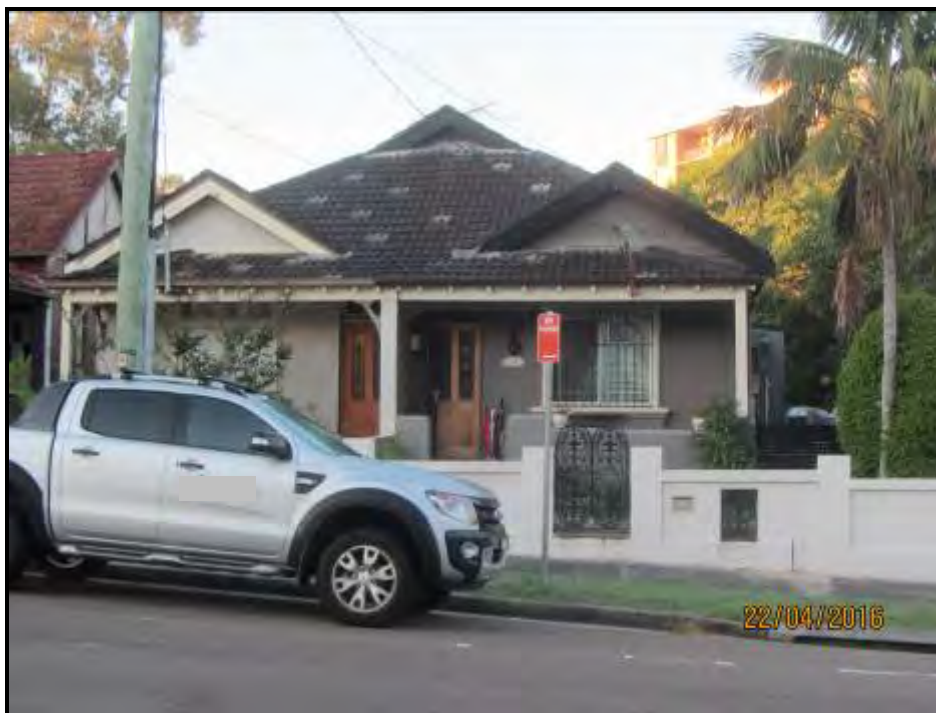
Front northern elevation of the adjoining properties:
No. 30 & No. 32 Gilderthorpe Avenue, Randwick
