HAZARDOUS MATERIALS ASSESSMENT REPORT

Job details: Owner/s: Mr. C. & Mrs. X. Alexander
Location: 8 Weston Road, Hurstville NSW

Our reference: HM03650215

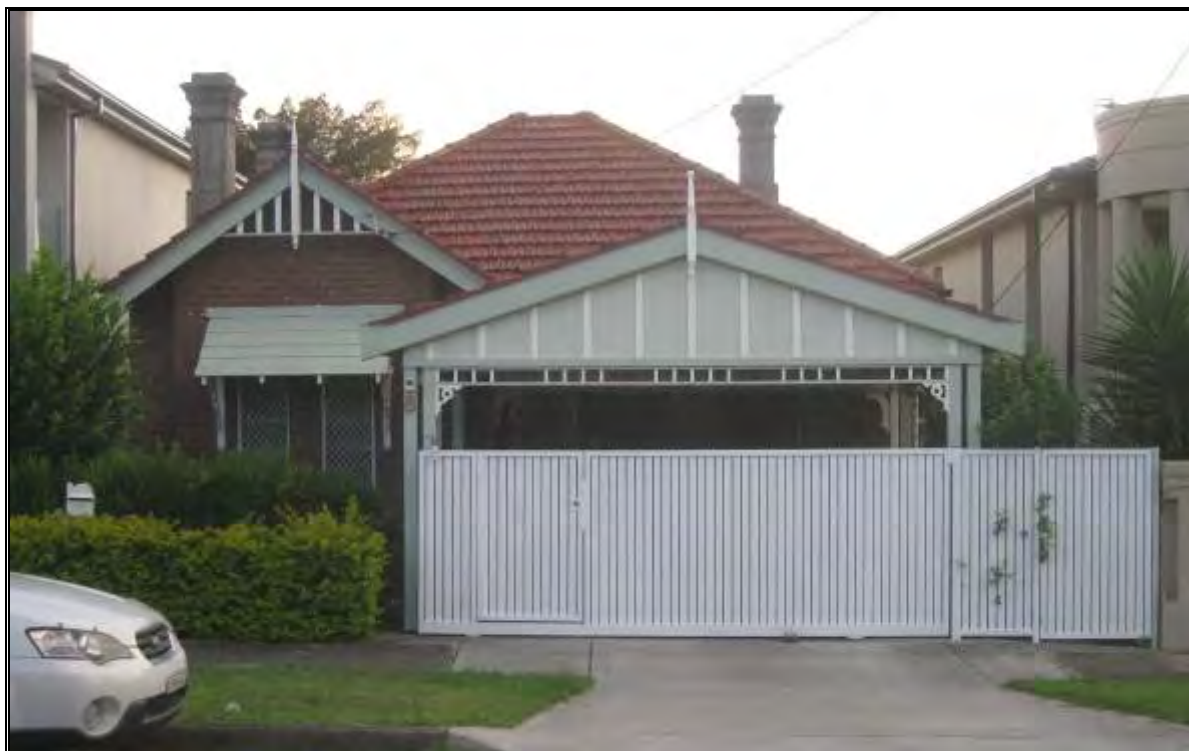
Front south western elevation of the residence
