HAZARDOUS MATERIALS ASSESSMENT REPORT

Job details: Owner: Mrs. L. Kawalsky.
Location: 50 George Street, Dover Heights.

Plans for Job No: 7848/17

Our reference: HM05910817

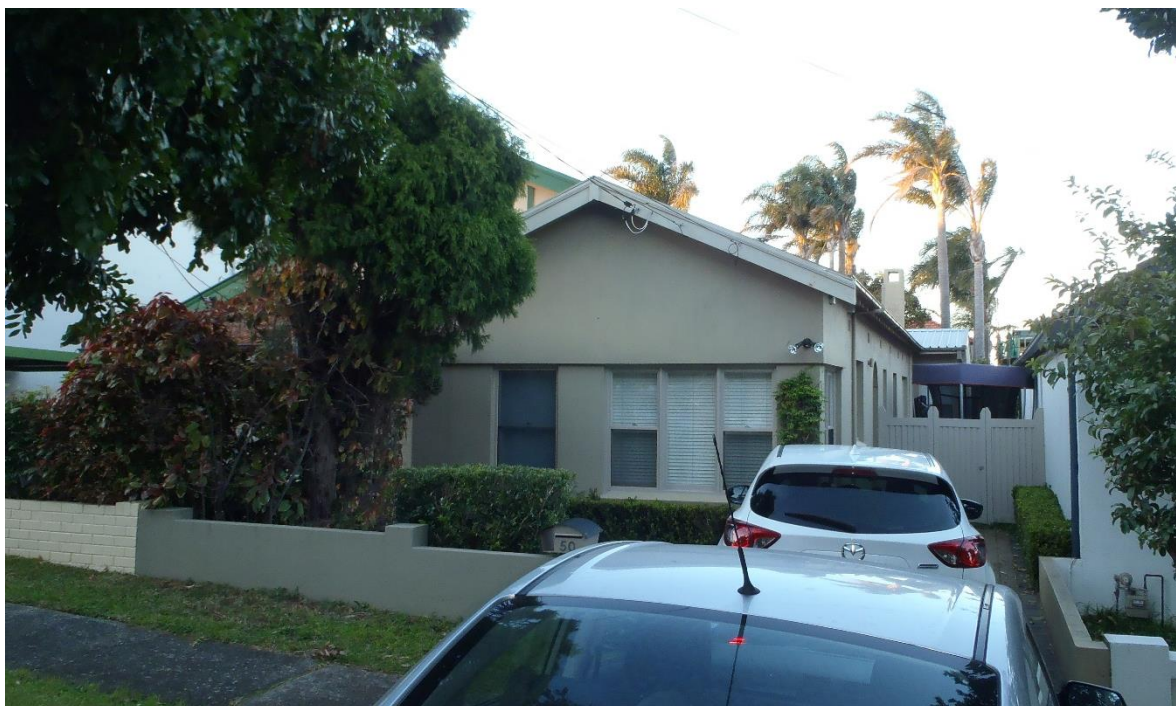
Front northern elevation of the residence
