Dilapidation Assessment Report

Prepared for: Cape Cod Australia Pty. Limited
Job address: 110 West Street, Crows Nest NSW 2065
Property Owner/s: Mr. R. Wynan & Ms. A. Mirek
Report reference: **NORTH SYDNEY COUNCIL**
Development Application No: not available
Date of assessment: 2nd March 2016

Re: Dilapidation Report - No. 110 West Street, Crows Nest

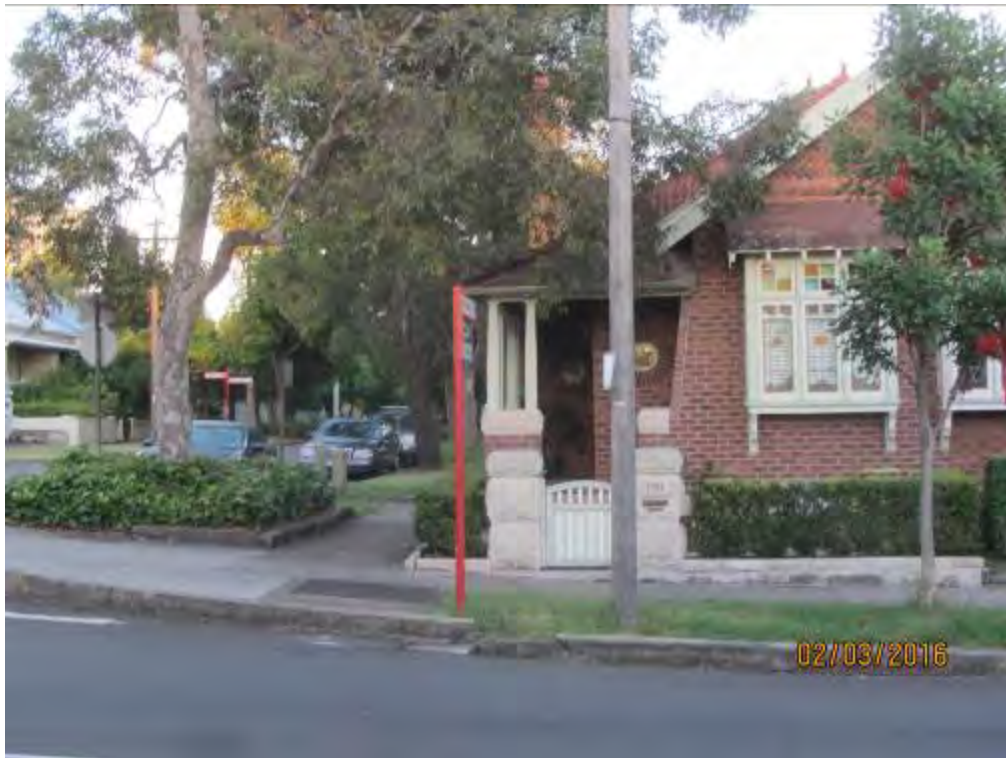
We did not observe any recent cracking to the clay masonry brickwork particularly at the junction between the properties. **[Photograph 1]**

Photograph 1 shows the front eastern elevation of this property

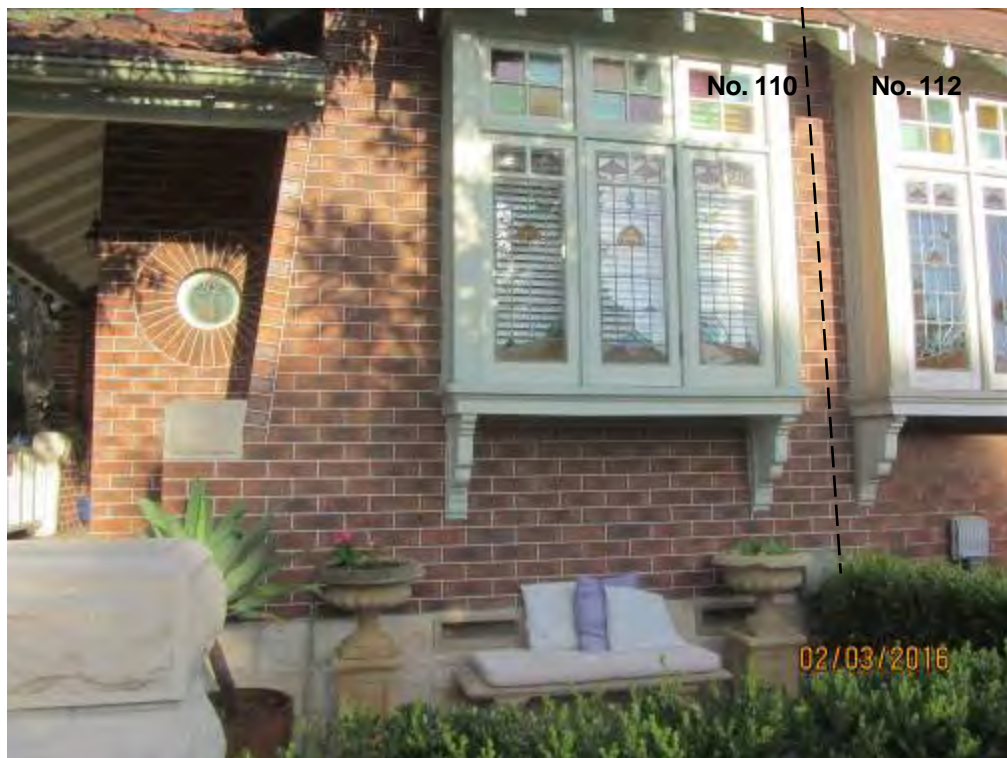
We noted that there has been previous refurbishment of the tuck pointing to the brickwork and to the mortar joints overall the length of the wall. **[Photograph 2]**

Photograph 2 shows the previously refurbished tuck pointing and mortar to the front eastern elevation

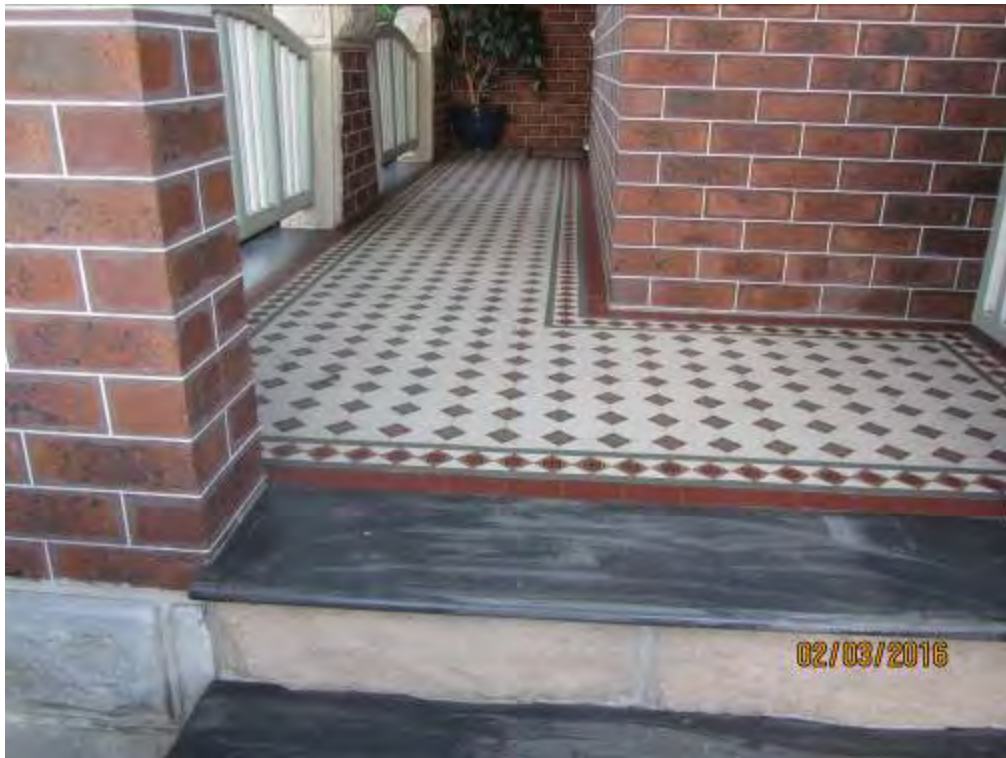
We noted that the front entry porch is finished with tessellated tiles. We did not observe any recent cracking to the tiles. **[Photograph 3]**

Photograph 3 shows the condition of the tessellated tiles to the front Verandah

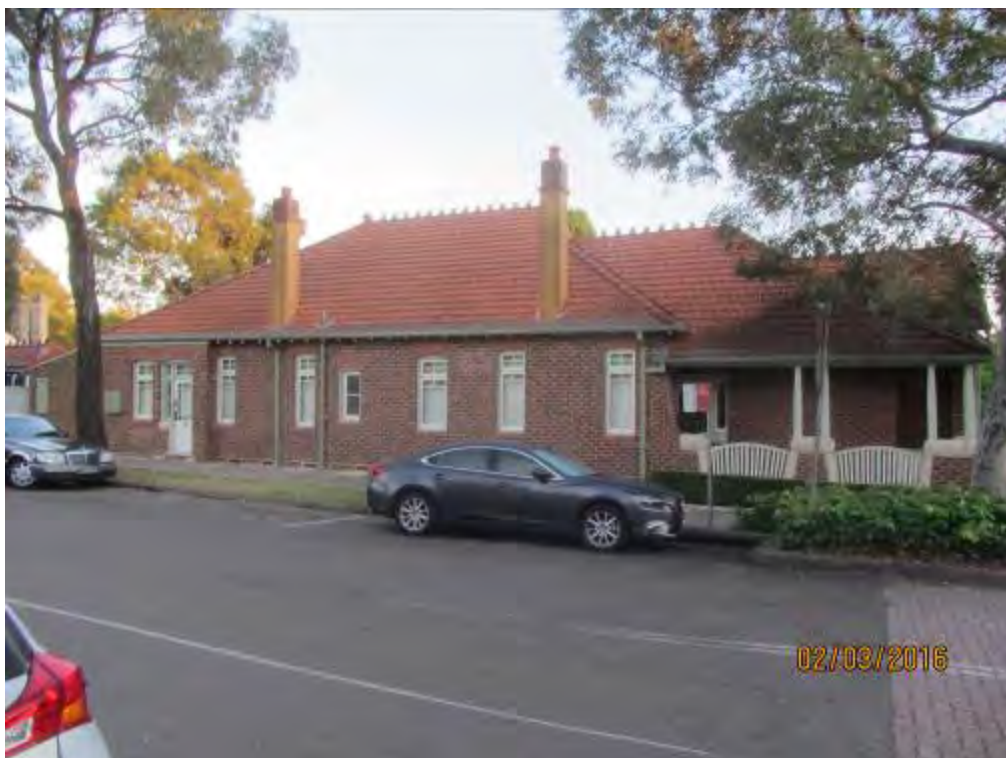
We noted that the southern wall of the property is located on the boundary and abuts the public footpath. **[Photograph 4]**

We did not observe any recent cracking to the clay masonry brickwork. However, we noted that there has been previous refurbishment of the tuck pointing to the brickwork and to the mortar joints overall the length of the wall. **[Photographs 4 and 5]**

Photograph 4 shows the southern elevation of the property

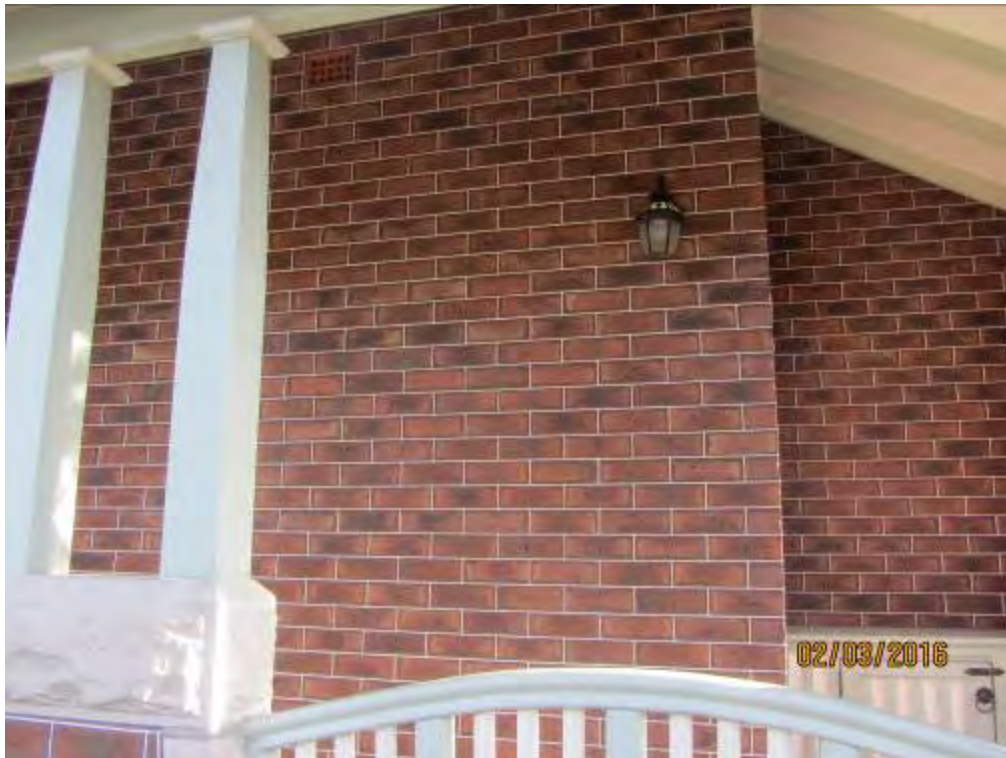
Photograph 5 shows the condition of the tuck pointing to the brickwork to the front Verandah

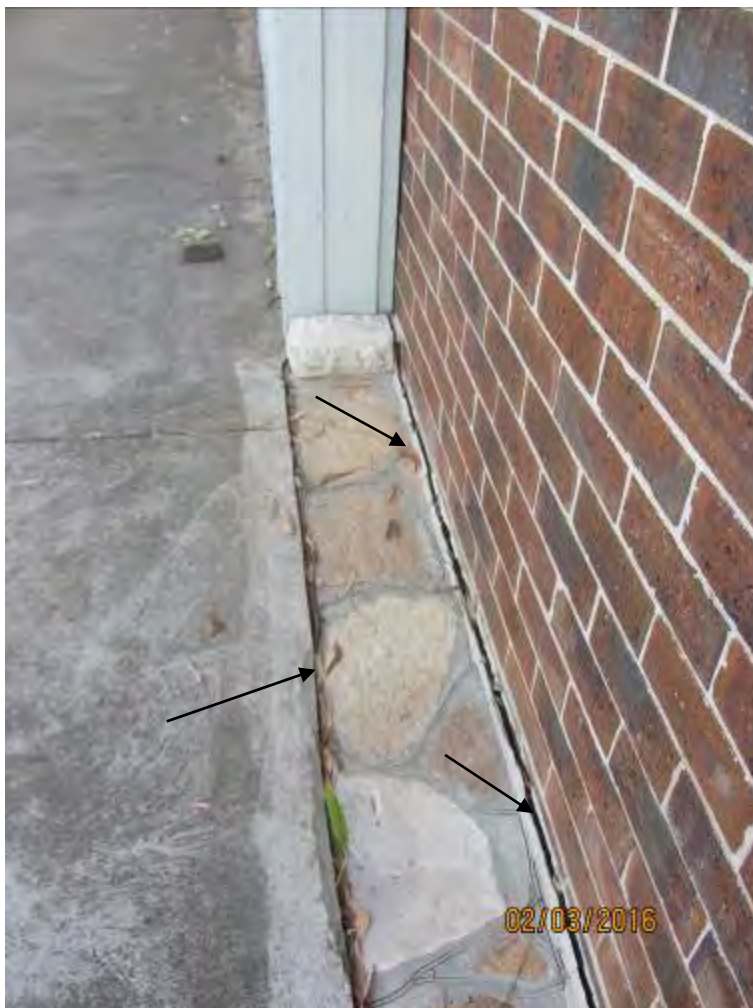
We noted that there is cracking between the sandstone flagging and the base of the wall at the western end of the wall. **[Photograph 6]**

Photograph 6 shows typical cracking between the sandstone flagging and the base of the southern wall

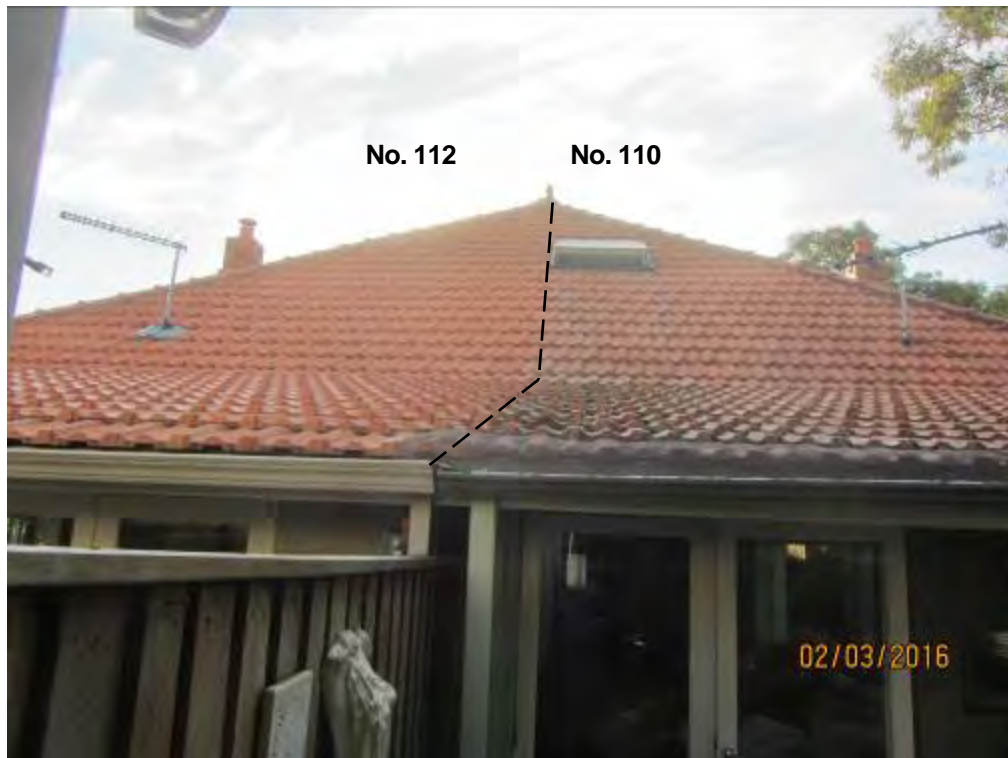
We did not observe any noticeable recent cracking to the surface coated cement rendered brickwork. **[Photograph 7]**

Photograph 7 shows the rear elevation junction between the properties

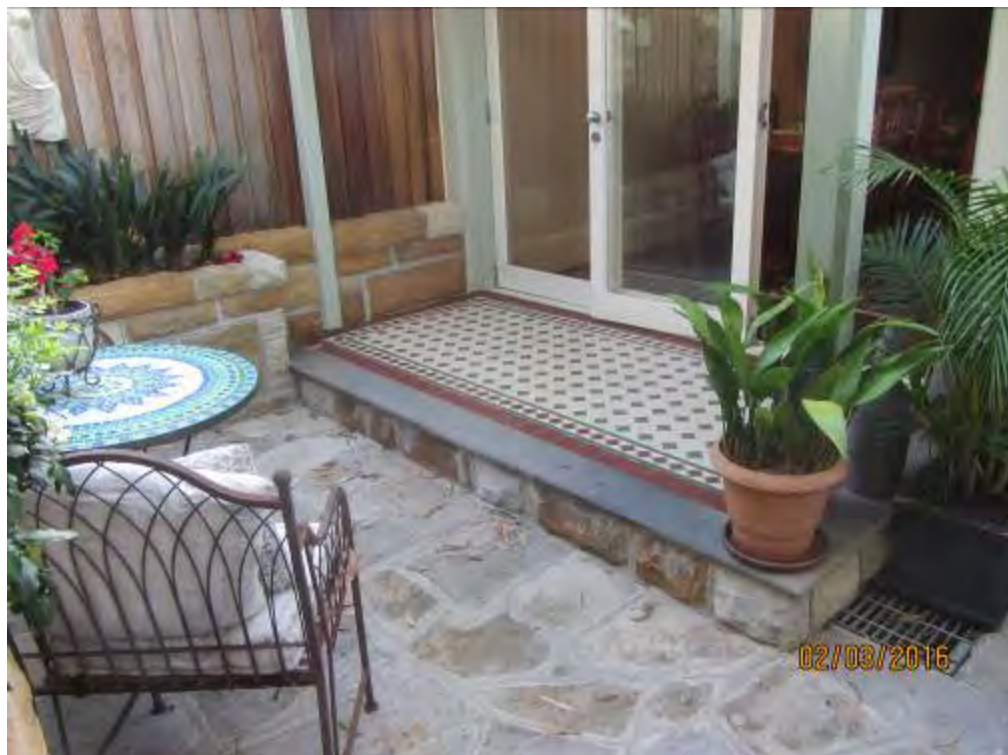
We noted that the rear entry patio is finished with tessellated tiles. We did not observe any recent cracking to the tiles. **[Photograph 8]**

Photograph 8 shows the rear entry patio and the condition of the tessellated tiles

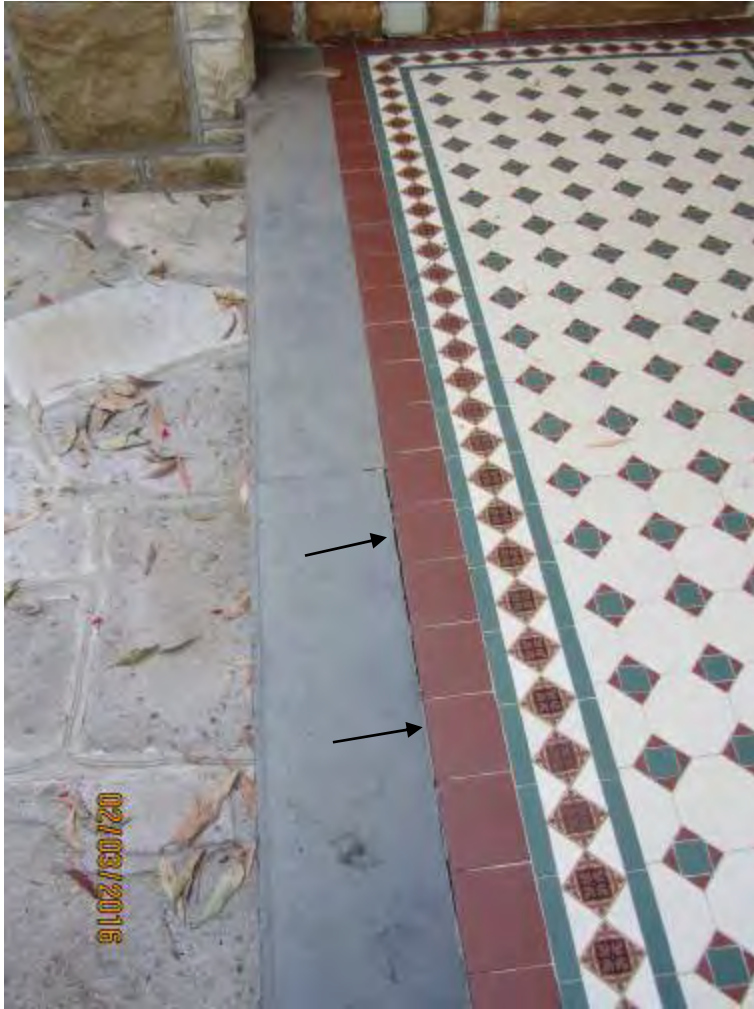
However, we noted that there is movement between the tiles and the threshold. **[Photograph 9]**

Photograph 9 shows a hairline crack between the tessellated tiles and the tread to the rear entry Patio

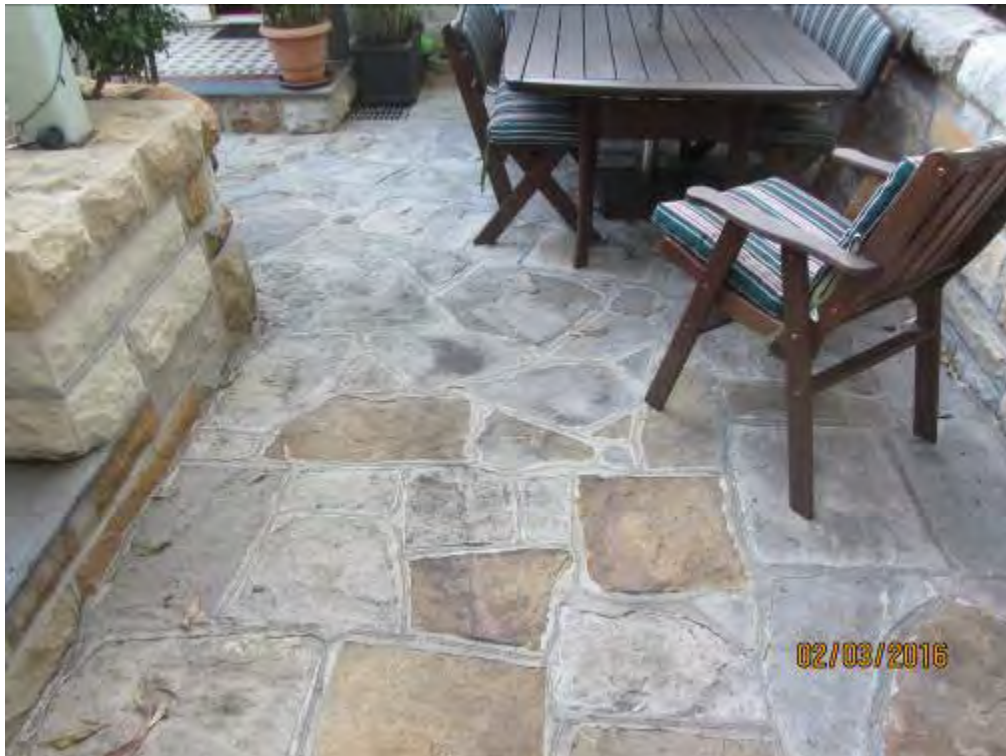
We noted that the rear yard is finished with sandstone flagging. The flagging when randomly “tap” tested appeared to be sound. Due to concealment we are unable to comment on the base strata to the flagging. **[Photograph 10]**

Photograph 10 shows the condition of the sandstone flagging to the rear courtyard

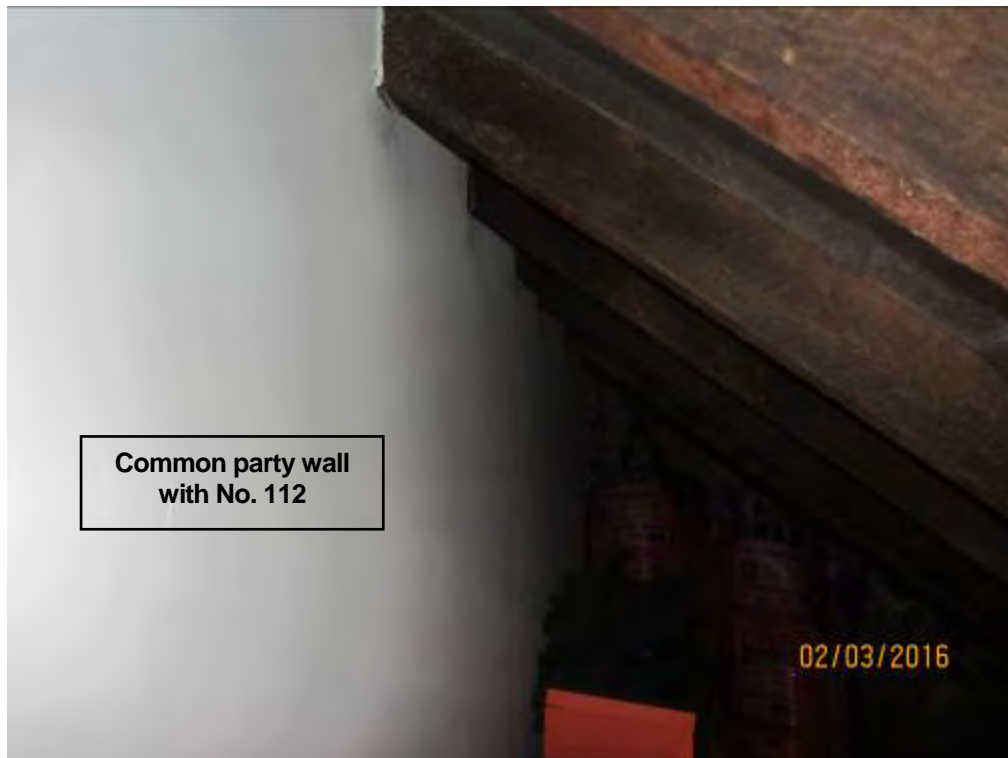
We accessed the front section of the *common* roof space from the WIR and noted roof is traditional cut and pitched timber structure with foil sarking to the underside of the roofing tiles. **[Photograph 11]**

We noted that the plasterboard lined framed *common separating / party* wall terminates just below the roofing tiles. **[Photograph 11]**

We noted that the timber ceiling joists are built into the *common party / separation wall*. We further noted that the *common* ridge to the roof is located over the *common party / separation wall*. **[Photograph 11]**

Photograph 11 shows the plasterboard lined framed *common party / separation* wall within the roof space

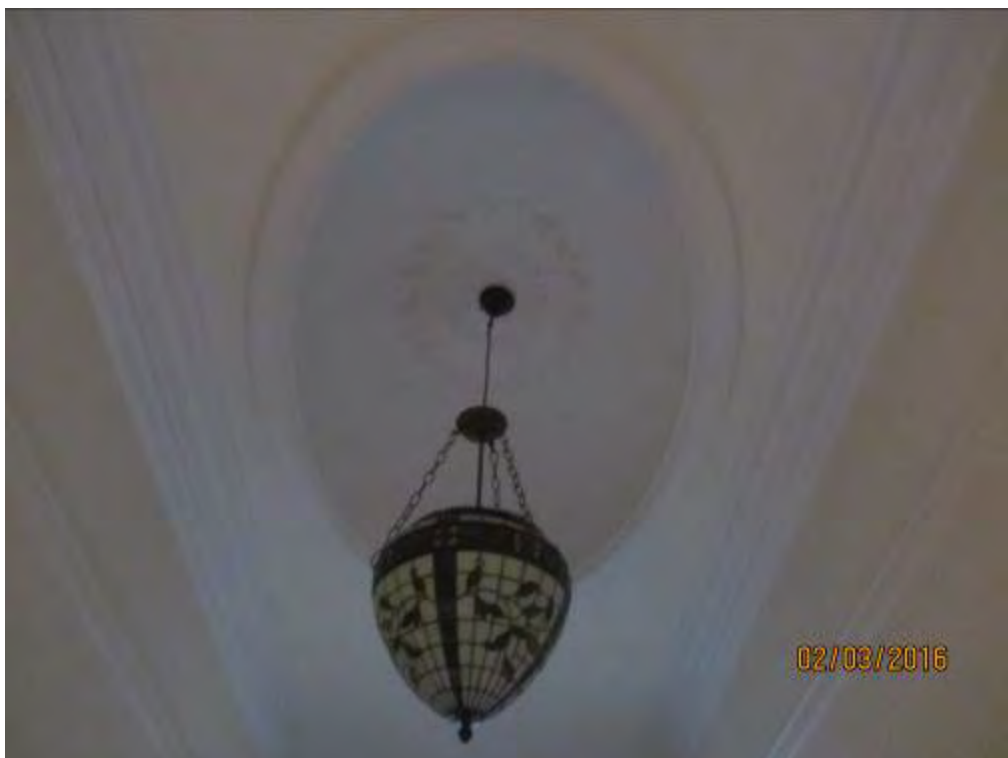
We noted that there is a vaulted [domed] recessed panel in the ceiling. We noted that there was no noticeable cracking to the ceiling or to the wide decorative profiled plaster cornice. **[Photograph 12]**

Photograph 12 shows the vaulted [domed] recessed light panel to the ceiling of the front entry

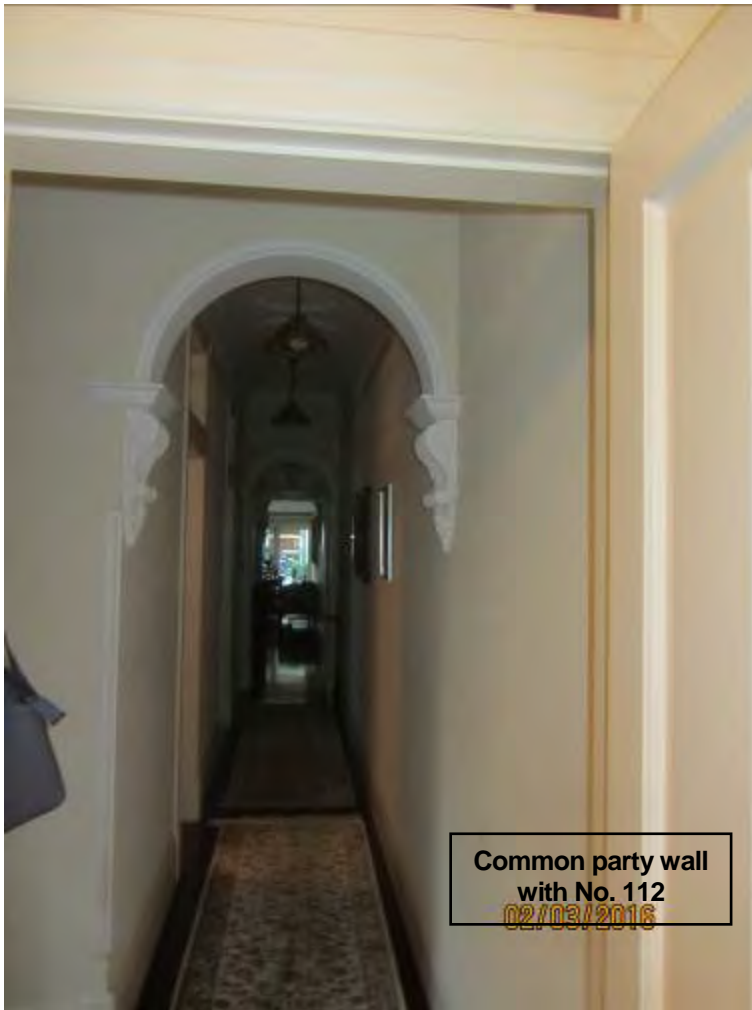
We noted that the northern wall of the Hallway is the *common party / separation* wall with the adjoining property, No. 112 West Street. **[Photograph 13]**

Photograph 13 shows the Hallway viewed towards the rear [Living room]

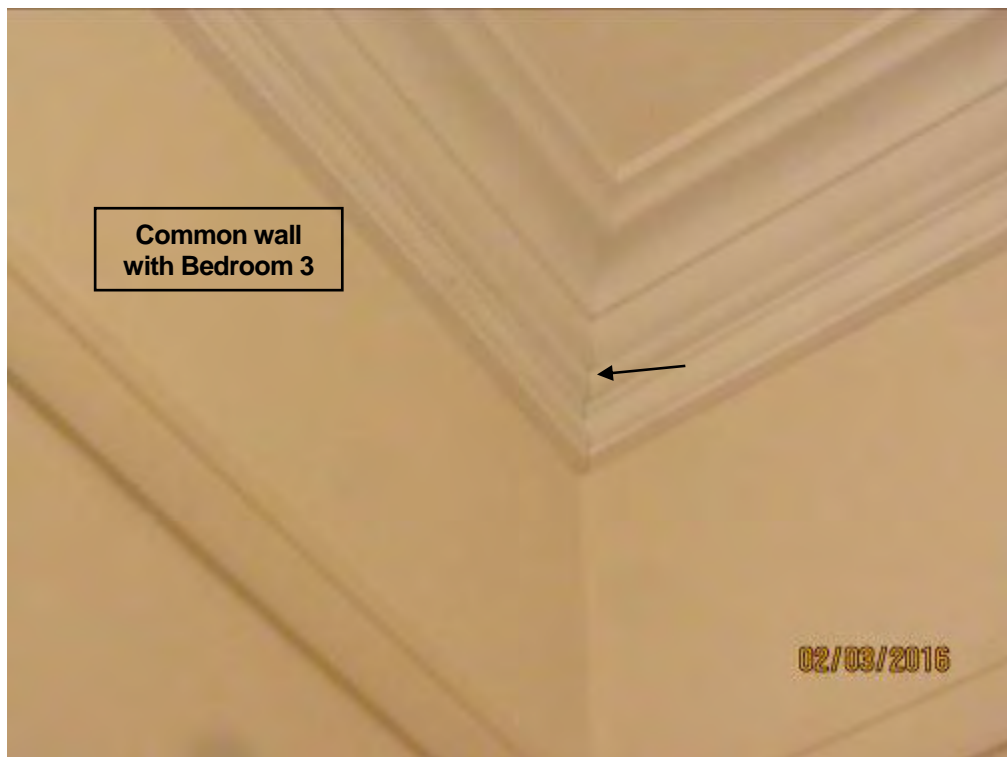
We did not observe any cracking to the recessed panelled plaster ceiling or to the mitred joints in the wide decorative profile plaster cornice. Notwithstanding this, we did note a hairline crack [$<1.0\text{mm}$] to the cornice at the southwest corner of the Hallway. **[Photograph 14]**

Photograph 14 shows the hairline crack to the cornice at the southwest corner of the Hallway

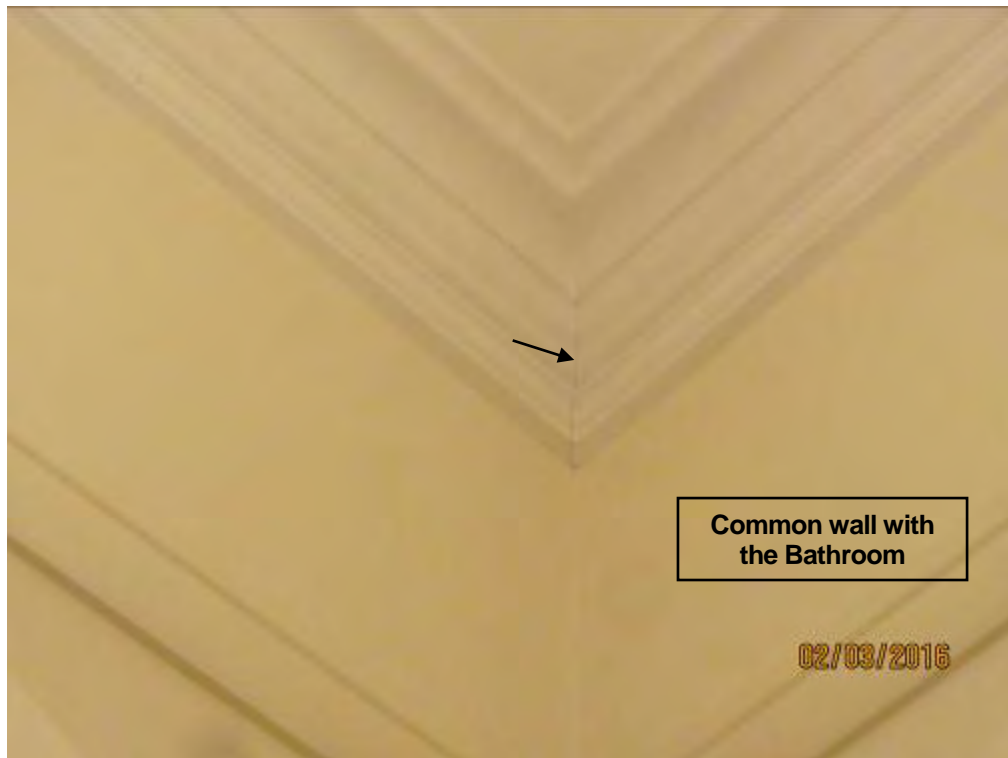
We did not observe any cracking to the plaster ceiling or to the mitred joints in the wide decorative profile plaster cornice. Notwithstanding this, we did note a hairline crack [$<1.0\text{mm}$] to the cornice at the northeast and northwest corner of the area. [**Photographs 15 and 16**]

Photograph 15 shows the hairline crack to the cornice to the southeast corner of Hallway 2

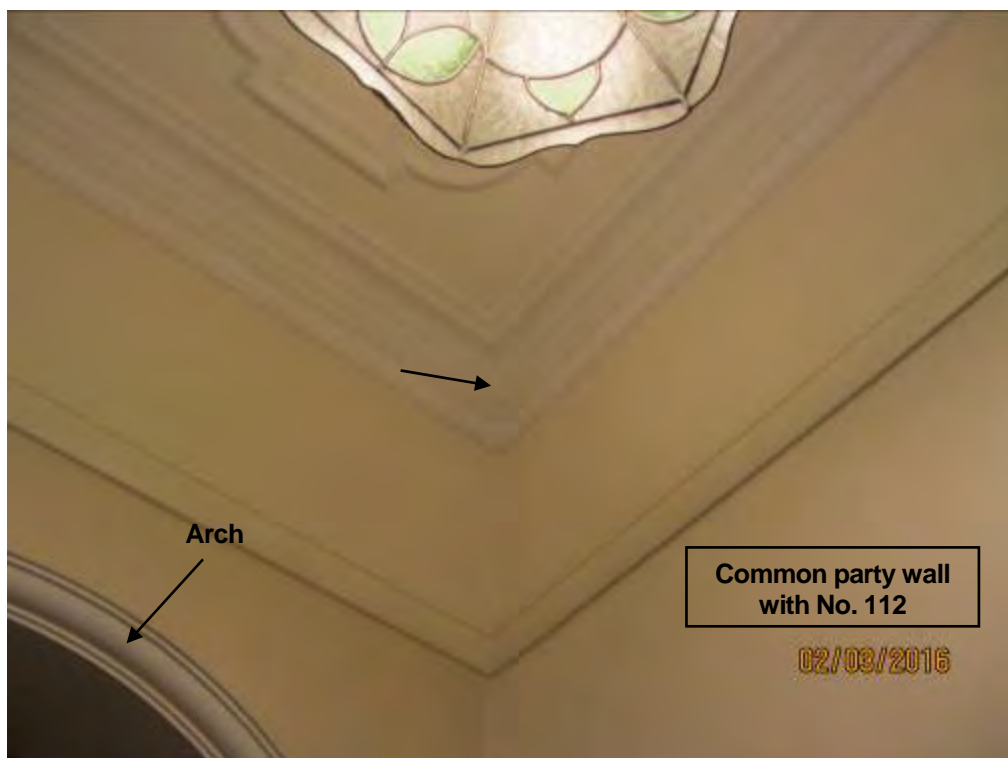
Photograph 16 shows the hairline crack to the cornice to the northwest corner of Hallway 2

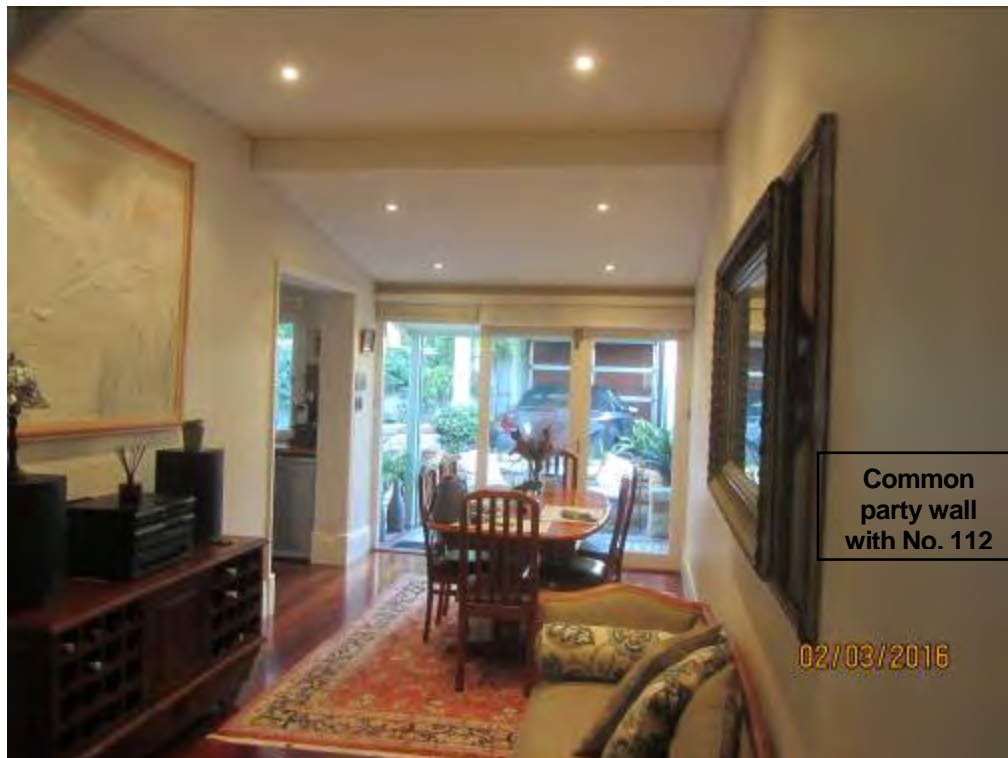
We noted that the ceiling is plasterboard with a shadow-line junction between the ceiling and wall **[Photograph 17]**

Photograph 17 shows the layout of the Family / Dining room

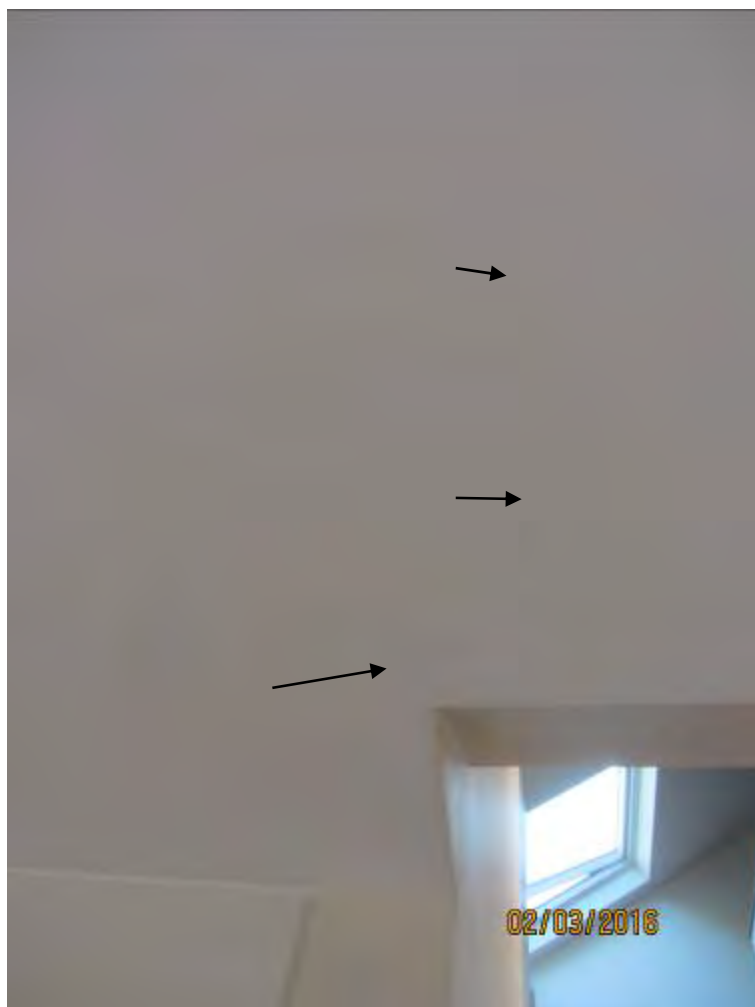
We noted a hairline crack [$<1.0\text{mm}$] to the Kitchen ceiling and bulkhead at the first landing of the stairs. **[Photograph 18]**

Photograph 18 shows the crack to the ceiling at the bulkhead to the stairwell

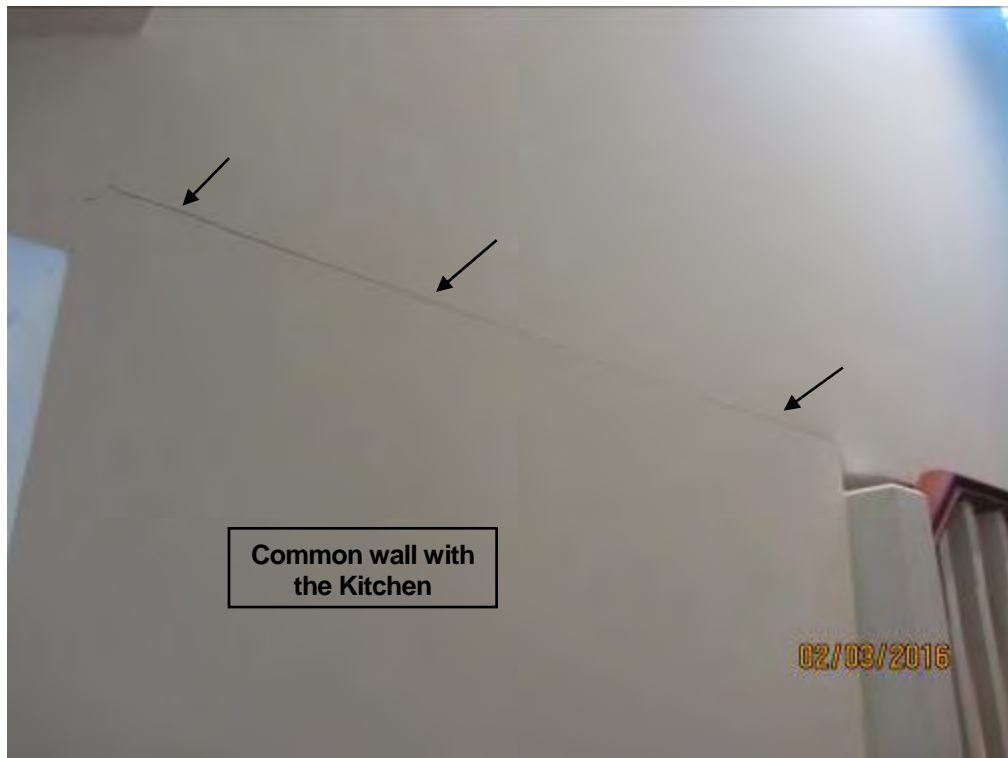
We noted a horizontal differential movement crack [1.0mm] to the ground floor level surface coated cement rendered wall surface and the plasterboard lining to the framed wall at the first landing of the stairs. **[Photograph 19]**

Photograph 19 shows the horizontal crack to the wall of the stairwell

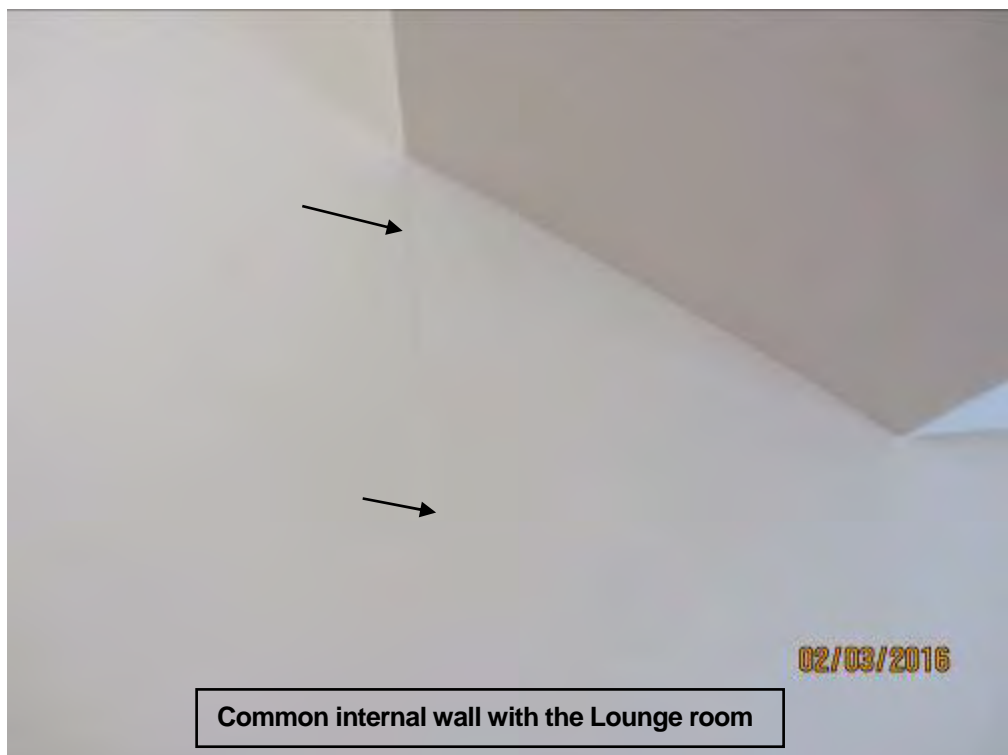
We noted a vertical crack [$<1.0\text{mm}$] extending from the base of the splayed plasterboard bulkhead at the first landing of the stairs and the common internal wall with the Lounge room. **[Photograph 20]**

Photograph 20 shows the vertical crack extending down from the splayed bulkhead to the stairs

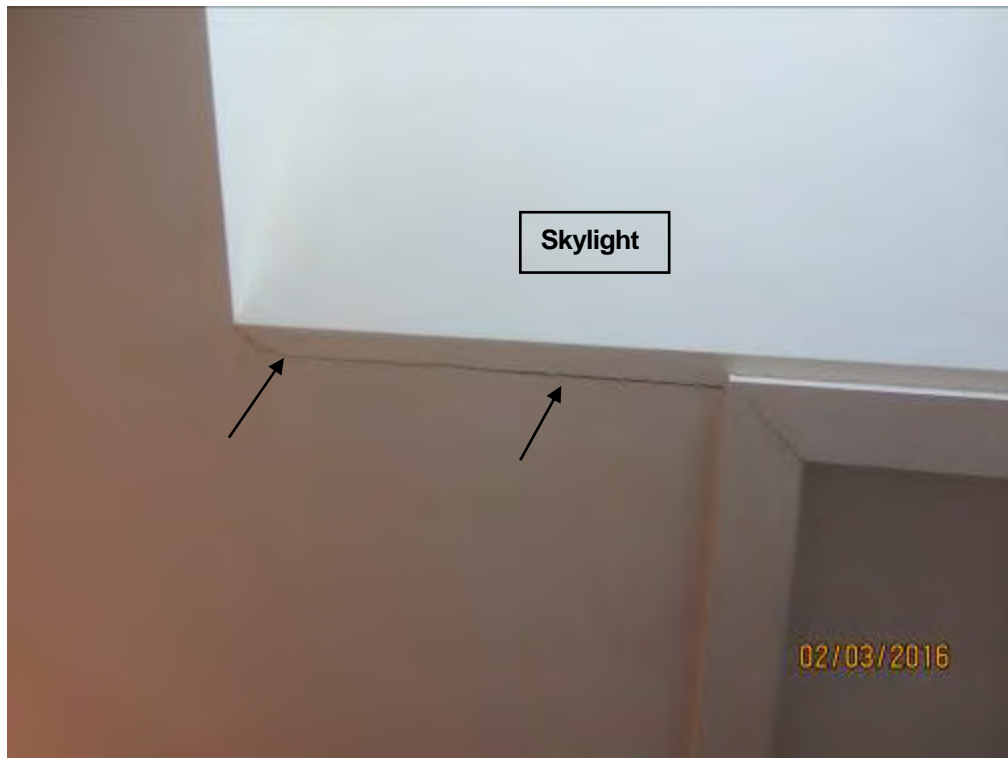
We noted a horizontal crack [1.0mm - 3.0mm] between the wall and the sill of skylight at the top landing of the stairs. **[Photograph 21]**

Photograph 21 shows the horizontal crack to the sill of the skylight at the mid-landing of the stairs

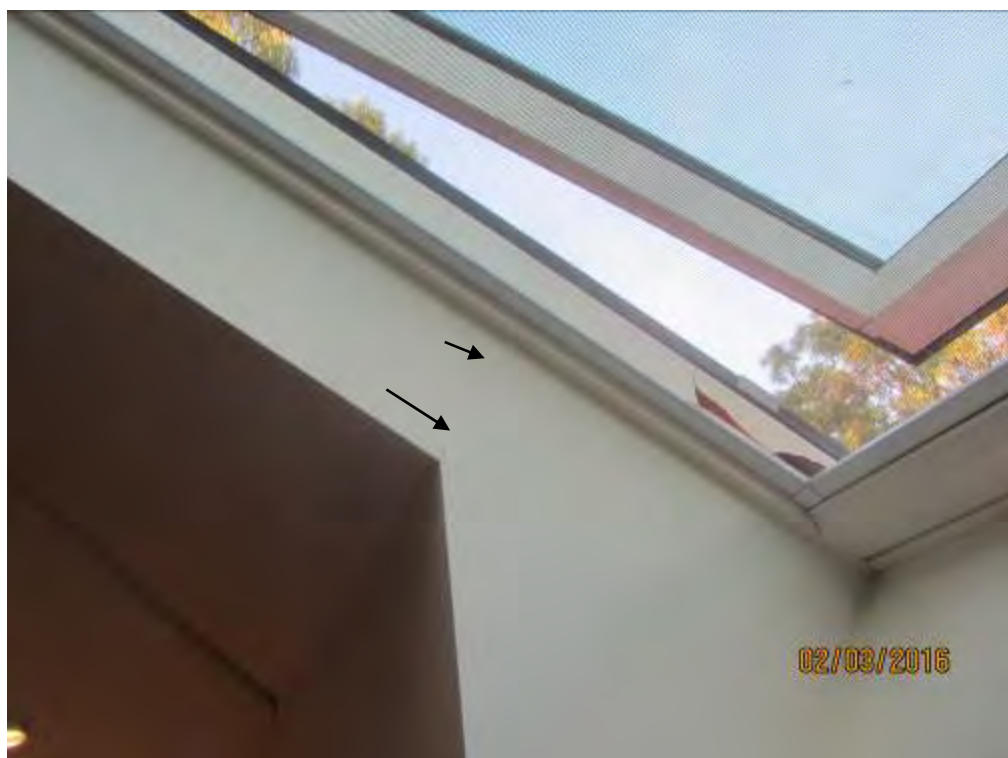
We noted a radial hairline crack [$<1.0\text{mm}$] to the splayed ceiling / skylight shaft at the top landing of the stairs. **[Photograph 22]**

Photograph 22 shows the radial crack to the splayed ceiling / skylight shaft at the top landing of the stairs

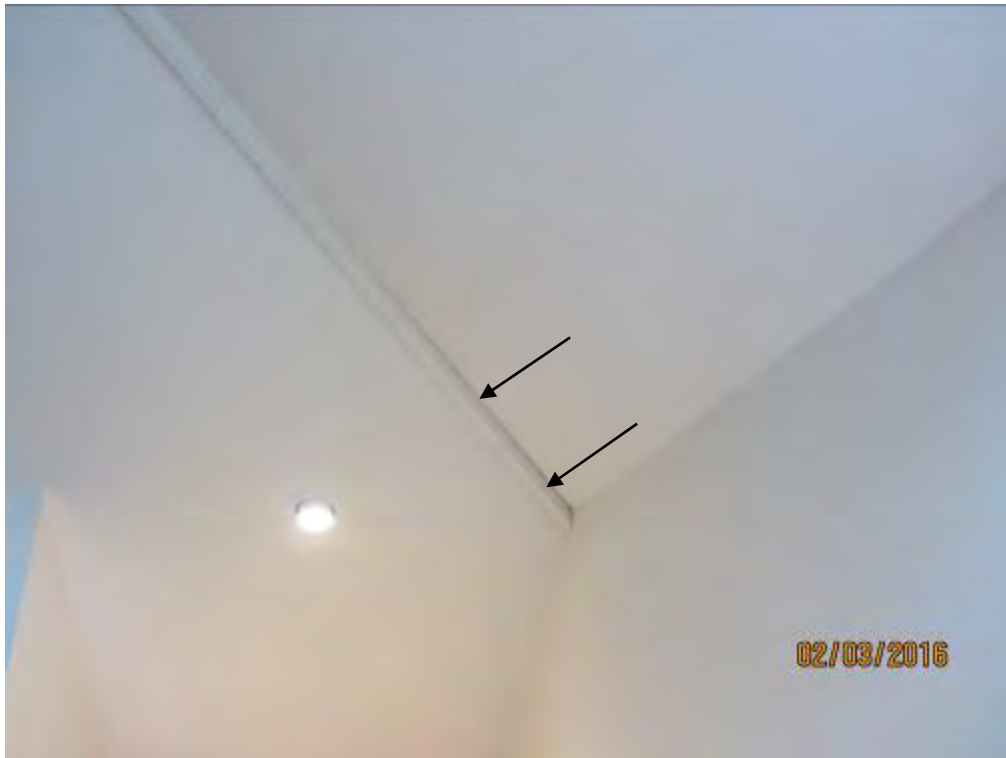
We noted that the plasterboard ceiling follows the line of the roof structure over. We did not observe any cracking to the ceiling lining or to the square set wall / ceiling junctions. Notwithstanding this, we noted a separation crack [1.0mm] between the timber cover moulding to the junction of the splayed ceiling surfaces. **[Photograph 23]**

Photograph 23 shows the hairline crack between the cover mould and the splayed ceiling over the stairwell
