Dilapidation Assessment Report

Prepared for: Cape Cod Australia Pty. Limited
Job address: No. 68 Nancy Street, North Bondi.
Property Owner/s: Mr. Anthony & Mrs. Amourla Kemeny.
Report reference: **WAVERLEY COUNCIL**
Development Application No: not available
Date of assessment: 17th February 2017

Re: Dilapidation Report – No. 68 Nancy Street, North Bondi.

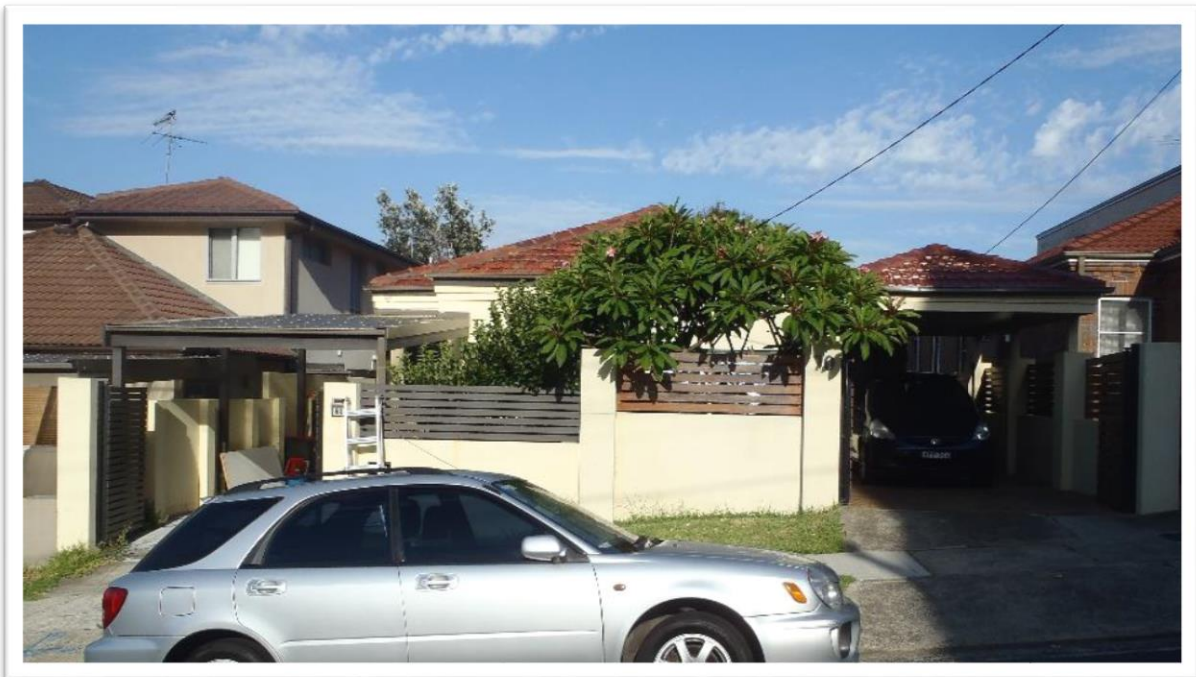
Shows the front eastern elevation of the adjoining properties:
No. 68 and No. 70 Nancy Street, North Bondi.

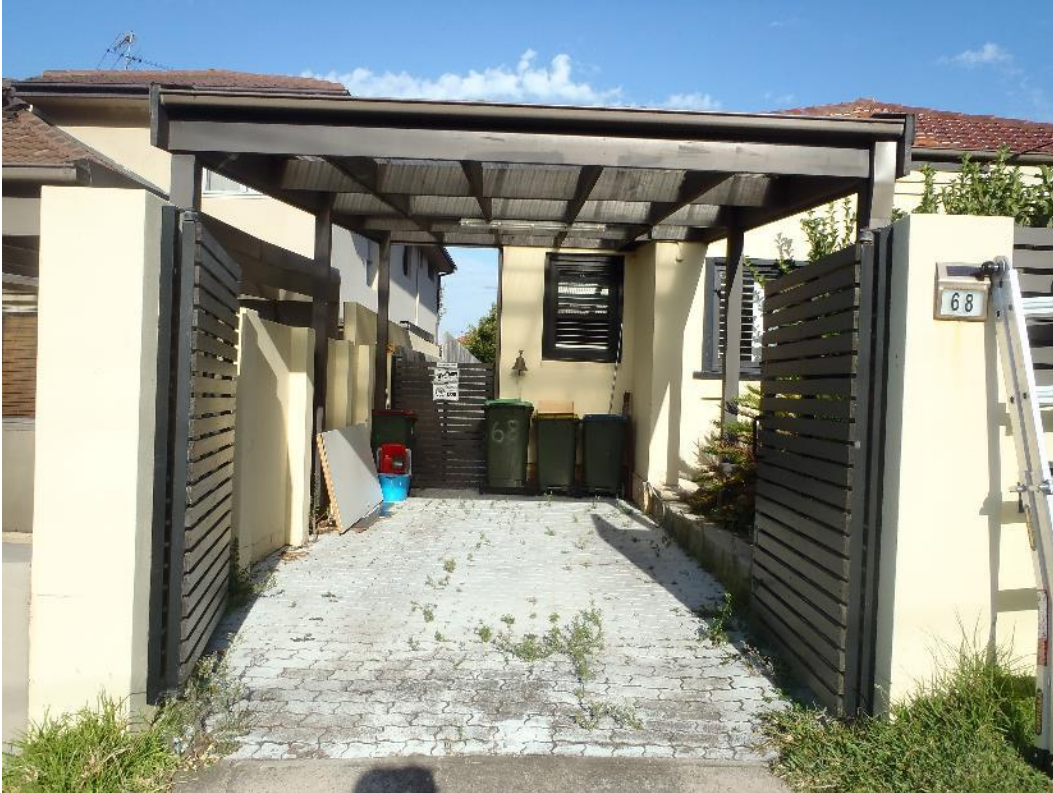
We noted a timber framed carport structure with cement rendered clay masonry brick walls and corrugated profile acrylic sheet roofing. **[Photograph 1]**

We noted vegetation growth through the paved floor of the carport. **[Photograph 1]**

Photograph 1 shows the general condition of the carport.

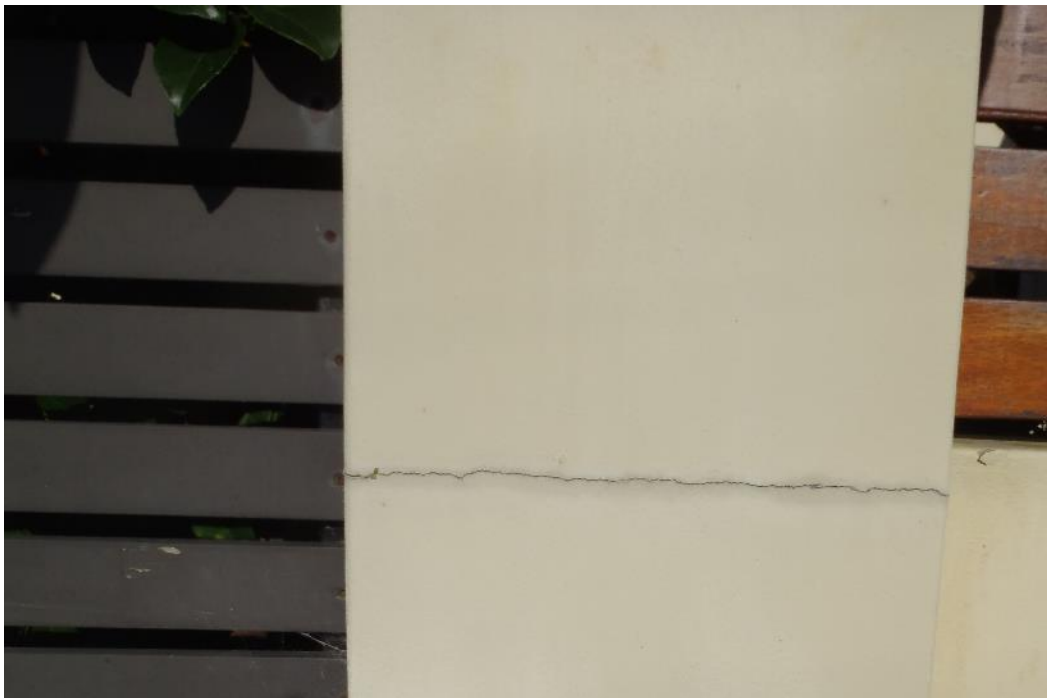
We noted horizontal cracking [$<1.0\text{mm}$] to the common front boundary wall with the adjoining property, No. 70 Nancy Street, North Bondi. **[Photograph 2]**

Photograph 2 shows horizontal cracking to the common front boundary wall with the adjoining property, No. 70 Nancy Street.

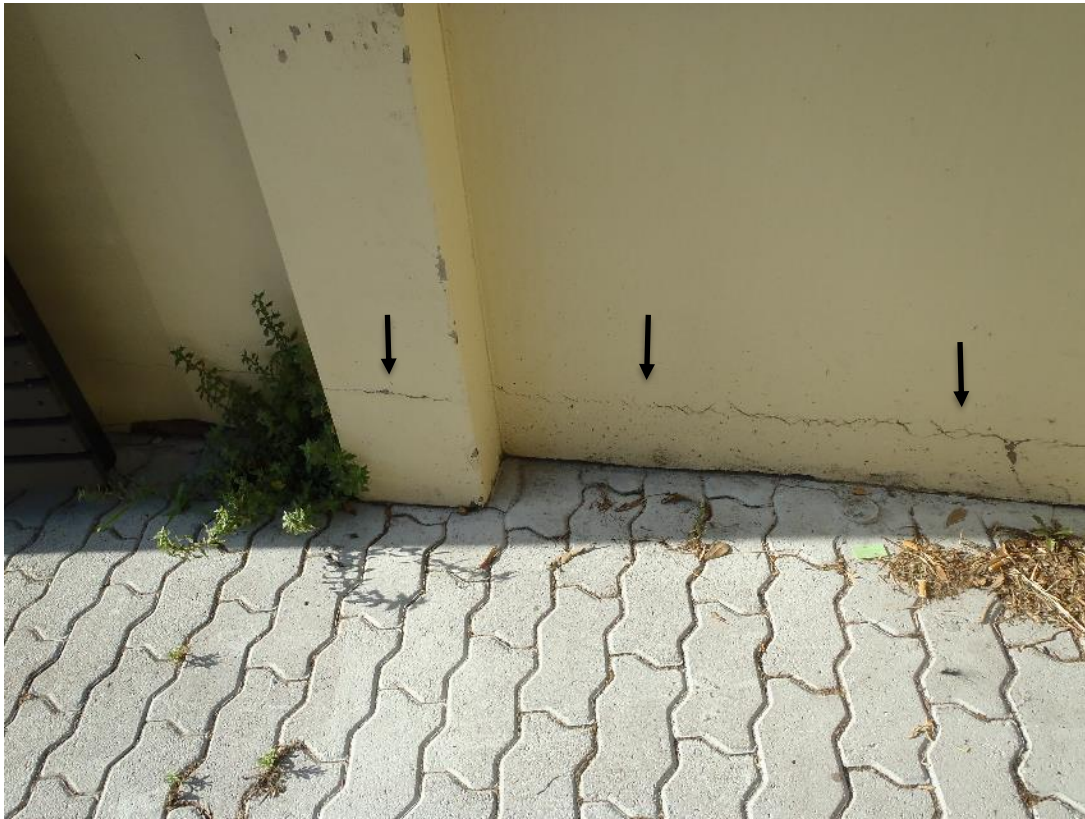
We noted horizontal cracking [$<1.0\text{mm}$] to the southern elevation cement rendered boundary wall. **[Photograph 3]**

Photograph 3 shows horizontal cracking to the southern elevation cement rendered boundary wall.

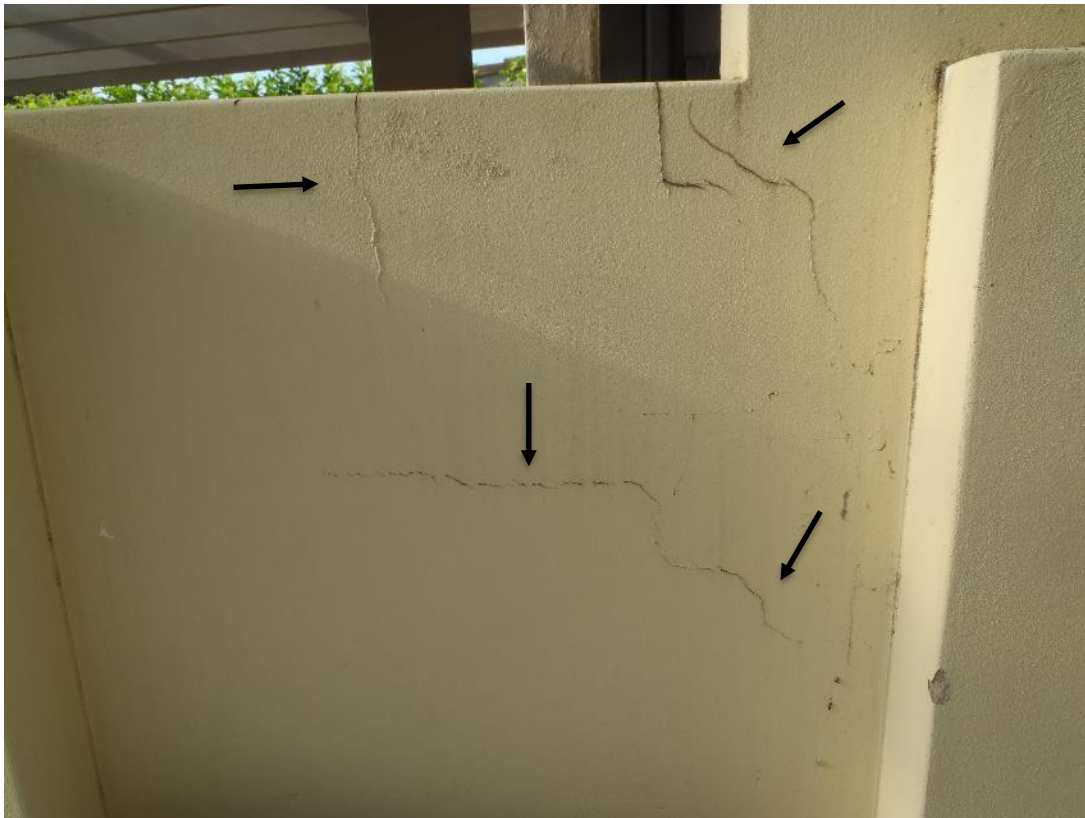
We noted step cracking [$<1.0\text{mm}$] to the southern elevation cement rendered boundary wall. **[Photograph 4]**

Photograph 4 shows step cracking to the southern elevation cement rendered boundary wall.

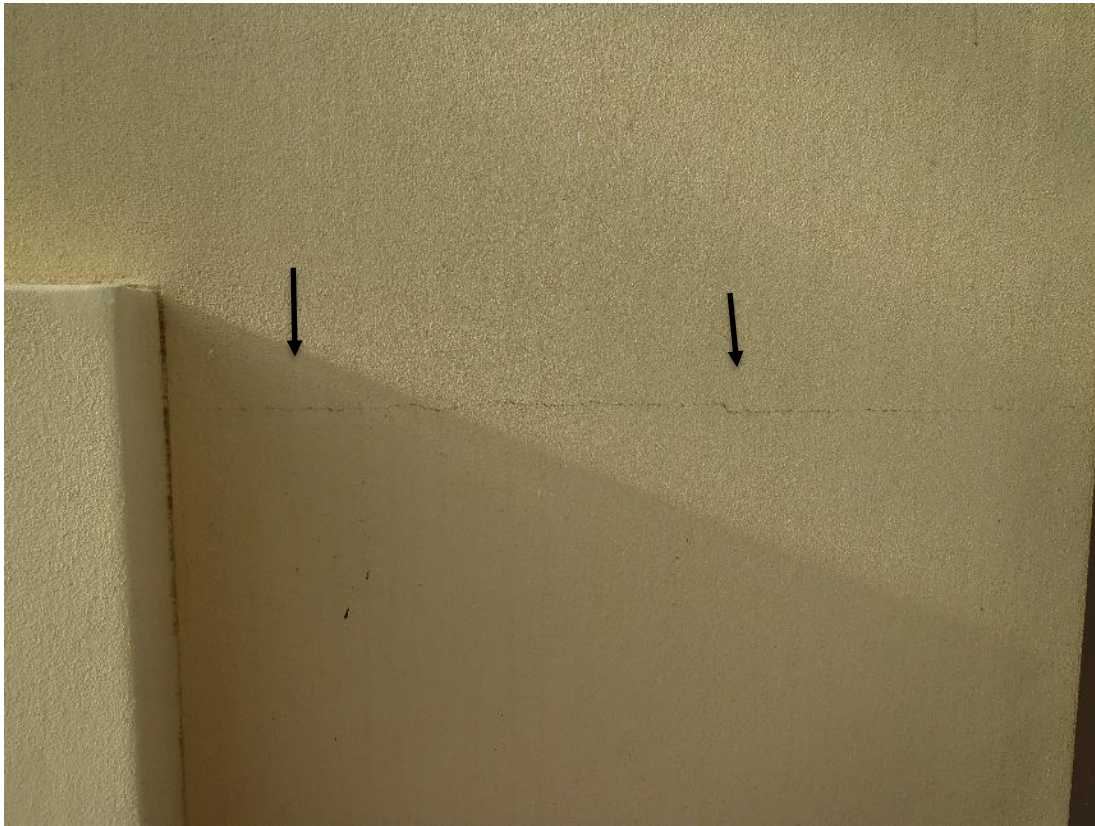
We noted horizontal cracking [$<1.0\text{mm}$] to the southern elevation cement rendered boundary wall adjacent to the side gate. **[Photograph 5]**

Photograph 5 shows horizontal cracking to the southern elevation cement rendered boundary wall adjacent to the side gate.

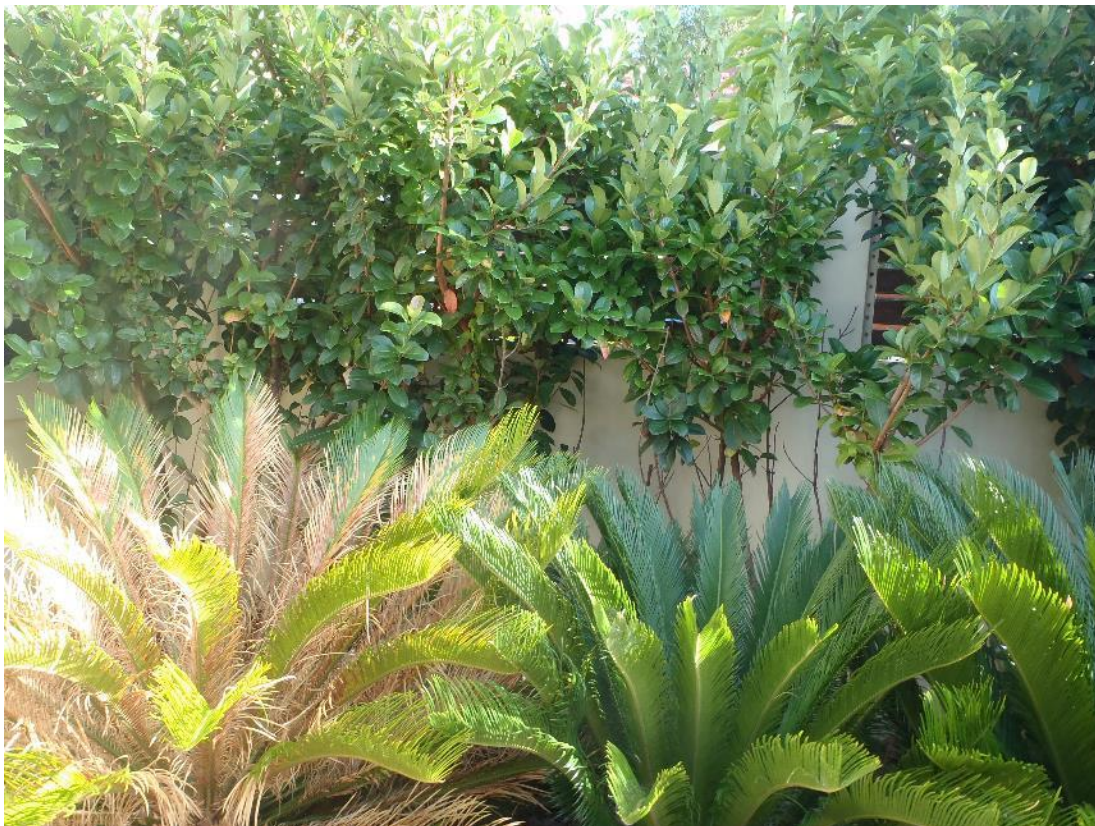
We observed a cement rendered *common* boundary wall with the adjoining property, No. 70 Nancy Street, North Bondi with vegetation growth. **[Photograph 6]**

Photograph 6 shows the general condition of the front common boundary wall with the adjoining property, No. 70 Nancy Street.

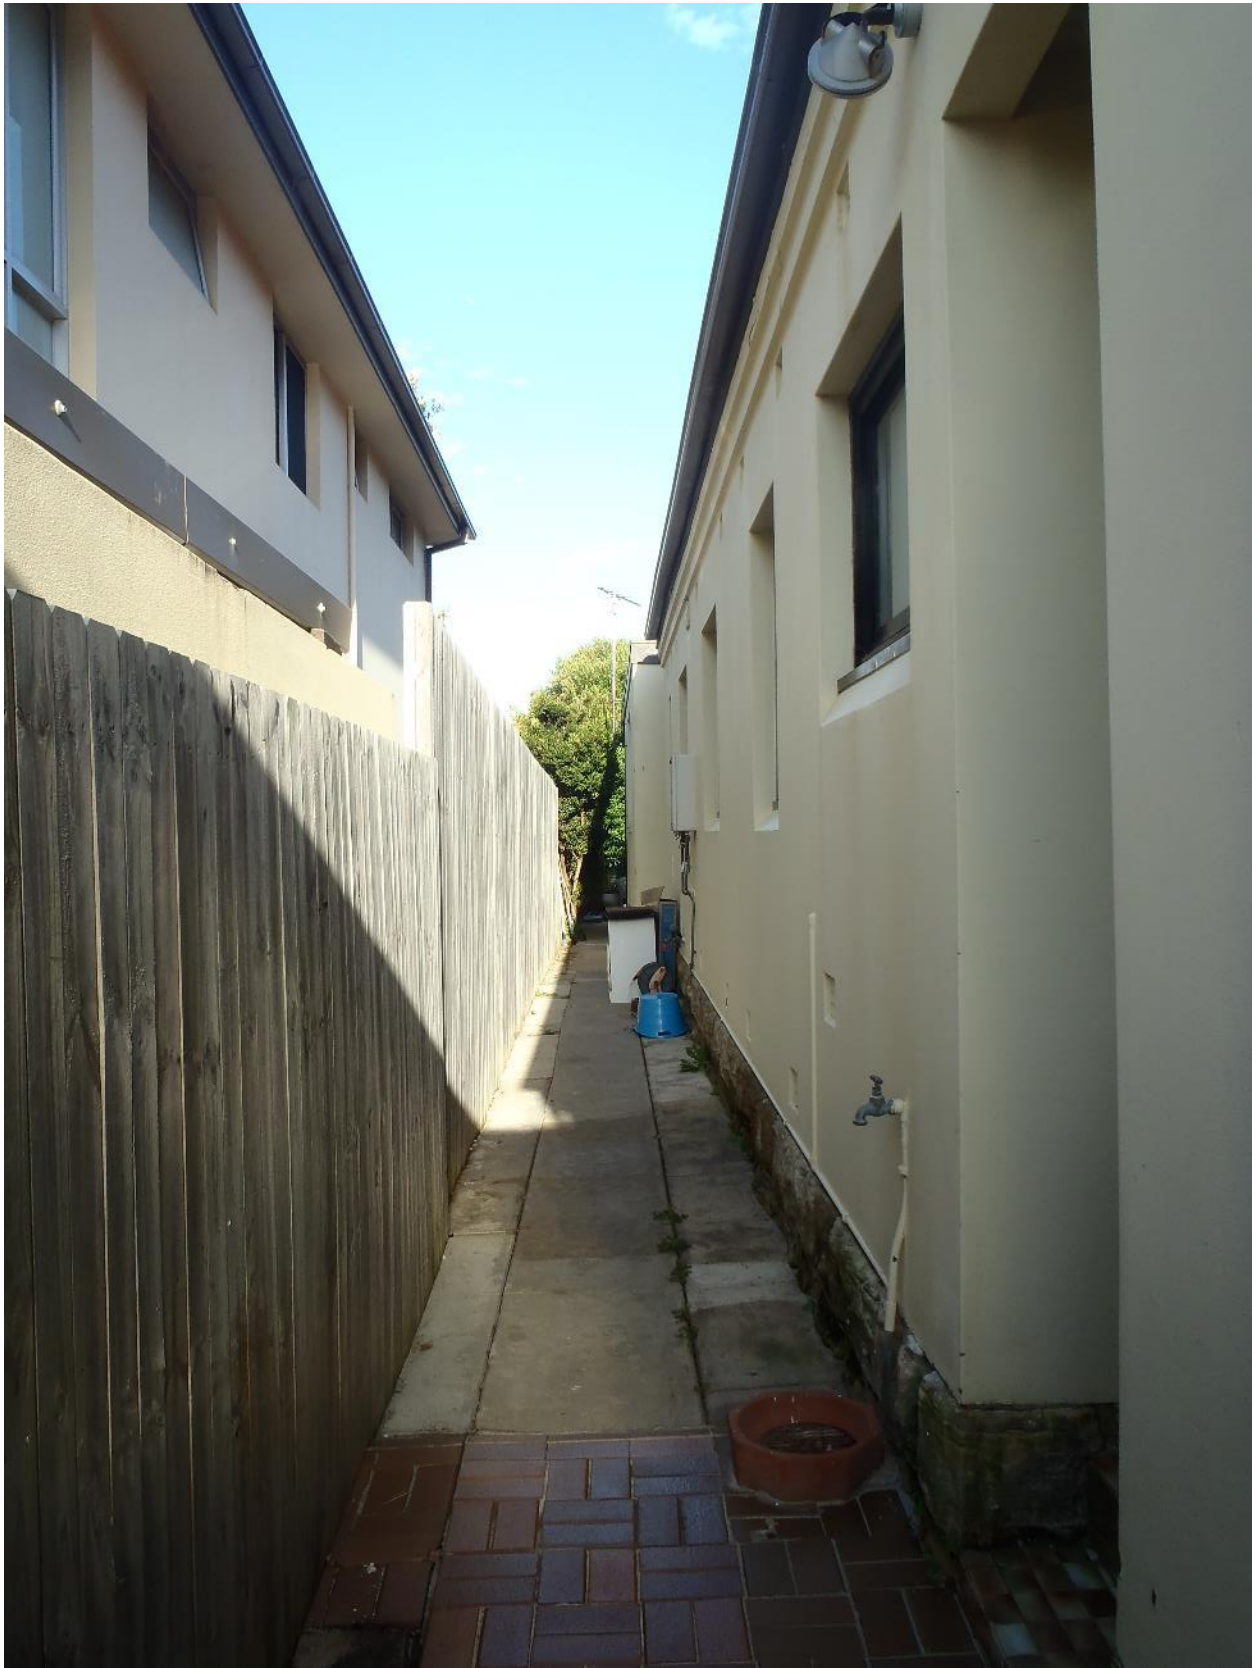
We noted that the side of the property was paved with a concrete pathway. **[Photograph 7]**

Photograph 7 shows the general condition of the southern elevation.

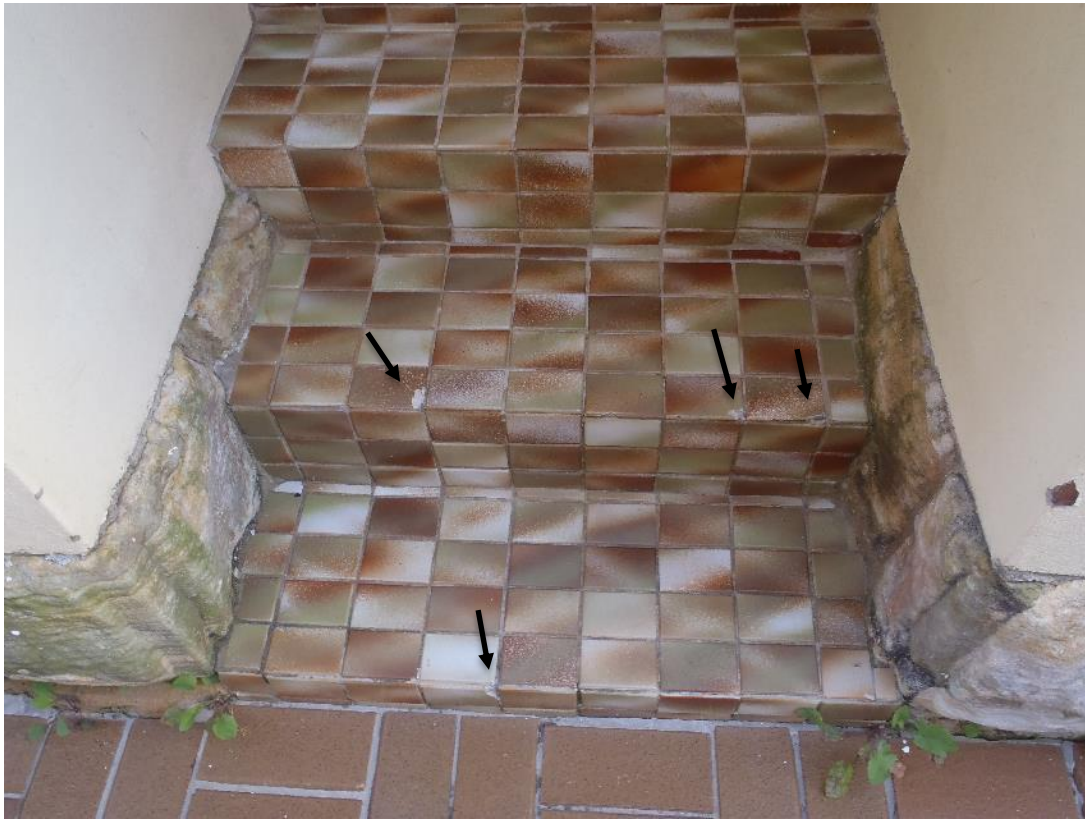
We noted cracking to the front entrance porch step tiles. **[Photograph 8]**

Photograph 8 shows cracking to the front entrance porch step tiles.

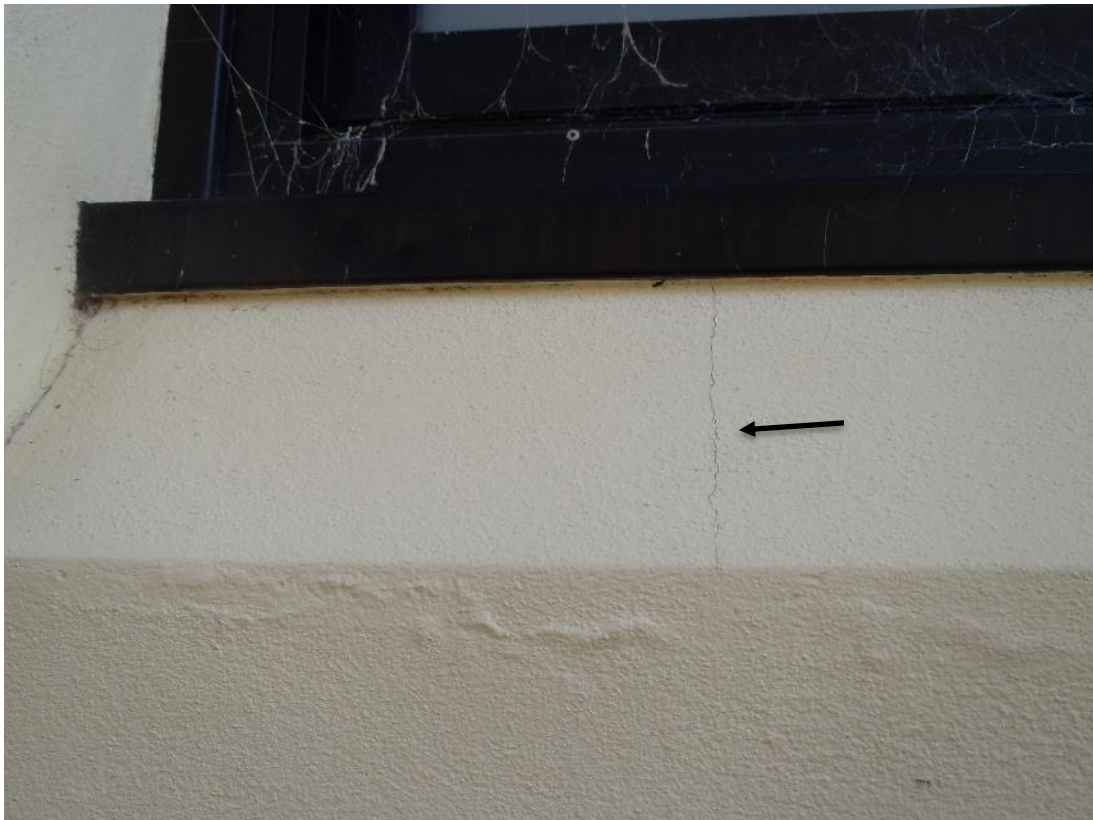
We noted cracking [$<1.0\text{mm}$] to the cement rendered window sill outside the Bathroom. **[Photograph 9]**

Photograph 9 shows cracking to the cement rendered window sill outside the Bathroom.

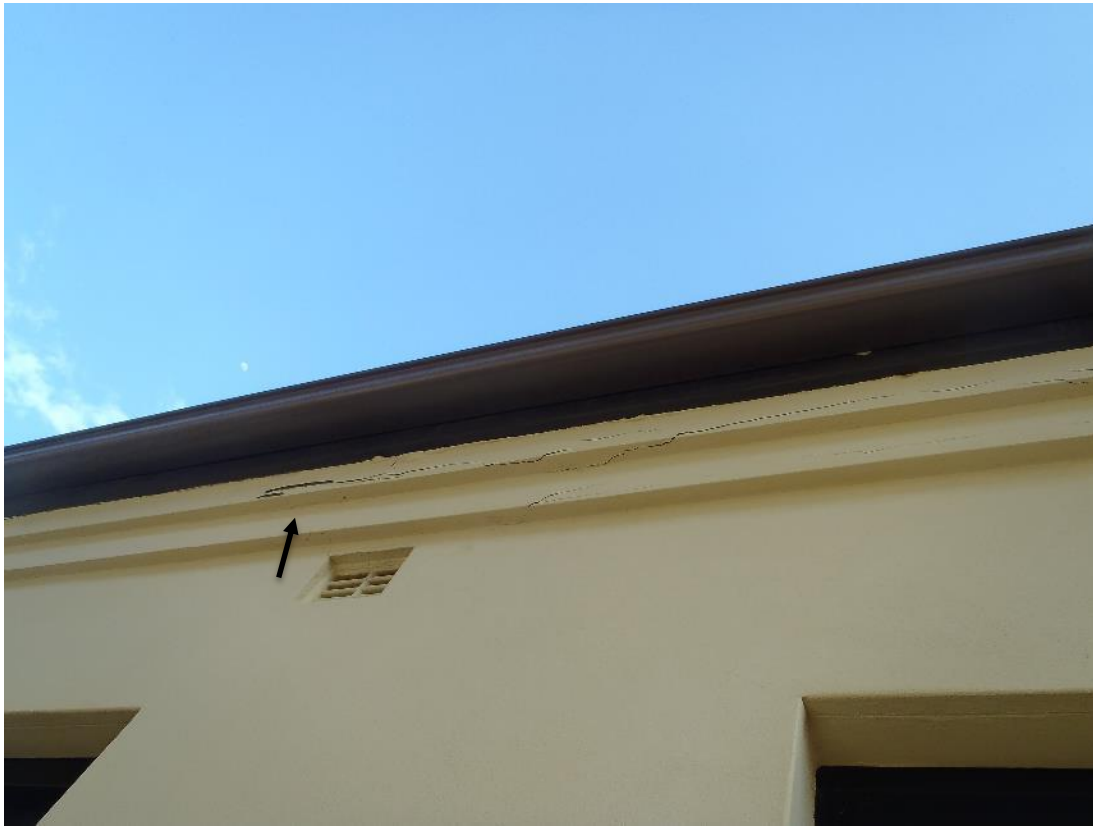
We noted deterioration the timber fascia board outside Bedroom 2. **[Photograph 10]**

Photograph 10 shows deterioration the timber fascia board outside Bedroom 2.

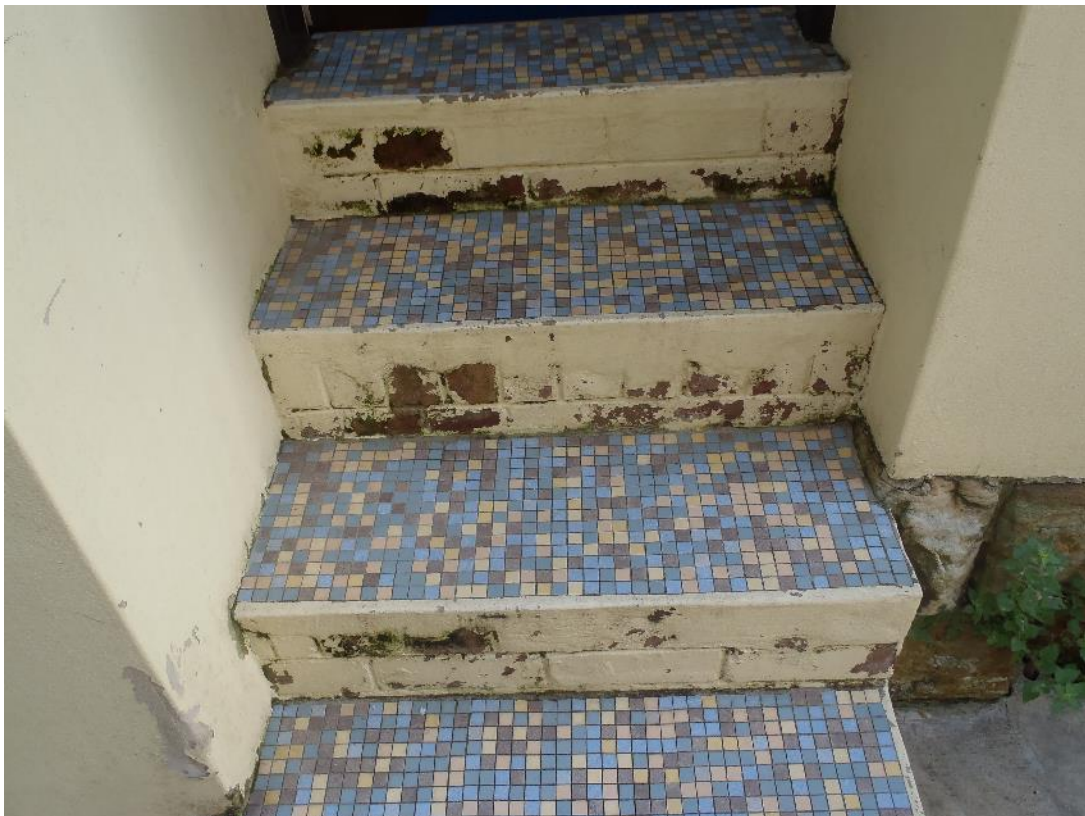
We noted flaking paint to the brick step risers to the rear (Lounge Room) entry porch.
[Photograph 11]

Photograph 11 shows flaking paint to the brick step risers to the rear entry porch.

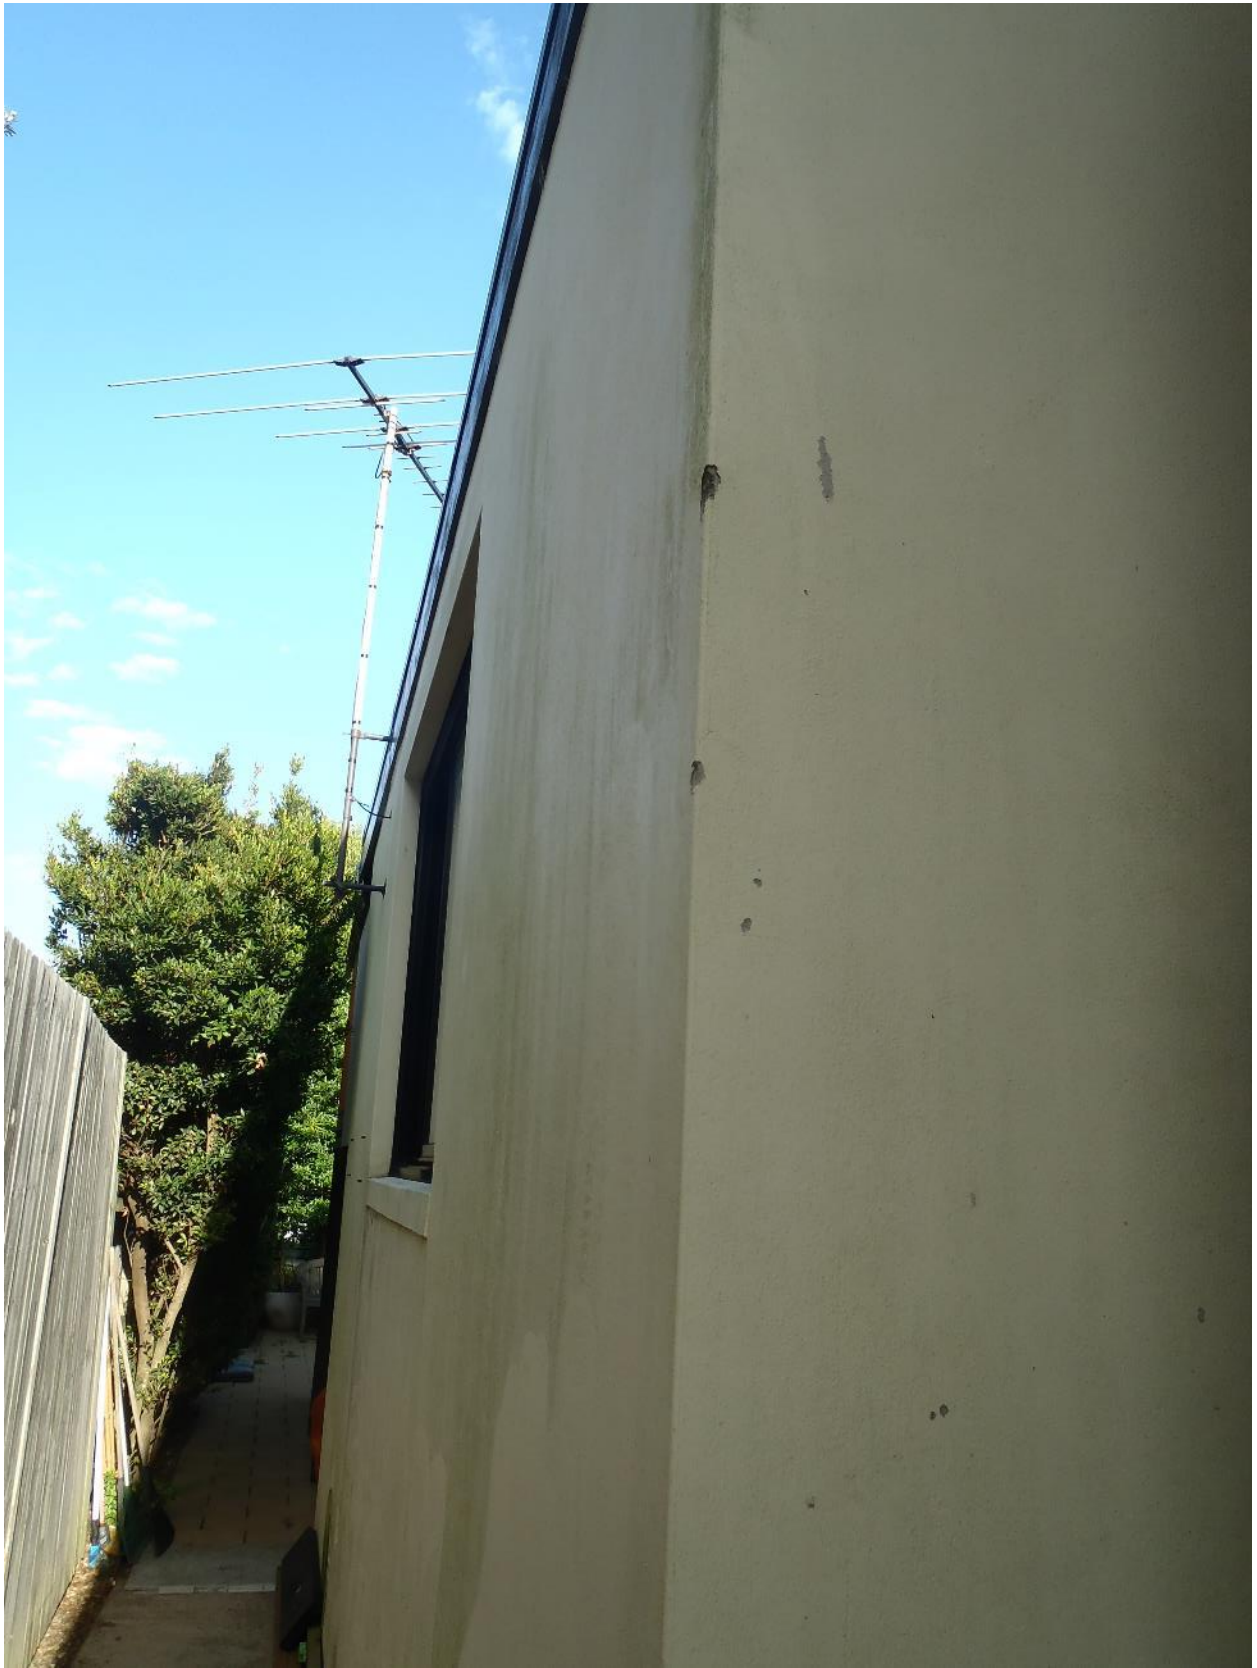
We noted damage to the rendered brick surface outside the rear (Lounge Room) entry porch.
[Photograph 12]

Photograph 12 shows damage to the rendered brick surface outside the rear entry porch.

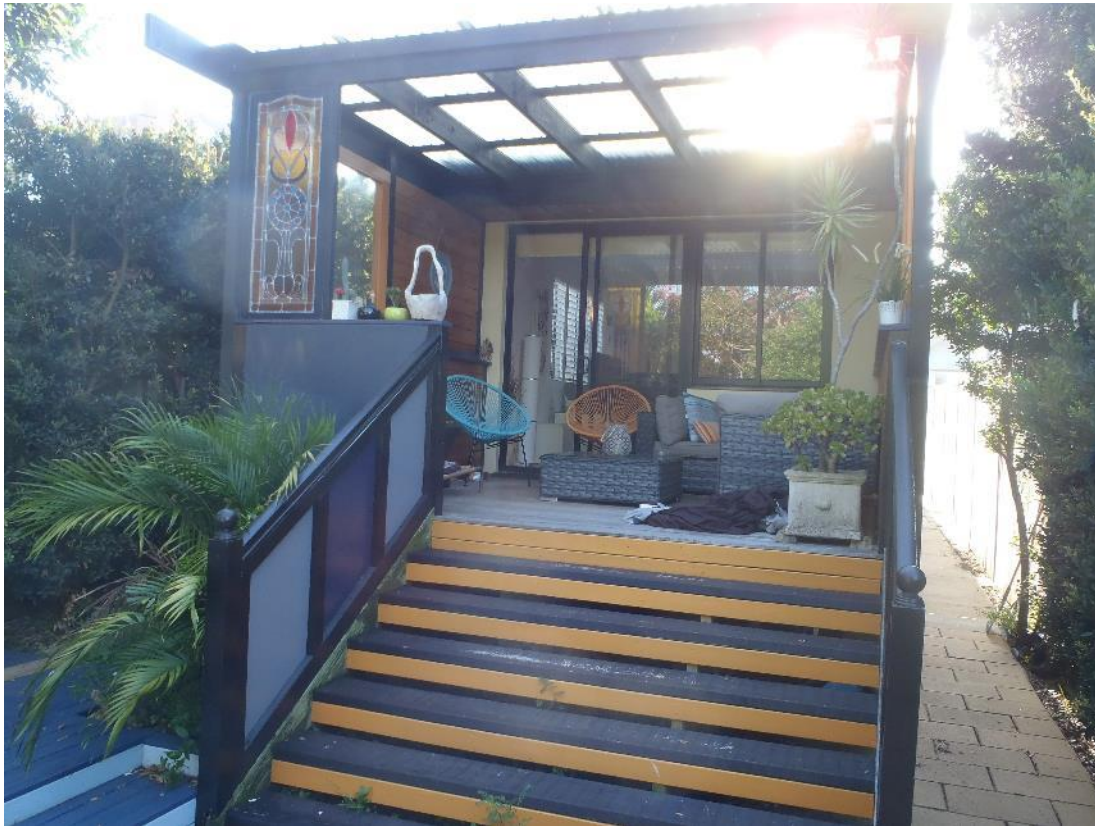
We noted a suspended timber framed pergola structure with timber framed and lined walls and corrugated profile acrylic sheet roofing. **[Photograph 13]**

Photograph 13 shows the rear elevation and timber pergola.

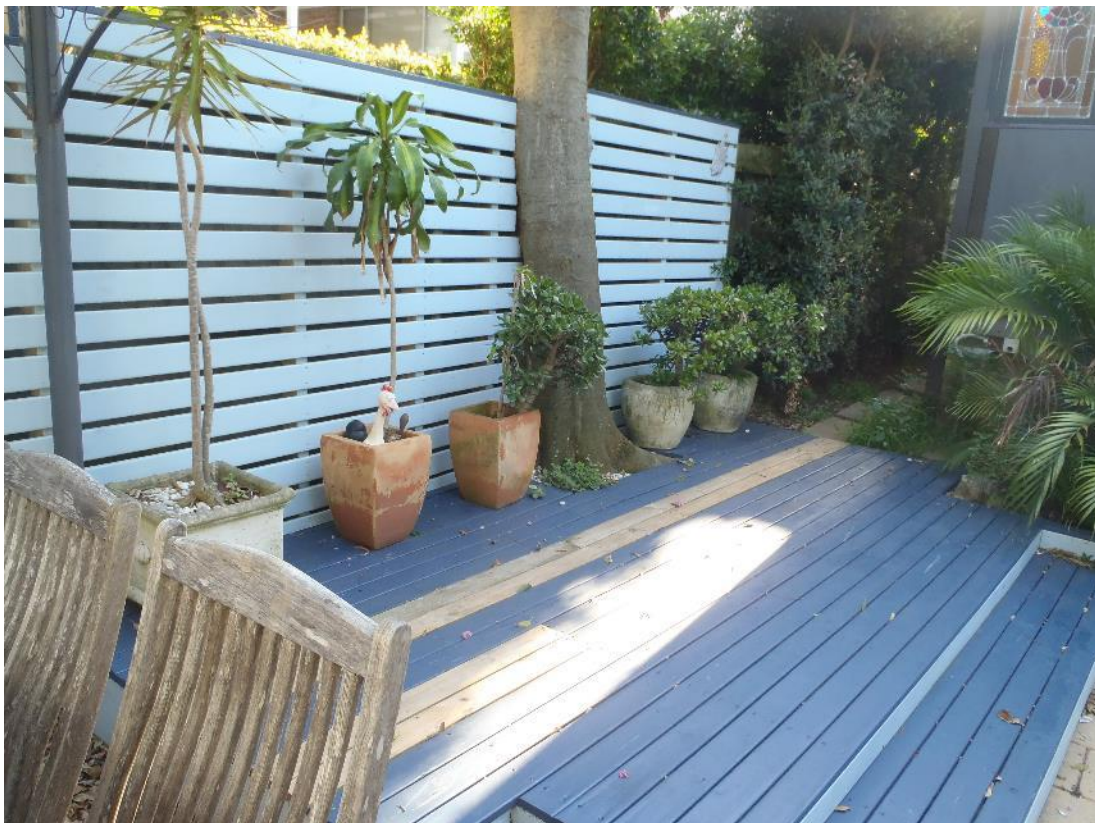
We noted a timber deck structure and timber privacy screen adjacent to the *common* boundary between No. 70 Nancy Street. We further noted replaced decking boards. **[Photograph 14]**

Photograph 14 shows the timber deck structure and timber privacy screen adjacent to the common boundary between No. 70 Nancy Street.

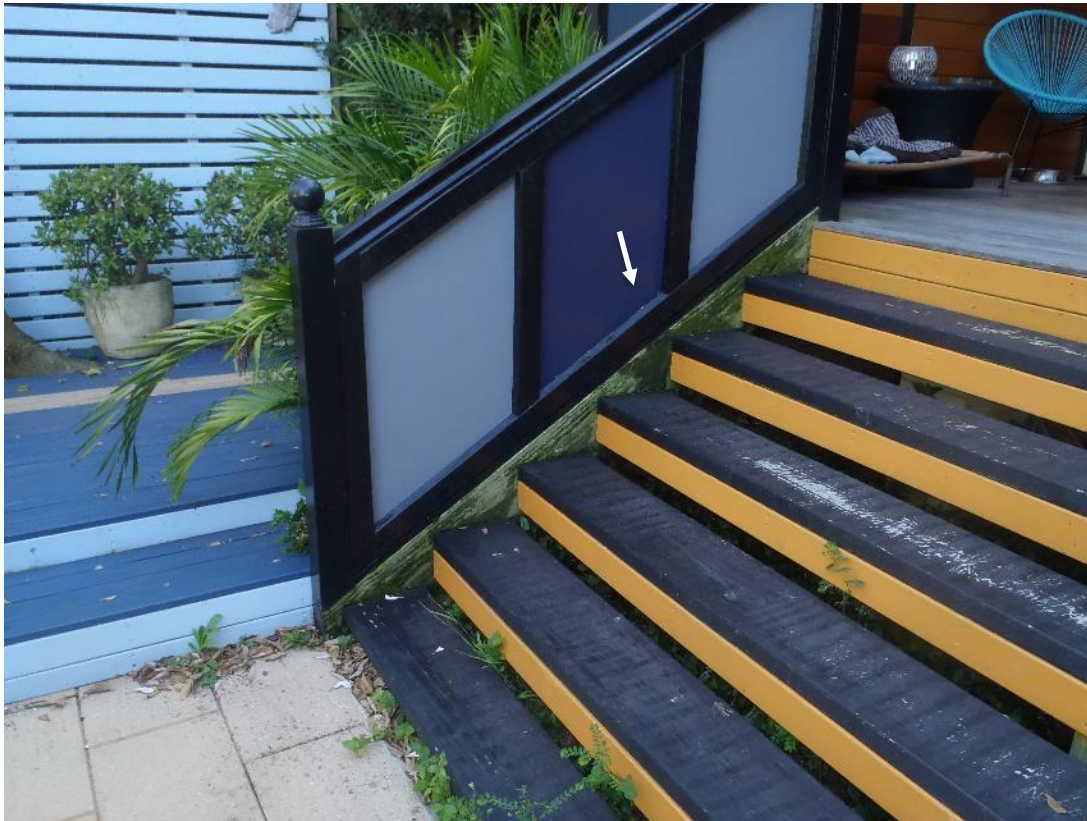
We noted mildew/mould growth to the timber step stringers. **[Photograph 15]**

Photograph 15 shows mildew/mould growth to the timber step stringers of the pergola.

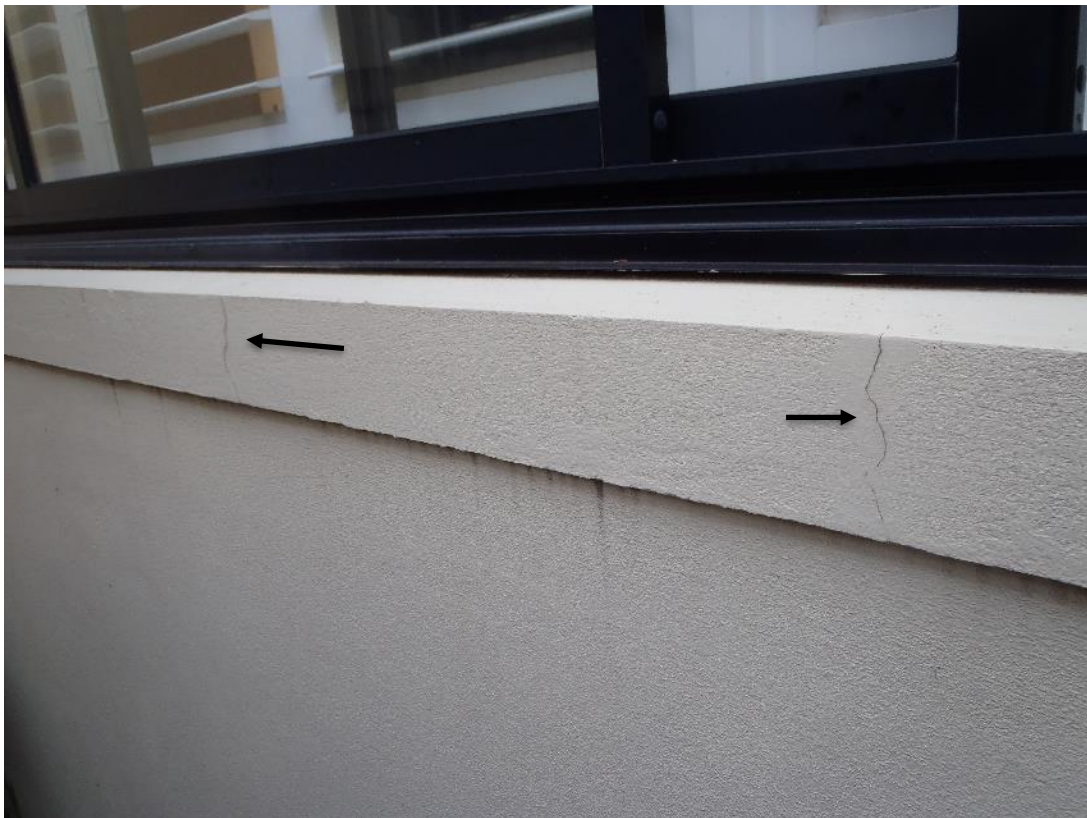
We noted cracking [$<1.0\text{mm}$] to the cement rendered window sill outside the Lounge Room.
[Photograph 16]

Photograph 16 shows cracking to the cement rendered window sill outside the Lounge Room.

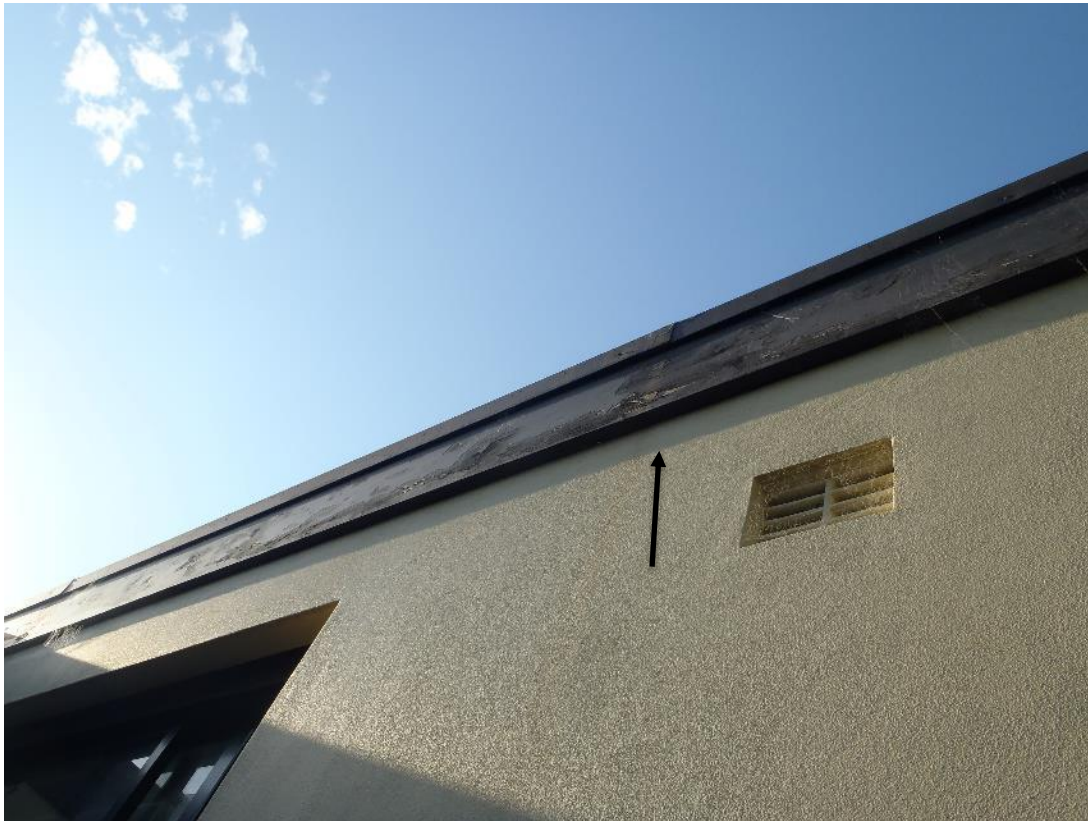
We noted flaking paint to the timber barge board. **[Photograph 17]**

Photograph 17 shows flaking paint to the timber barge board outside the Lounge Room.

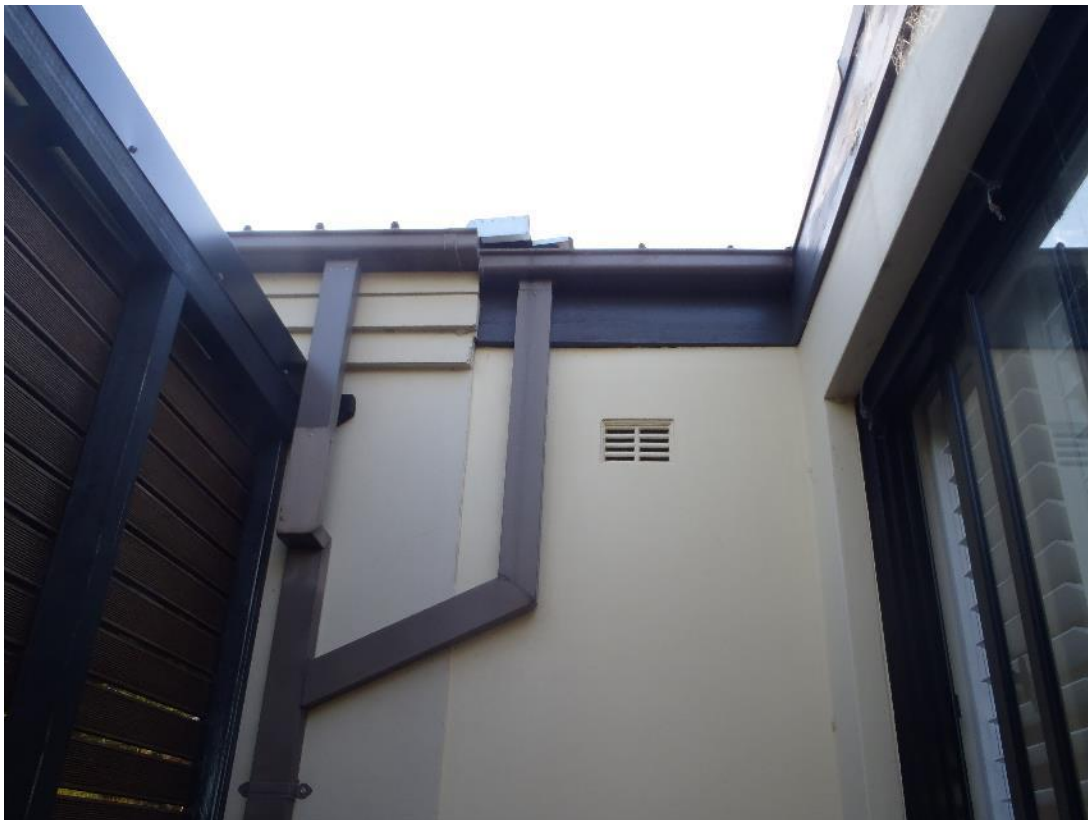
We noted that the roof surface water is discharged into the downpipe of the adjoining property No. 70 Nancy Street, North Bondi. **[Photograph 18]**

Photograph 18 shows the common downpipe connection and common wall.

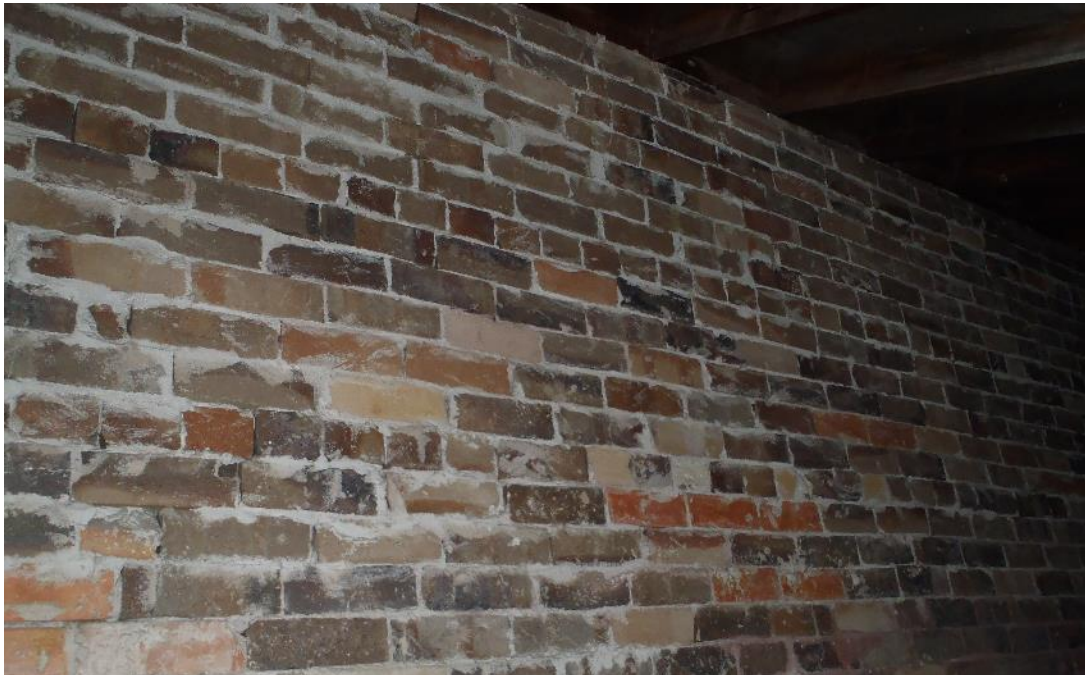
We also noted that the clay brick common party wall extends to the underside of the rafters.
[Photograph 19]

Photograph 19 shows the *common party / separation* wall inside the roof space.

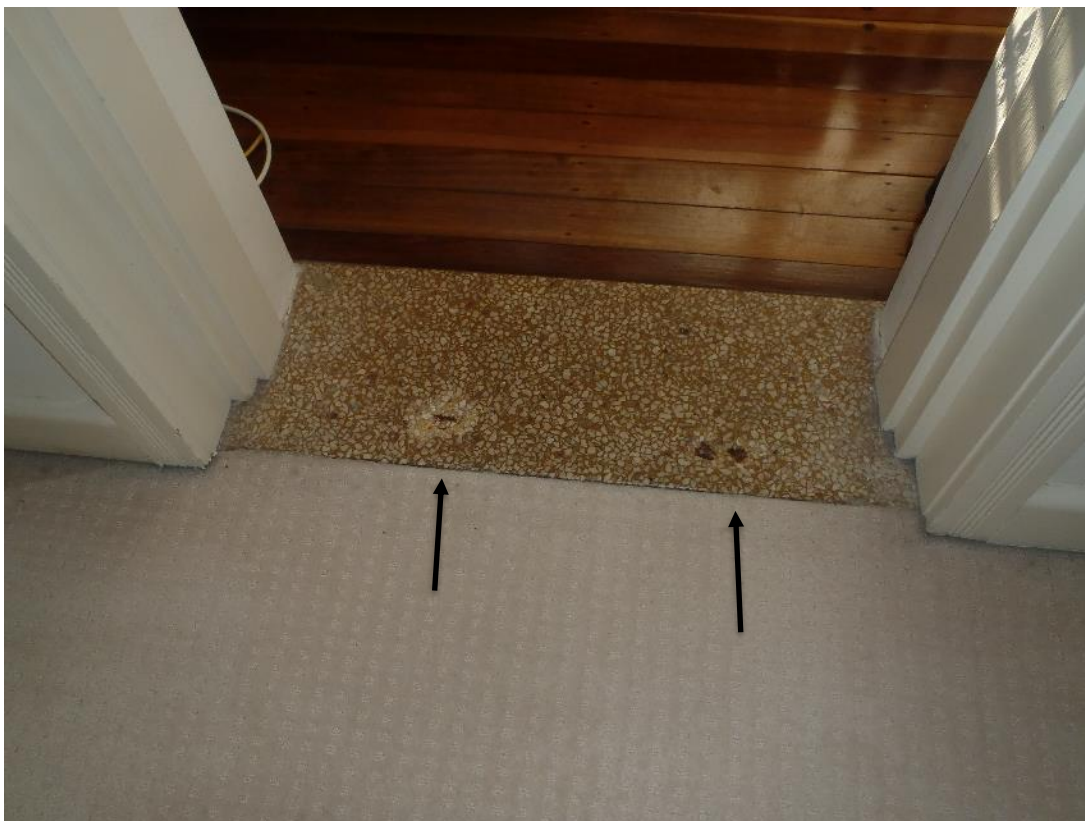
[Photograph 20]

We observed chipping to the threshold step between the Sunroom and Bedroom 1.

Photograph 20 shows damage to the threshold step between the Sunroom and Bedroom 1

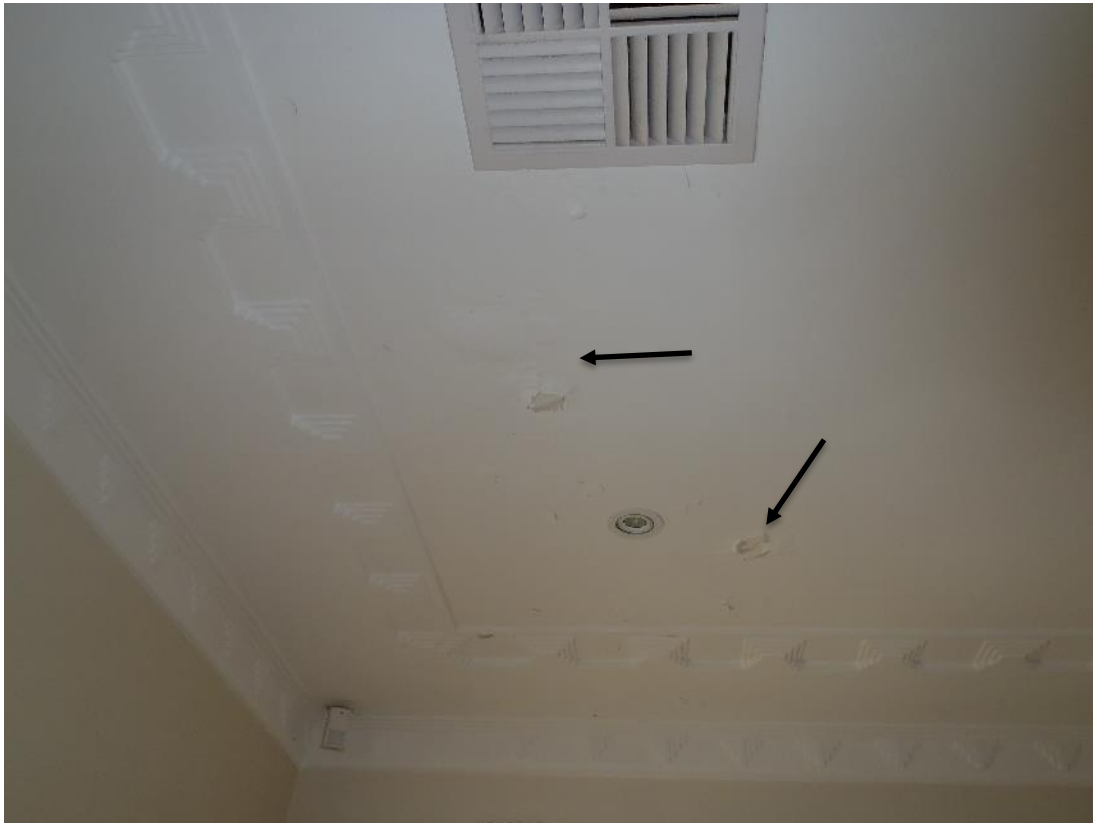
[Photograph 21]

We observed flaking/blistered paint to the decorative plaster ceiling in the south-eastern corner.

Photograph 21 shows flaking/blistered paint to the decorative plaster ceiling in the south-eastern corner in Bedroom 1.
