Dilapidation Assessment Report

Prepared for: Cape Cod Australia Pty. Limited
Job address: No. 68 Nancy Street, North Bondi.
Property Owner/s: Mr. Anthony & Mrs. Amourla Kemeny.
Report reference: **WAVERLEY COUNCIL**
Development Application No: not available
Date of assessment: 17th February 2017

Re: Dilapidation Report – No. 68 Nancy Street, North Bondi.

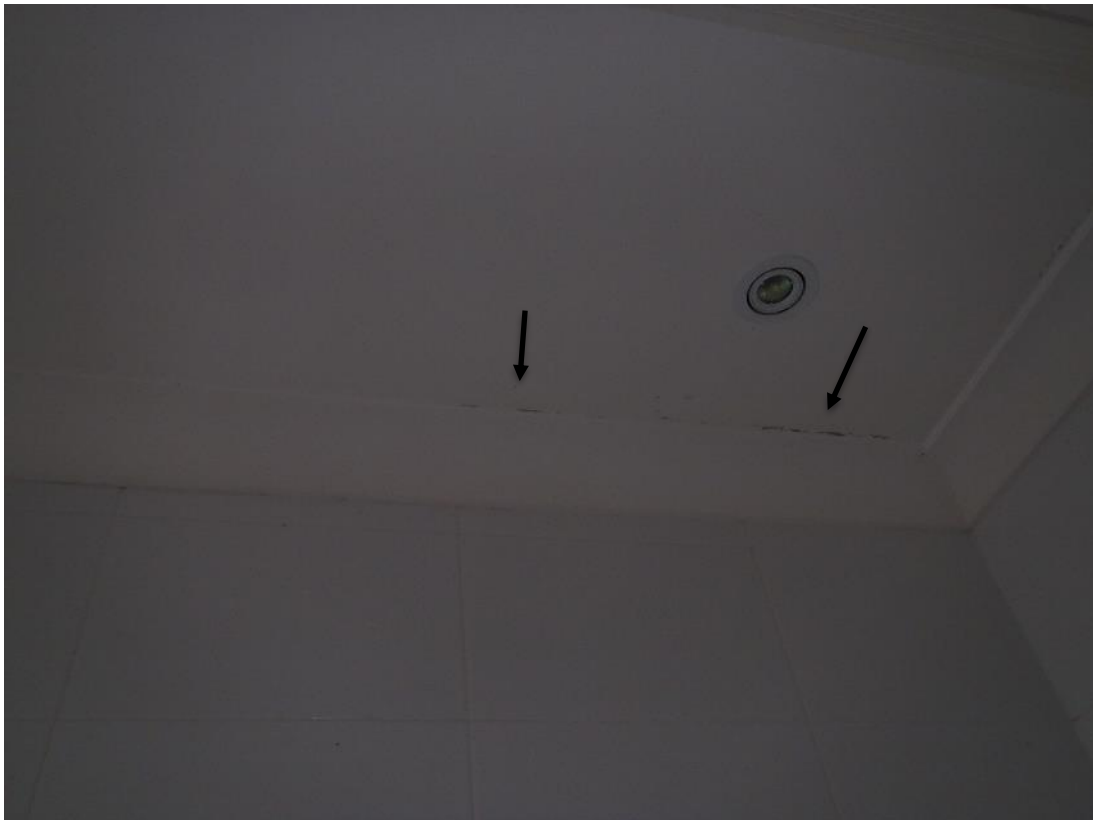
We observed flaking/blistered paint to the plaster ceiling in the shower. **[Photograph 22]**

Photograph 22 shows flaking/blistered paint to the plaster ceiling in the shower in the Bathroom.

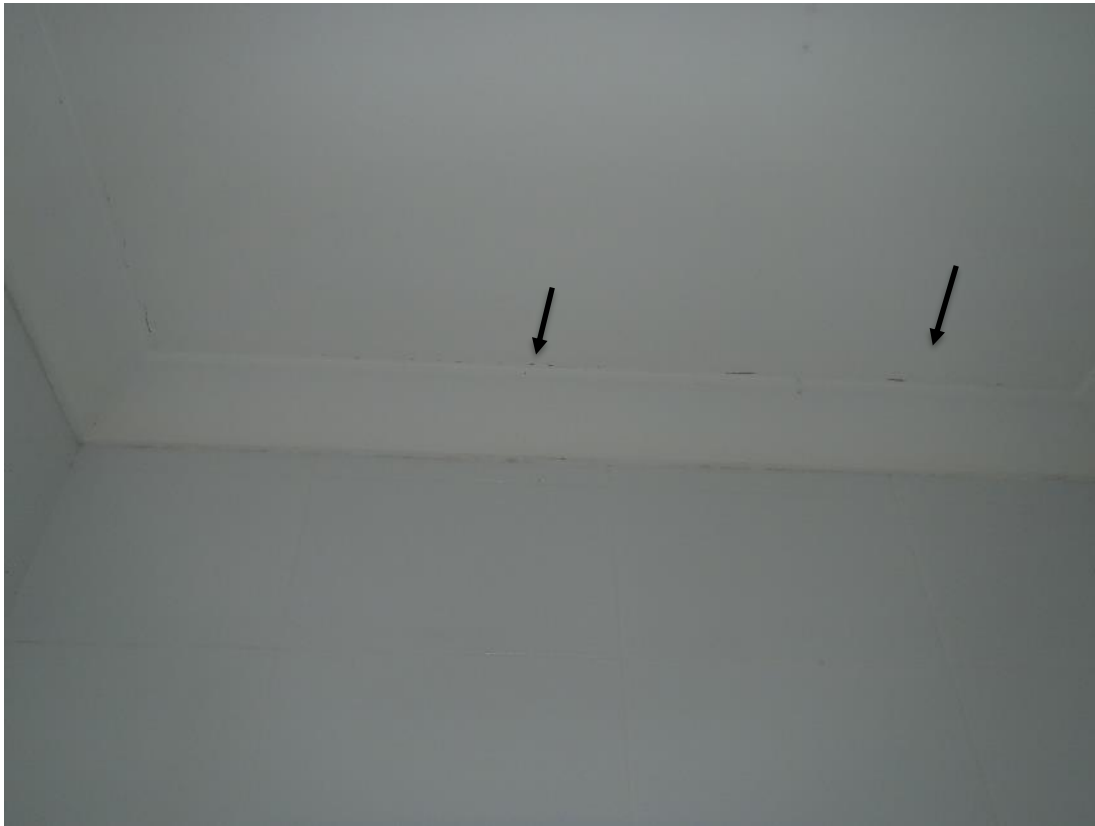
[Photograph 23]

We observed flaking/blistered paint to the plaster ceiling in the south-western corner.

Photograph 23 shows flaking/blistered paint to the plaster ceiling in the south-western corner of the Bathroom.

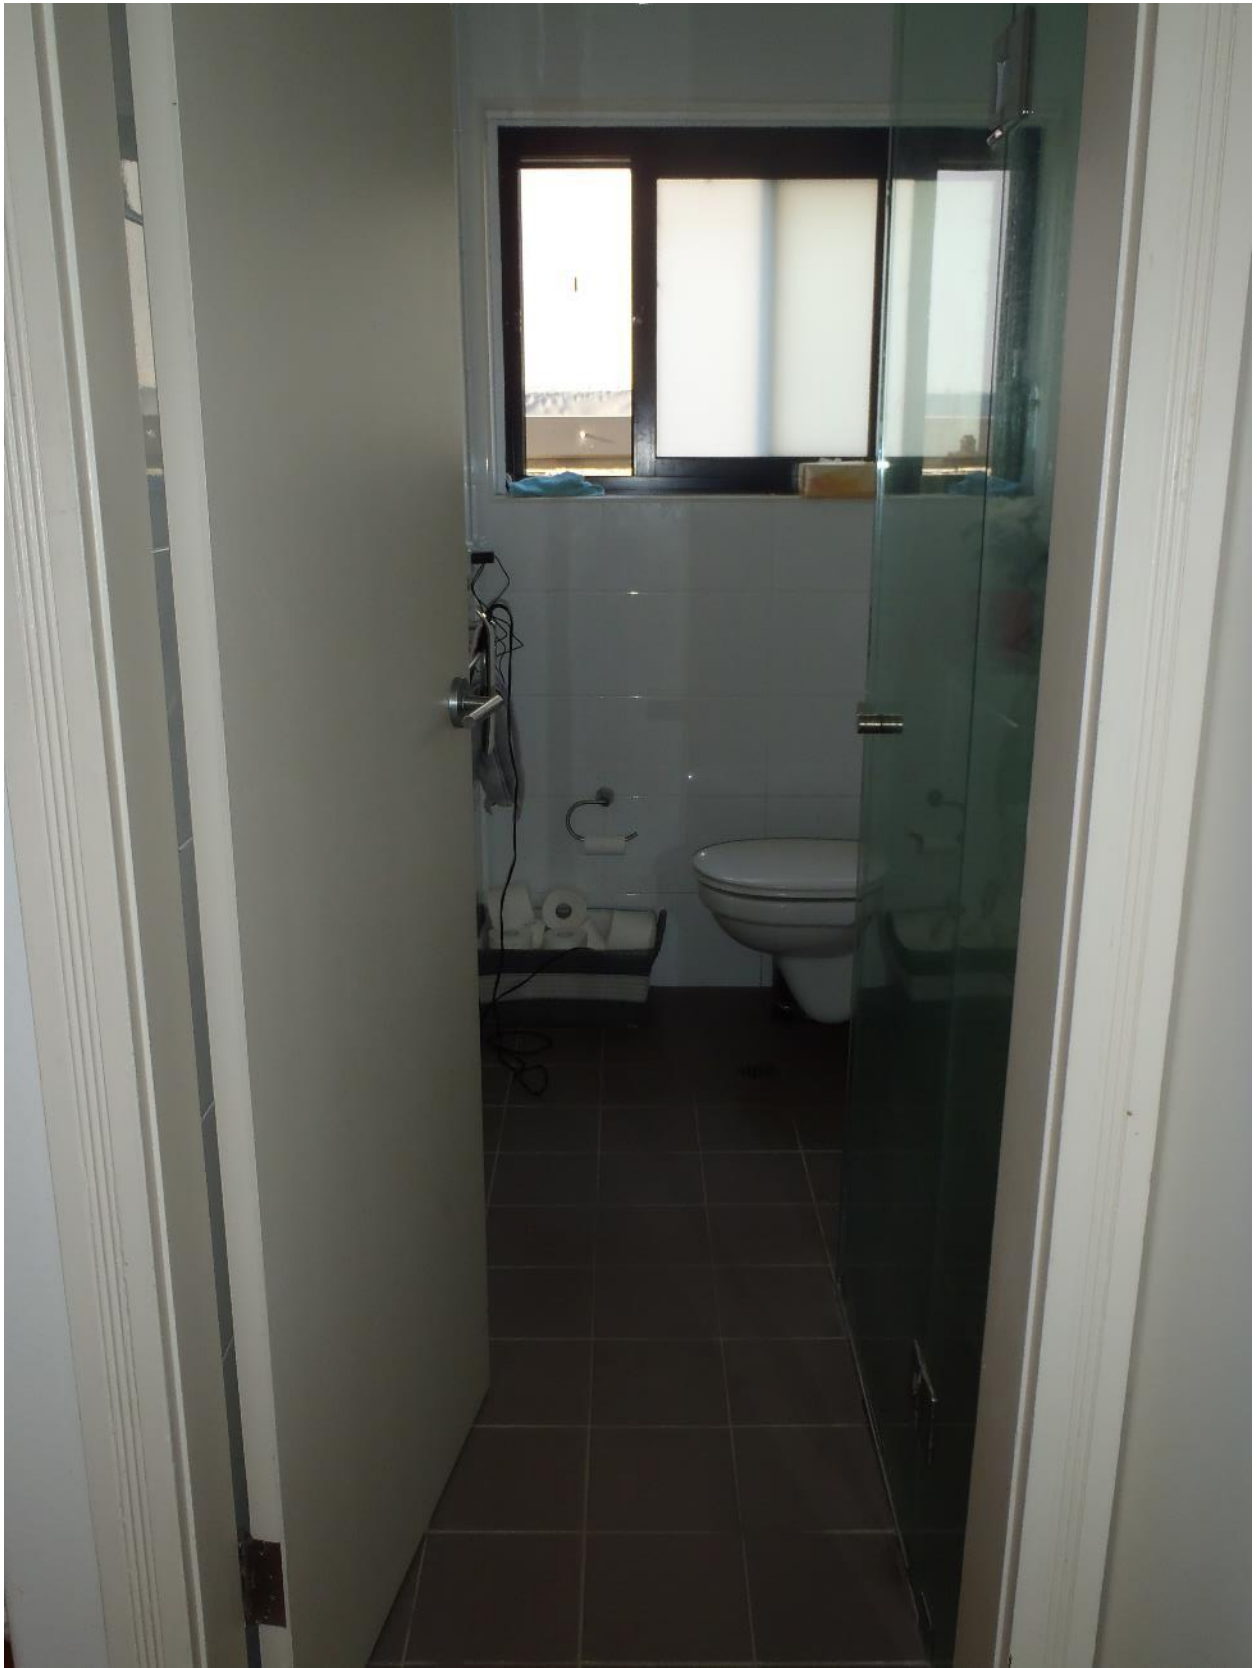
We noted that the grout to the wall and floor tiles is complete and that the wall and floor tiles when randomly “tap” tested appeared to be sound. We did not observe any recent cracking to the tile grout at the wall / wall, wall / floor junctions. **[Photograph 24]**

Photograph 24 shows the general condition of the Bathroom.

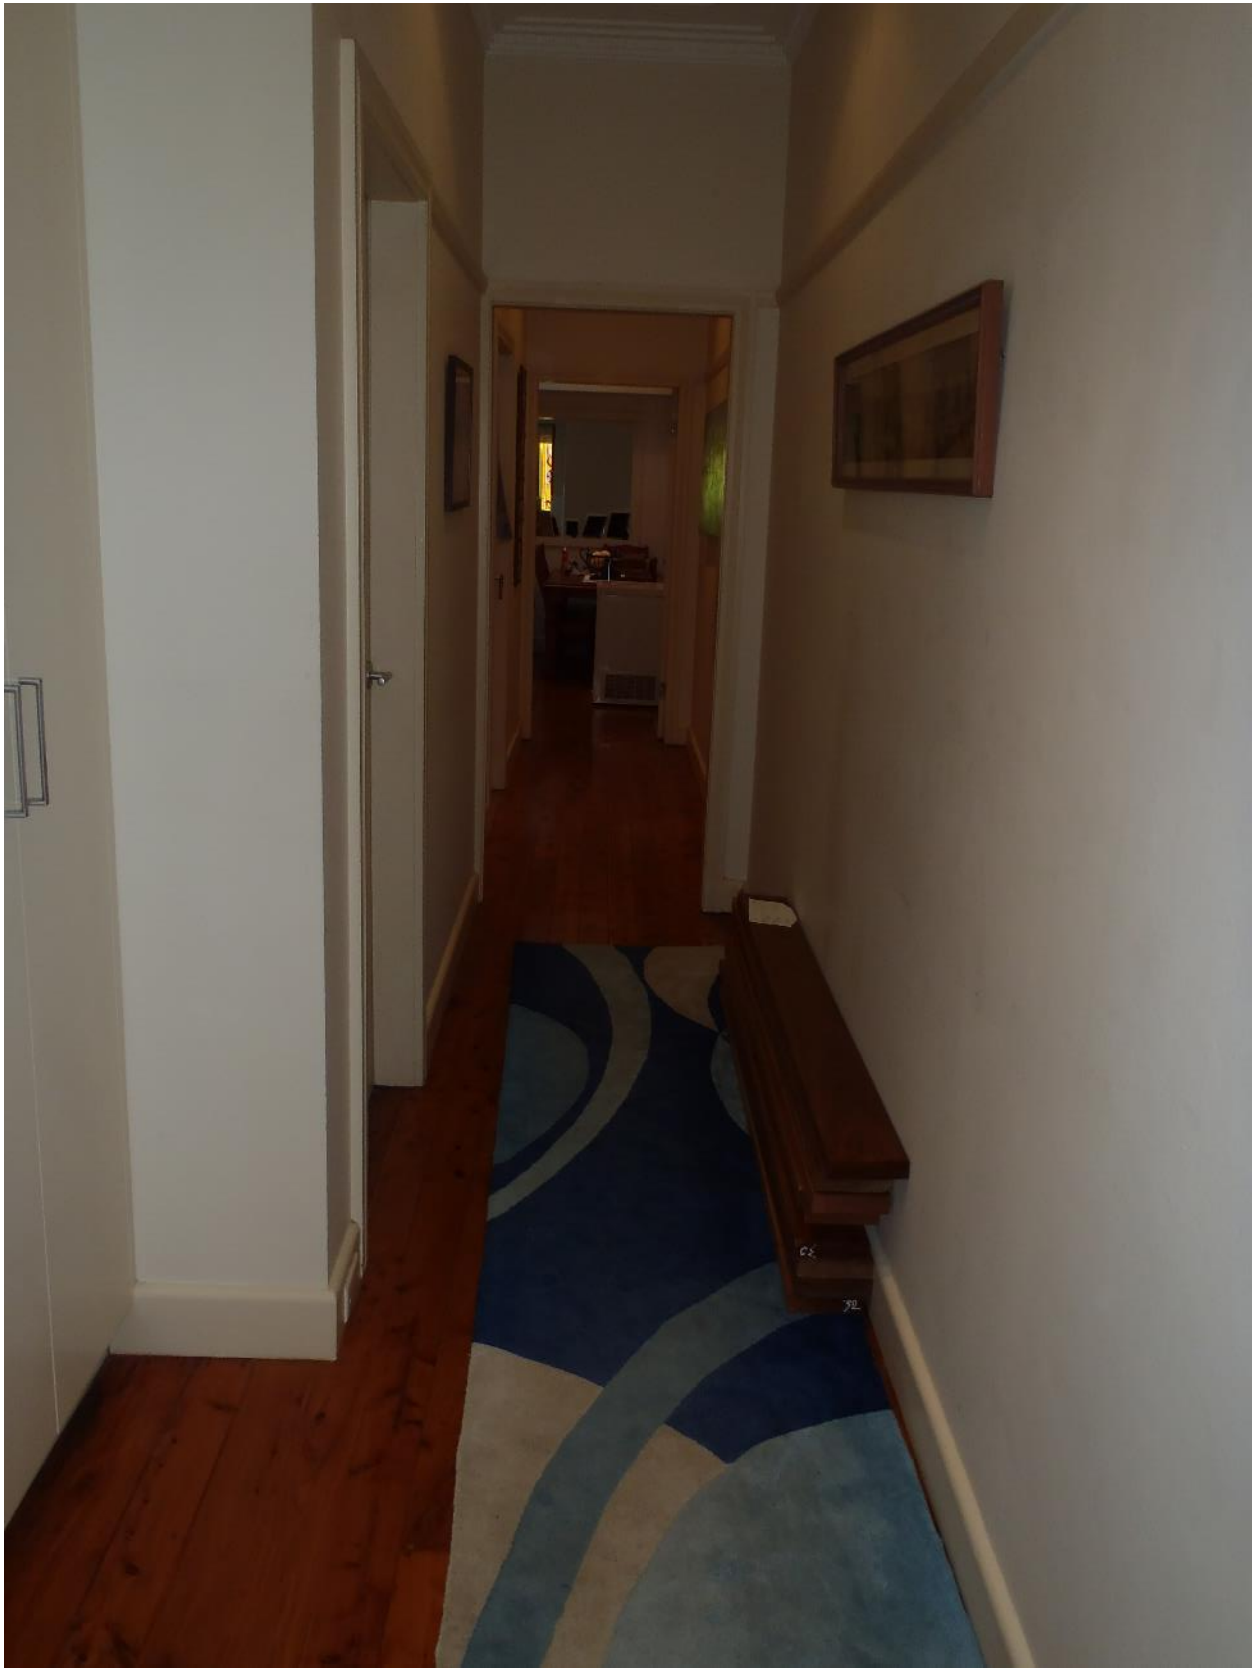
We noted that the northern wall of the hallway is the *common party / separation* wall with the adjoining property, No. 70 Nancy Street, North Bondi. **[Photograph 25]**

Photograph 25 shows the general condition of the Hallway. Note: the *common party / separation* wall.

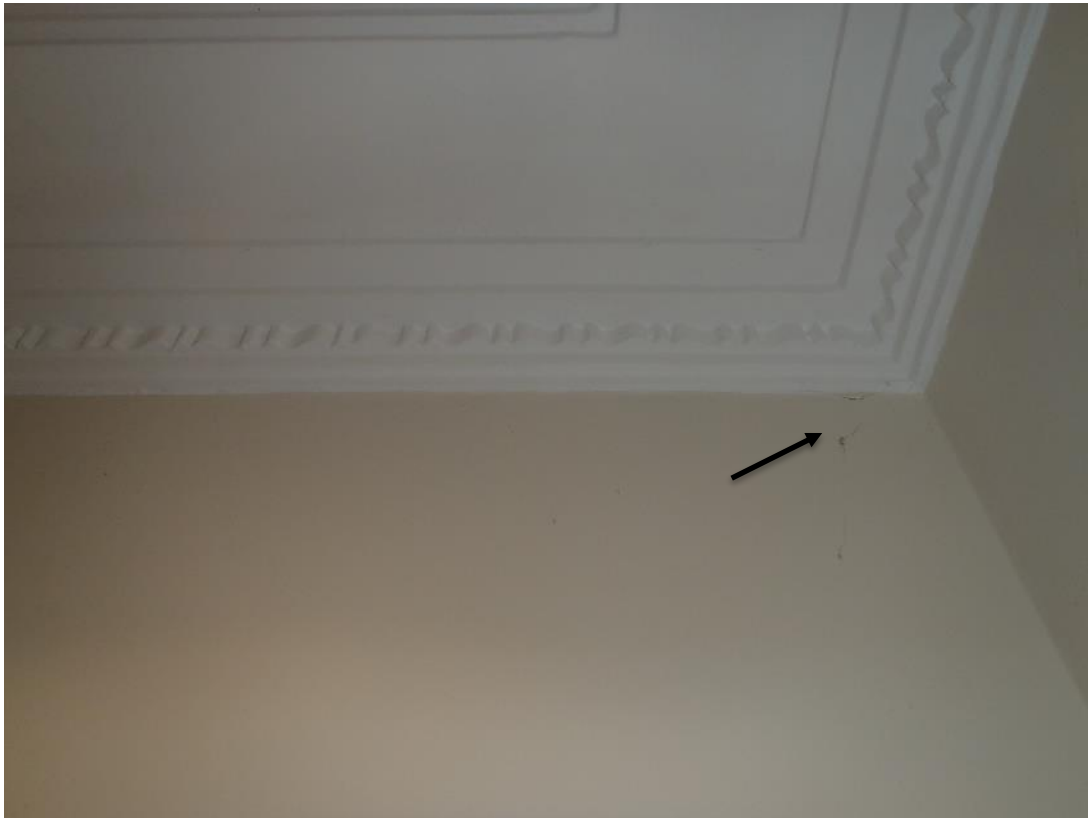
We noted separation cracking [$<1.0\text{mm}$] of the cornice from the *common party* wall in the north-east corner. **[Photograph 26]**

Photograph 26 shows separation cracking of the cornice from the *common* party wall in the north-eastern corner of the Hallway.

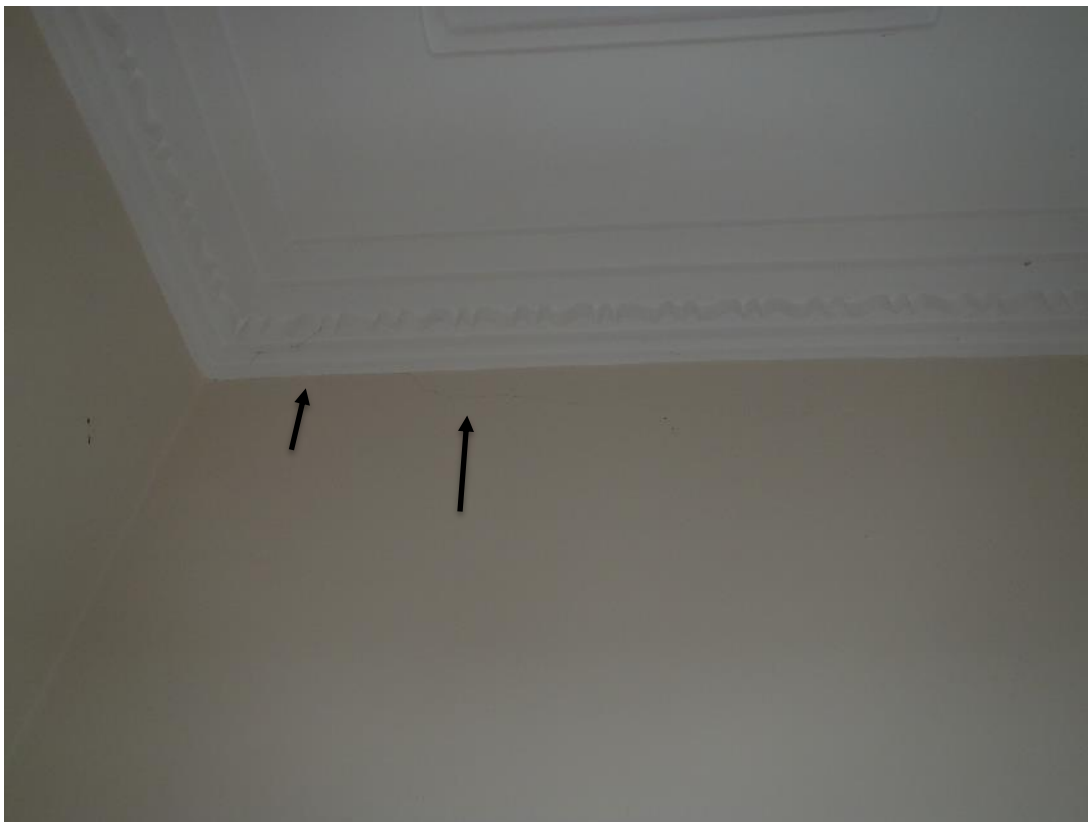
We noted hairline radial cracking [$<1.0\text{mm}$] along the cornice and the painted cement rendered *common party* wall above the hallway arch. **[Photograph 27]**

Photograph 27 shows hairline radial cracking along the cornice and the painted cement rendered *common* party wall above the hallway arch.

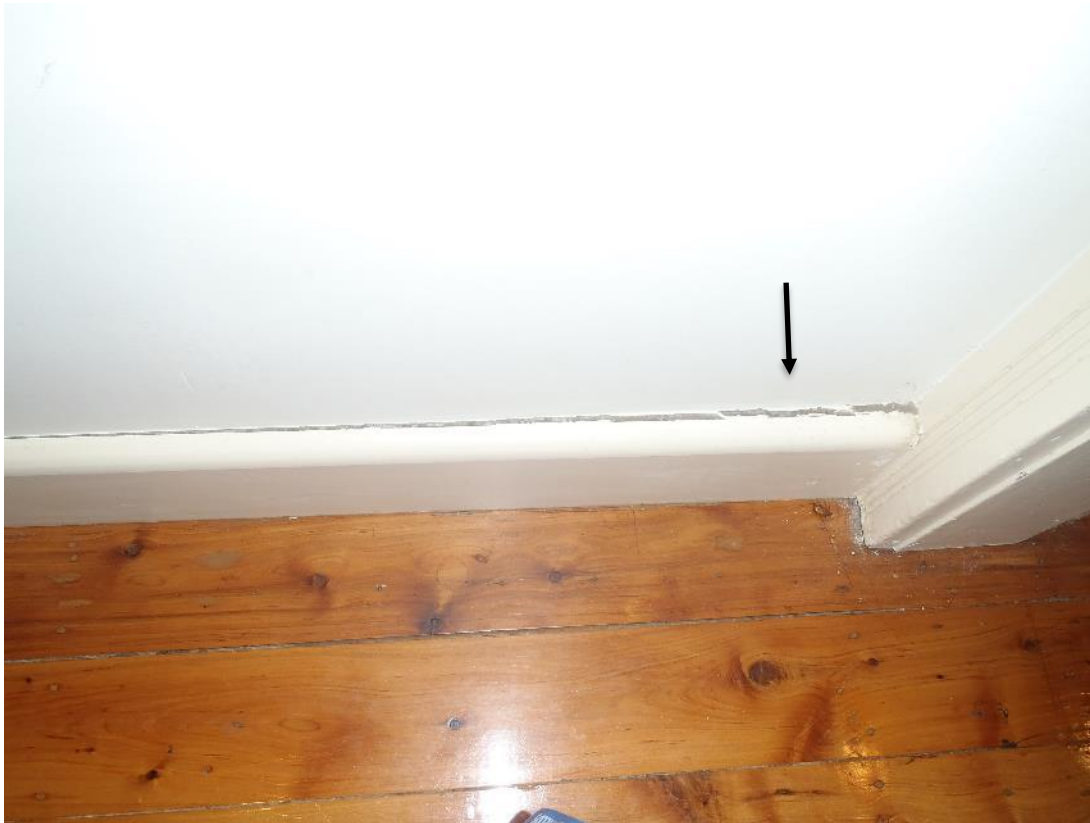
We noted separation cracking [$1.0 - 3.0\text{ mm}$] of the timber skirting from the wall surface in the western doorway. **[Photograph 28]**

Photograph 28 shows separation cracking of the timber skirting from the wall surface in the western doorway.

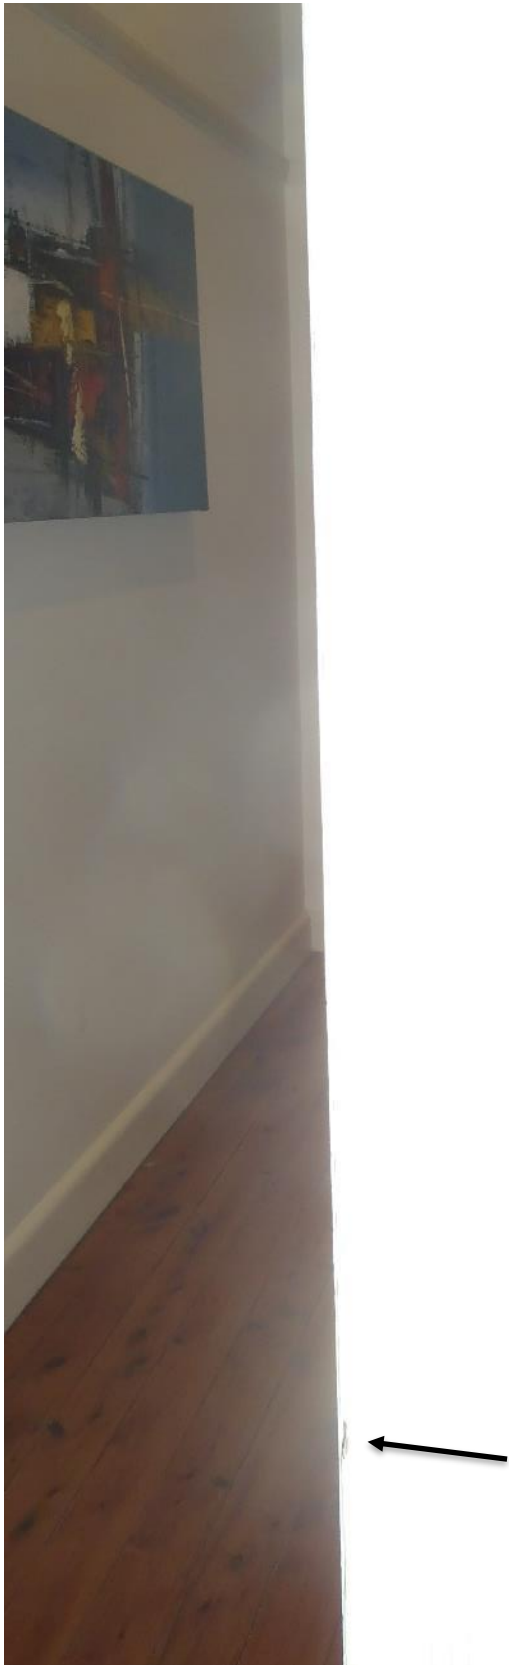
[Photograph 29]

We noted vertical cracking [1.0mm-3.0mm] along the door opening from the Hallway.

Photograph 29 shows vertical cracking along the door opening from the Hallway in the Kitchen.

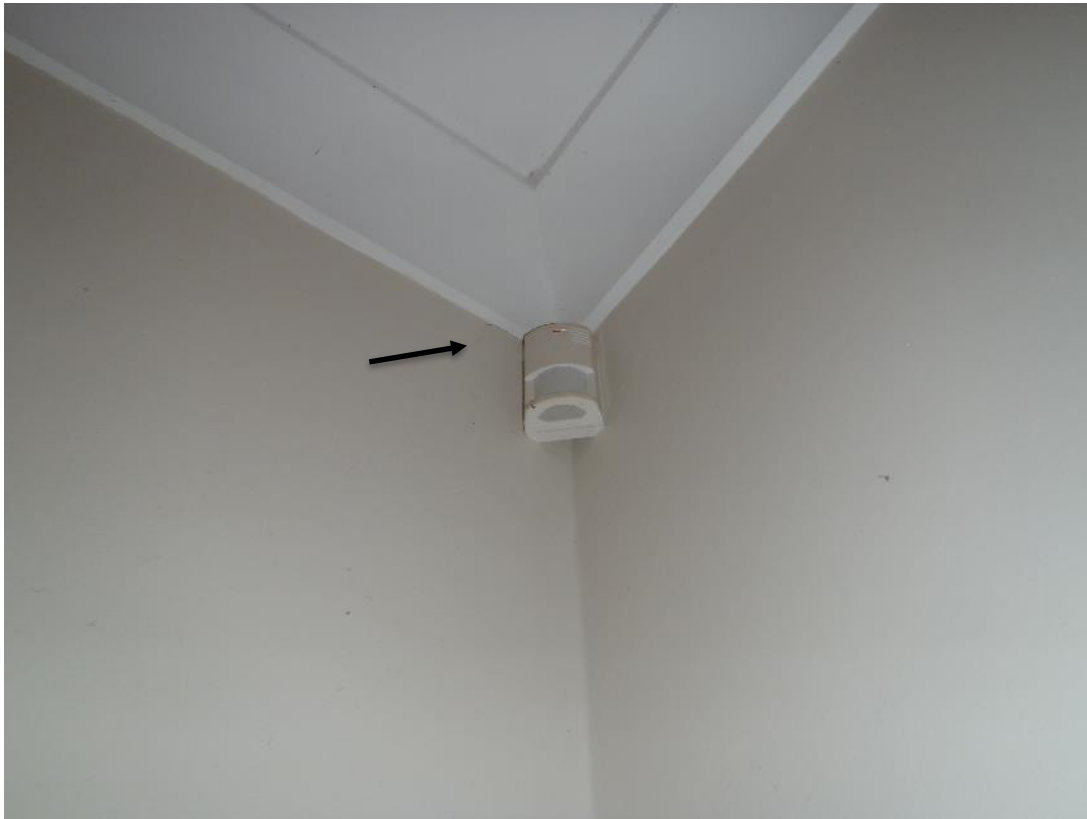
[Photograph 30]

We noted hairline radial cracking [$<1.0\text{mm}$] around the alarm sensor in the north-eastern corner.

Photograph 30 shows radial cracking around the alarm sensor in the north-eastern corner in the Kitchen.

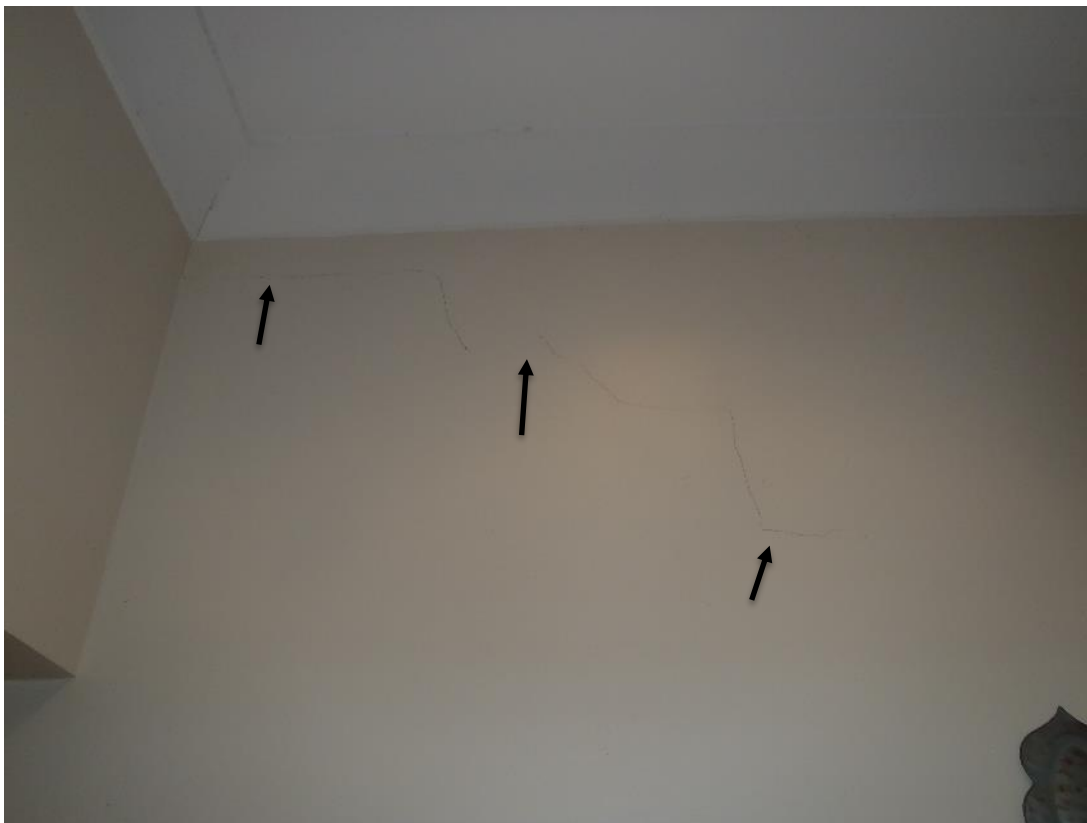
We noted step cracking [$<1.0\text{mm}$] along the painted cement rendered *common* party wall in the north-western corner. **[Photograph 31]**

Photograph 31 shows step cracking along the painted cement rendered *common* party wall in the north-western corner of the Kitchen.

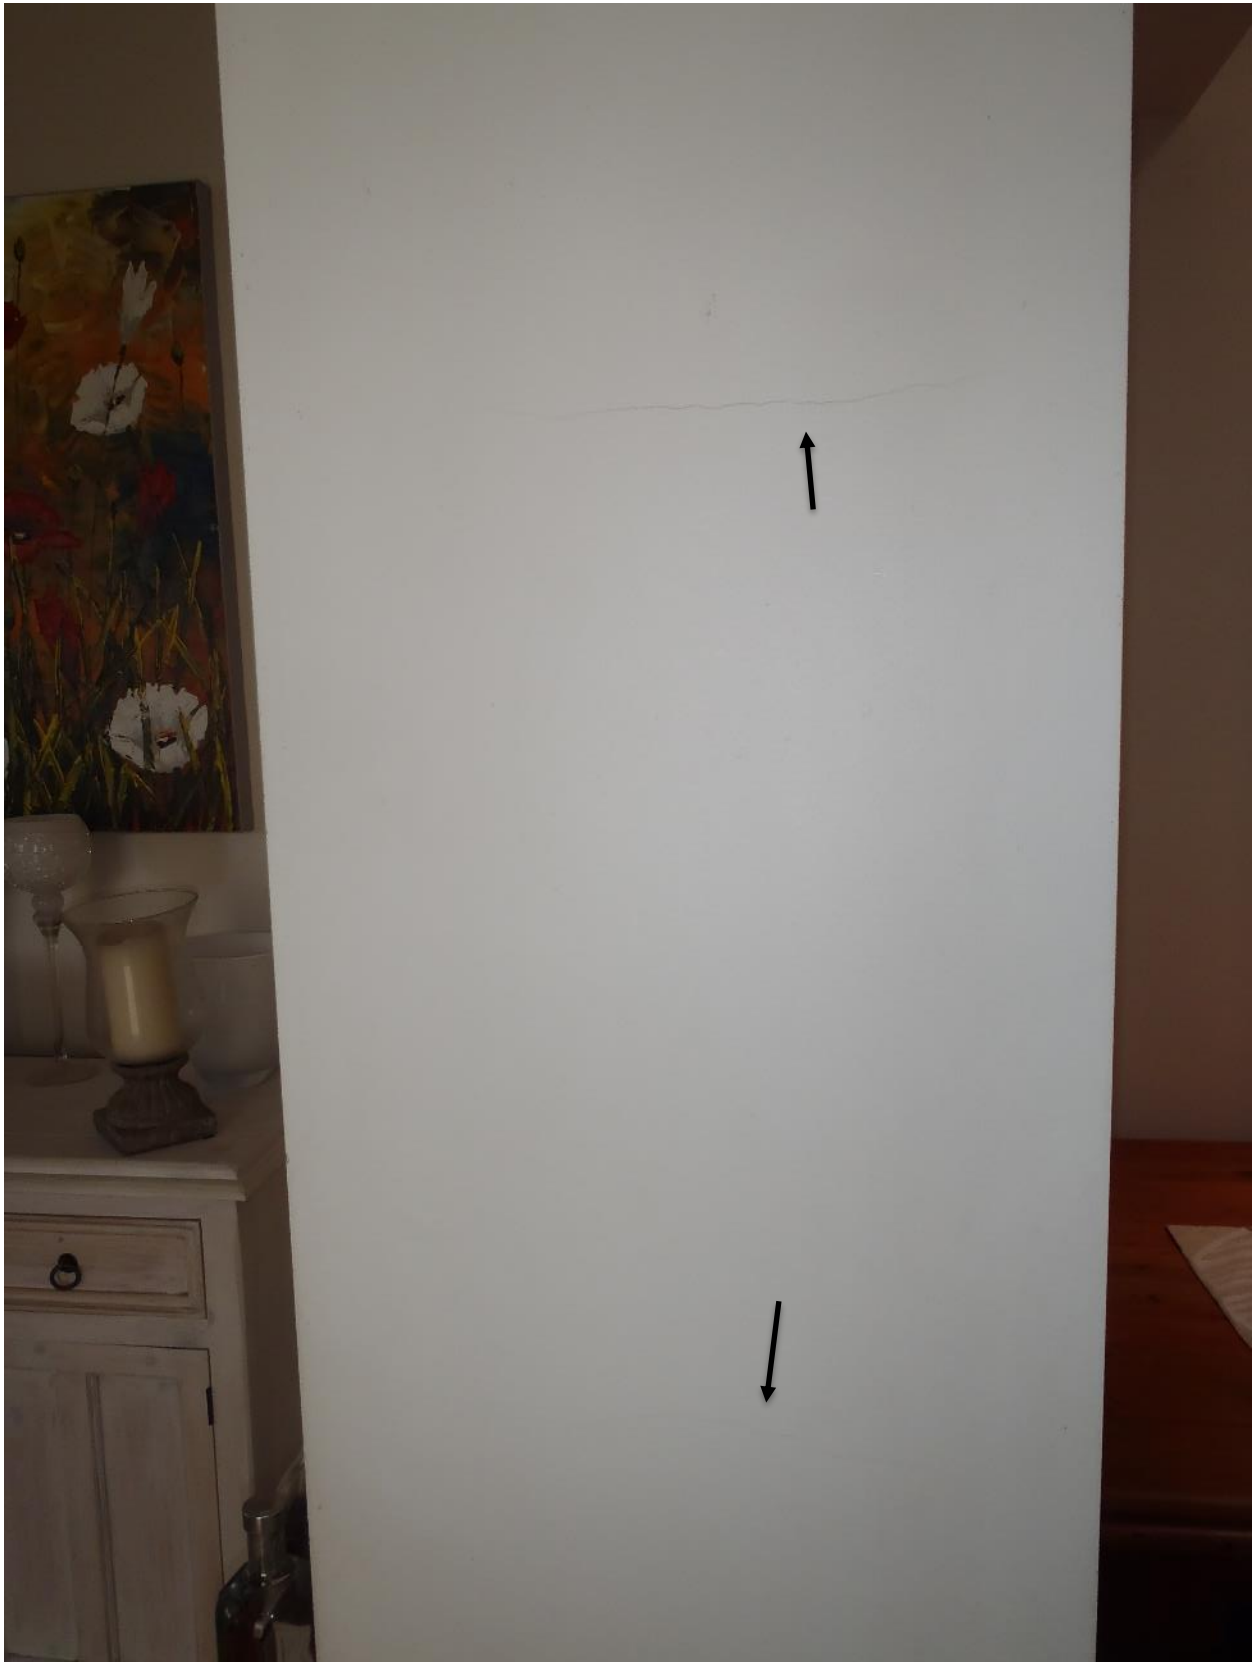
[Photograph 32]

We noted hairline horizontal cracking [$<1.0\text{mm}$] to the wall end common with the Kitchen.

Photograph 32 shows hairline horizontal cracking to the wall end common with the Kitchen and the Lounge Room.

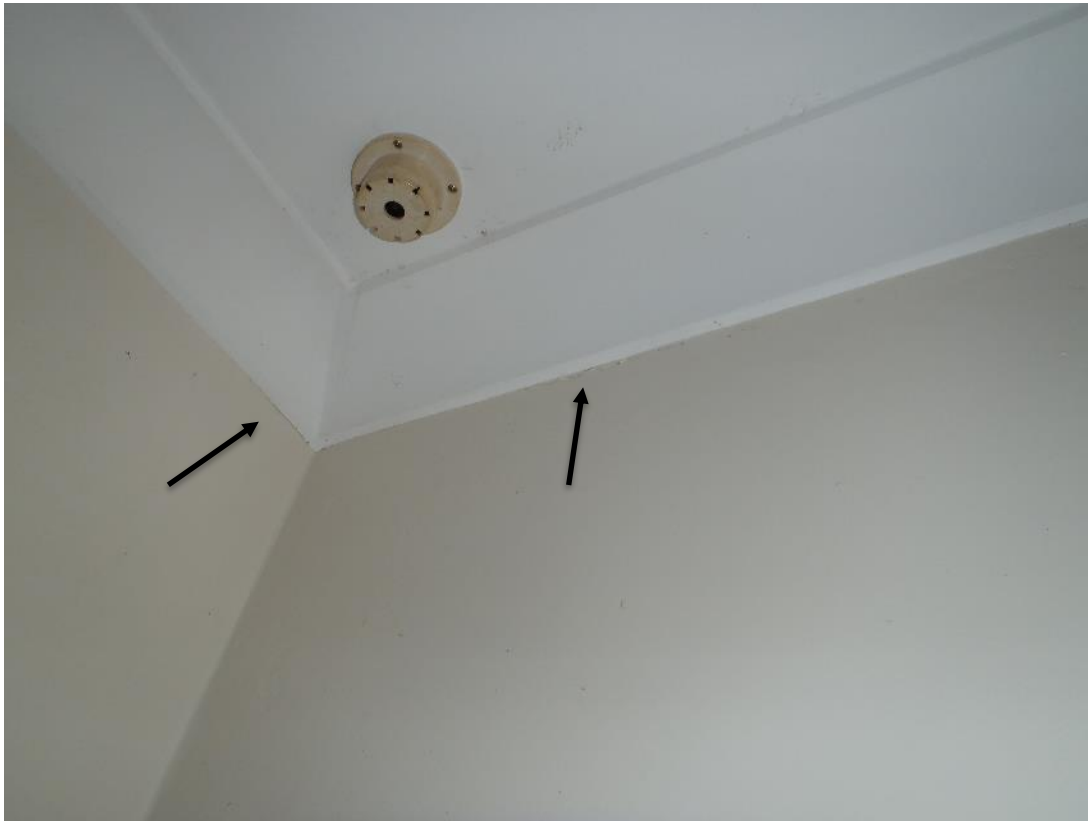
We noted separation cracking [$<1.0\text{mm}$] of the cove profiled plaster cornice from the wall surface in the north-eastern corner. **[Photograph 33]**

Photograph 33 shows separation cracking of the cove profiled plaster cornice from the wall surface in the north-eastern corner of the Lounge Room.

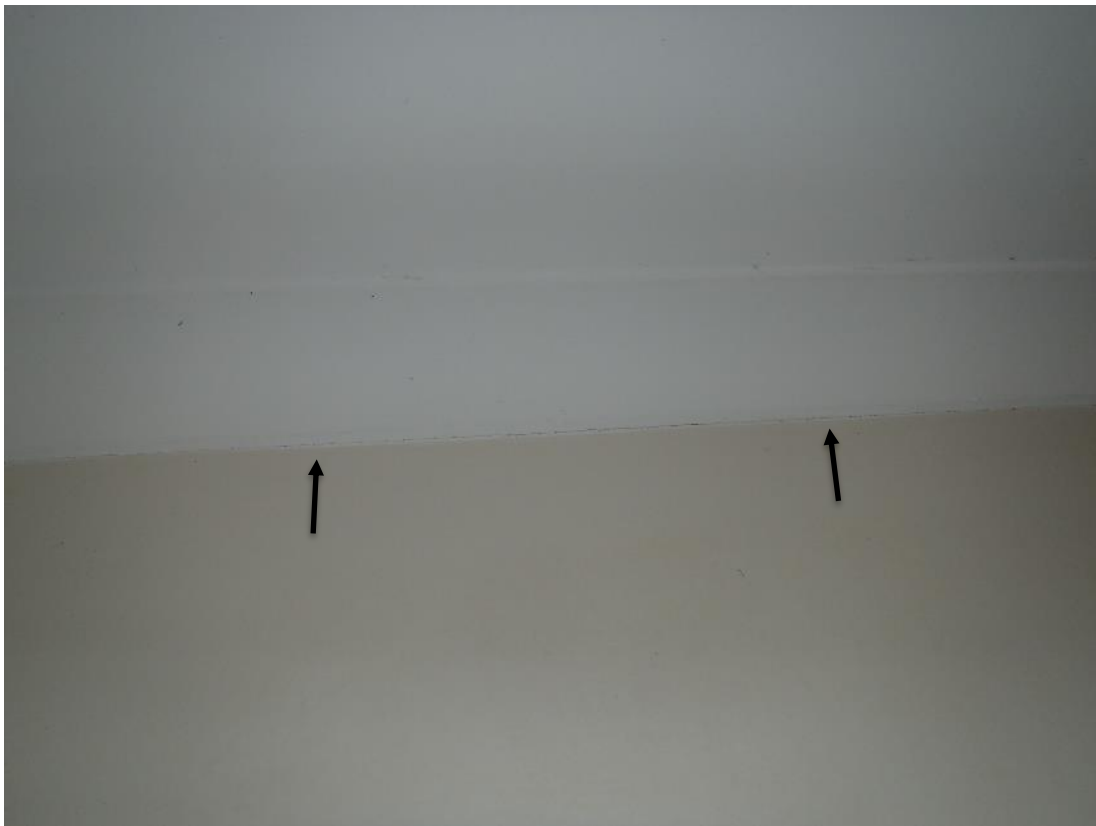
We noted separation cracking [$<1.0\text{mm}$] of the cove profiled plaster cornice from the wall surface along the painted cement rendered *common* party wall. **[Photograph 34]**

Photograph 34 shows separation cracking of the cove profiled plaster cornice from the wall surface along the painted cement rendered *common* party wall in the Lounge Room.

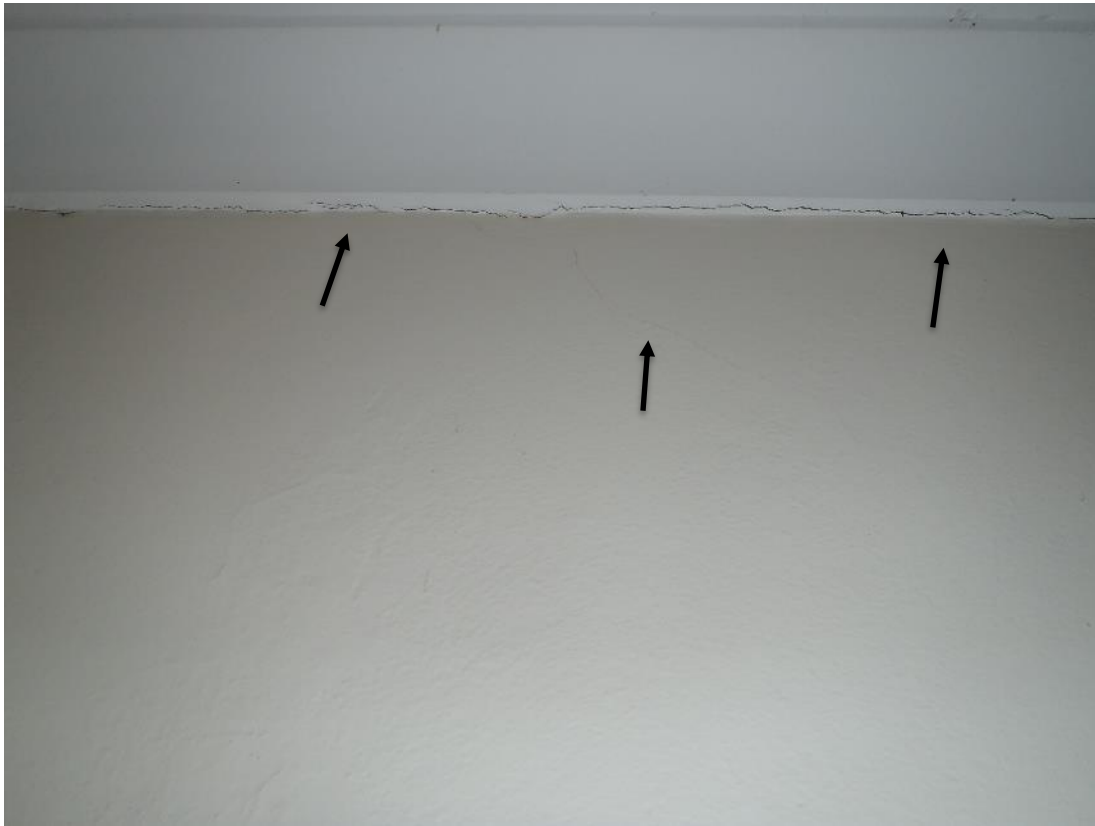
We noted separation cracking [$<1.0\text{mm}$] of the cove profiled plaster cornice from the southern elevation wall surface and down the cement rendered wall surface. **[Photograph 35]**

Photograph 35 shows separation cracking of the cove profiled plaster cornice from the southern elevation wall surface and down the cement rendered wall surface in the Lounge Room.

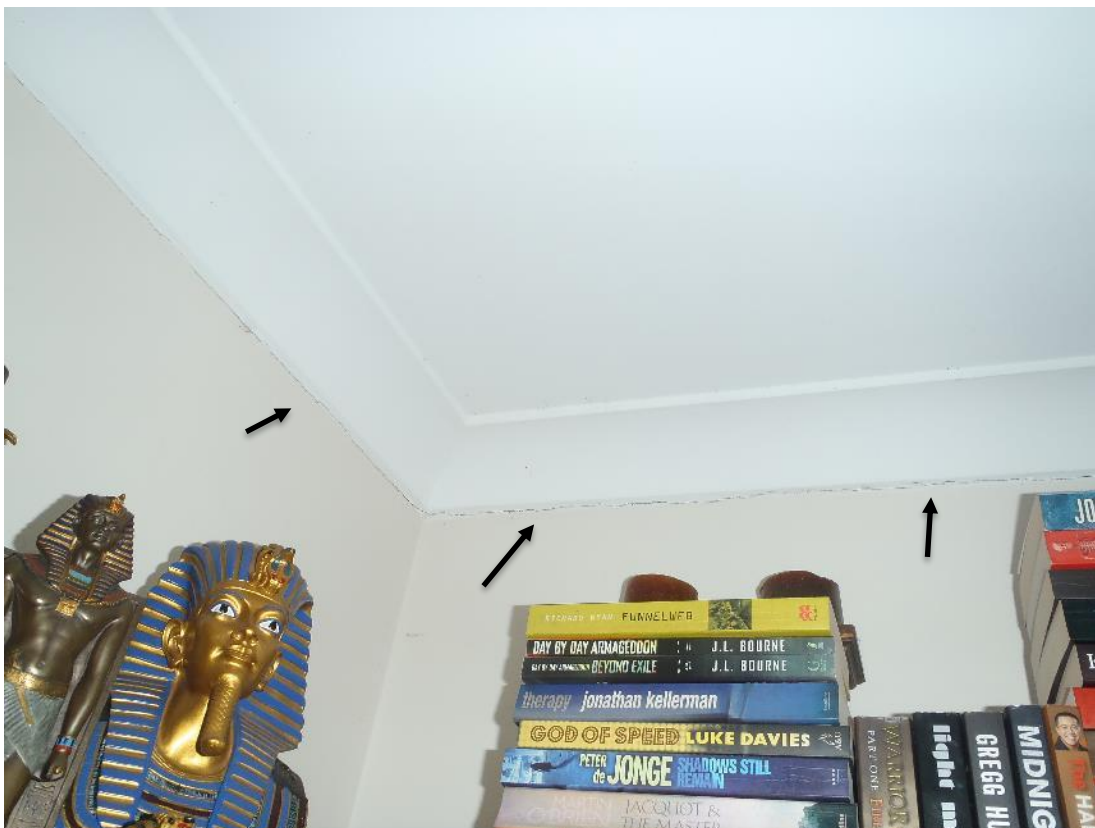
We noted separation cracking [$<1.0\text{mm}$] of the cove profiled plaster cornice from the wall surface in the south-eastern corner. **[Photograph 36]**

Photograph 36 shows separation cracking of the cove profiled plaster cornice from the wall surface in the south-eastern corner in the Lounge Room.

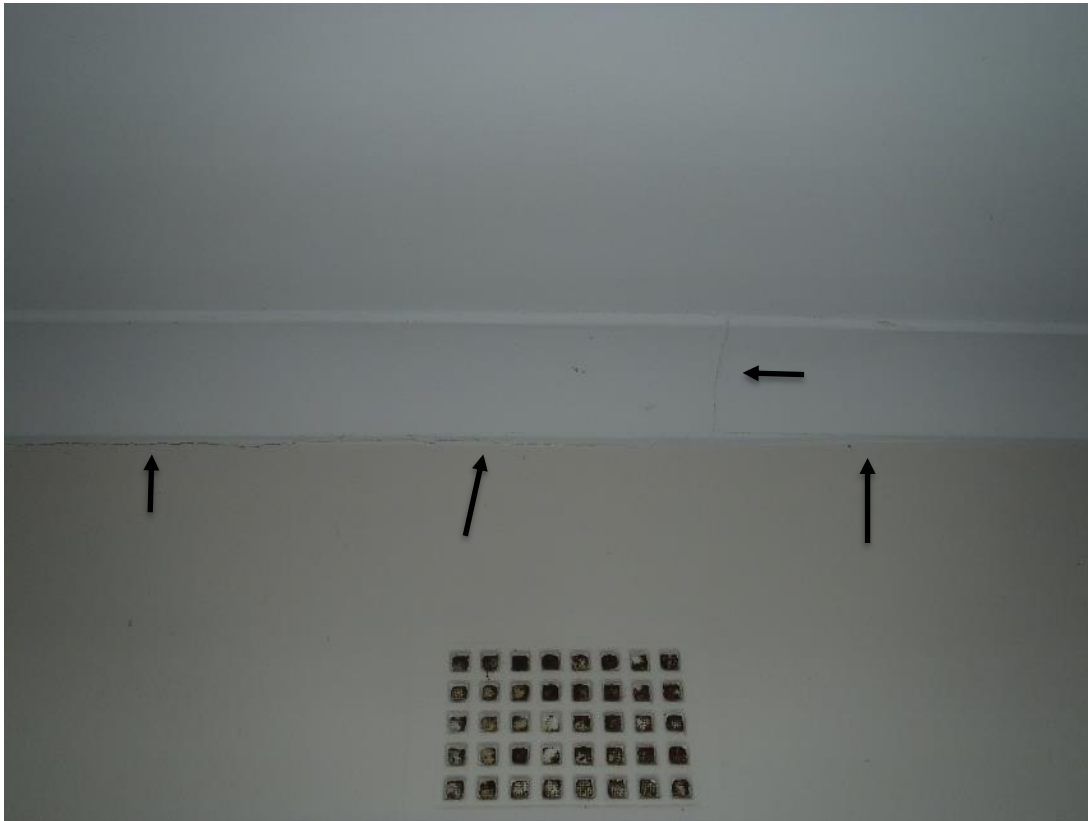
[Photograph 37]

We noted separation cracking [$<1.0\text{mm}$] of the cove profiled plaster cornice from the southern elevation wall surface and to the joint in the plaster cornice in the south-western corner.

Photograph 37 shows separation cracking of the cove profiled plaster cornice from the southern elevation wall surface and to the joint in the plaster cornice in the south-western corner of the Lounge Room.
