HAZARDOUS MATERIALS ASSESSMENT REPORT

Client: Cape Cod Australia Pty. Limited

Job details: Owner/s: Mr. J. Martin & Ms. M. Bower
Location: 12 Banks Street, Ashfield NSW

Our reference: HM04850416

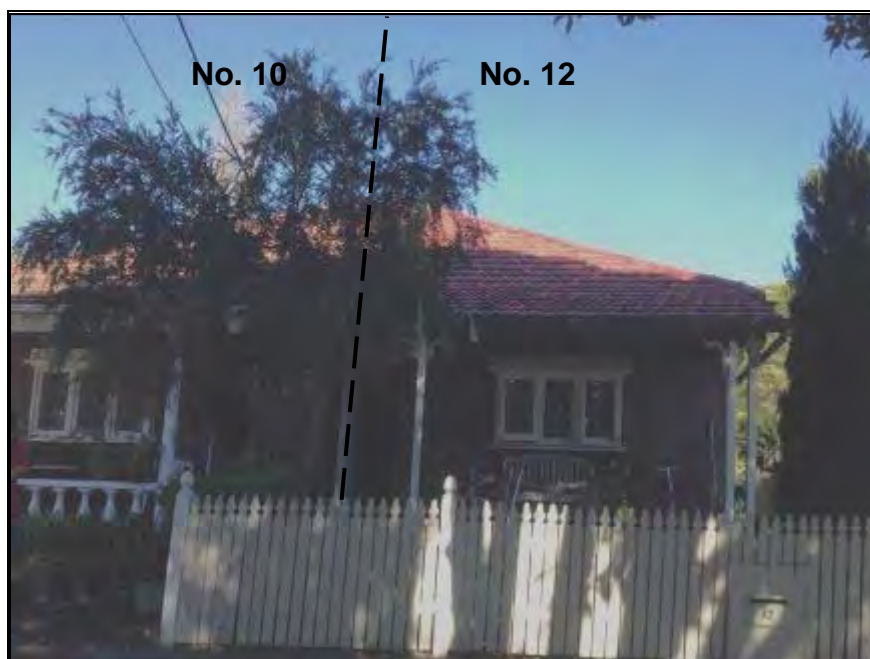
Front north eastern elevation of the adjoining properties:
No. 10 & No. 12 Banks Street, Ashfield
