## **HAZARDOUS MATERIALS ASSESSMENT REPORT**

**Job details:** Owner/s: Mr. M. Eadie & Mrs. K. Smit-Eadie  
Location: 45 Baker Street, Oatley NSW

**Our reference:** HM04180815

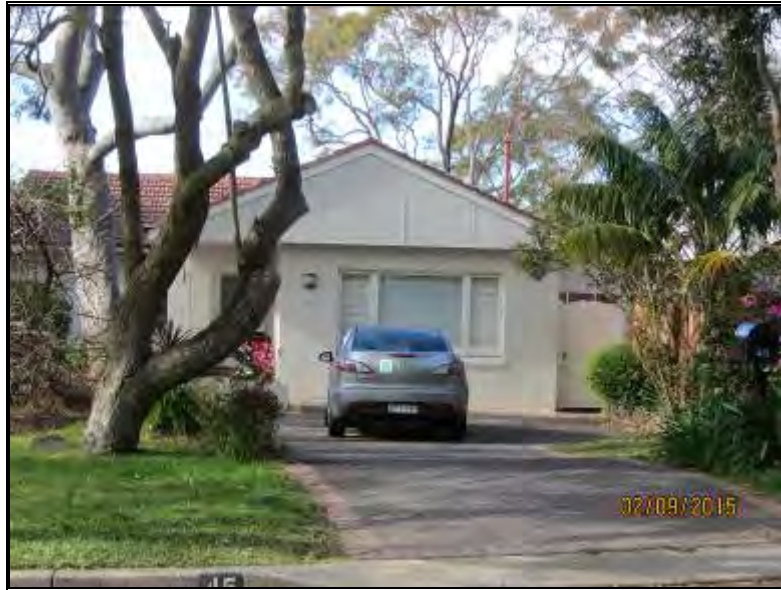
Front north western elevation of the residence
