HAZARDOUS MATERIALS ASSESSMENT REPORT

Job details: Owner: Mr. P. & Mrs. L. Green.
Location: 3 Argyle Avenue, Ryde.

Our reference: HM06030917

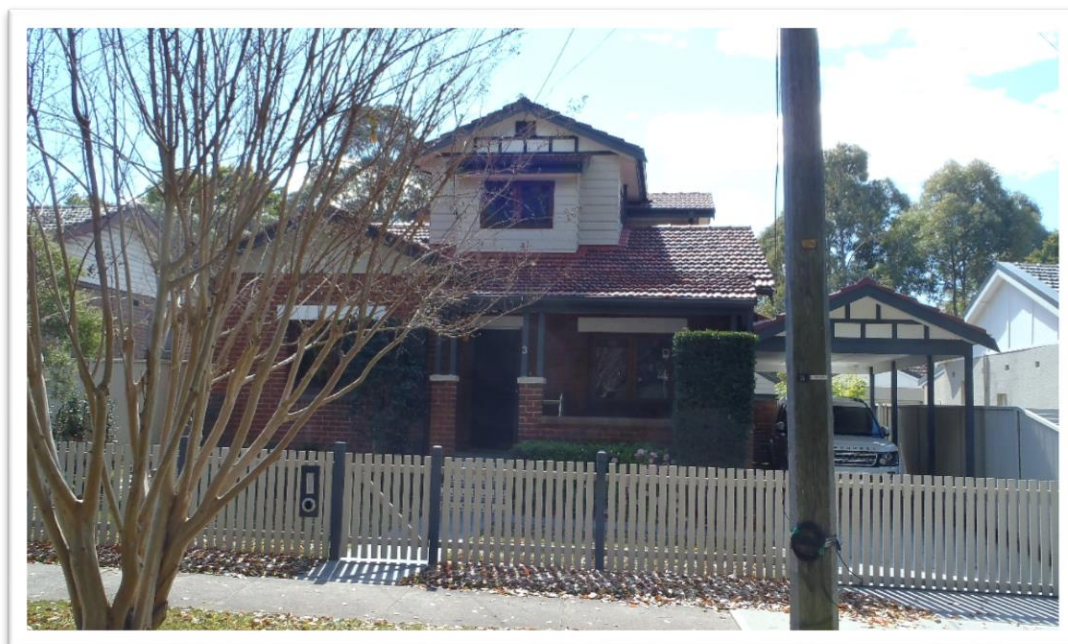
Front south western elevation of the residence
